UT to Magness Creek Mitigation Project

Year 1 (2023) Monitoring Report FINAL

Cleveland County, North Carolina

DMS Project ID No. 100081

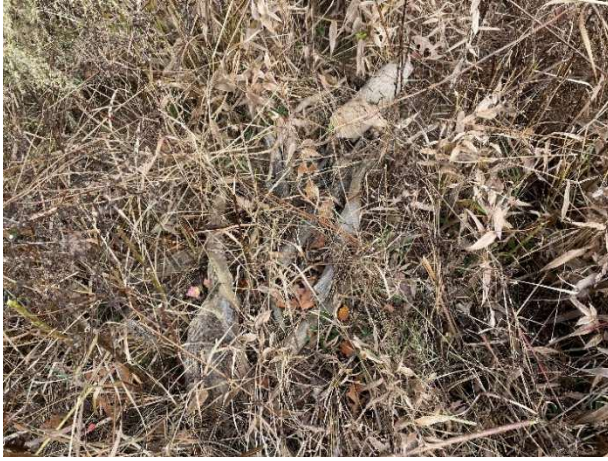
During Year 1 monitoring, one post-construction bankfull event was observed. This event occurred on 3/15/2023 as documented by a spike in the water levels shown in the data from automated Crest Gauge 1 on R1A (Table 10). Woody debris indicating an overbank event was visible on the floodplains throughout the project during MY1; however, this evidence is difficult to attribute to one rain event and therefore is not mentioned in Table 10. Examples of these occurrences are shown in Appendix B, Monitoring Gauges and Additional Photographs.

Overbank evidence. Debris in upper Reach 1B floodplain (Photo taken November 16, 2023)

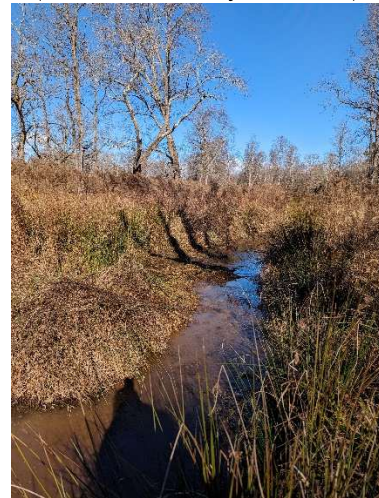
General: As discussed in the MY0 IRT comments, the IRT would like a condition update and additional photos at Photo Point 10 where there was a reported mid-channel bar (see IRT comments (E. Davis) for further detail).

Mid-Channel Bar Repair on Reach 1A (Photo taken December 6, 2023)

1. Photo Point 10 – A vegetated mid channel bar is shown. This appears to the approximate location where bedrock was encountered, and the channel was widened. Please include a condition update and additional photos in the MY1 report, including whether proposed hand repairs were completed.

RESPONSE: The mid-channel bar was repaired by hand using shovels to fill in one side of the split channel. A photo of the repair is shown in Appendix B, Monitoring Gauges and Additional Photographs, Page 2. The photo was taken on December 6, 2023 and at that time the repair appeared to be intact, with the channel maintaining a single thread.

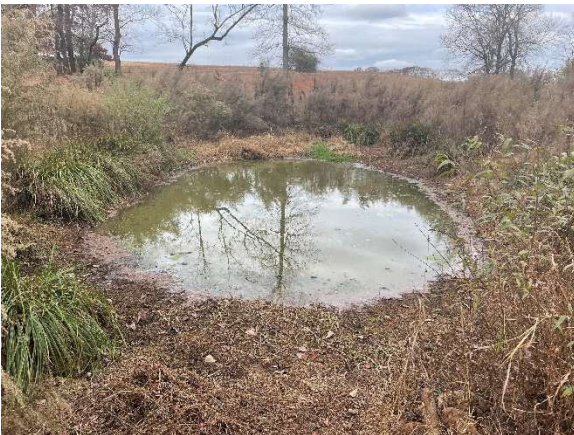
BMP. Lower Reach 1A. (Photo taken November 16, 2023)

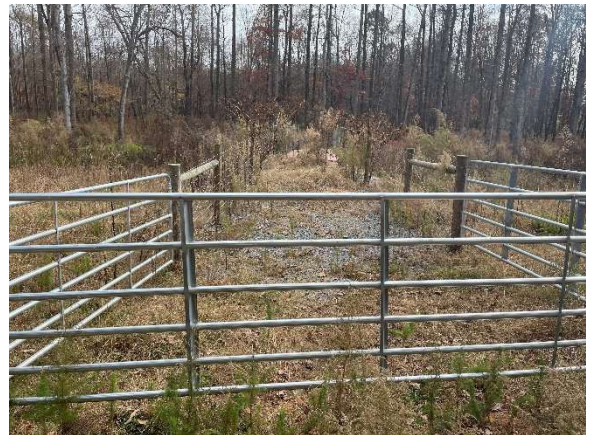
Gate at Railroad Bridge Crossing. Below Reach 1A. (Photo taken November 16, 2023)

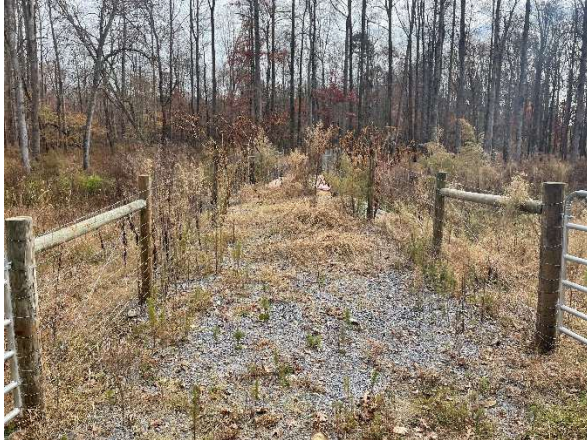
Railroad Bridge Crossing. Below Reach 1A. (Photo taken November 16, 2023)

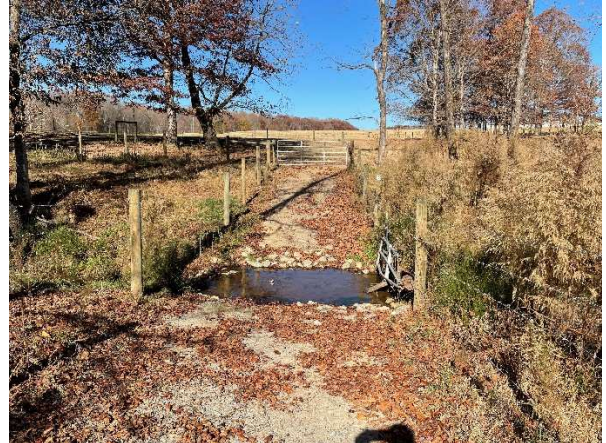
Crossing at terminus of project. (Photo taken November 16, 2023)

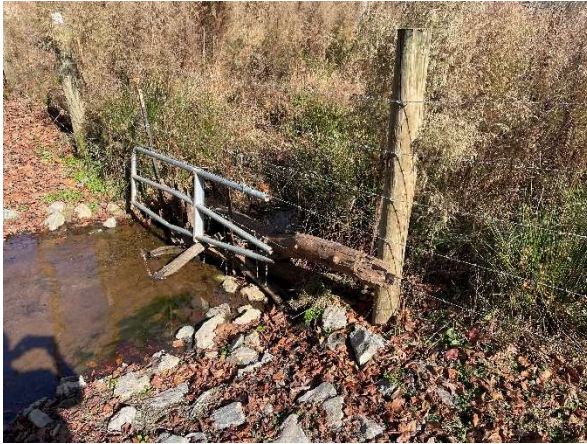
Fence in crossing. Bottom of Reach 1B. (Photo taken November 16, 2023)

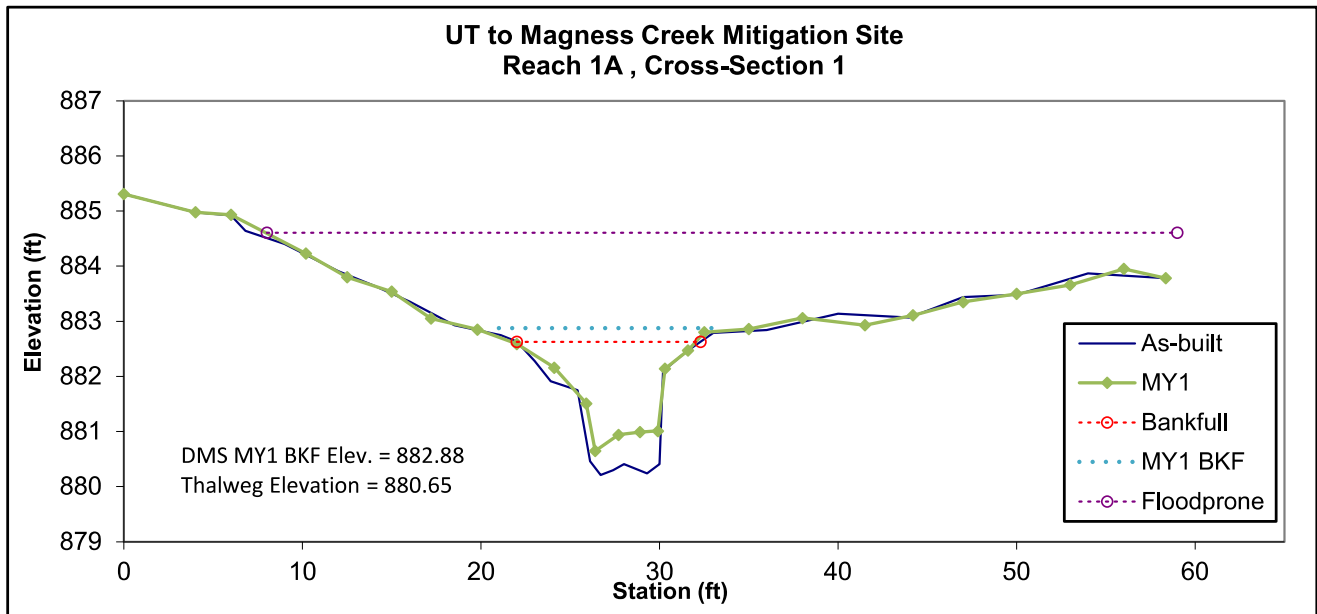
Permanent Cross-Section 1

Feature	Stream Type	BKF Area	BKF Width	BKF Depth	Max BKF Depth	W/D	BH Ratio	ER	BKF Elev	LTOB Elev
Riffle	C4	9.6	10.4	0.9	2.0	11.2	0.9	2.9	882.63	882.60

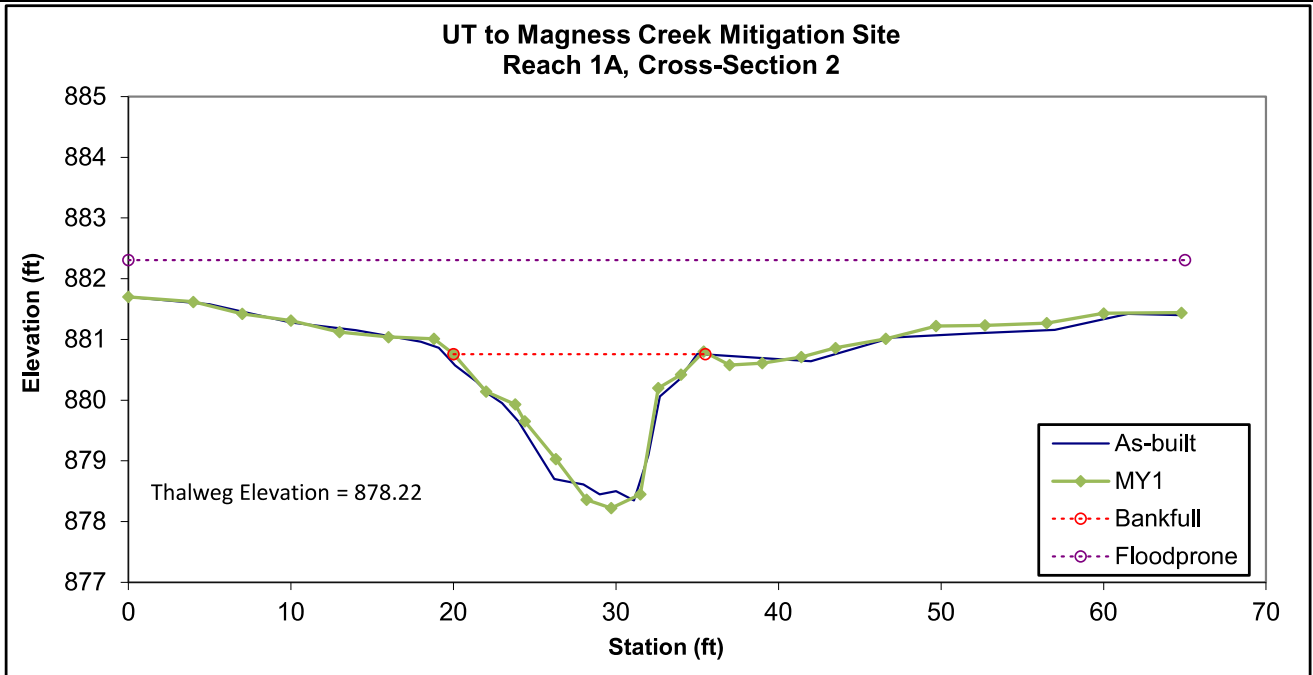
Permanent Cross-Section 2
 Year 1 Survey Collected: November 2023

Feature	Stream Type	BKF Area	BKF Width	BKF Depth	Max BKF Depth	W/D	BH Ratio	ER	BKF Elev	LTOB Elev
Pool	C4	19.6	15.3	1.3	2.5	11.9	--	--	880.76	880.76

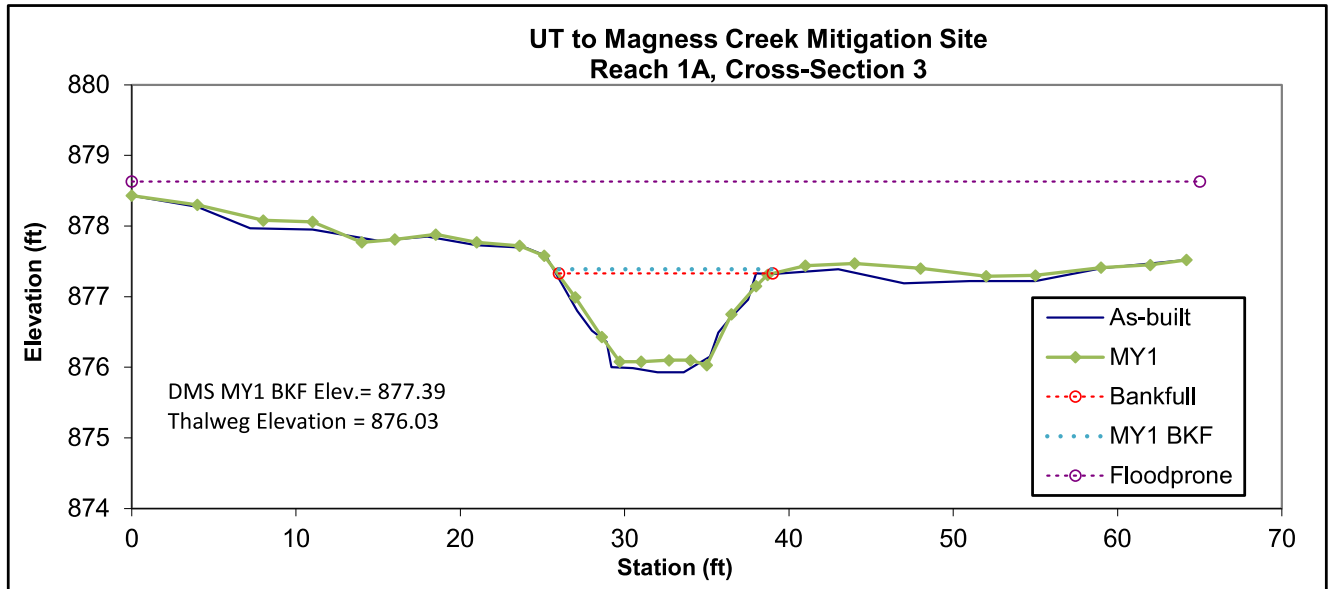
Permanent Cross-Section 3
 Year 1 Survey Collected: November 2023

Feature	Stream Type	BKF Area	BKF Width	BKF Depth	Max BKF Depth	W/D	BH Ratio	ER	BKF Elev	LTOB Elev
Riffle	C4	11.0	13.1	0.8	1.3	15.7	1.0	2.5	877.33	877.33

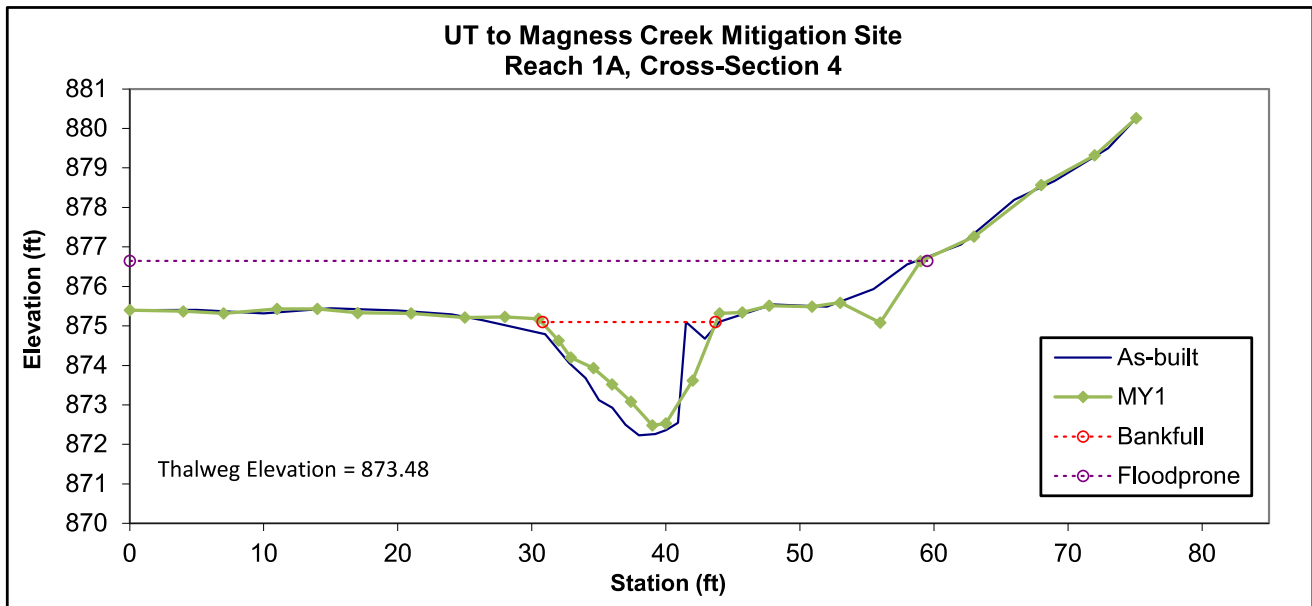
Permanent Cross-Section 4
 Year 1 Survey Collected: November 2023

Feature	Stream Type	BKF Area	BKF Width	BKF Depth	Max BKF Depth	W/D	BH Ratio	ER	BKF Elev	LTOB Elev
Pool	C4	18.8	13.2	1.4	2.6	9.3	--	--	875.10	875.18

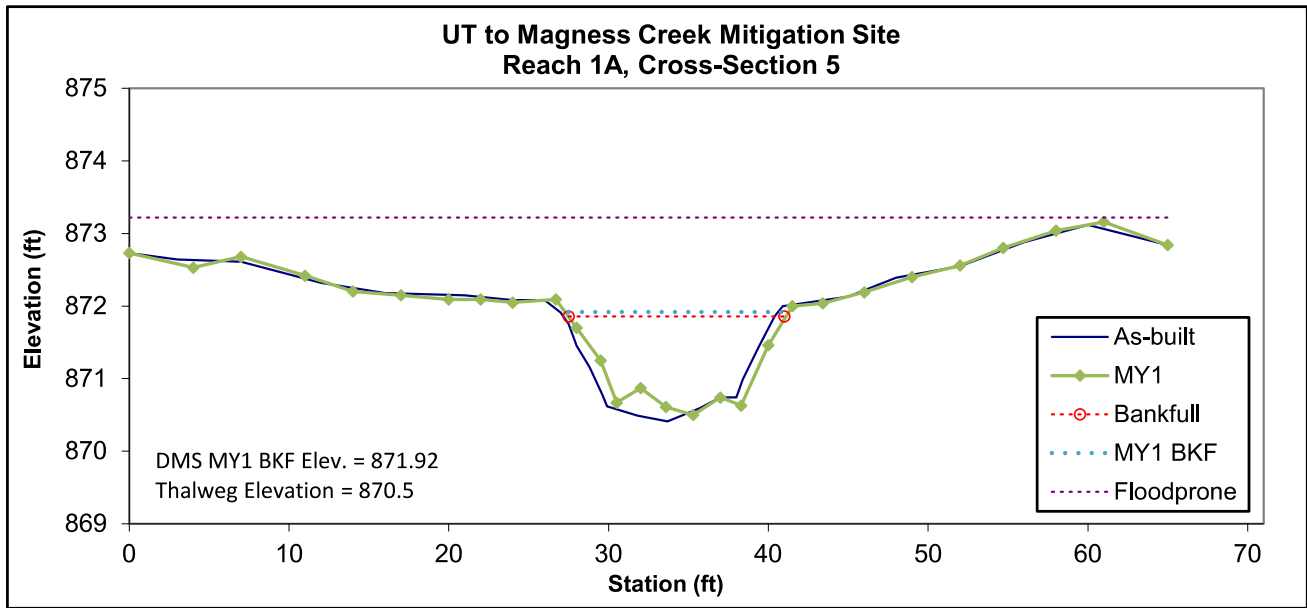
Permanent Cross-Section 5

Feature	Stream Type	BKF Area	BKF Width	BKF Depth	Max BKF Depth	W/D	BH Ratio	ER	BKF Elev	LTOB Elev
Riffle	C4	12.4	13.6	0.9	1.4	15.0	1.1	2.5	871.86	872.00

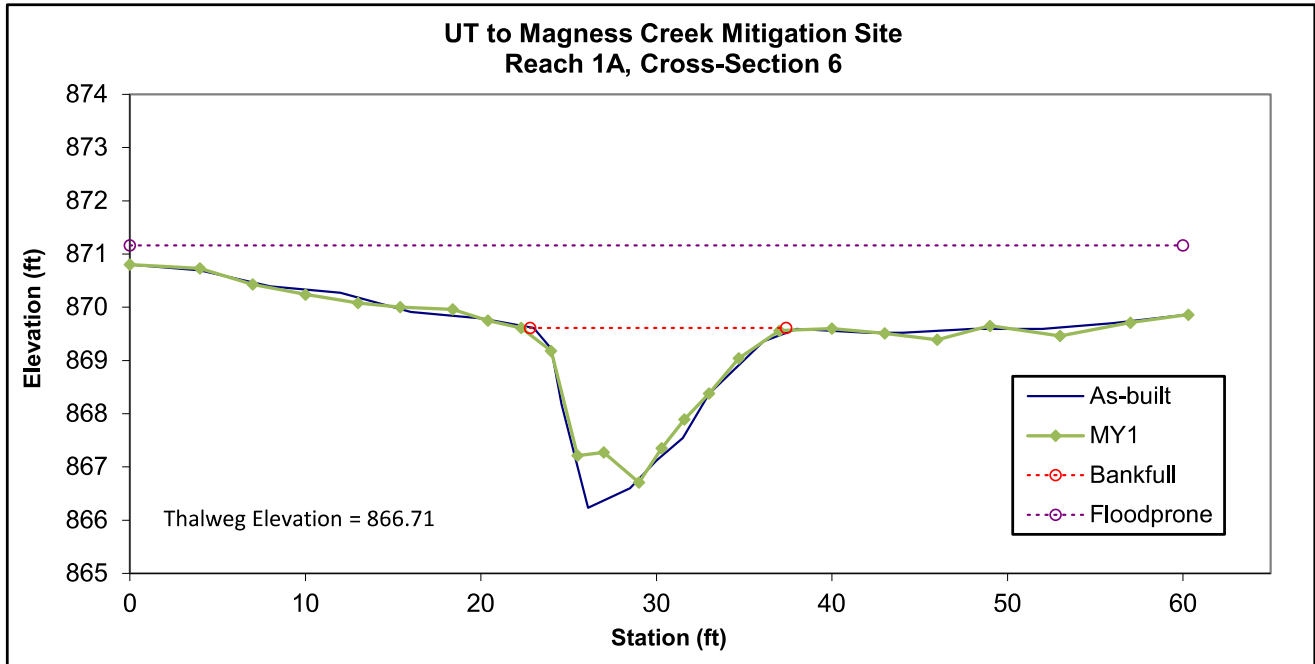
Permanent Cross-Section 6
 Year 1 Survey Collected: November 2023

Feature	Stream Type	BKF Area	BKF Width	BKF Depth	Max BKF Depth	W/D	BH Ratio	ER	BKF Elev	LTOB Elev
Pool	C4	21.6	17.7	1.2	2.9	14.5	--	--	869.61	869.56

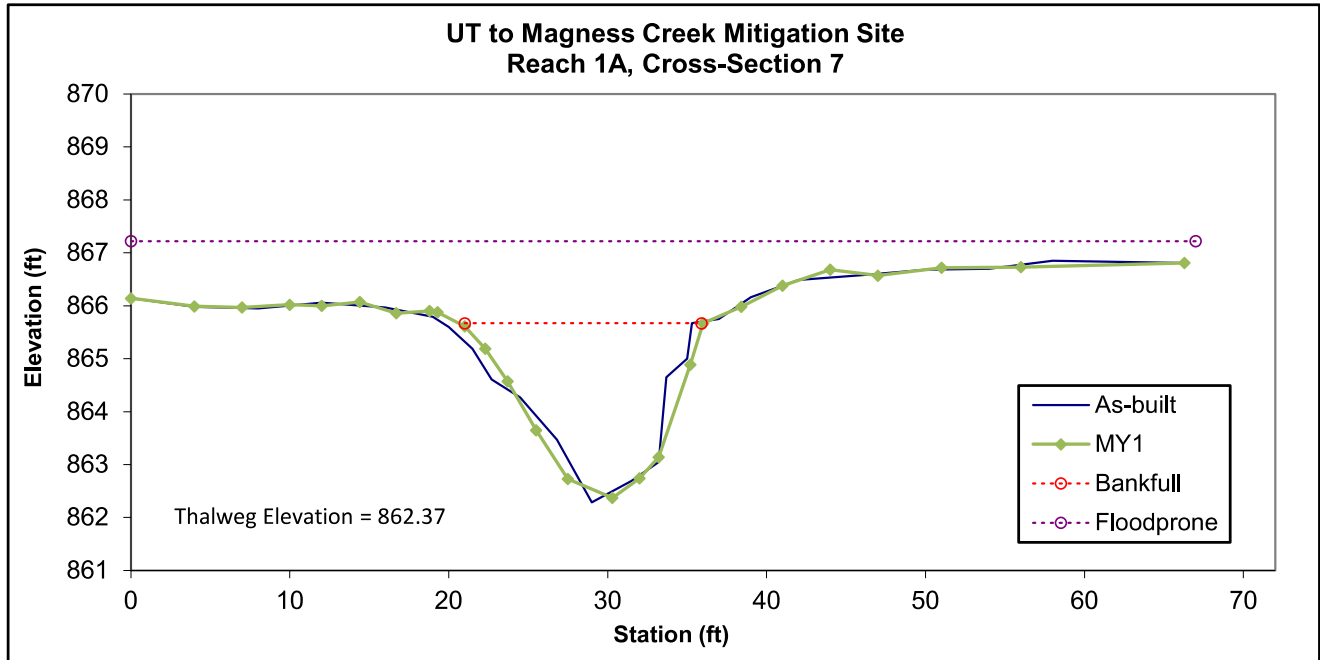
Permanent Cross-Section 7

Feature	Stream Type	BKF Area	BKF Width	BKF Depth	Max BKF Depth	W/D	BH Ratio	ER	BKF Elev	LTOB Elev
Pool	C4	30.2	15.4	2.0	3.3	7.8	--	--	865.67	865.67

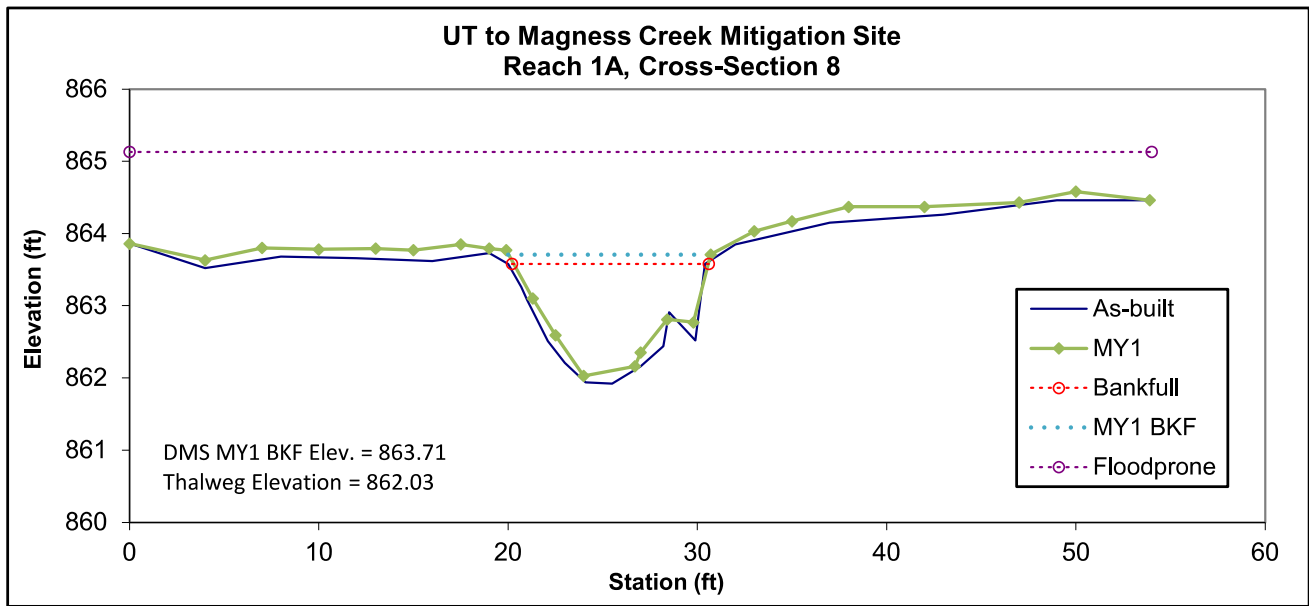
Permanent Cross-Section 8
 Year 1 Survey Collected: November 2023

Feature	Stream Type	BKF Area	BKF Width	BKF Depth	Max BKF Depth	W/D	BH Ratio	ER	BKF Elev	LTOB Elev
Riffle	C4	10.3	10.3	1.0	1.6	10.3	1.0	4.0	863.58	863.71

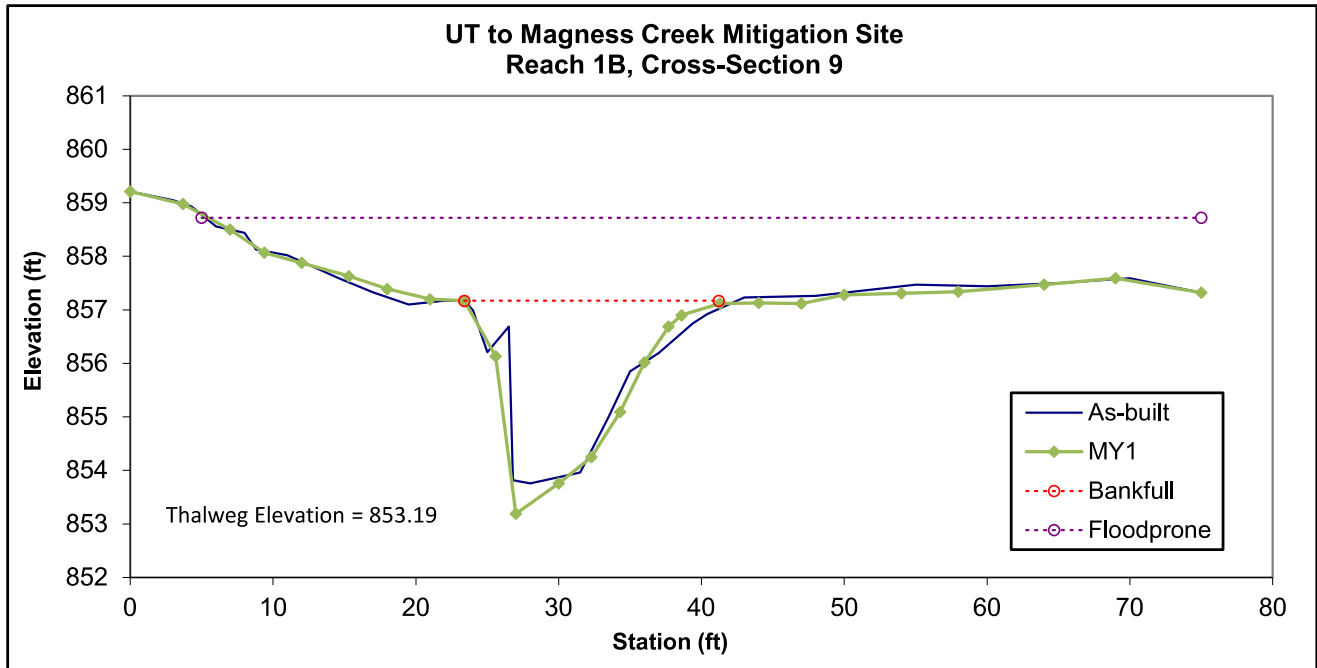
Permanent Cross-Section 9
 Year 1 Survey Collected: November 2023

Feature	Stream Type	BKF Area	BKF Width	BKF Depth	Max BKF Depth	W/D	BH Ratio	ER	BKF Elev	LTOB Elev
Pool	C4	33.2	24.5	1.4	4.0	18.1	--	--	857.17	856.90

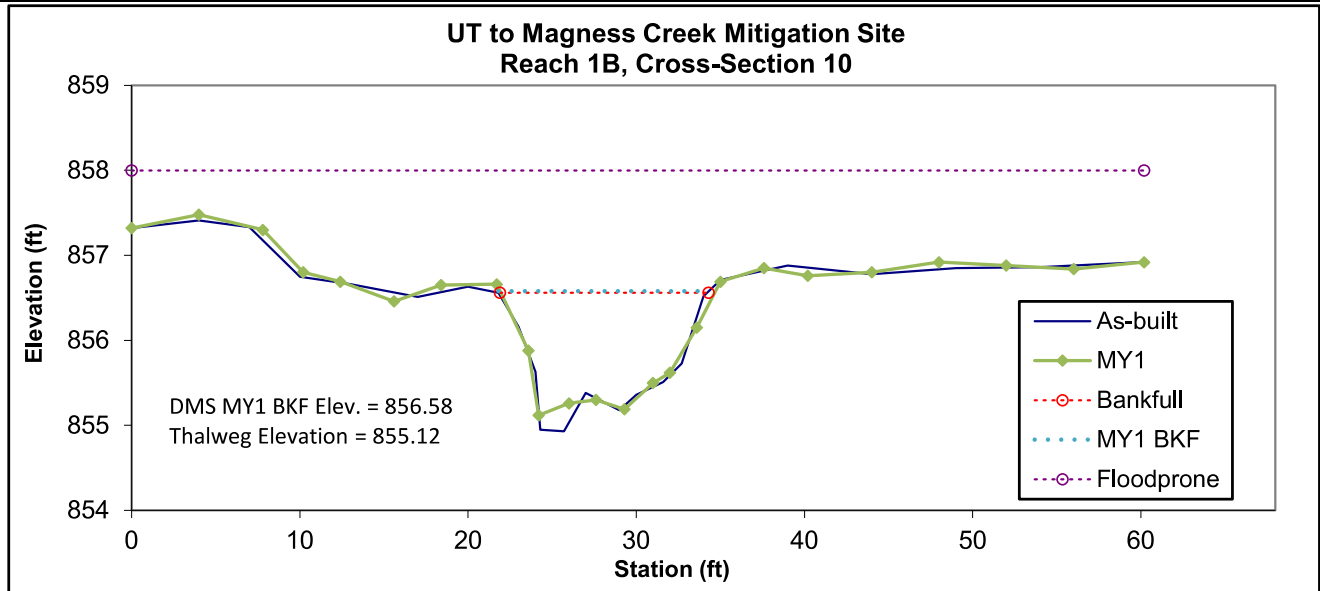
Permanent Cross-Section 10
 Year 1 Survey Collected: November 2023

Feature	Stream Type	BKF Area	BKF Width	BKF Depth	Max BKF Depth	W/D	BH Ratio	ER	BKF Elev	LTOB Elev
Riffle	C4	12.3	12.7	1.0	1.4	13.1	1.1	4.7	856.56	856.66

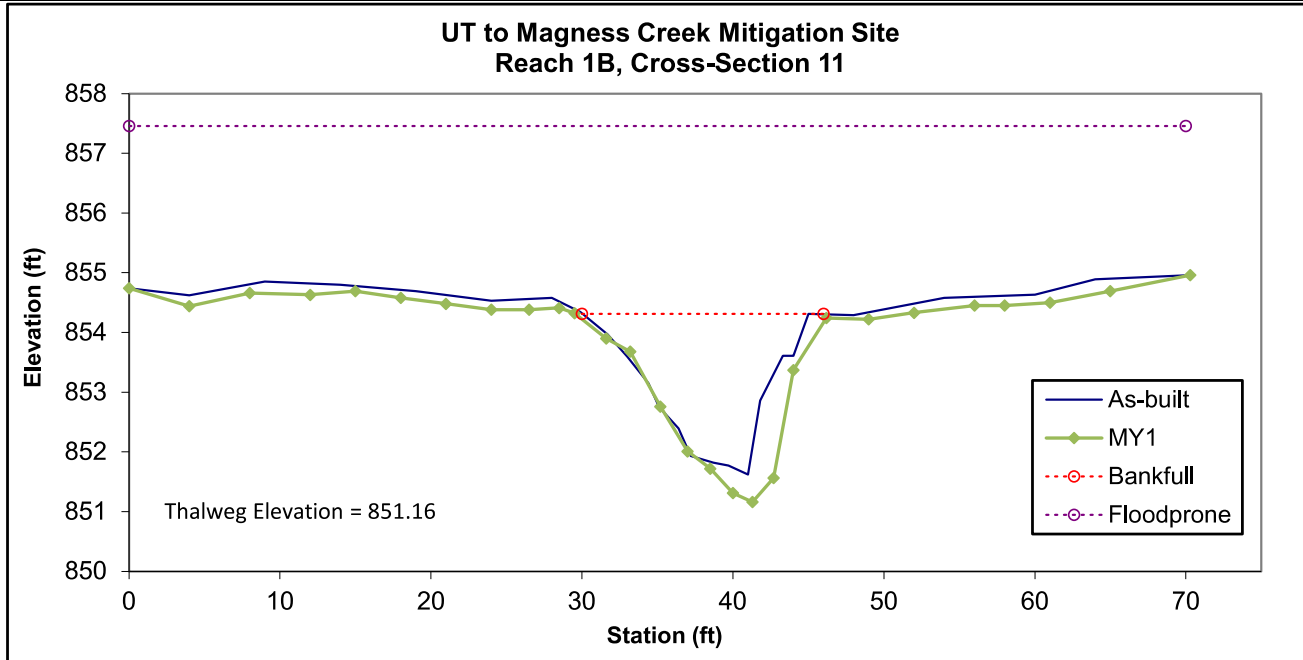
Permanent Cross-Section 11
 Year 1 Survey Collected: November 2023

Feature	Stream Type	BKF Area	BKF Width	BKF Depth	Max BKF Depth	W/D	BH Ratio	ER	BKF Elev	LTOB Elev
Riffle	C4	26.4	16.6	1.6	3.1	10.5	--	--	854.31	854.31

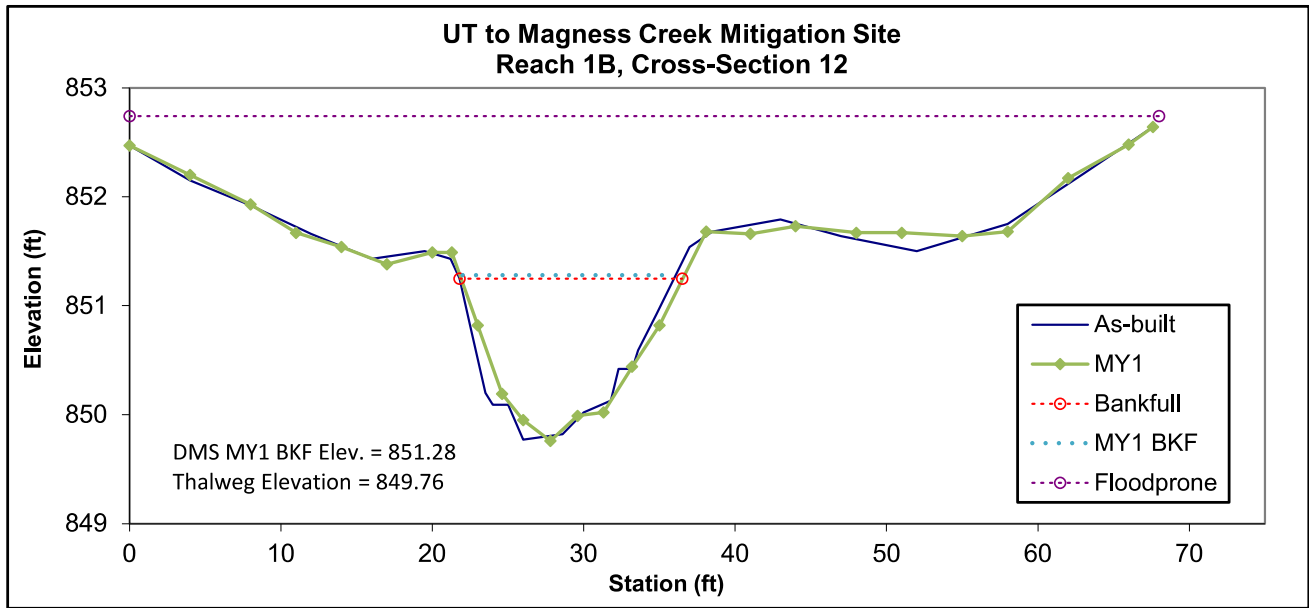
Permanent Cross-Section 12

Feature	Stream Type	BKF Area	BKF Width	BKF Depth	Max BKF Depth	W/D	BH Ratio	ER	BKF Elev	LTOB Elev
Riffle	C4	13.6	14.6	0.9	1.5	15.8	1.1	1.9	851.25	851.49

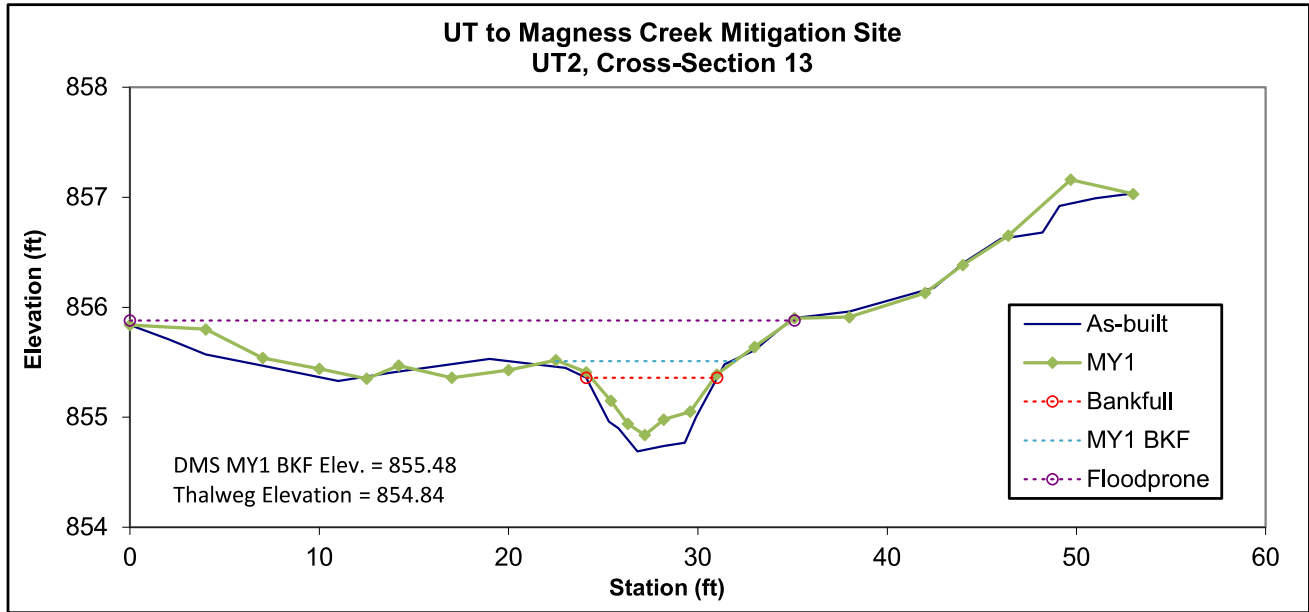
Permanent Cross-Section 13
 Year 1 Survey Collected: November 2023

Feature	Stream Type	BKF Area	BKF Width	BKF Depth	Max BKF Depth	W/D	BH Ratio	ER	BKF Elev	LTOB Elev
Riffle	B4	1.9	6.9	0.3	0.5	24.7	0.9	1.3	855.36	855.39

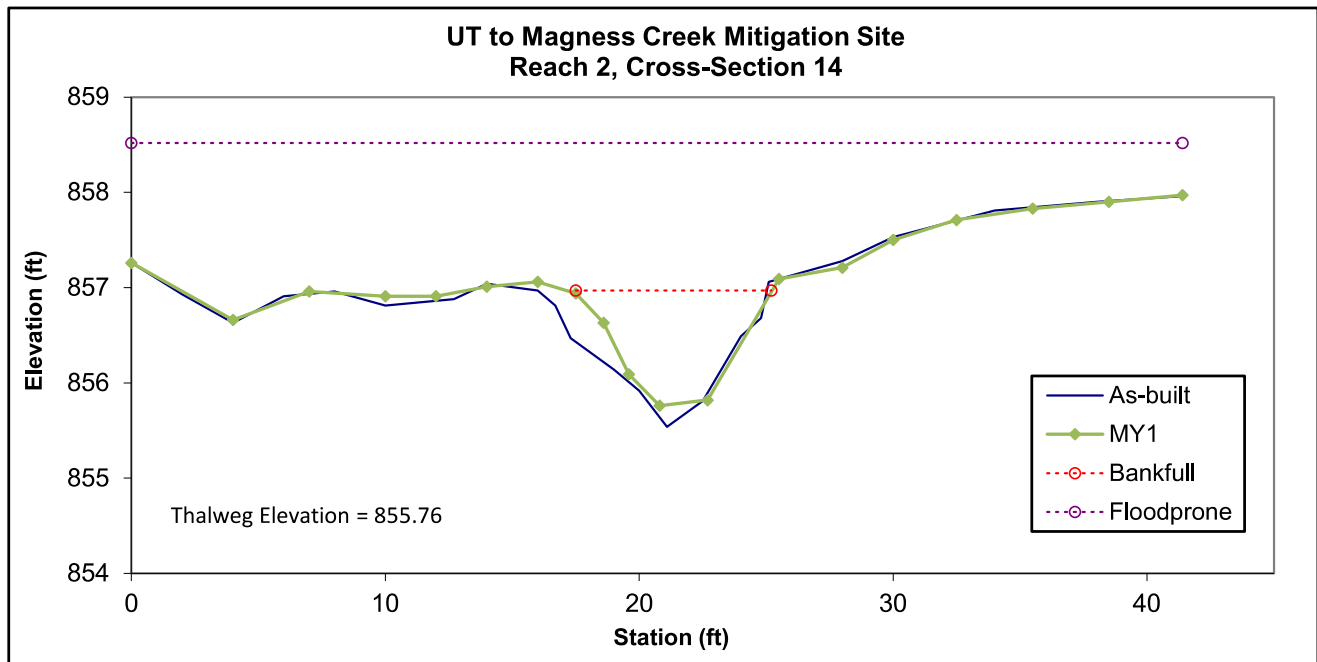
Permanent Cross-Section 14
 Year 1 Survey Collected: November 2023

Feature	Stream Type	BKF Area	BKF Width	BKF Depth	Max BKF Depth	W/D	BH Ratio	ER	BKF Elev	LTOB Elev
Pool	B4	5.8	8.1	0.7	1.2	11.4	--	--	856.97	856.94
