FINAL
ANNUAL MONITORING REPORT
YEAR 2 (2013)
UT TO BALD STREAM/WETLAND RESTORATION SITE
YANCEY COUNTY, NORTH CAROLINA
(EEP Project No. 92596, Contract No. 4997)
Construction Completed December 2011

Submitted to:
North Carolina Department of Environment and Natural Resources
Ecosystem Enhancement Program
Raleigh, North Carolina

January 2014

Prepared by:
Axiom Environmental, Inc.
218 Snow Avenue
Raleigh, North Carolina 27603

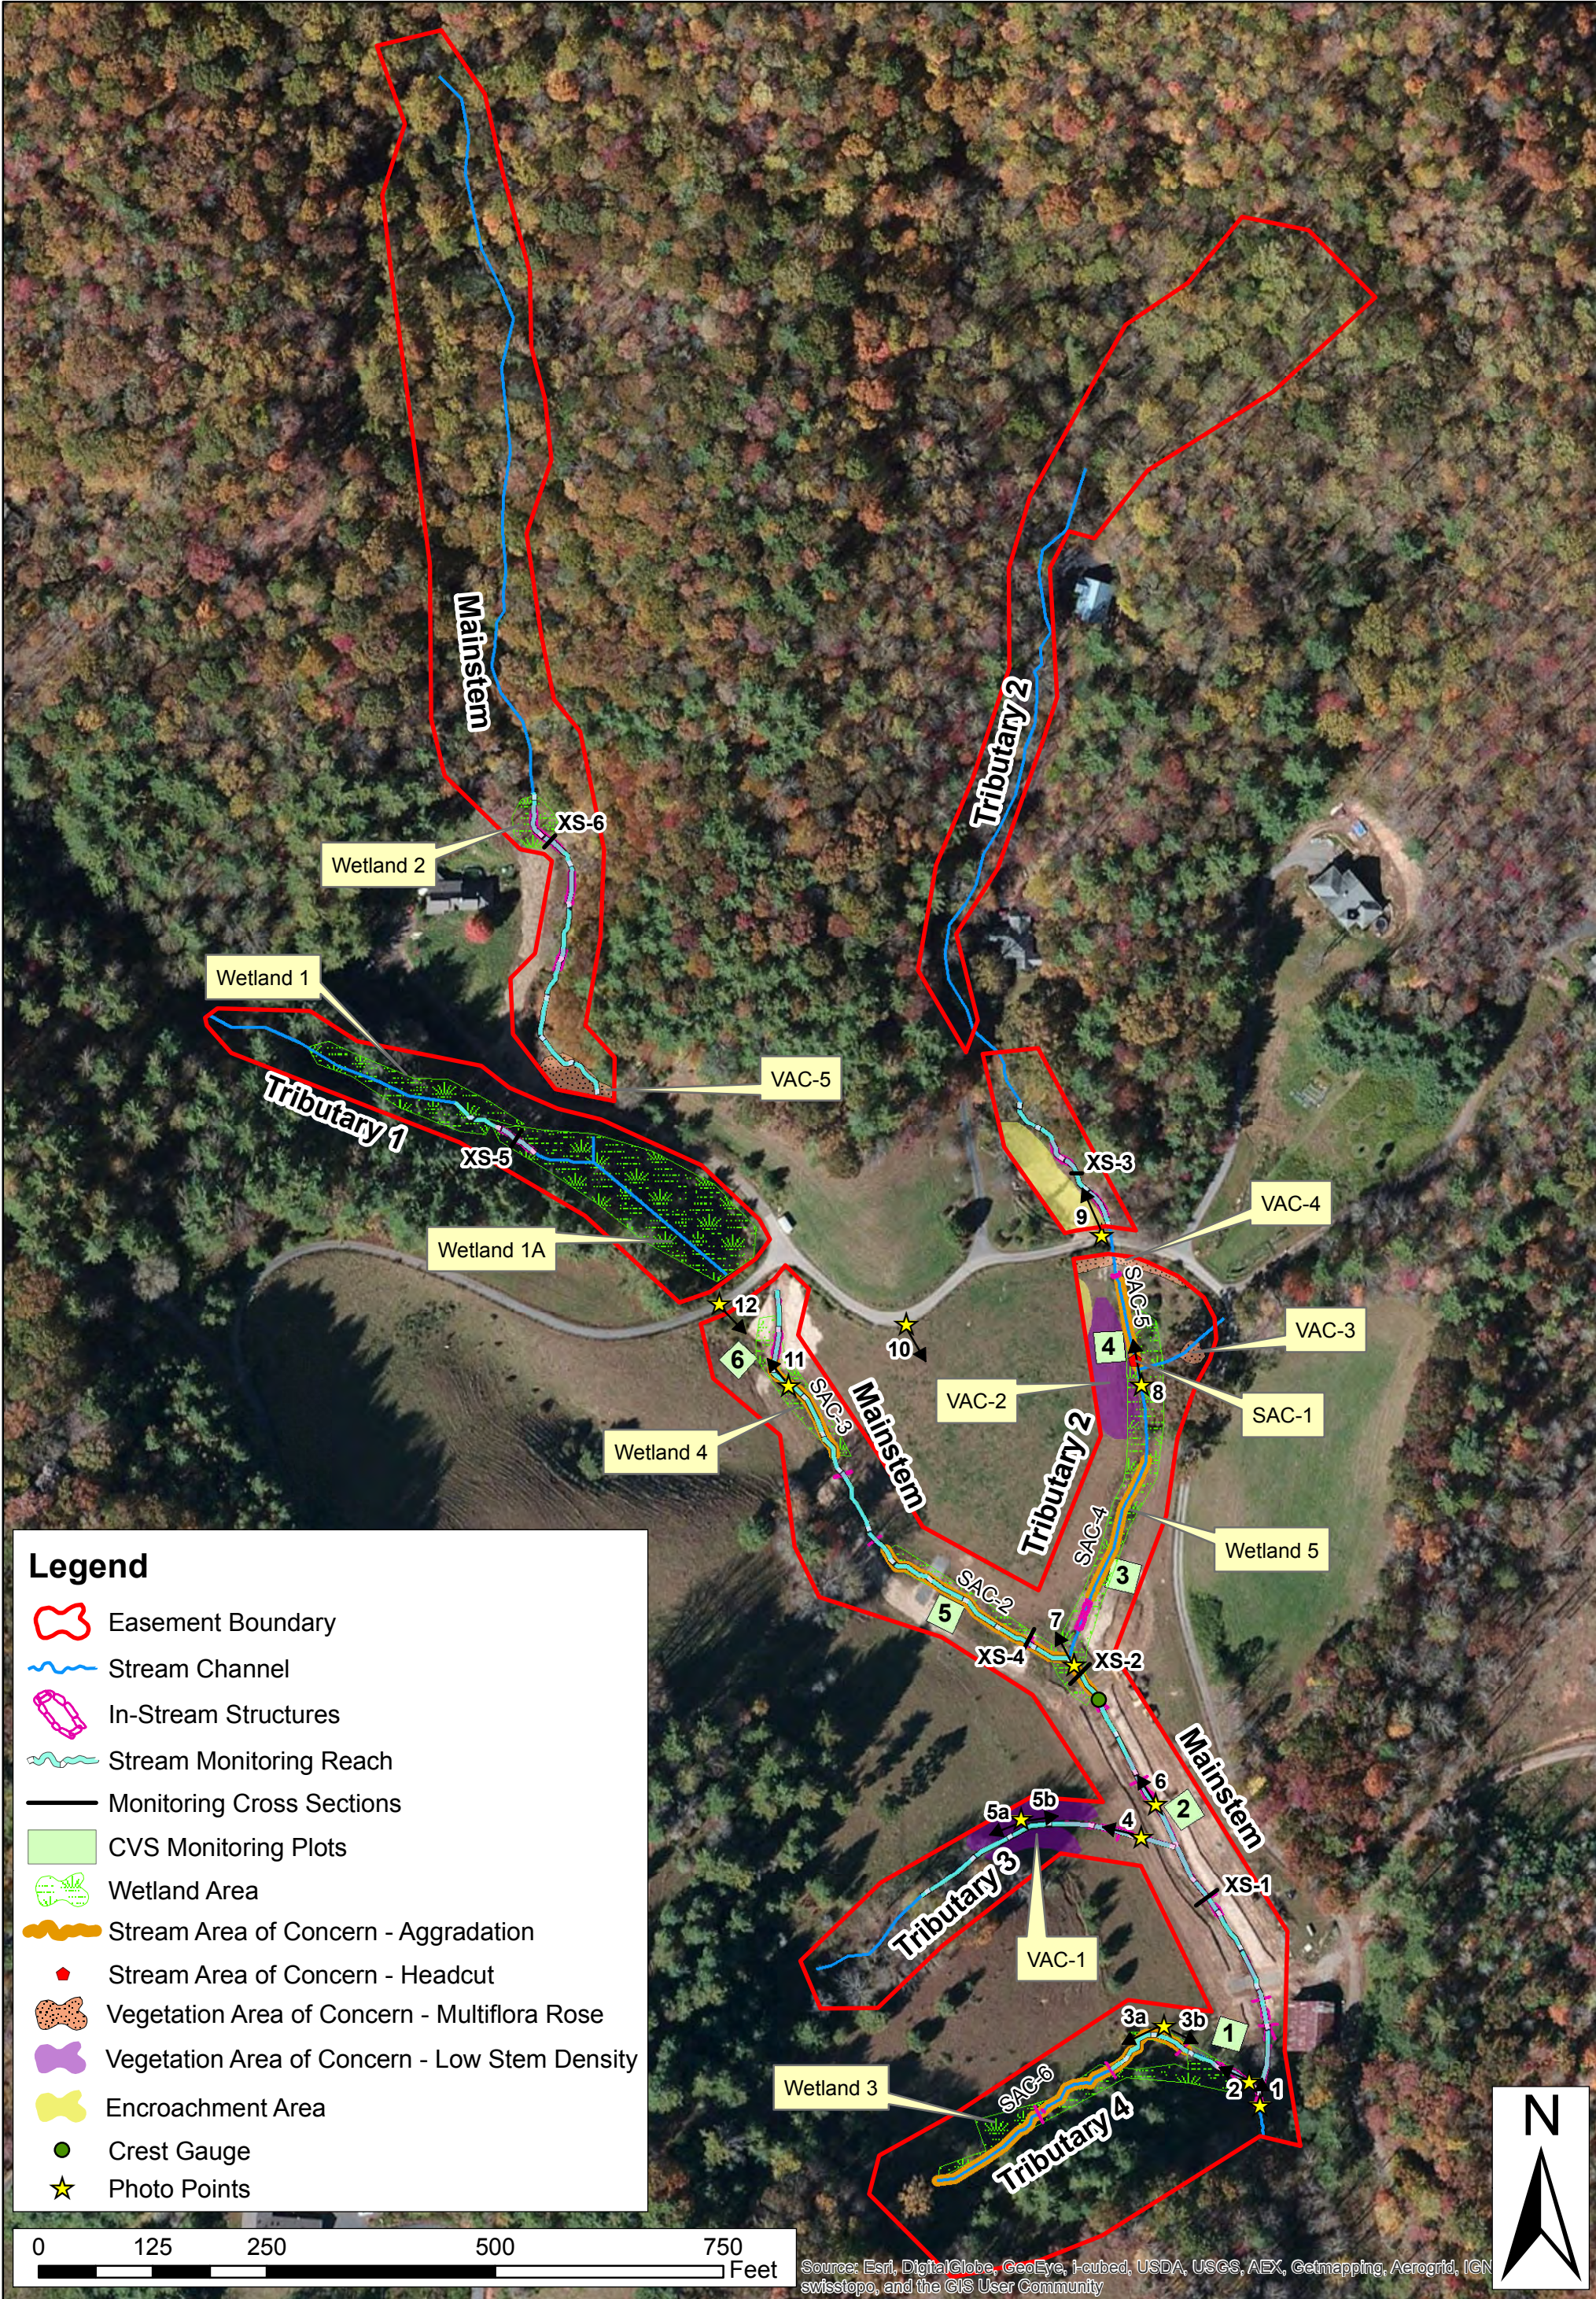
Figure 2. Current Conditions Plan View

Five vegetation areas of concern were identified on the site. Planted stem density was moderate to poor throughout the site. Planted stems in the drier portions of the site were generally hard to locate due to the thick fescue. Wetter areas in the site had poor stem growth due to saturation and competition with sedges and soft rush (*Carex* spp. and *Juncus effusus*). Additionally, three small patches of multiflora rose (*Rosa multiflora*) were identified in the site. These areas of concern are summarized below and depicted on the attached Figure 2 (Appendix B).

Map Identifier	Feature/Issue
VAC-1	Low stem density around tributary 3
VAC-2	Low stem density in and around Veg Plot 4
VAC-3 to 5	Multiflora Rose

channels appear to be exhibiting aggradation of fine materials, possibly from surface flows across the adjacent floodplain and extensive herbaceous vegetation growth within the channel bed. Currently, aggradation does not appear to present a problem; however, continued observation throughout the monitoring period should determine if the system is able to flush aggraded material. Stream areas of concern are summarized in the following table and are depicted on Figure 2 (Appendix B).

Map Identifier	Feature/Issue
SAC-1	Headcut on Tributary 2
SAC-2 to 6	Aggradation on Mainstem, Tributary 2, and Tributary 4

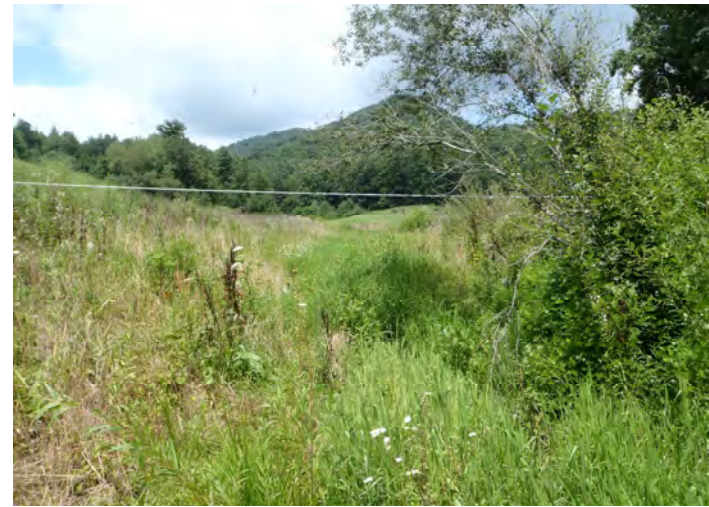
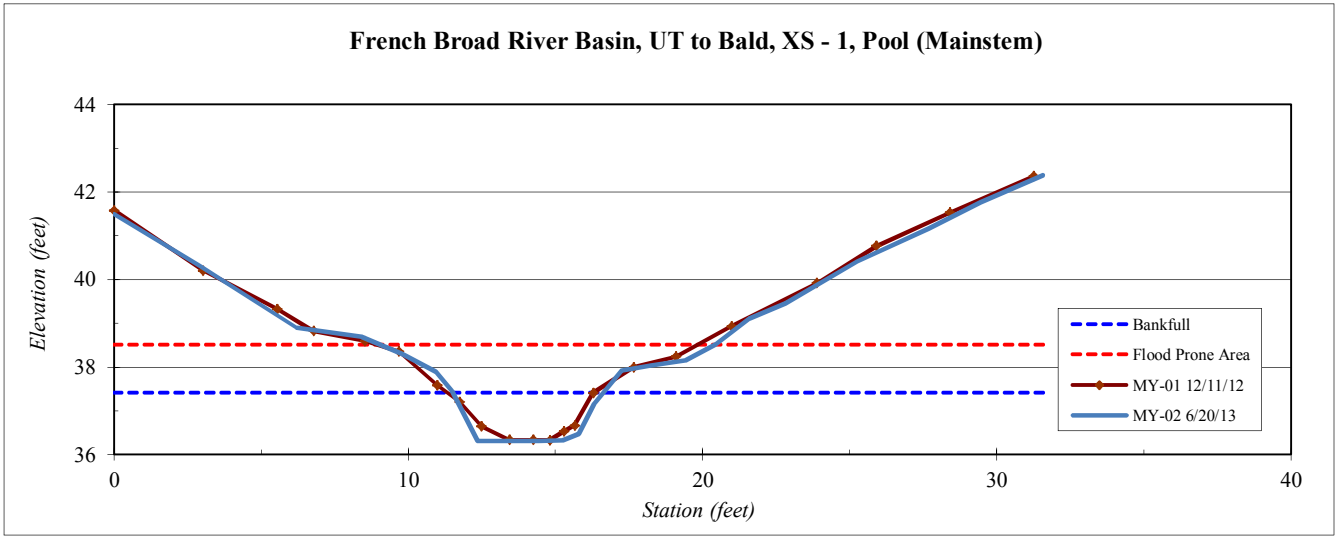
River Basin:	French Broad
Site Name	UT to Bald
XS ID	XS - 1, Pool (Mainstem)
Drainage Area (sq mi):	0.19
Date:	6/20/2013
Field Crew:	Perkinson, Jernigan

SUMMARY DATA	
Bankfull Elevation:	37.4
Bankfull Cross-Sectional Area:	4.5
Bankfull Width:	5.1
Flood Prone Area Elevation:	---
Flood Prone Width:	---
Max Depth at Bankfull:	1.1
Mean Depth at Bankfull:	0.9
W / D Ratio:	---
Entrenchment Ratio:	---
Bank Height Ratio:	1.0

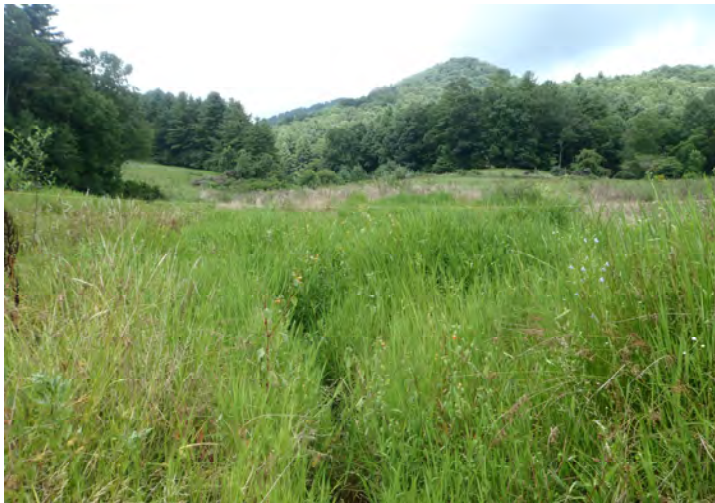
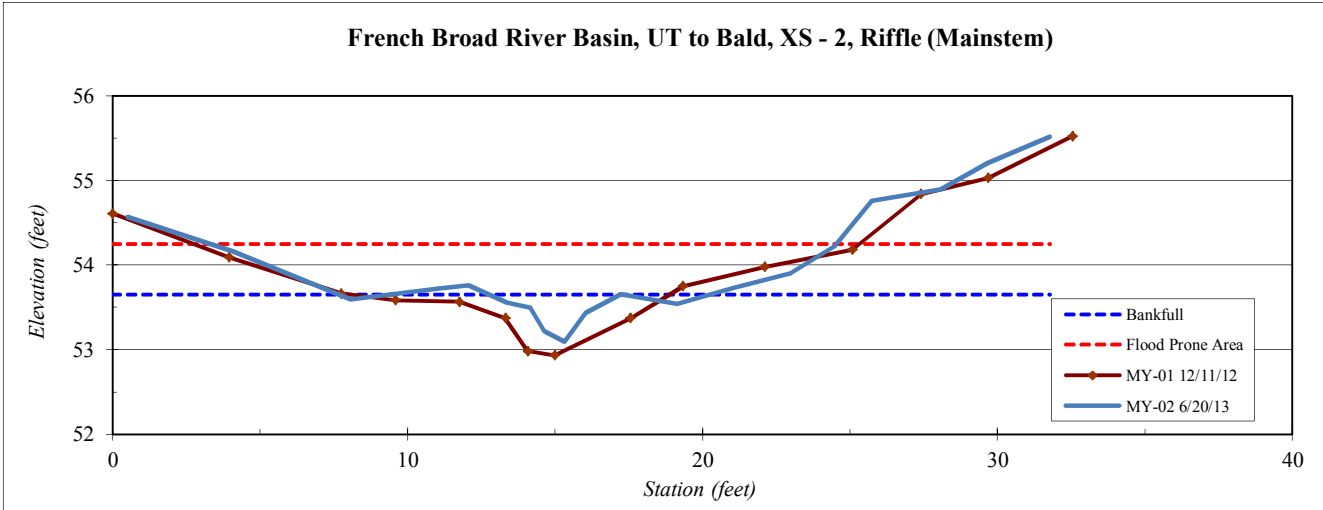
River Basin:	French Broad
Site Name	UT to Bald
XS ID	XS - 2, Riffle (Mainstem)
Drainage Area (sq mi):	0.19
Date:	6/20/2013
Field Crew:	Perkinson, Jernigan

SUMMARY DATA	
Bankfull Elevation:	53.7
Bankfull Cross-Sectional Area:	1.0
Bankfull Width:	4.5
Flood Prone Area Elevation:	54.3
Flood Prone Width:	20.0
Max Depth at Bankfull:	0.6
Mean Depth at Bankfull:	0.2
W / D Ratio:	20.3
Entrenchment Ratio:	4.4
Bank Height Ratio:	1.0

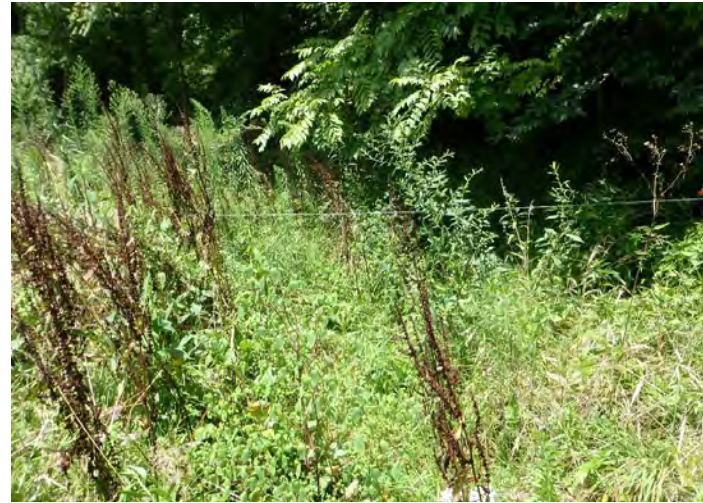
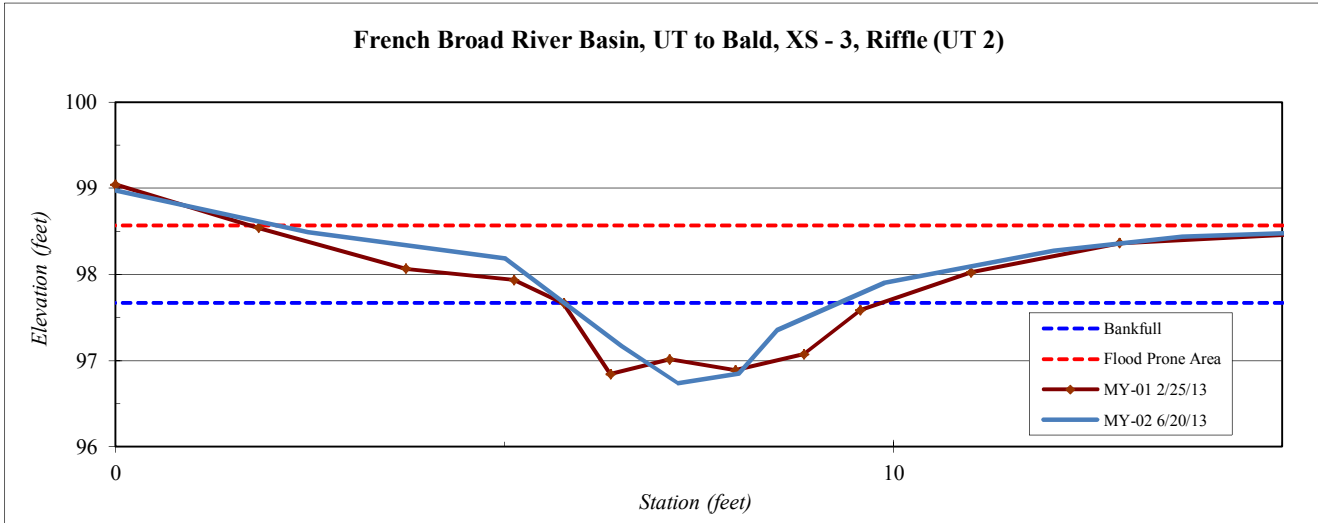
River Basin:	French Broad
Site Name	UT to Bald
XS ID	XS - 3, Riffle (UT 2)
Drainage Area (sq mi):	0.06
Date:	6/20/2013
Field Crew:	Perkinson, Jernigan

SUMMARY DATA	
Bankfull Elevation:	97.7
Bankfull Cross-Sectional Area:	1.8
Bankfull Width:	3.5
Flood Prone Area Elevation:	98.6
Flood Prone Width:	14.0
Max Depth at Bankfull:	0.9
Mean Depth at Bankfull:	0.5
W / D Ratio:	6.8
Entrenchment Ratio:	4.0
Bank Height Ratio:	1.0

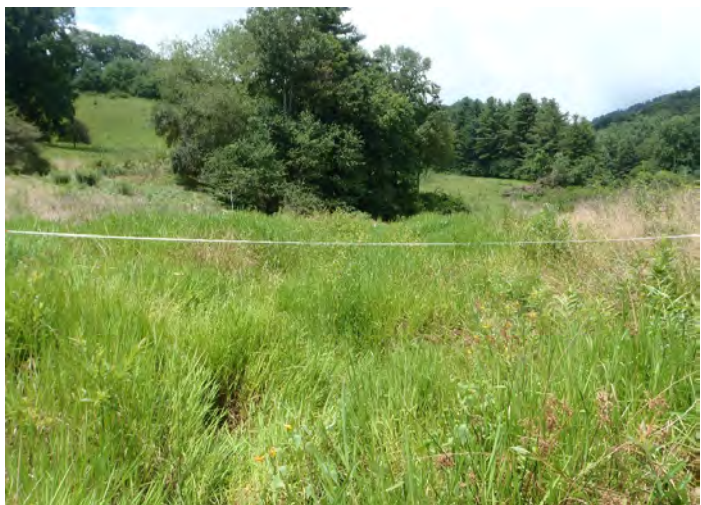
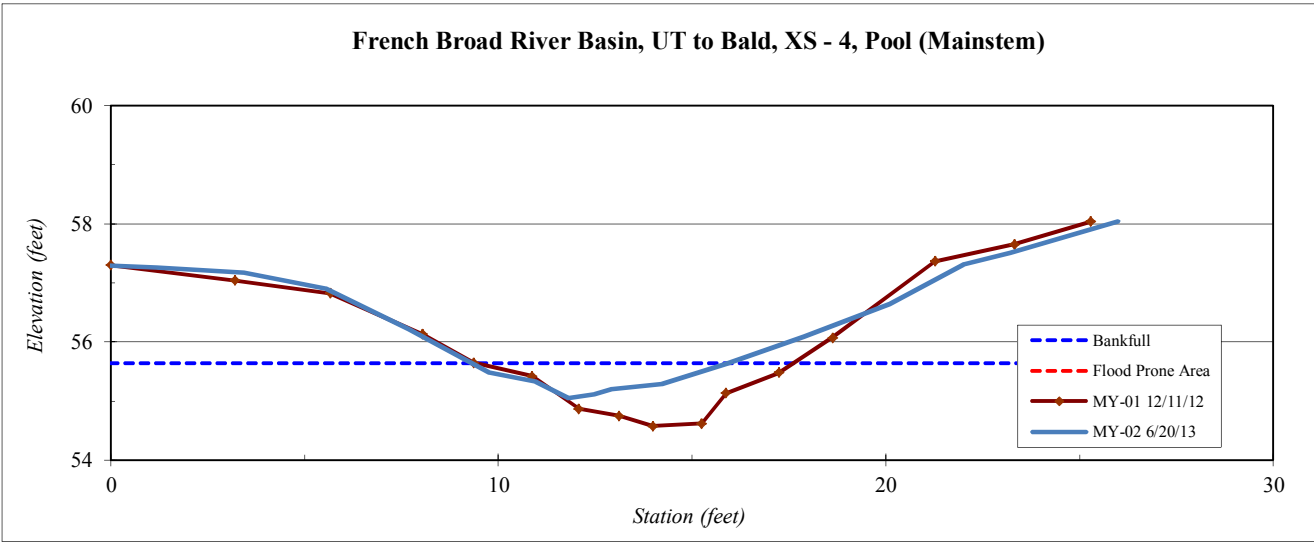
River Basin:	French Broad
Site Name	UT to Bald
XS ID	XS - 4, Pool (Mainstem)
Drainage Area (sq mi):	0.04
Date:	6/20/2013
Field Crew:	Perkinson, Jernigan

SUMMARY DATA	
Bankfull Elevation:	55.6
Bankfull Cross-Sectional Area:	2.1
Bankfull Width:	6.6
Flood Prone Area Elevation:	-
Flood Prone Width:	-
Max Depth at Bankfull:	0.6
Mean Depth at Bankfull:	0.3
W / D Ratio:	-
Entrenchment Ratio:	-
Bank Height Ratio:	1.0

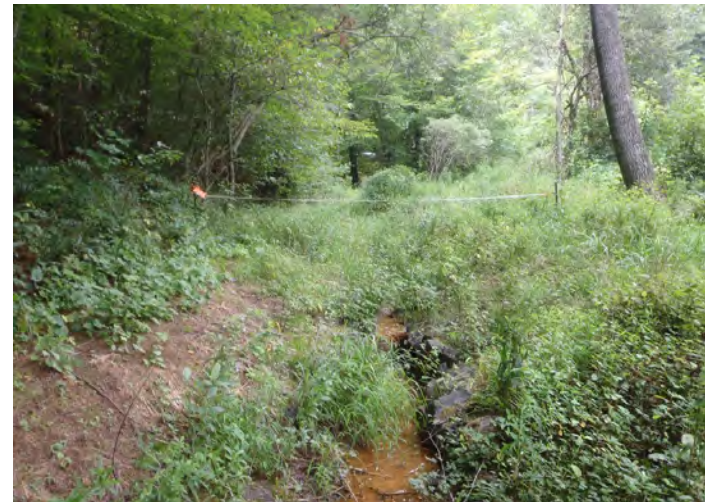
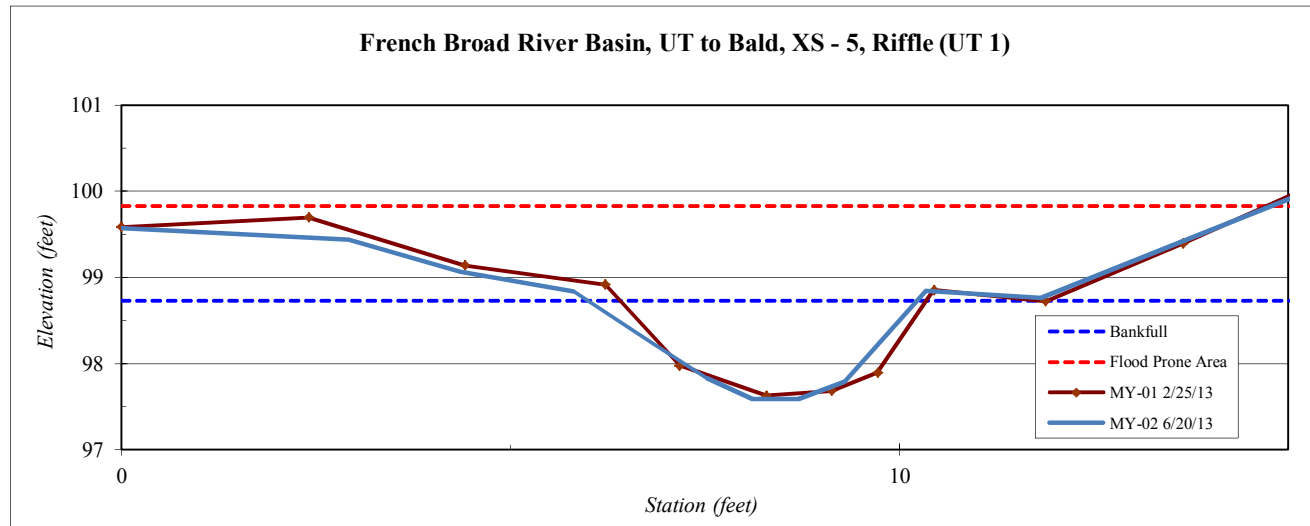
River Basin:	French Broad
Site Name	UT to Bald
XS ID	XS - 5, Riffle (UT 1)
Drainage Area (sq mi):	0.025
Date:	6/20/2013
Field Crew:	Perkinson, Jernigan

SUMMARY DATA	
Bankfull Elevation:	98.7
Bankfull Cross-Sectional Area:	3.0
Bankfull Width:	4.2
Flood Prone Area Elevation:	99.8
Flood Prone Width:	16.0
Max Depth at Bankfull:	1.1
Mean Depth at Bankfull:	0.7
W / D Ratio:	5.9
Entrenchment Ratio:	3.8
Bank Height Ratio:	1.0

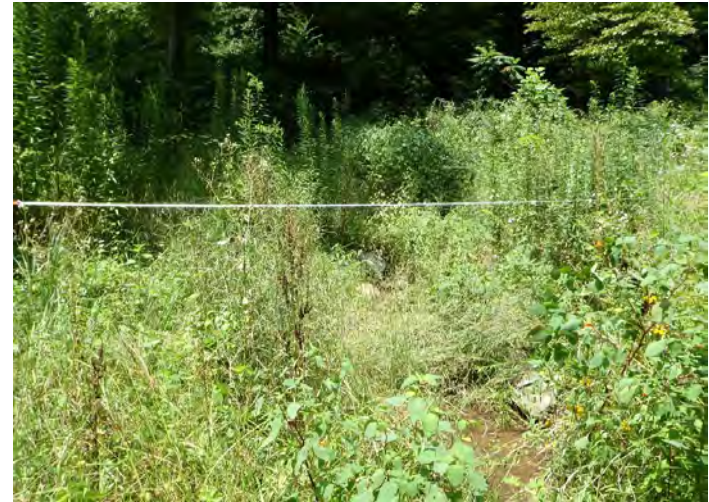
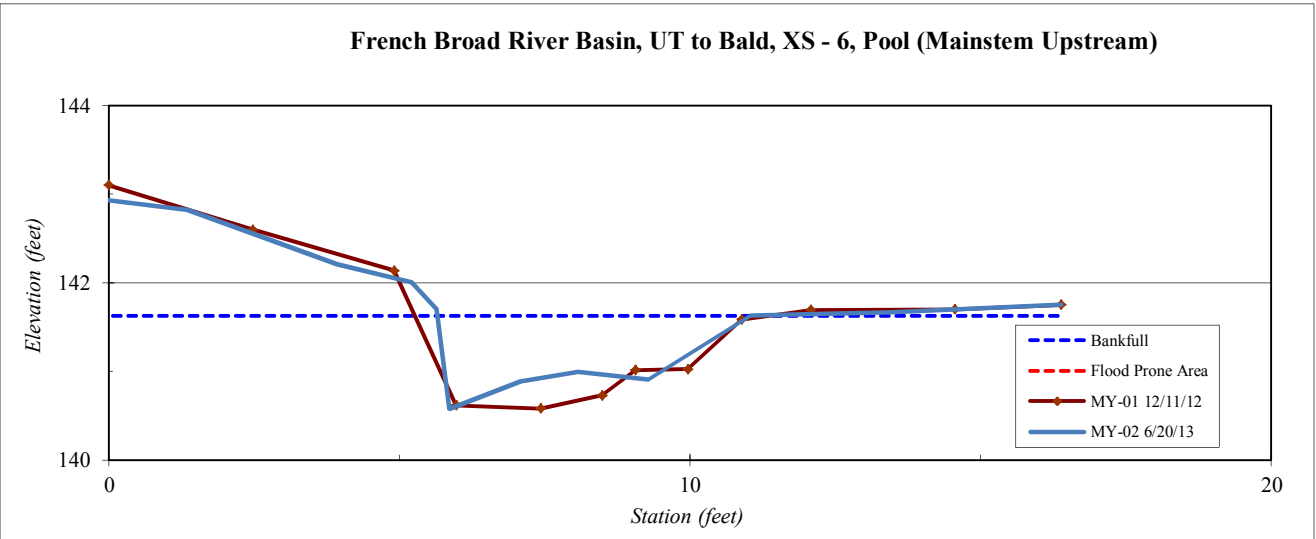
River Basin:	French Broad
Site Name:	UT to Bald
XS ID:	XS - 6, Pool (Mainstem Upstream)
Drainage Area (sq mi):	0.04
Date:	6/20/2013
Field Crew:	Perkinson, Jernigan

Bankfull Elevation:	141.6
Bankfull Cross-Sectional Area:	3.3
Bankfull Width:	5.4
Flood Prone Area Elevation:	-
Flood Prone Width:	-
Max Depth at Bankfull:	1.1
Mean Depth at Bankfull:	0.6
W / D Ratio:	-
Entrenchment Ratio:	-
Bank Height Ratio:	1.0
