**FINAL**  
**ANNUAL MONITORING REPORT**  
**YEAR 4 (2015)**  
**UT TO BALD STREAM/WETLAND RESTORATION SITE**  
**YANCEY COUNTY, NORTH CAROLINA**  
**(DMS Project No. 92596, Contract No. 4997)**  
**Construction Completed December 2011**

December 2015

Prepared by:  
Axiom Environmental, Inc.  
218 Snow Avenue  
Raleigh, North Carolina 27603

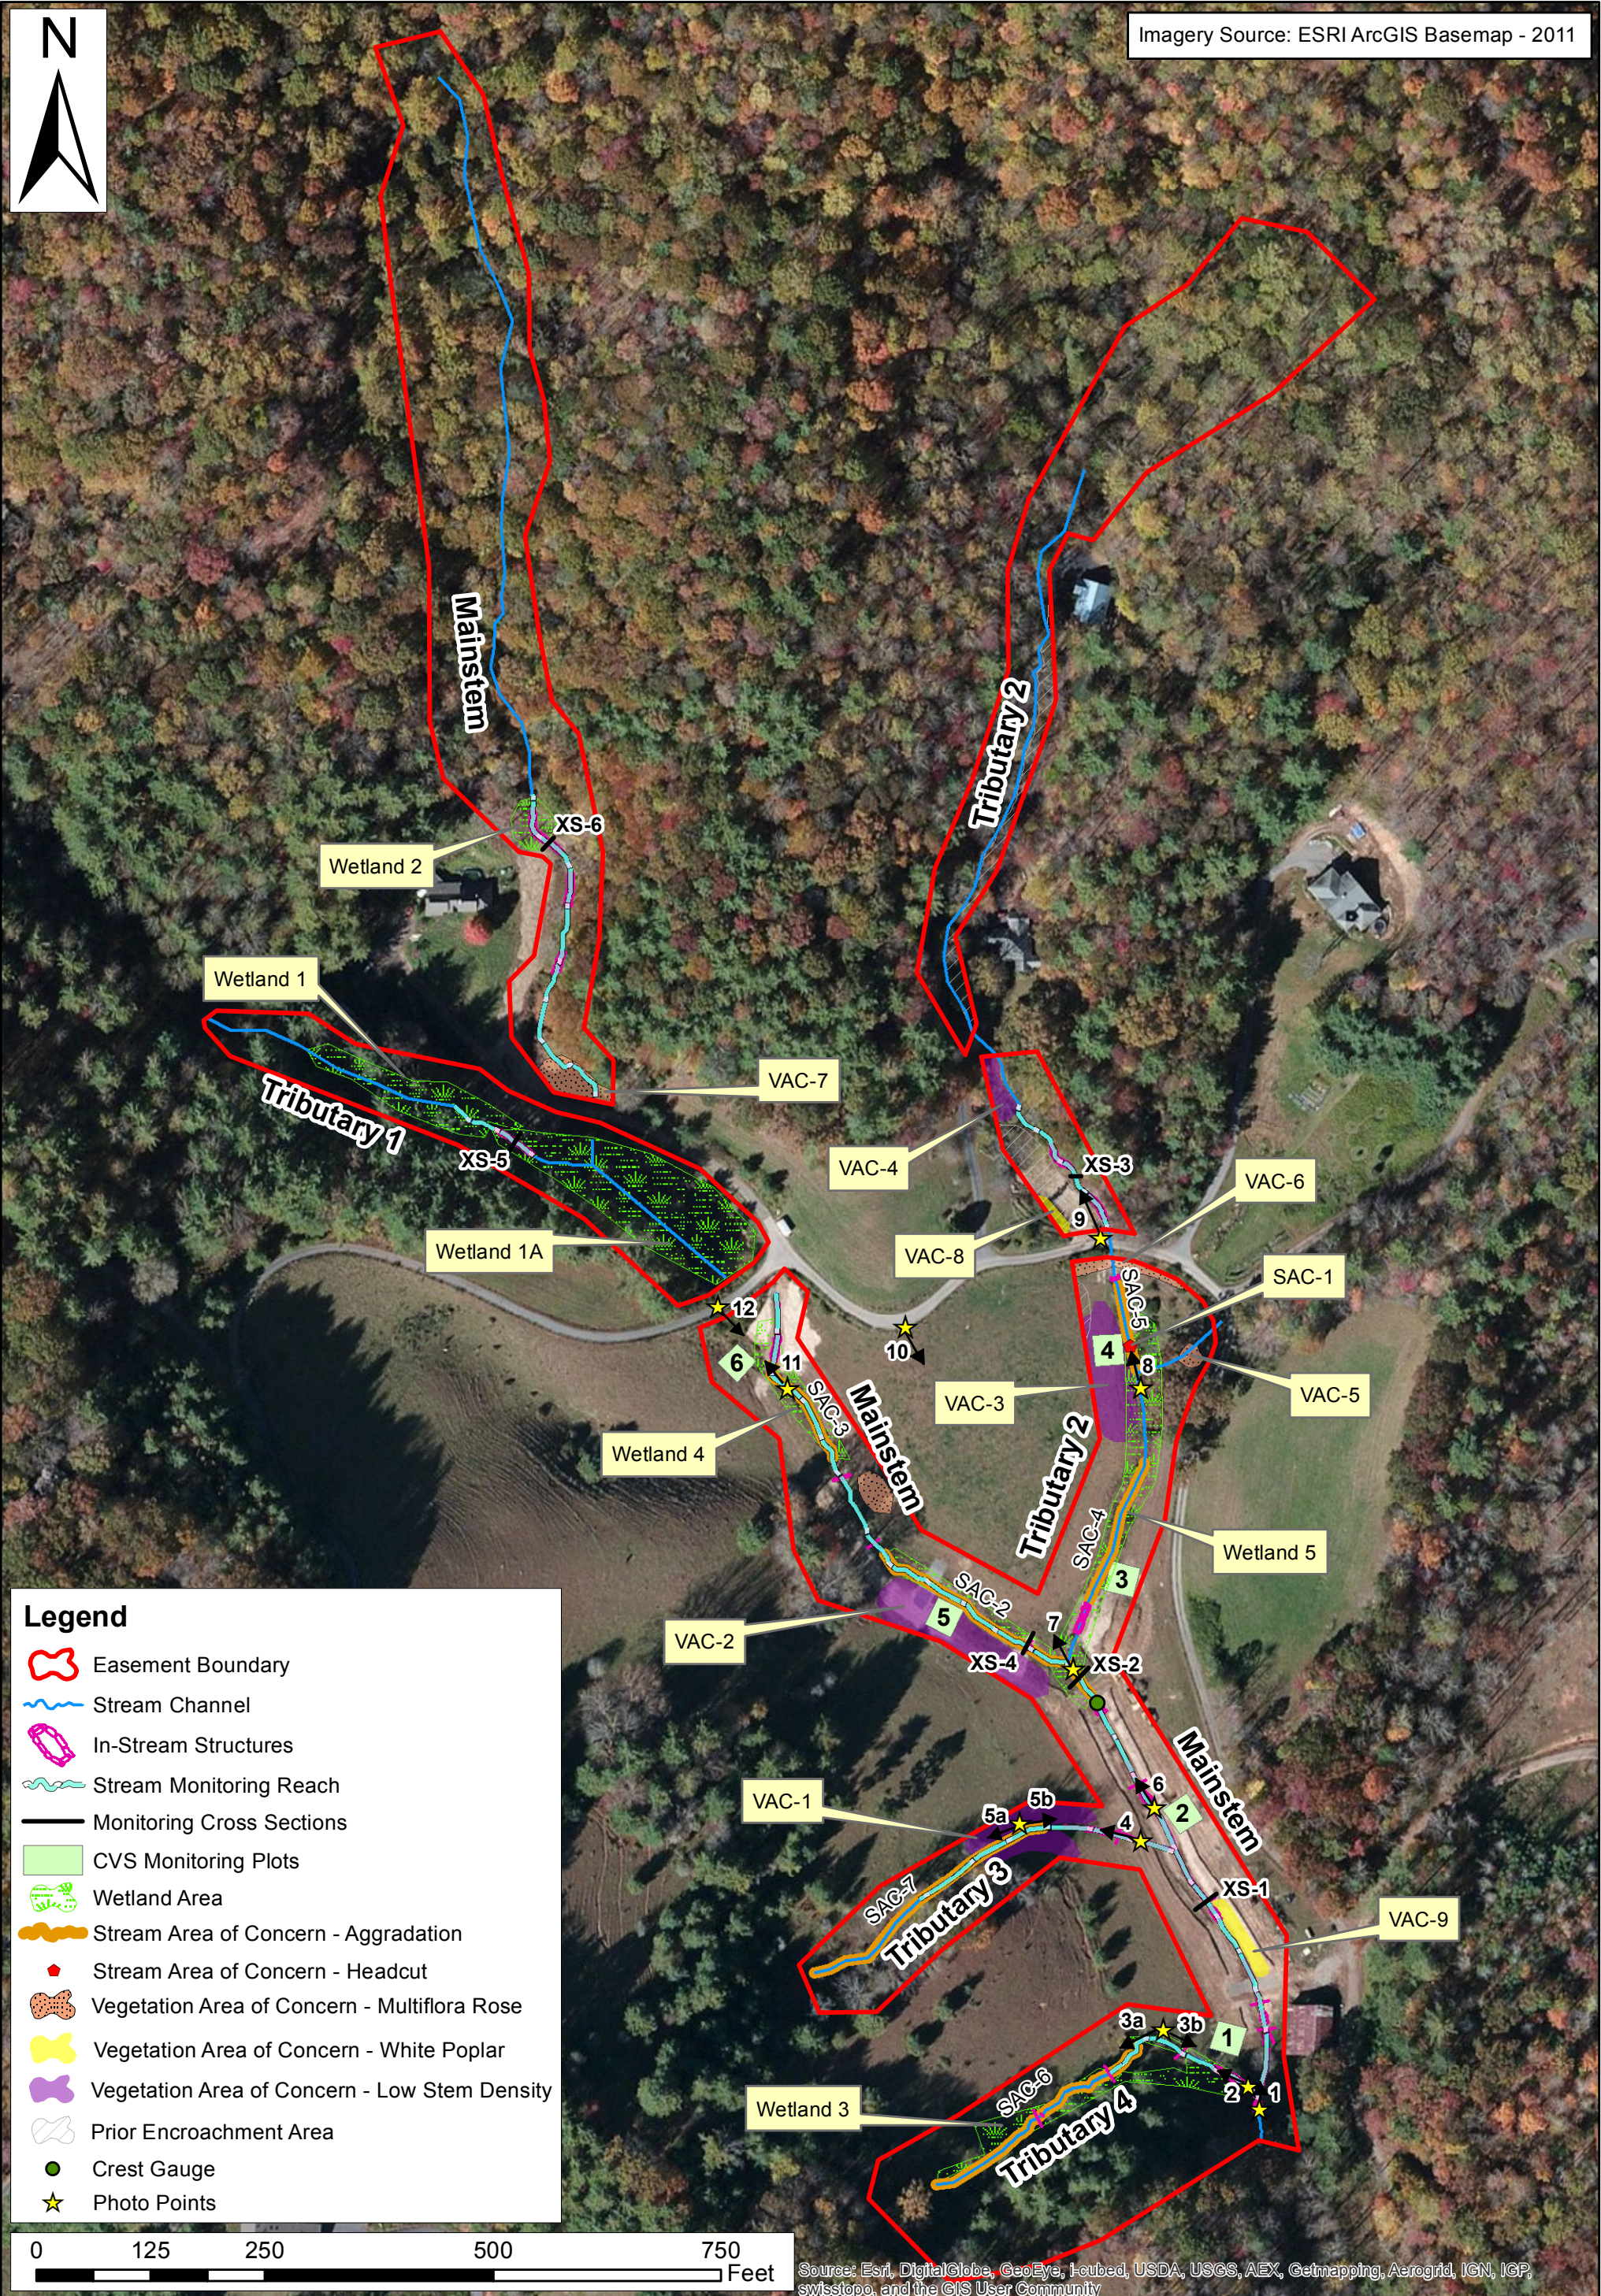
Figure 2. Current Conditions Plan View

Map Identifier	Feature/Issue
VAC-1	Low stem density around Tributary 3
VAC-2	Low stem density on the right bank of the Mainstem in and around Veg Plot 5
VAC-3	Low stem density in and around Veg Plot 4
VAC-4	Low stem density on the right bank of Tributary 2 near an adjacent driveway
VAC-5 to -7	Multiflora rose
VAC-8 to -9	Dense white poplar

distance upstream since Year 3 (2014) monitoring; however, it currently poses no immediate threat to stream stability. In addition, six areas of aggradation (SAC-2 to -7) were observed along the mainstem, Tributary 2, Tributary 3, and Tributary 4. Several of these areas were documented previously and conditions continue to improve. During Year 3 (2014) monitoring, it was noted that the upper reaches of Tributary 3 and Tributary 4 have indiscernible bed and bank for varying lengths. These tributaries exhibit intermittent flow regimes, and low flow may be responsible for the lack of bed and bank characteristics in these reaches. These areas remained unchanged during Year 4 (2015) monitoring. Upper reaches of the Mainstem and Tributary 2 appear to be exhibiting aggradation of fine materials, possibly due to surface flows across the adjacent floodplain and extensive herbaceous vegetation growth within the channel bed combined with low energy flow in the channel. Continued observation throughout the monitoring period should determine if the system is able to transport aggraded material. Cross-section 2, which exhibited significant down cutting during year 3 (2014) monitoring, has aggraded slightly during year 4 (2015). This area was previously aggraded with fine sediment that was washed out during Year 3 (2014), and now has refilled with natural levels of sediment during year 4 (2015); it is currently not an area of concern. Stream areas of concern are summarized in the following table and are depicted on Figure 2 (Appendix B).

Map Identifier	Feature/Issue
SAC-1	Headcut on Tributary 2
SAC-2 to 7	Aggradation on Mainstem, Tributary 2, Tributary 3, and Tributary 4
