FINAL
ANNUAL MONITORING REPORT
YEAR 5 (2016)
UT TO BALD STREAM/WETLAND RESTORATION SITE
YANCEY COUNTY, NORTH CAROLINA
(DMS Project No. 92596, Contract No. 4997)
Construction Completed December 2011

December 2016

Prepared by:
Axiom Environmental, Inc.
218 Snow Avenue
Raleigh, North Carolina 27603

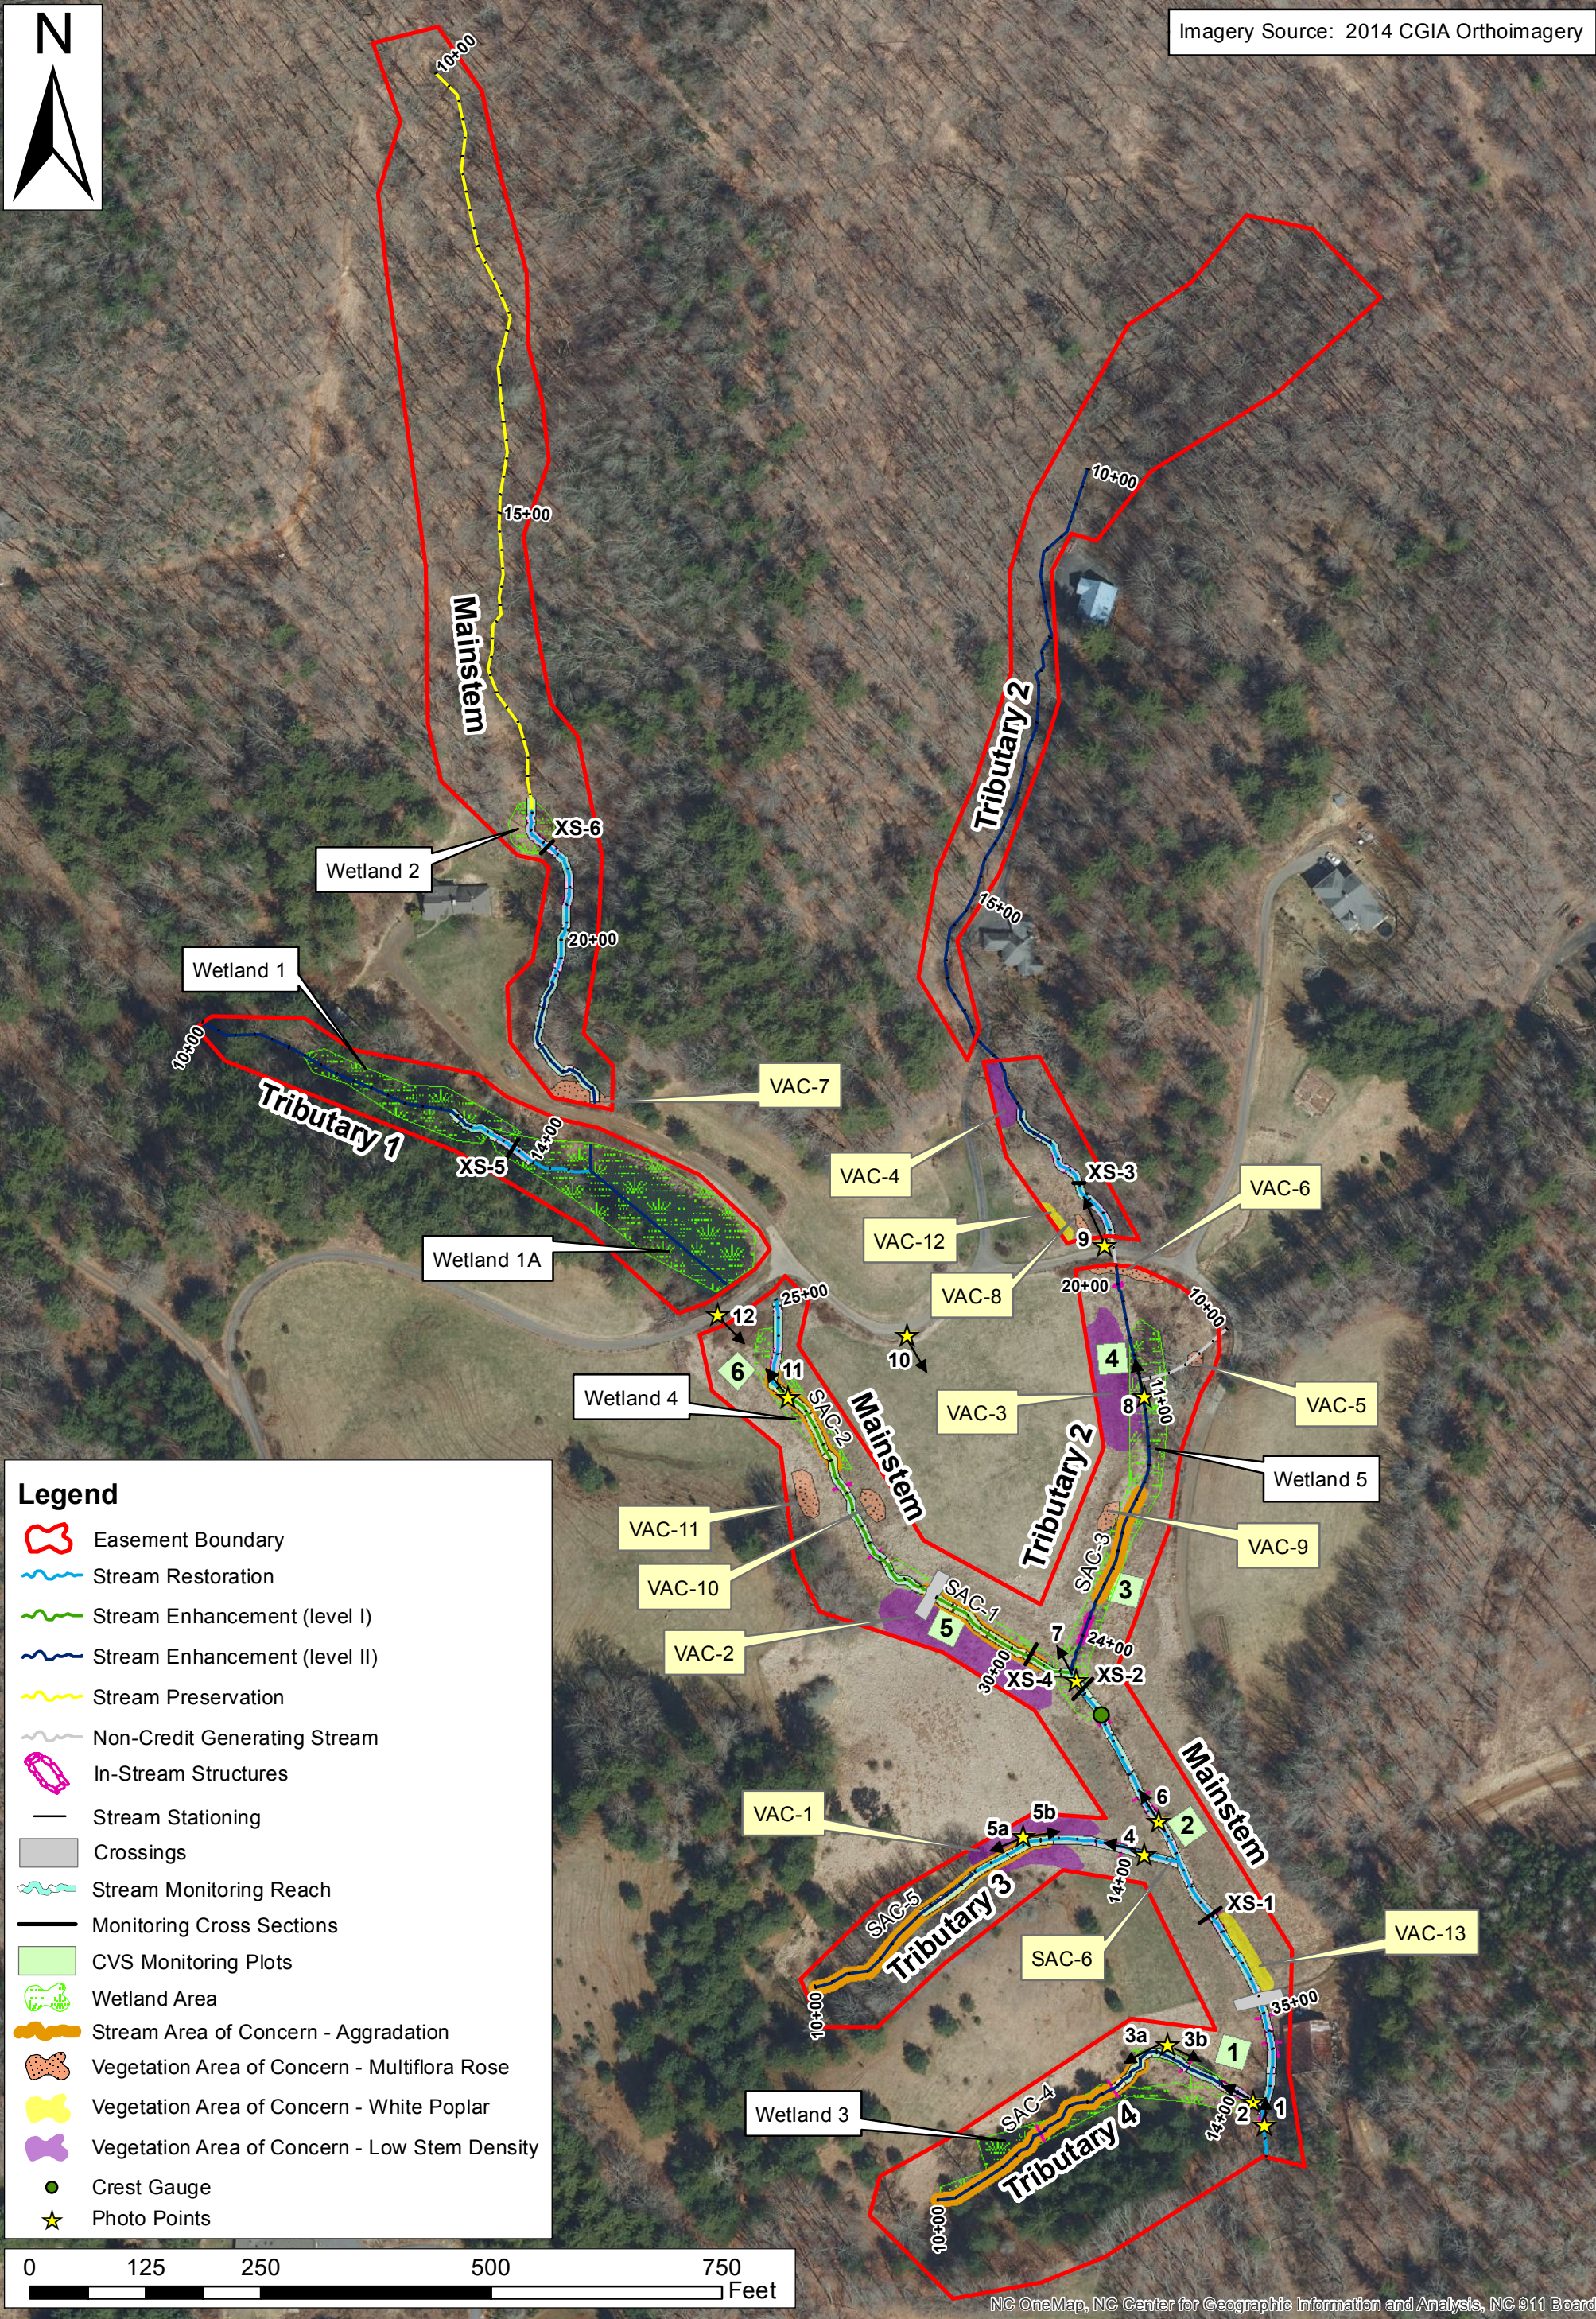
Figure 2. Current Conditions Plan View

Map Identifier	Feature/Issue
VAC-1	Low stem density around Tributary 3
VAC-2	Low stem density on the right bank of the Mainstem in and around Veg Plot 5
VAC-3	Low stem density in and around Veg Plot 4
VAC-4	Low stem density on the right bank of Tributary 2 near an adjacent driveway
VAC-5 to -11	Multiflora rose
VAC-12 to -13	Dense white poplar

Map Identifier	Feature/Issue
SAC-1 and -2	Aggradation on Mainstem
SAC-3	Aggradation on the lower portion of Tributary 2
SAC-4 and -5	Indiscernible bed and bank on the upper reaches of Tributaries 3 and 4
SAC-6	Failed rock structure on Tributary 3

The stream reach adjacent to cross-section 2 exhibited significant down cutting during years 3 (2014) and 4 (2015). During early summer 2016, a headcut was observed rapidly migrating upstream through this area creating significant incision below it, damaging a log structure. In October 2016, NCDMS performed stream repairs in order to repair the structure and return the streambed to its design elevation. This repair is depicted in the Cross Section 2 plot (Appendix D). A previously observed headcut and resulting incision in the lower portion of Tributary 2 was also repaired at that time. Some down cutting was also observed at cross-section 3 during year 5 (2016); however, this was the result of an isolated high-energy flow, and it does not pose any threat to stream stability or Site success.
