**UT to Barnes Creek
Stream and Wetland Restoration Project
Project No. 397
2009 Monitoring Report: Year 4 of 5**

November 2009 (Revised May 2010)

Prepared by: Jordan, Jones & Goulding
9101 Southern Pine Blvd., Suite 160
Charlotte, NC 28273

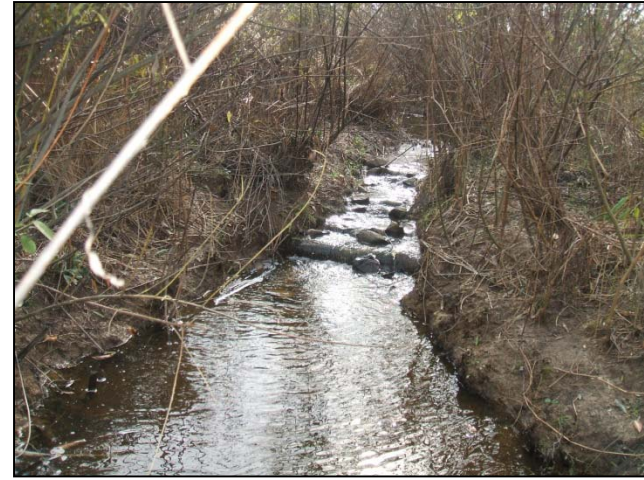
T-1 View Downstream
Tributary (11/2009)

Based on current monitoring data and the visual inspection, the channel is impacted by beaver activity. Three beaver dams were located along the channel with inundation levels above the top of bank. Fine sediment deposition is occurring throughout the reach due to the stagnant flow conditions. The average bankfull width (13.70 ft) of the surveyed cross-sections is lower than the proposed 14.40 ft, and the average surveyed mean bankfull depth is 1.0 ft compared to the proposed 0.7 ft. The surveyed bankfull widths and depths lead to an average Width/Depth ratio of 17.6, which typifies a Rosgen C-type stream. The average water surface slope and the average bankfull slope were very slightly different for the surveyed reach, 0.0085 ft/ft and 0.0091 ft/ft, respectively. This is most likely due to the inundated conditions occurring onsite during the longitudinal survey.

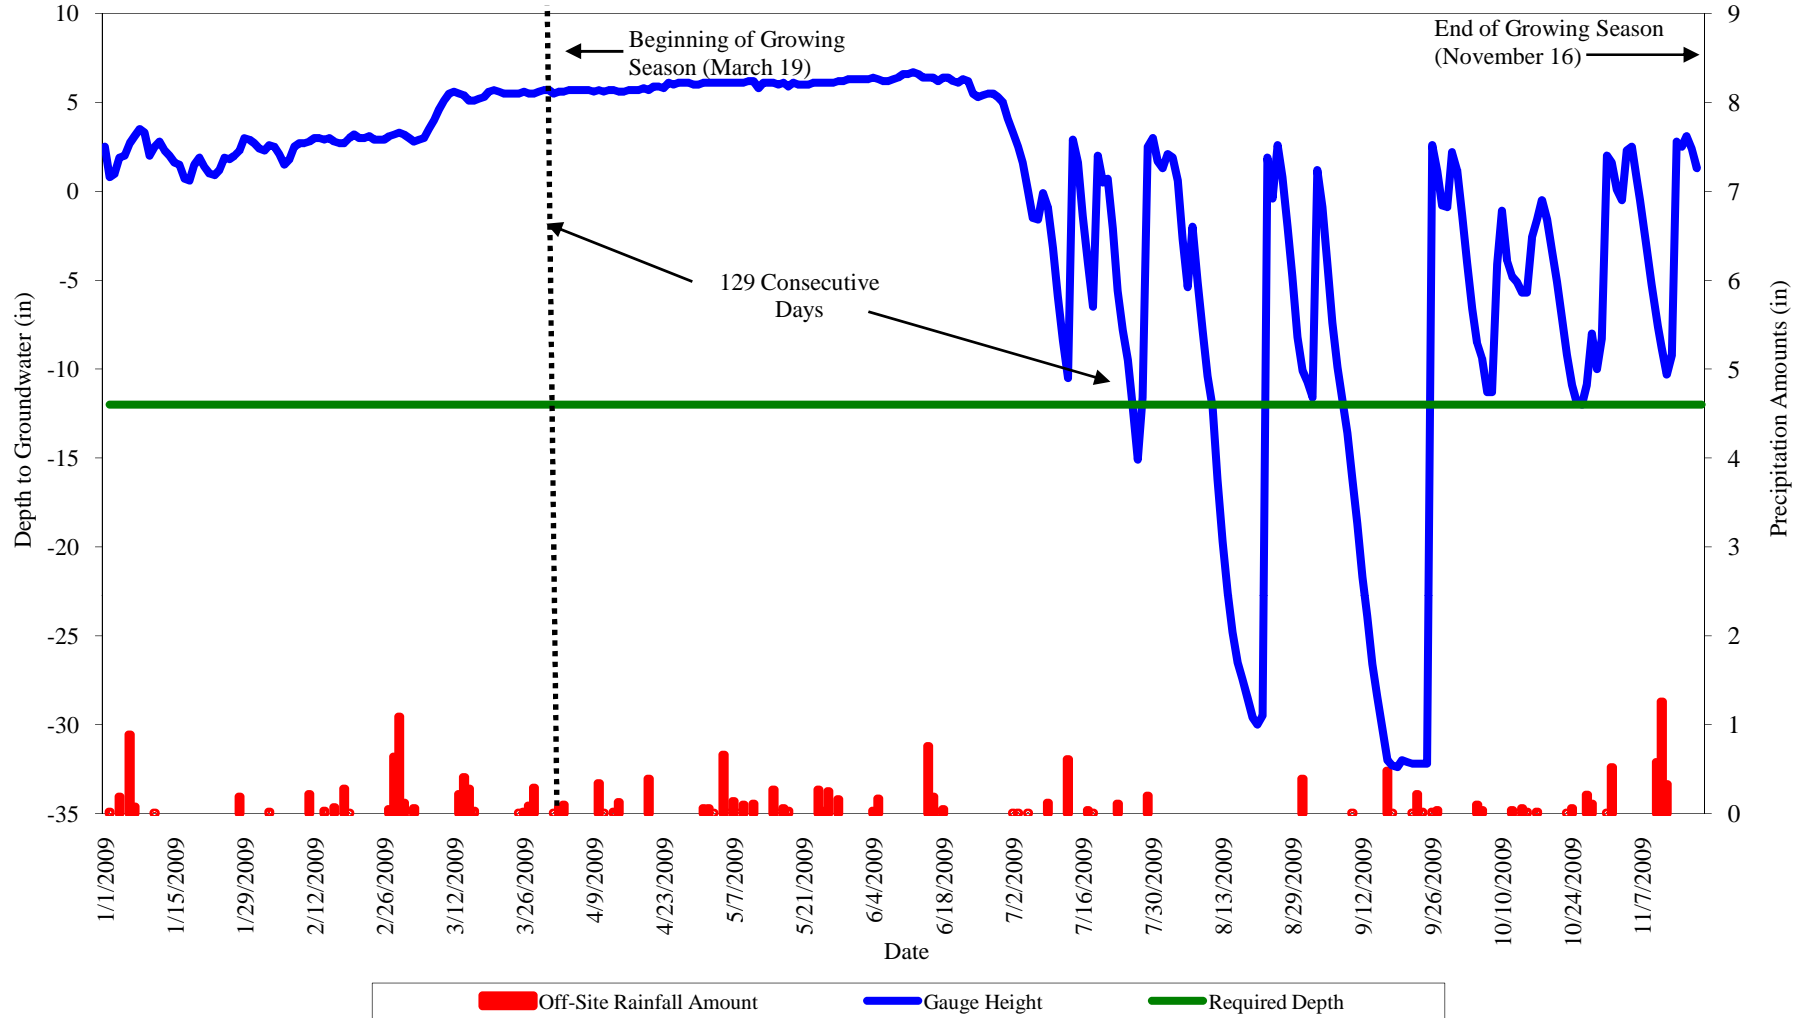
UT to Barnes Hydrology Monitoring
Groundwater Gauge MW3

appears to be present. Although all the gauges achieved the wetland success criteria for the 2009 monitoring year, MW3's success may be attributed to beaver activity observed throughout the 2009 monitoring year.
