# UT to Cane Creek Stream Restoration Site

2008 Annual Monitoring Report (Year 2)

Alamance County  
EEP Project No. 69  
Design Firm: Stantec Consulting Services, Inc.

May 2009

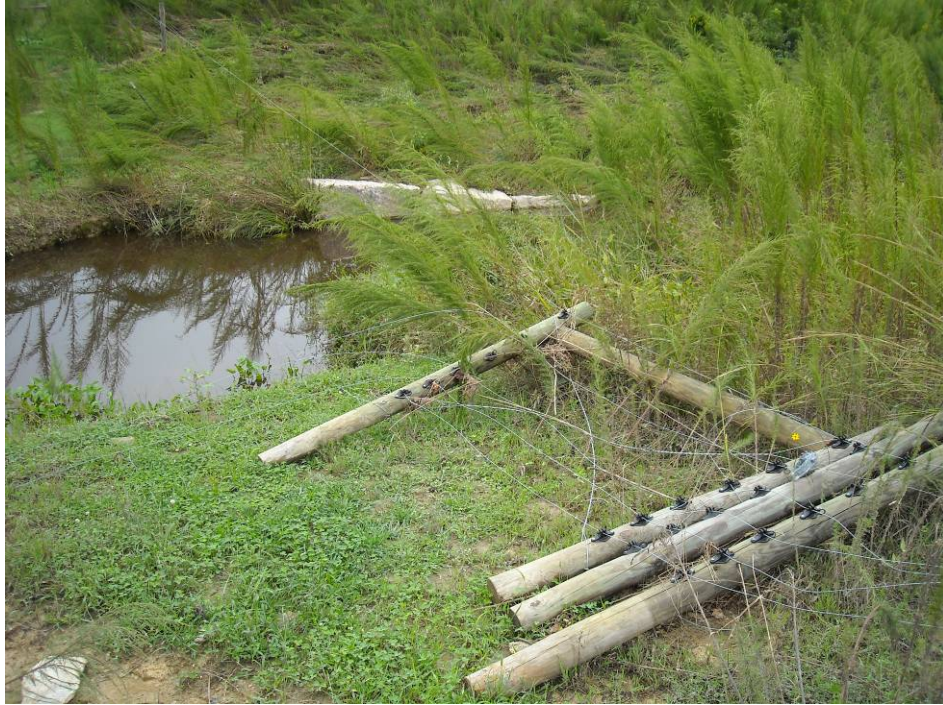
Photo 9. VPA 11

| VPA # | Station # | Probable Cause | Photo # |
|---|---|---|---|
| 11 | 19+00 | fence washed out from flooding event on September 8, 2008 | 9 |

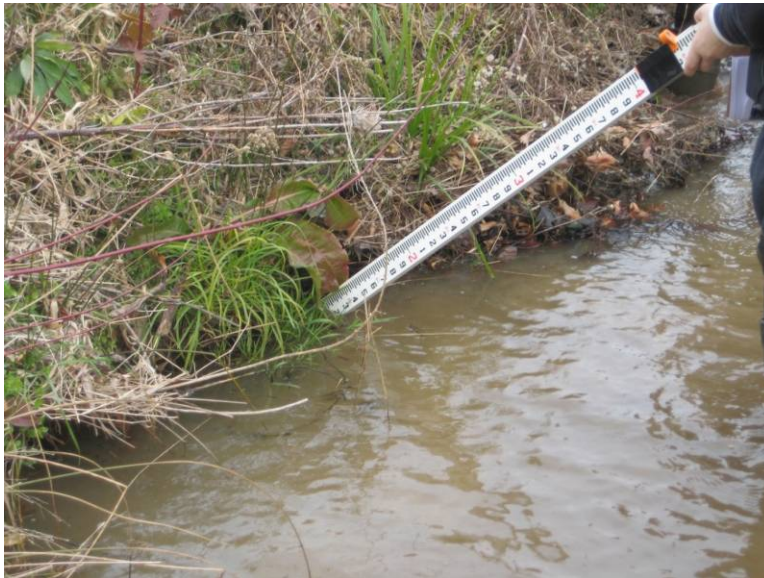
**SPA 2**

| <b>Feature Issue</b> | <b>Station Numbers</b> | <b>Suspected Cause</b> | <b>Photo Number</b> |
|--|---|--|---|
| <b>Bank Erosion: Left<br/>Bank</b> | 10+80 | Left bank undercutting due to upstream aggradation has caused a thalweg shift. | PA 2 |

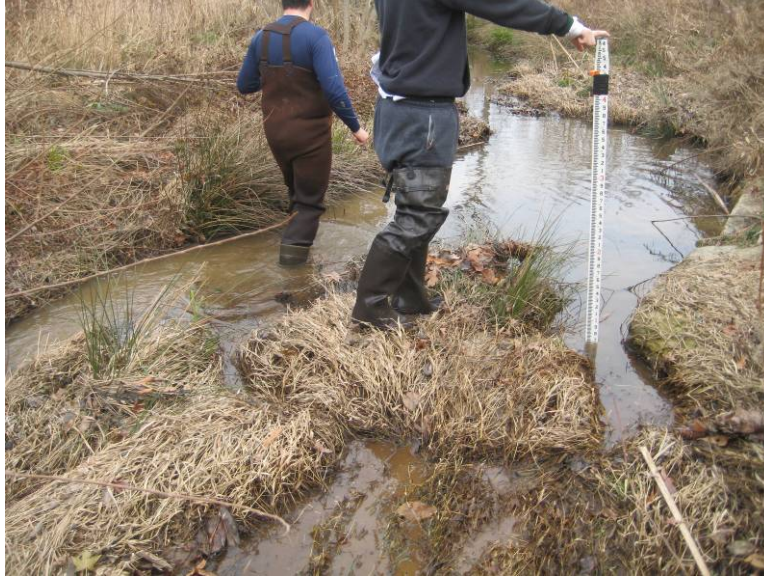
**SPA 7**

| Structure Failure | 15+60 | Structure failure due to piping, channel migration towards left descending bank causing bank erosion. | PA 7 |

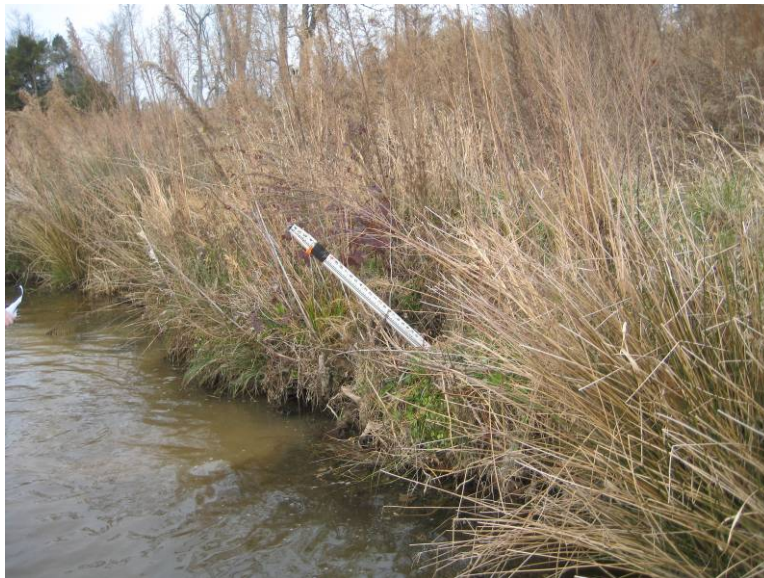
**SPA 8**

| Bank Erosion: Right Bank | 17+80 | Undercutting bank due to rootwad failure. | PA 8 |

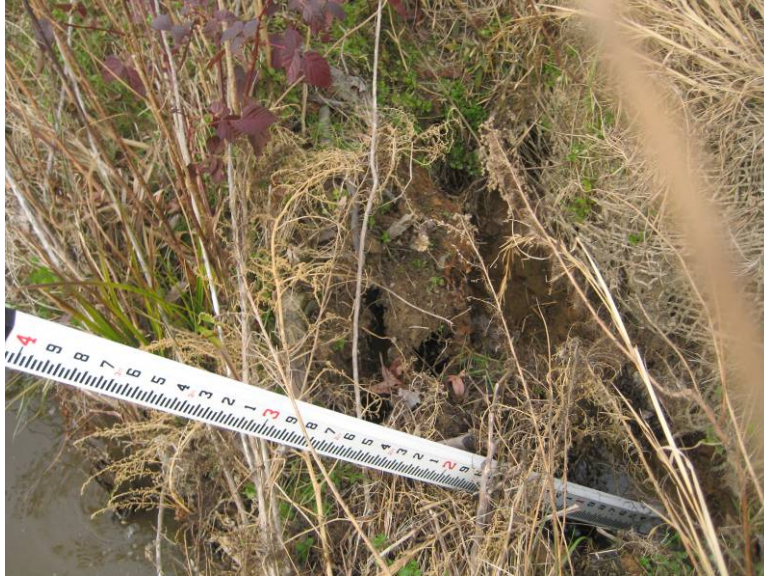
**SPA 9**

| Structure Failure | 17+80 | Rootwad failure most likely due to backwater caused by stream crossing. | PA 9 |

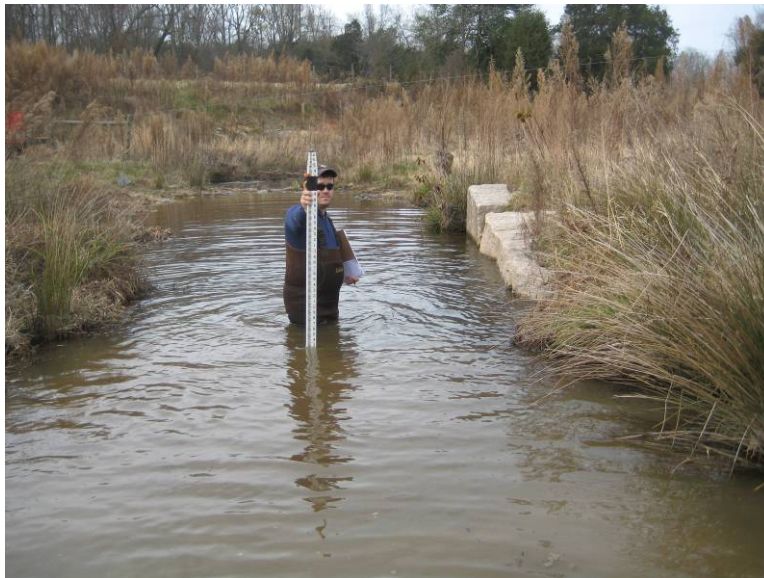
**SPA 10**

| Structure Failure | 18+70 | Structure failure due to backwater caused by stream crossing. Inundation of the structure prevents intended function. | PA 10 |

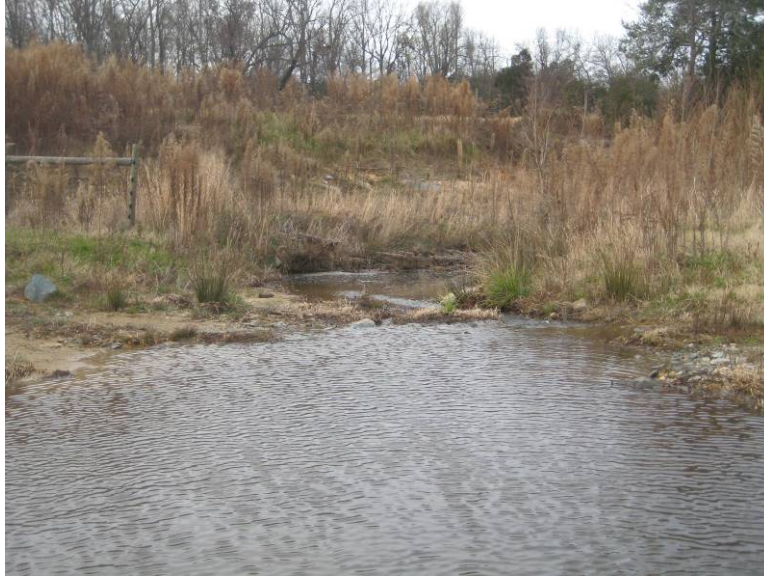
**SPA 11**

The backwater impacts involve a significant length of stream. The first area is upstream of the ford crossing at station 19+12. The elevation of the ford, 570.5 feet, has backed water up approximately 360 feet to station 15+52. The structures and riffles in this area are not functioning as designed, as they are impacted by high water levels. A more appropriate level for this crossing based on the bankfull and water surface slopes is elevation 569.4 which is approximately 1.1 feet lower than the existing crossing.

| Structure Failure | 19+00 | Crossings high grade causing backwater within the channel. | PA 11 |

It is recommended that the three aforementioned causes of backwater effects be repaired to restore the lost function of the stream features and structures in those areas. Lowering the elevation of the stream fords and elevated riffle would alleviate the backwater effects and likely reduce the deposition of sediments throughout the affected areas.

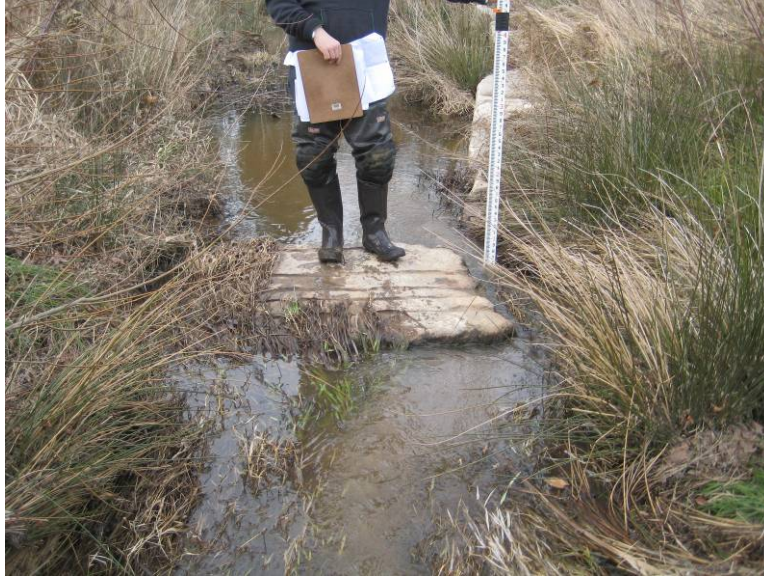
**SPA 17**

| Structure Failure | 22+70 | Structure piping due to the size of boulders used, gaps do not appear to be chinked properly. | PA 17 |
