**Cane Creek (EEP #69)
Stream Restoration Site
2009 Annual Monitoring Report (Year 3)**

**Alamance County
EEP Project No. 69
Design Firm: Stantec Consulting Services, Inc.**

December 2009

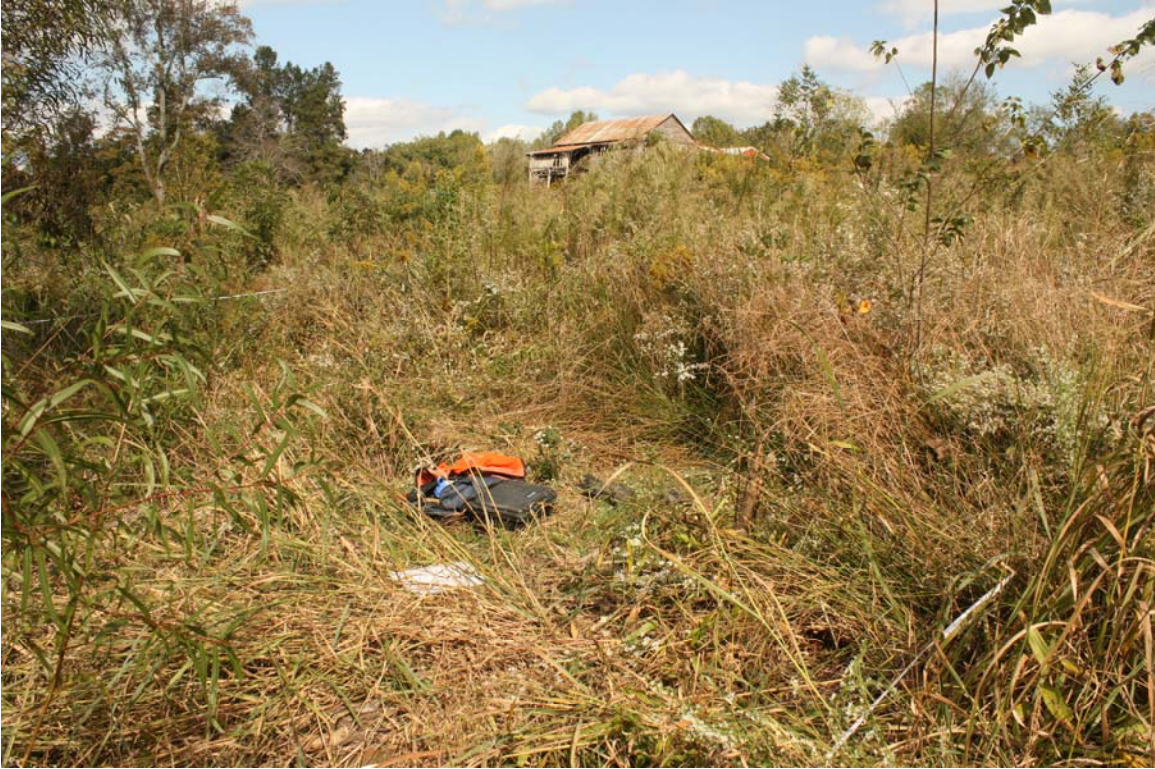
Photo 4. Vegetation Plot 4

*Tract Mean met for Plot 04, the only plot with confirmed planted stems

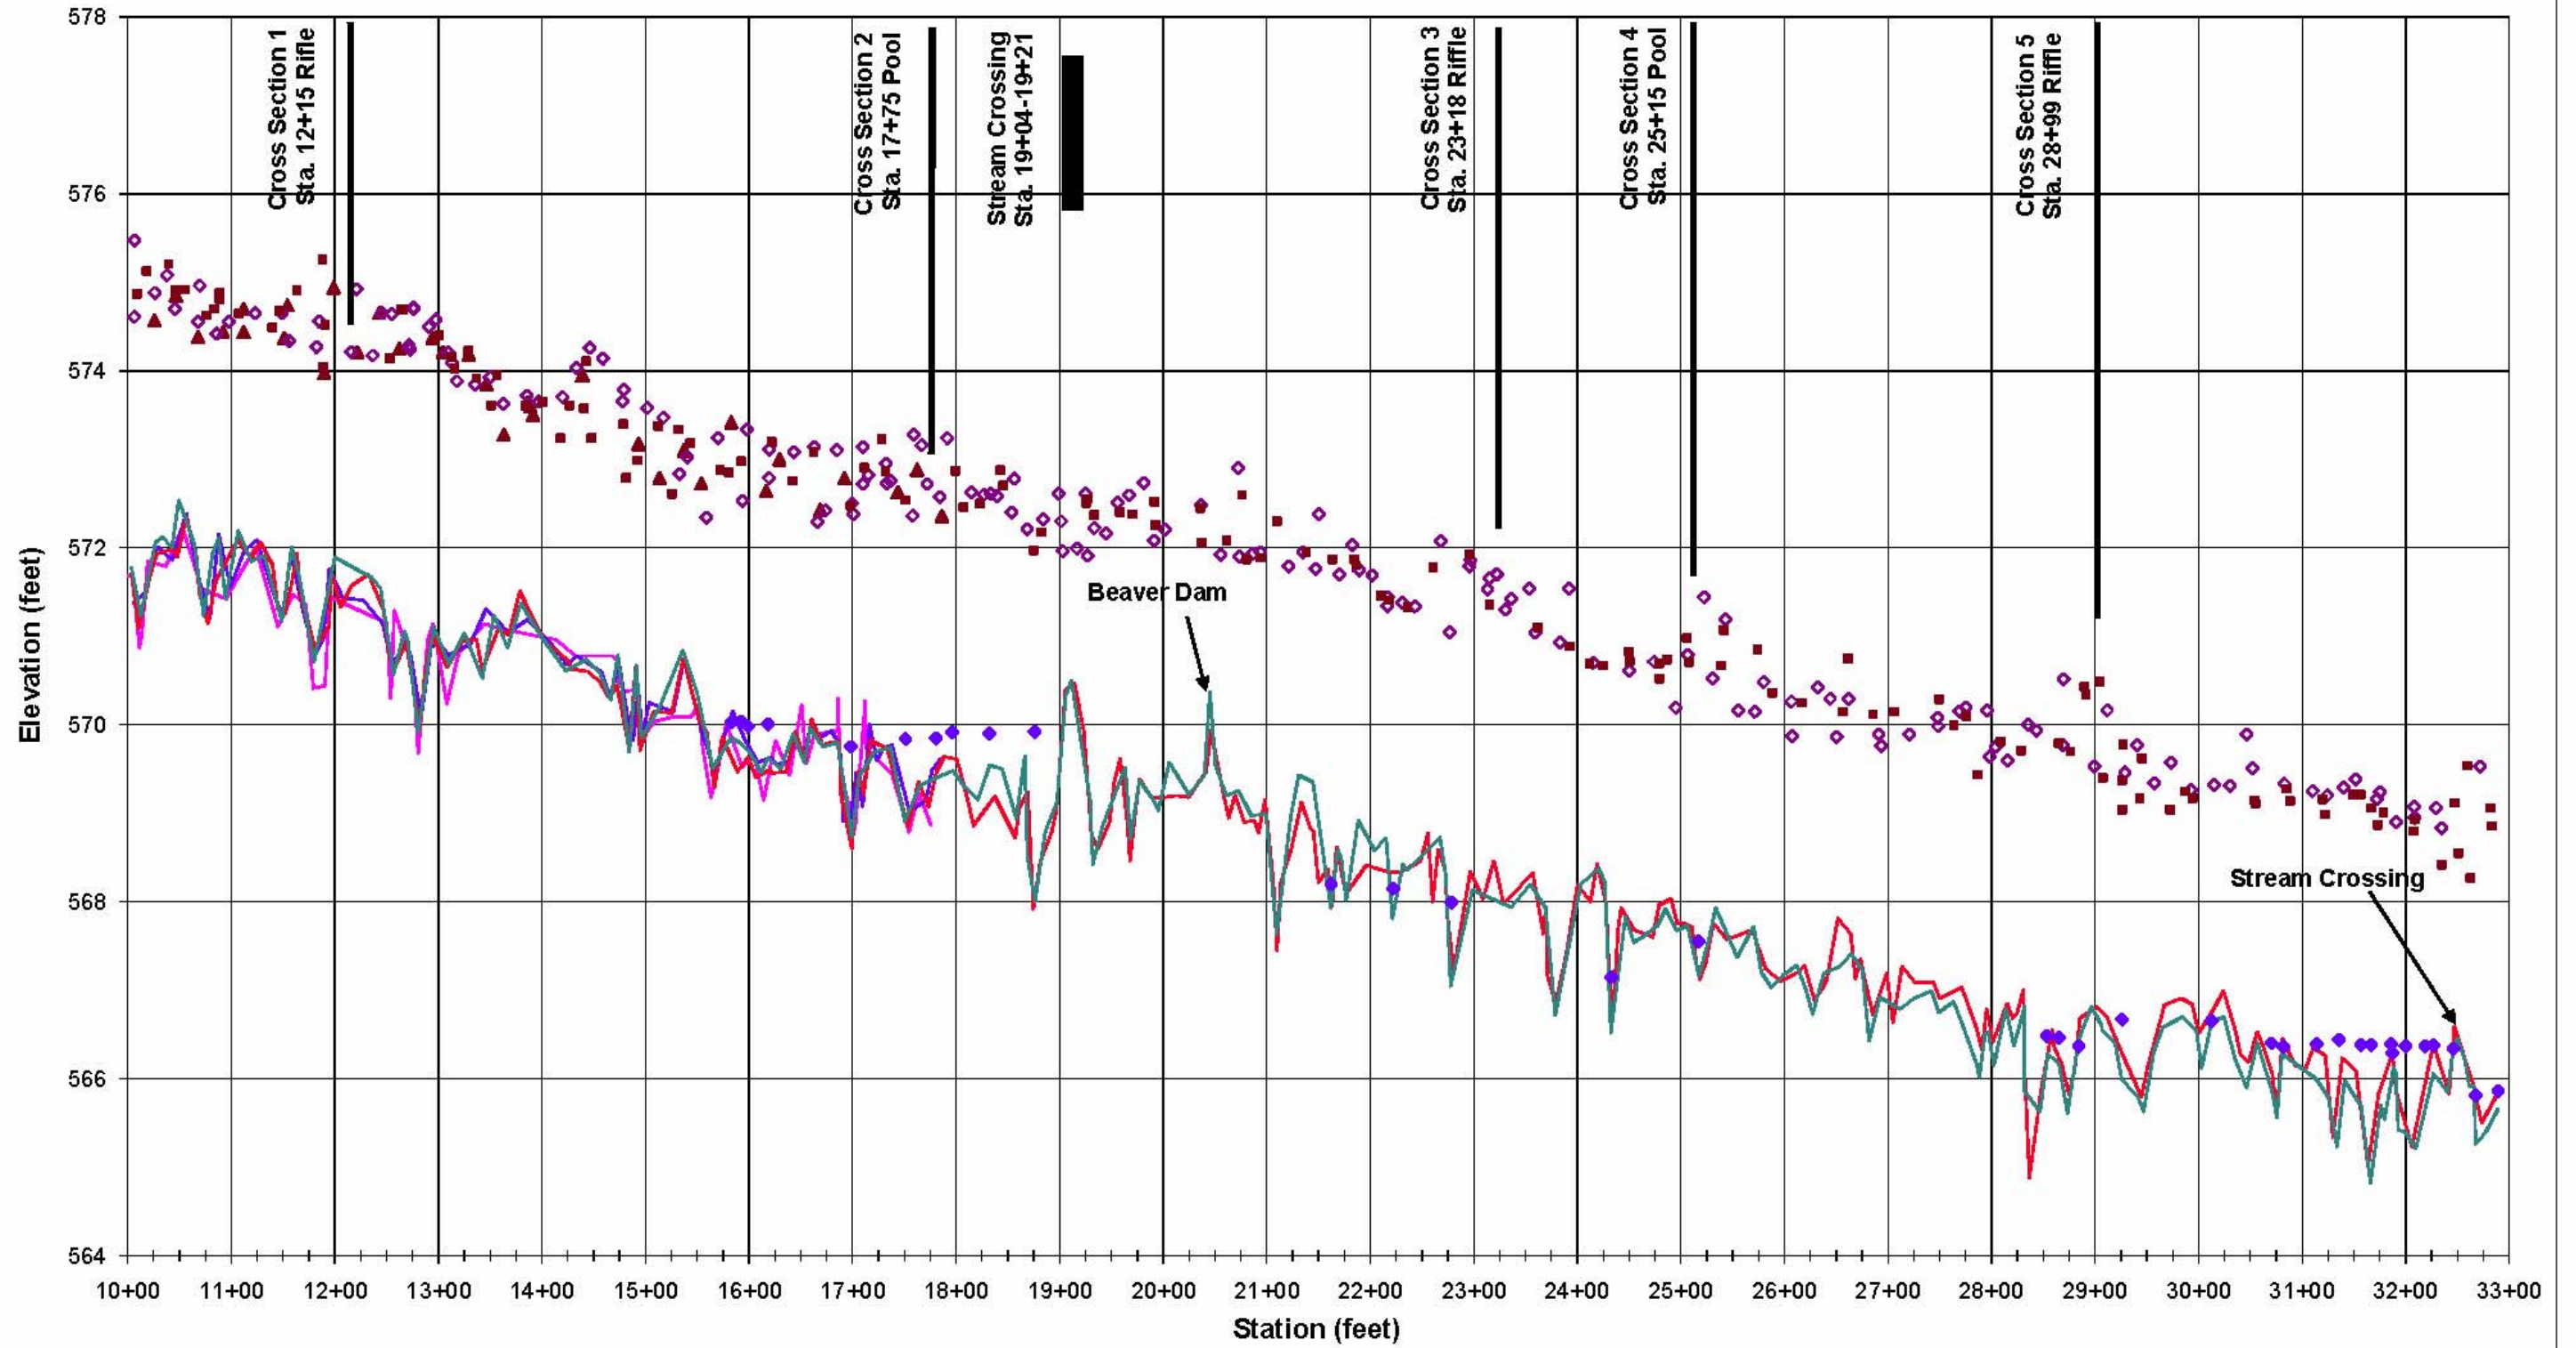
UT to Cane Creek
Longitudinal Profile
Main Channel: Station 10+00-32+90

The Cane Creek (EEP #69) Restoration project shows little change from MY-02 to MY-03. The channel was mainly dry and overgrown with vegetation during the monitoring period. Vegetation is becoming well established on the banks. The banks and structures are stable and holding grade. A comparison of the longitudinal profile and cross sections between MY-02 and MY-03 shows little change in the profile or dimension of the restored reach. Aggradation and the formation of mid-channel bars, present in MY-02, are still an issue throughout most of the project due primarily to the low flows associated with the drought which promoted in-channel growth of vegetation. In some areas the aggradation is being exacerbated by backwater at crossings, however as mentioned, the thalweg elevation has not appreciably changed. The mid-channel bars are preventing the flow from centering in the channel. Pebble counts at cross sections one and three show a trend towards a finer substrate from MY-02 to MY-03; with the d_{50} shifting from 22.6mm to 1.3mm and 42mm to 15.6mm, respectively. The increased vegetation and low rainfall in 2009, likely contributed to the further accumulation of fine sediment. Aggradation is occurring in approximately 38% of the project length. The two stream crossings, at stations 19+10 and 32+50, continue to cause backwater conditions for distances of 300 and 200 feet upstream, respectively
