Cane Creek (EEP #69) Stream Restoration Site

2010 Annual Monitoring Report (Year 4 of 5)

**Alamance County, North Carolina
EEP Project No. 69
Design Firm: Stantec Consulting Services, Inc.**

April 2011

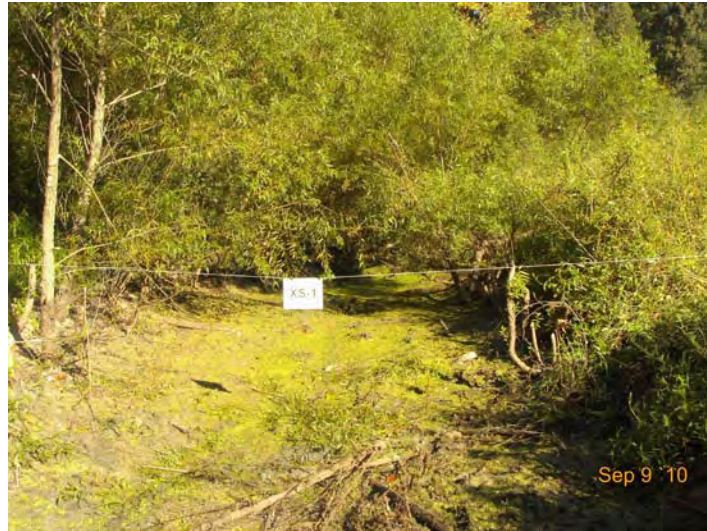
Photo 1. Looking downstream at XS-1

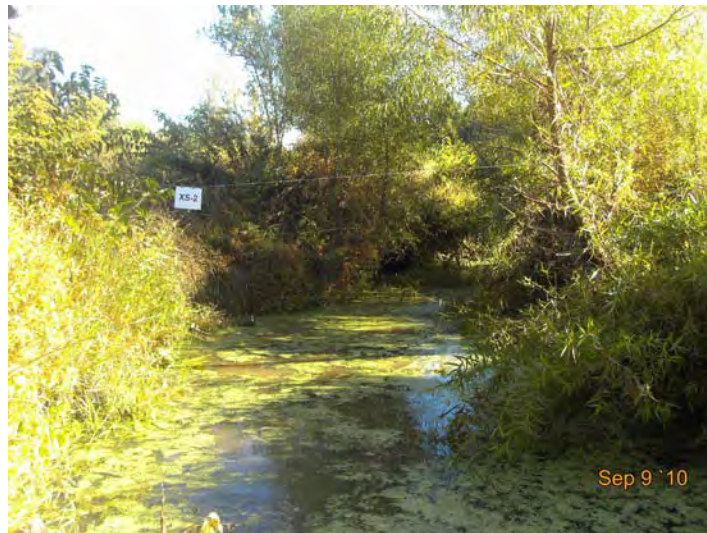
A comparison of the cross sections between MY-03 and MY-04 shows little change. Cross Section 2 shows slight bank erosion due to local disturbance caused by a dislodged tree on the bank. The stream banks in general are in good condition and the vegetation is well established at the permanent cross section locations. For MY-04, the bankfull data calculations were based on the baseline bankfull elevations. This elevation has varied in previous monitoring years. Pebble counts at riffle Cross Sections 1 and 3 show a trend towards a finer substrate due to the impoundment caused by the beaver dams. The pebble count at the riffle on Cross Section 5 continues a trend toward coarser substrate.

Photo 2. Looking downstream at XS-2

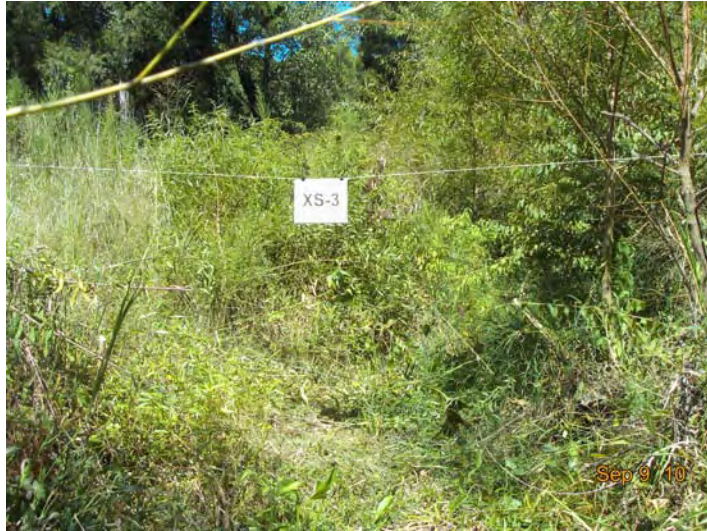
Photo 3. Looking downstream at XS-3

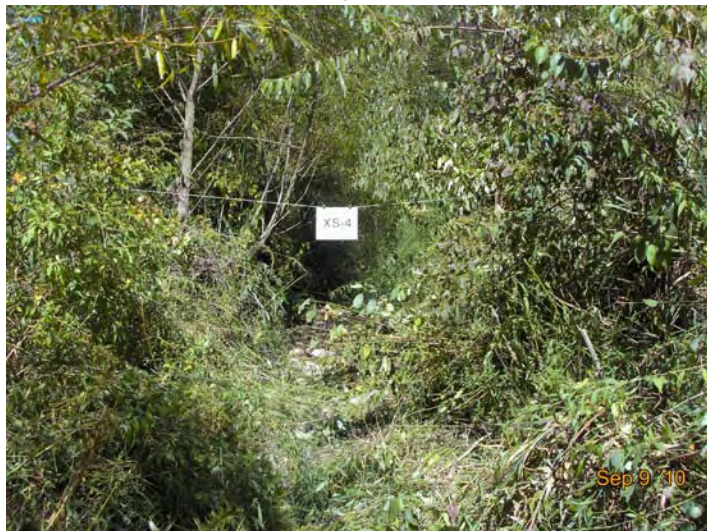
Photo 4. Looking downstream at XS-4

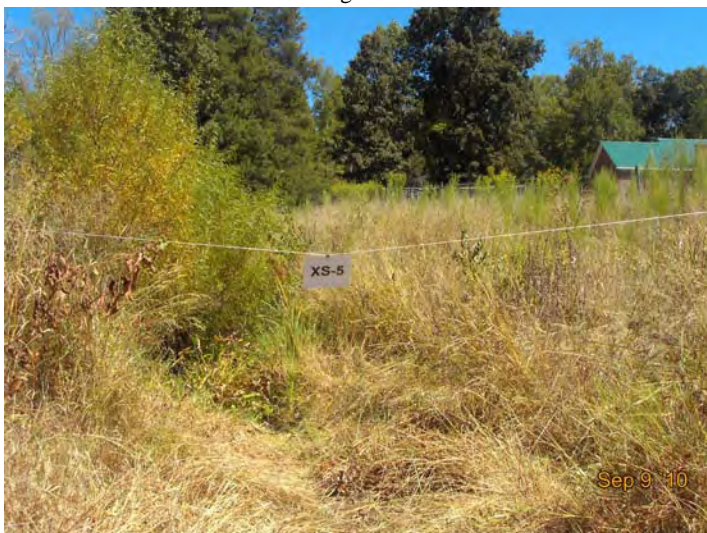
Photo 5. Looking downstream at XS-5

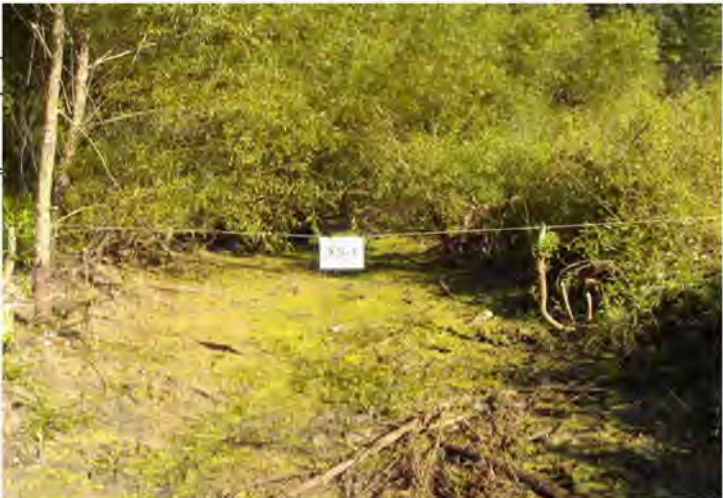
Cross Section 1 Sta 12+15 Rifle

Photo of XS-1, looking in the downstream direction

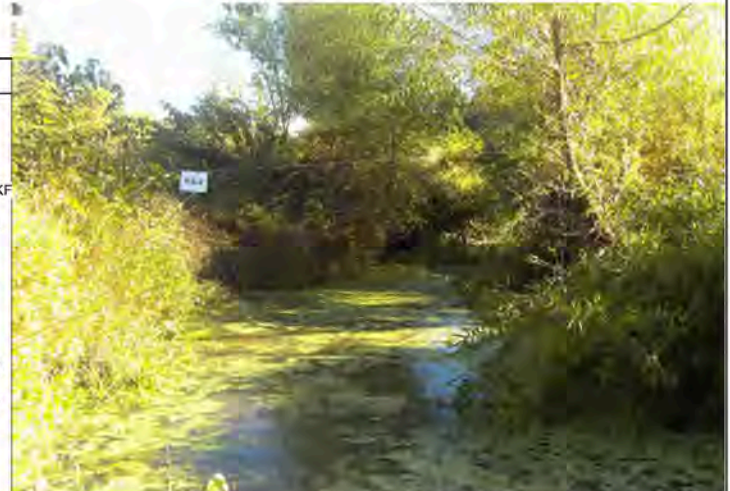
Cross Section 2 Sta 17+22 Pool

Photo of XS-2, looking in the downstream direction

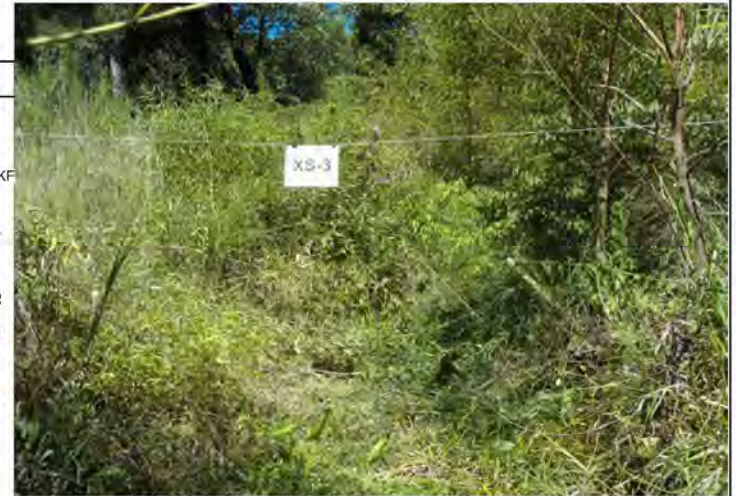
Cross Section 3 Sta 23+18 Riffle

Photo of XS-3 looking in the downstream direction

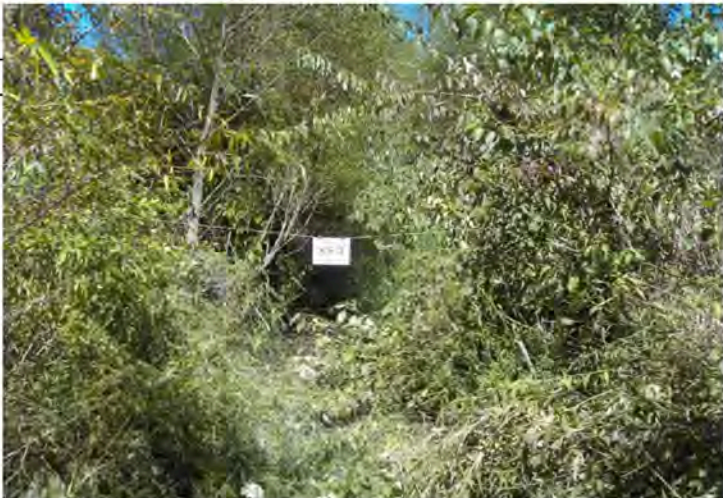
Cross Section 4 Sta 25+14 Pool

Photo of XS-4, looking in the downstream direction

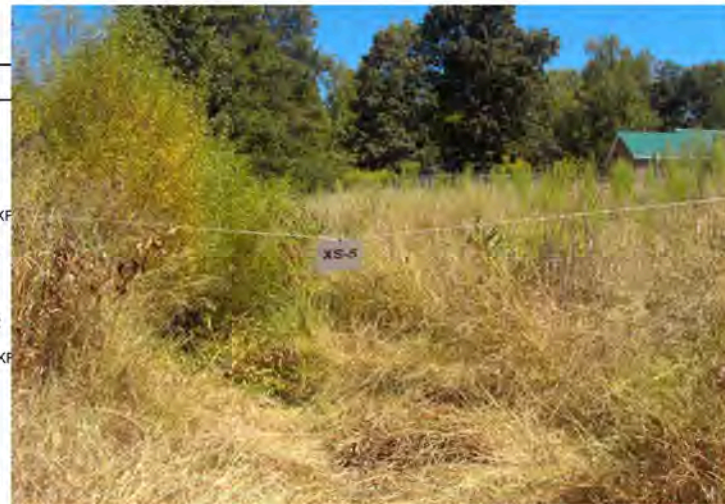
Cross Section 5 Sta 28+99 Riffle

Photo of XS-5, looking in the downstream direction
