# **Cane Creek (EEP #69) Stream Restoration Site**

**2011 Annual Monitoring Report (Year 5 of 5)**

**Alamance County, North Carolina**

**EEP Project No. 69**

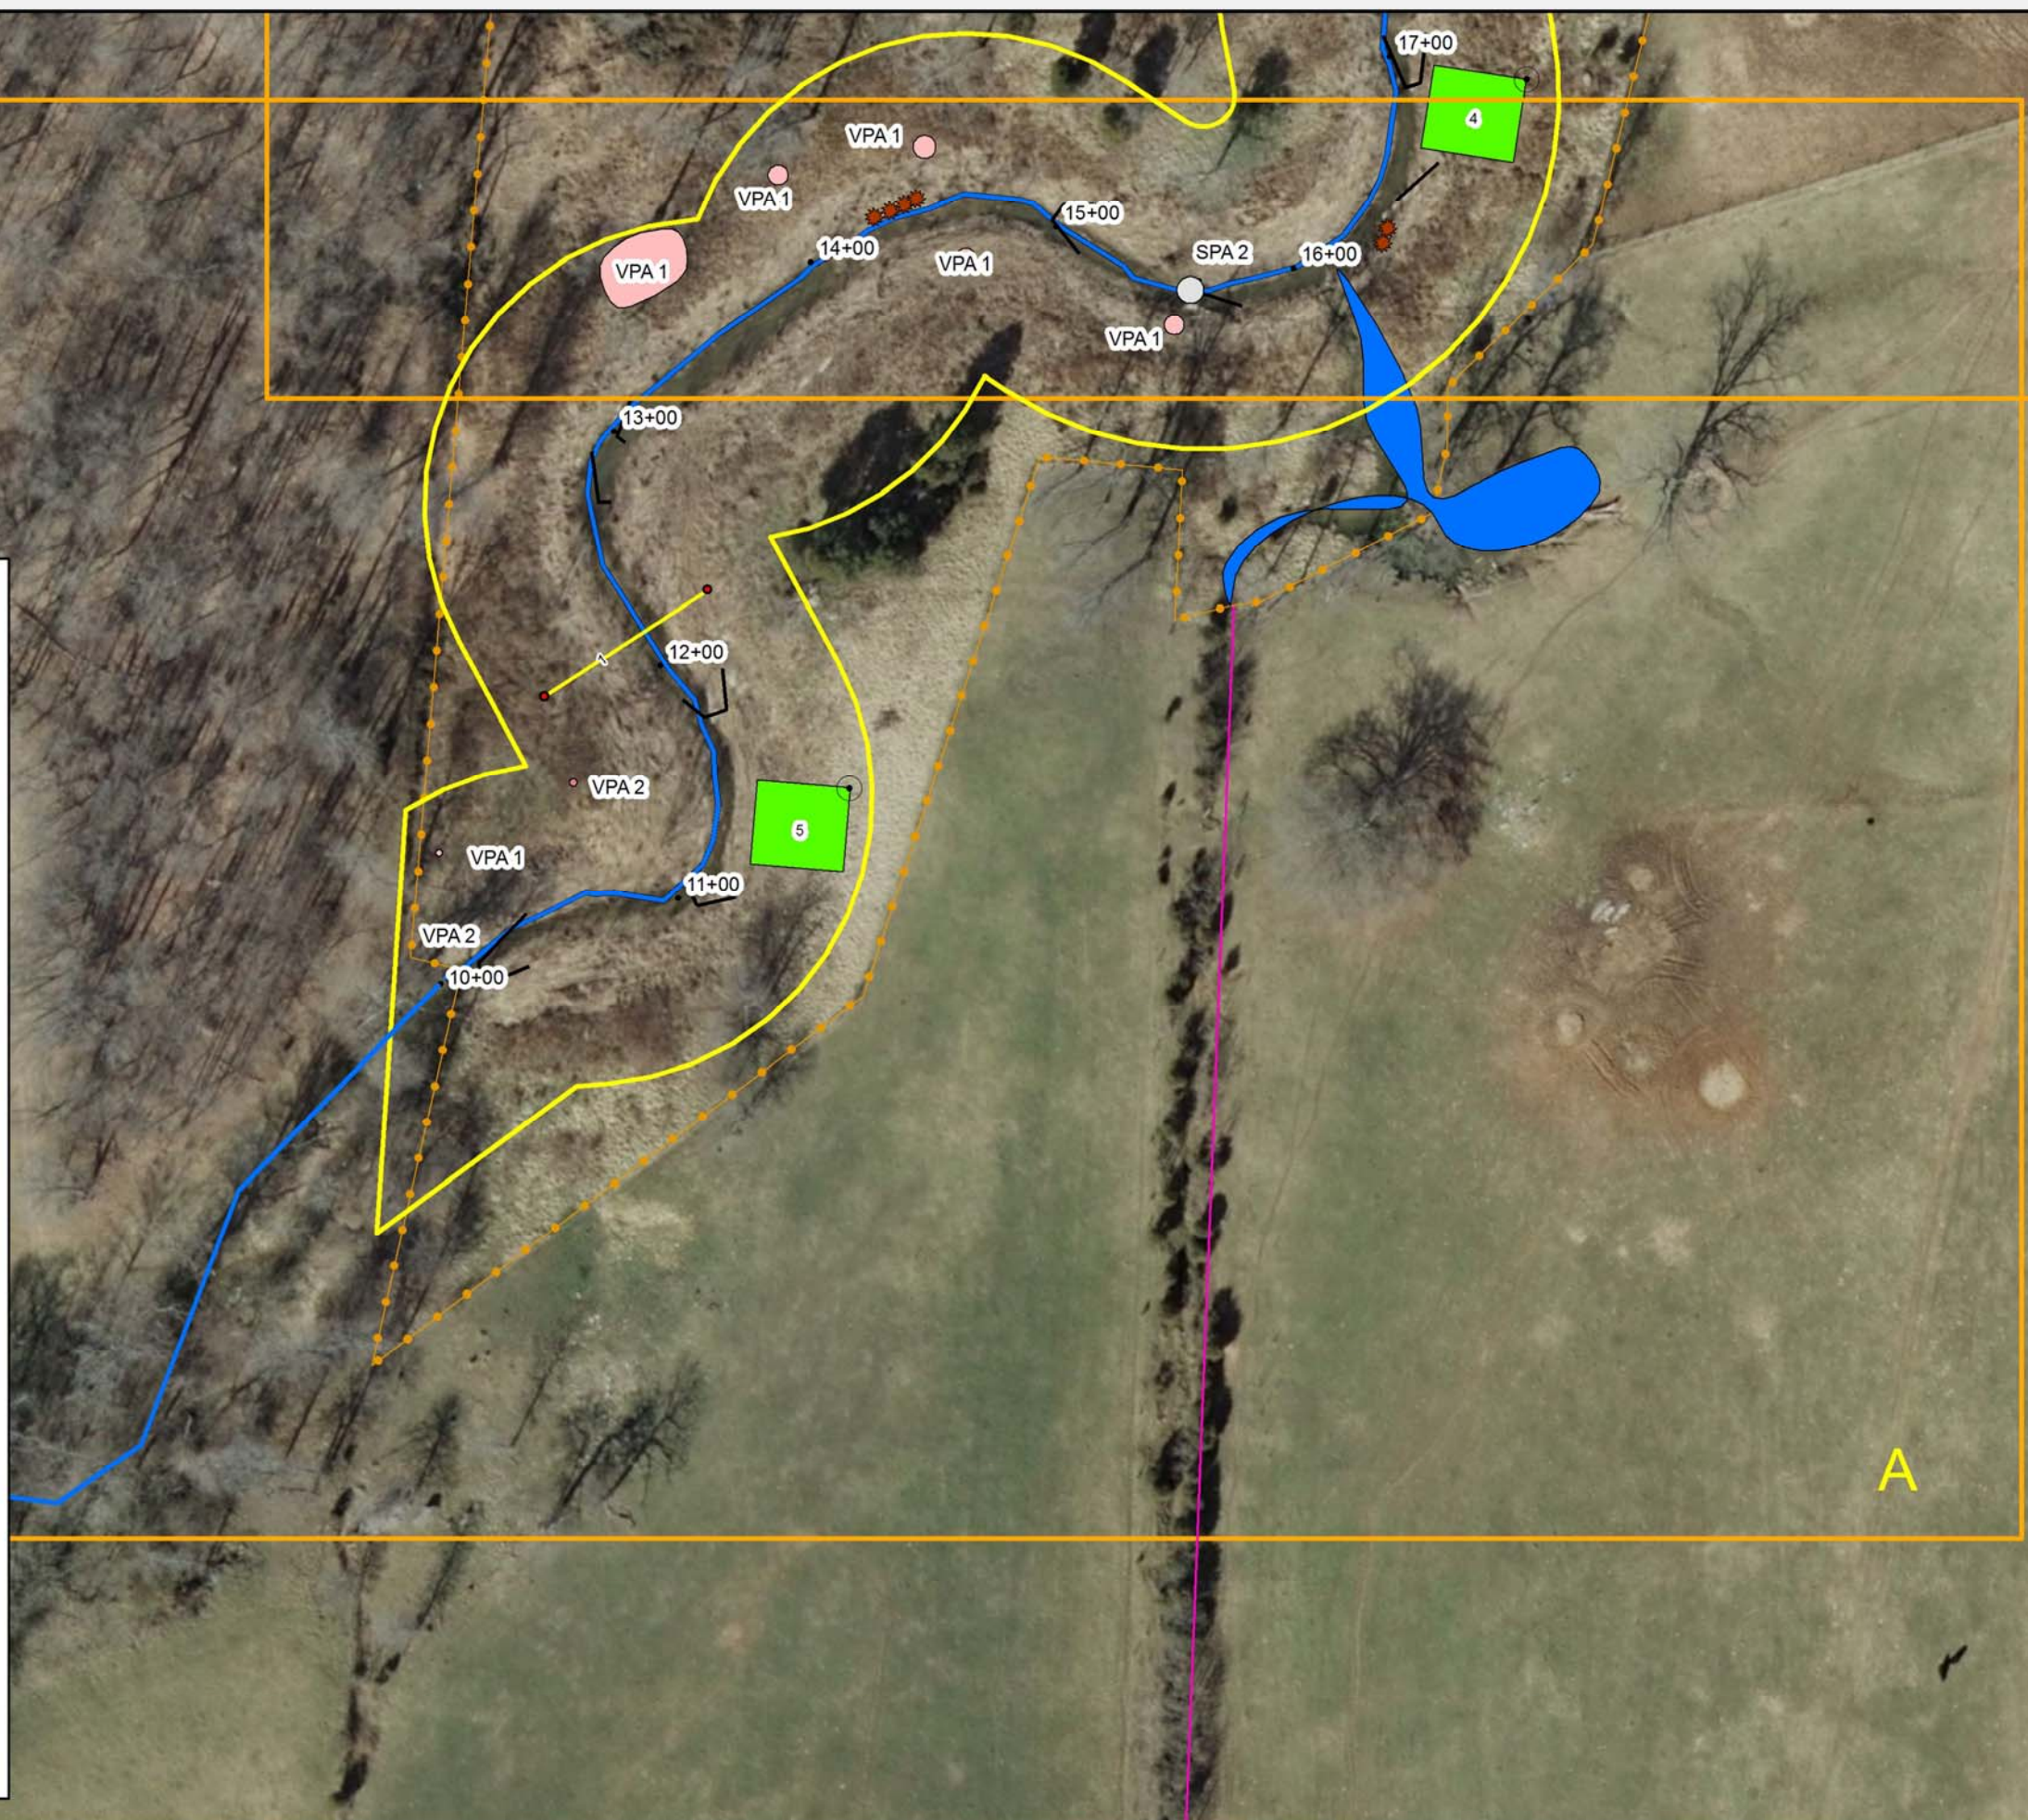
Figure  
**A**

Beaver activity has been present within the conservation easement in past monitoring years. During the site visit in October 2011, evidence of new beaver activity was observed in several locations along the stream. Recently cut woody vegetation was observed from station 17+60 to the stream crossing at station 19+10 for a distance of approximately 150 linear feet. A vegetative debris and muck collection was found under the water surface that may be the beginnings of a future beaver dam near stream station 18+40. Additional beaver activity was observed downstream of the stream crossing at station 19+10 through approximate stream station 20+50. The remnant beaver dam at station 20+50 (breached by monitoring performers in February 2011) was rebuilt as observed in the October site visit, with freshly cut vegetation. This rebuilt beaver dam at station 20+50 is creating impoundment issues upstream approximately 120 feet to the stream crossing.

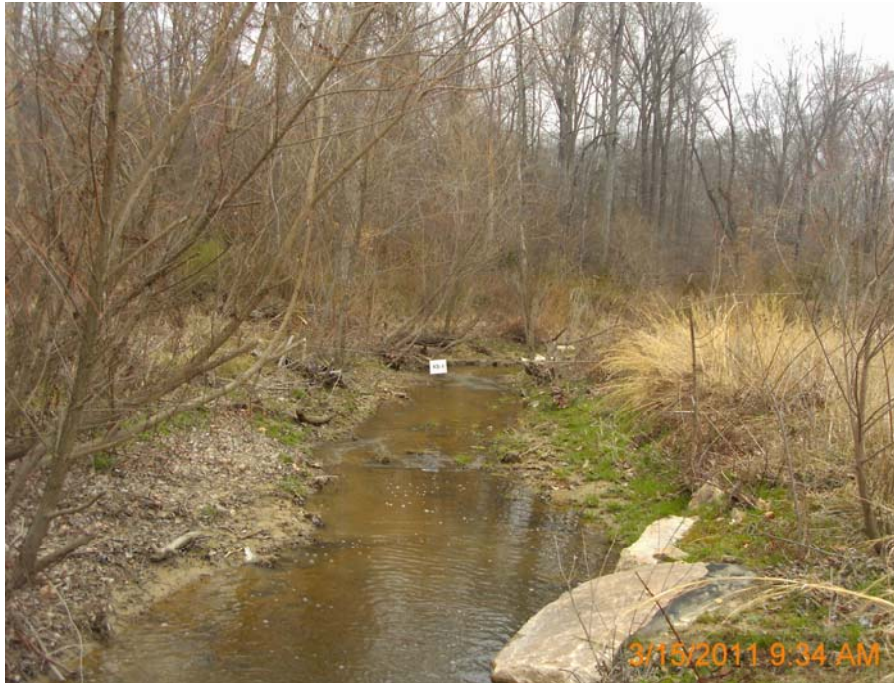
**Photo 1.** Looking downstream at XS-1

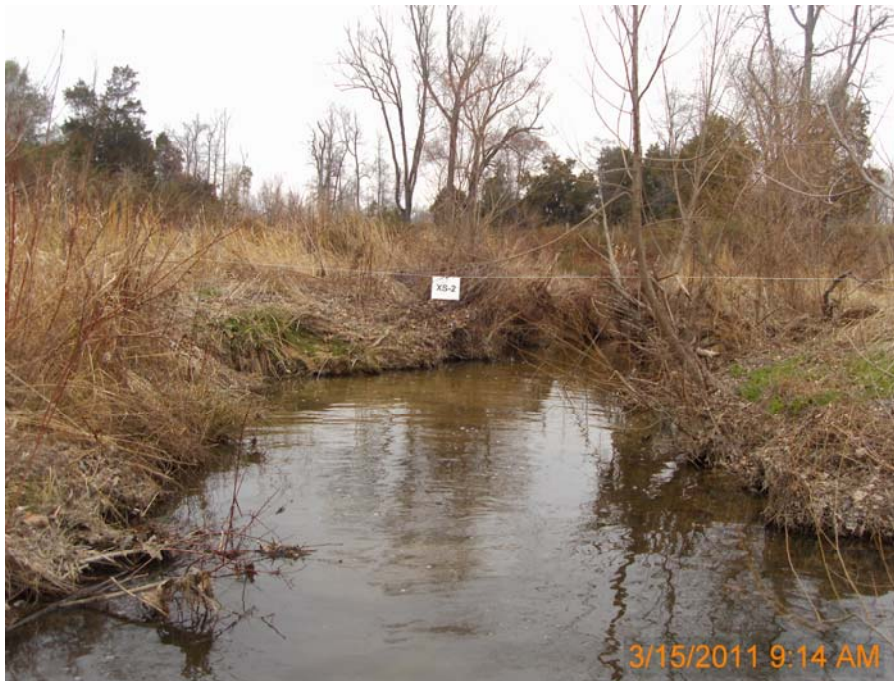
**Photo 2.** Looking downstream at XS-2

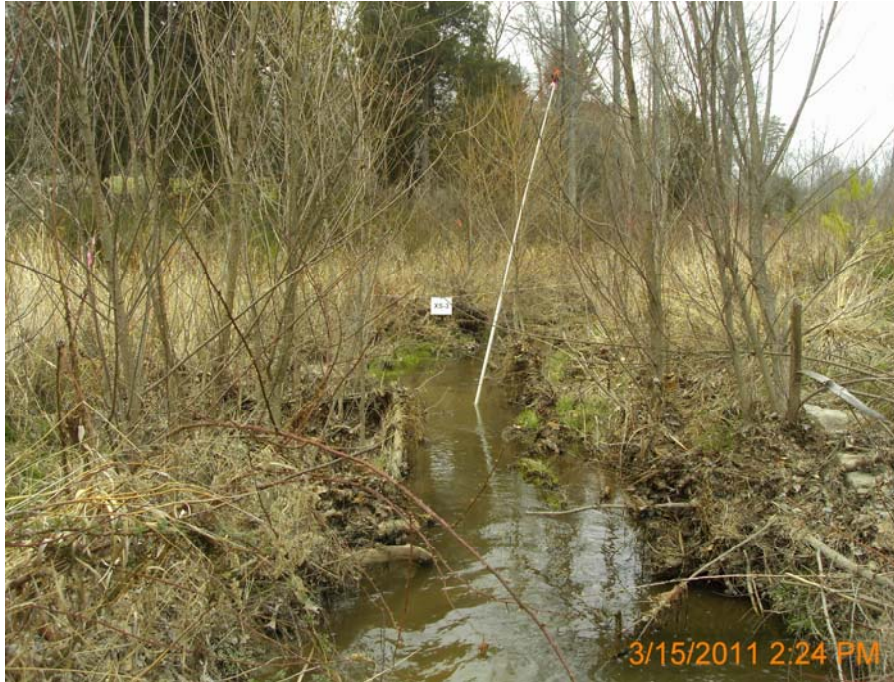
**Photo 3.** Looking downstream at XS-3

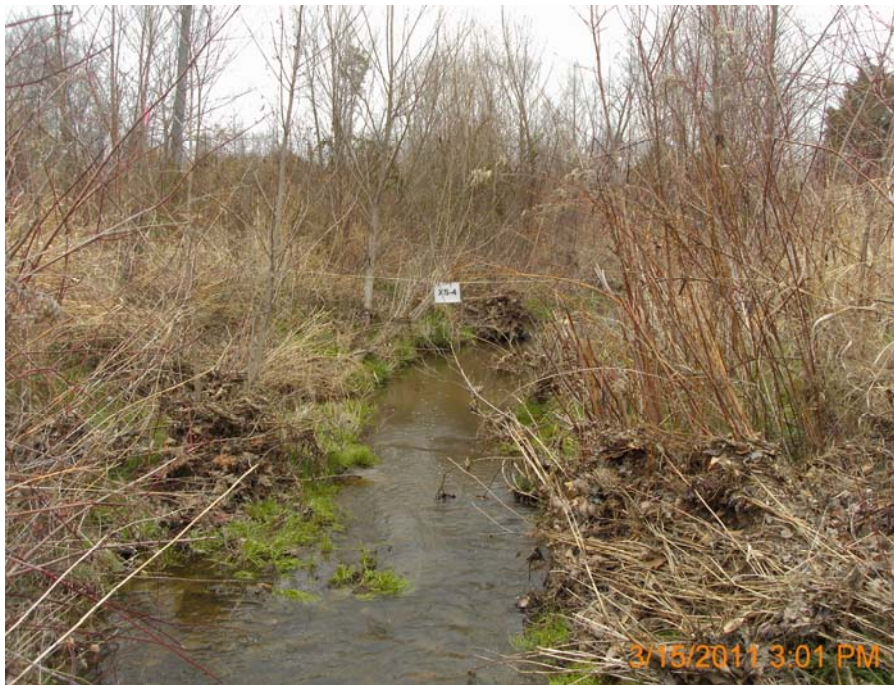
**Photo 4.** Looking downstream at XS-4

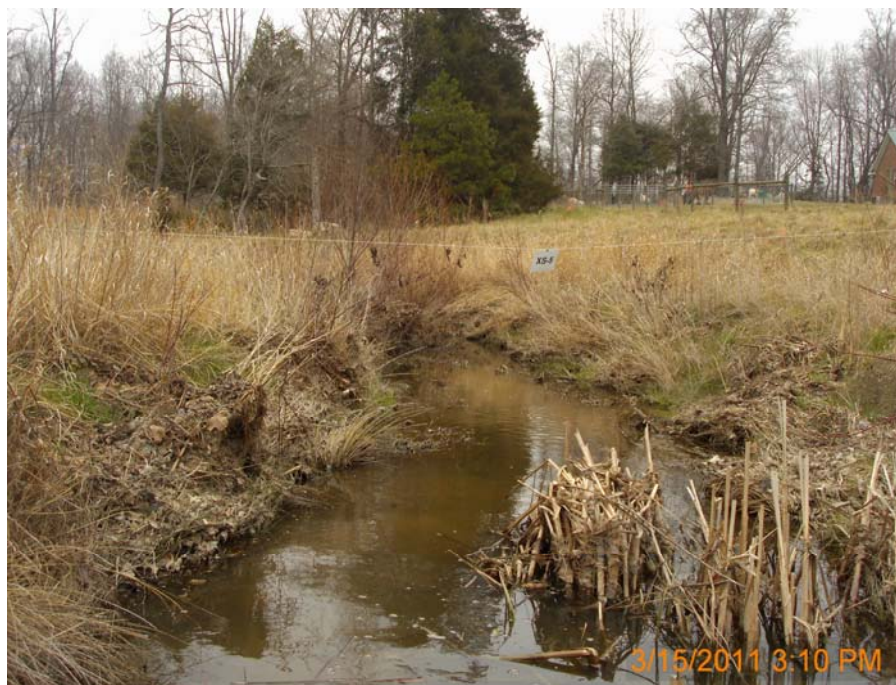
**Photo 5.** Looking downstream at XS-5

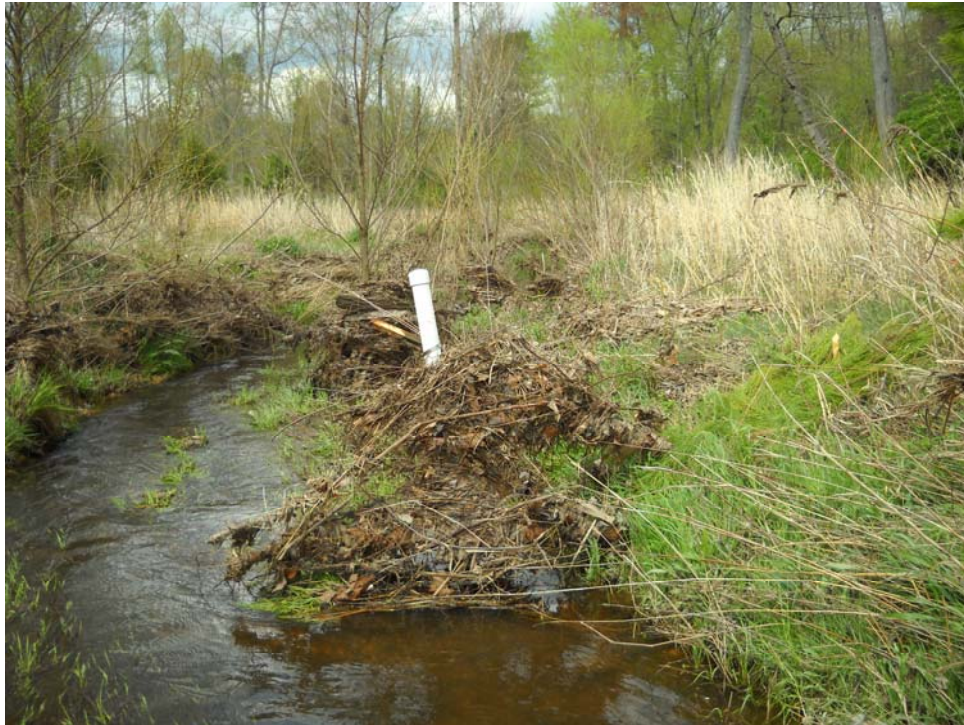
**Photo 1.** Evidence of bankfull event observed on February 28, 2011.
