ANNUAL MONITORING REPORT UT to CANE CREEK RESTORATION SITE

**ALAMANCE COUNTY, NORTH CAROLINA
(EEP Project No. 395)**

Monitoring Year 1 of 5 (2009)

November 2009

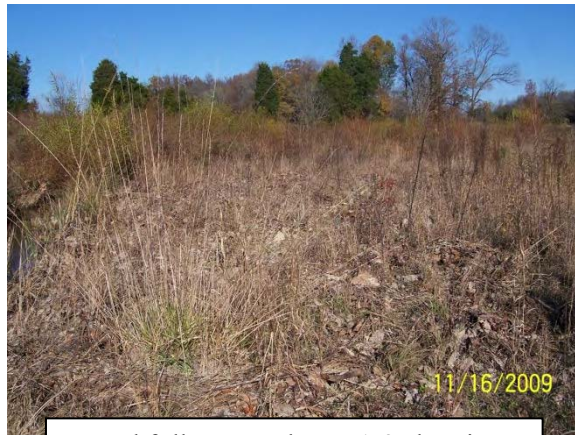
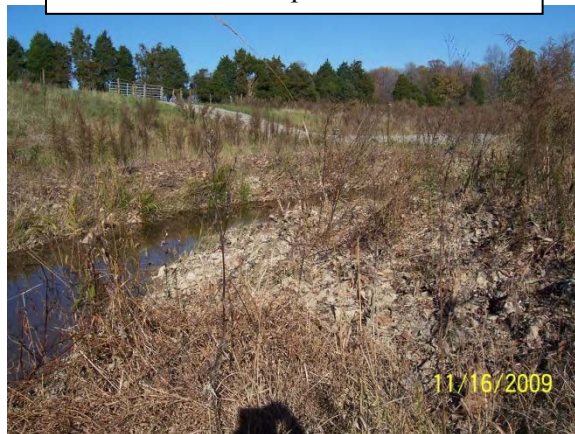
Date of Data Collection	Date of Occurrence	Method	Photo (if available)
November 16, 2009	November 11, 2009	Visual observation of wrack adjacent to the stream channel and within the floodplain as the result of Tropical Storm Ida	1-2

Bankfull Event Photos 1-2 showing evidence of overbank through wrack lines on banks and debris deposition from overland flow within the floodplain.
