**Upper UT to Cane Creek (Pickard)  
Restoration Site  
Alamance County, North Carolina  
EEP Project #395**

**MY-03 Monitoring Report**

**Upper UT to Cane Creek (Pickard)  
Restoration Site  
EEP Project #395  
Alamance County  
North Carolina**

**MY-03 Monitoring Report  
Prepared By:**

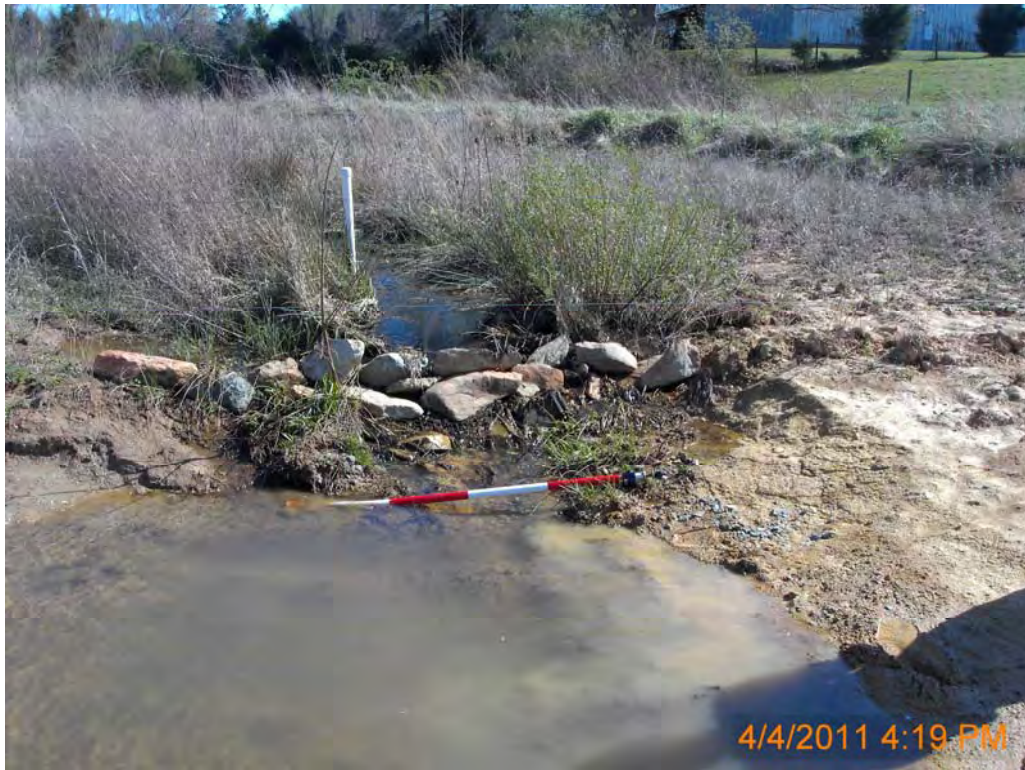
Encroachment 1 –  
Upstream side of  
stream crossing

Photo taken from the stream crossing looking upstream

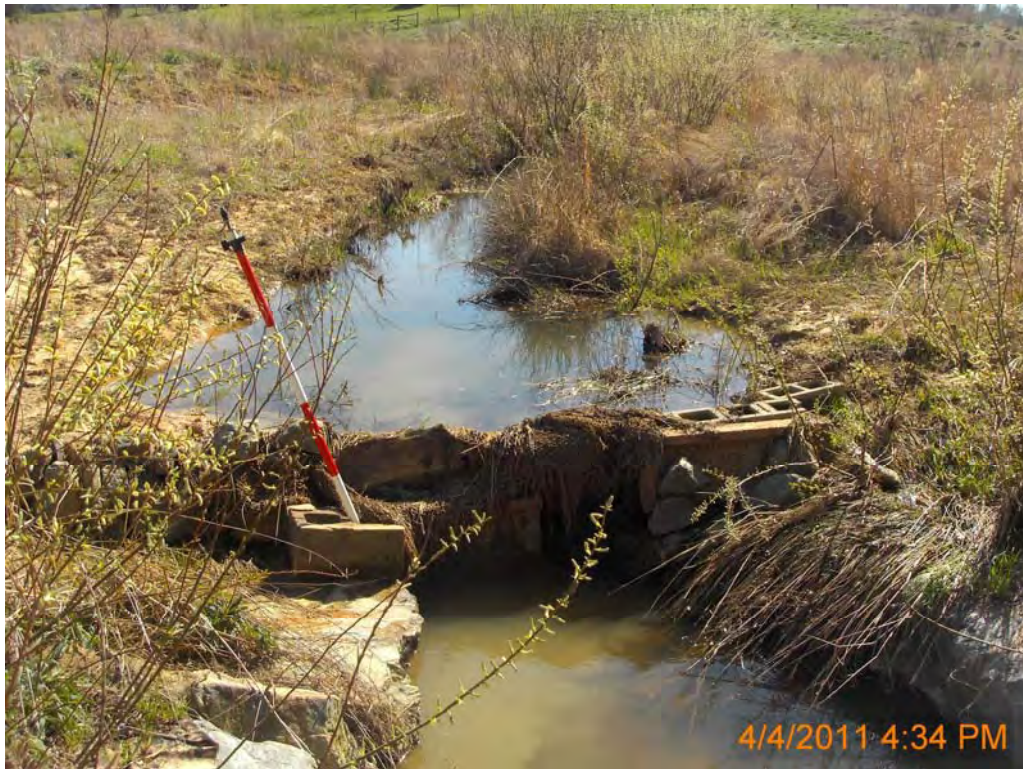
Encroachment 3 –  
Debris at sill rock  
of rock structure

Photo taken from right bank looking upstream

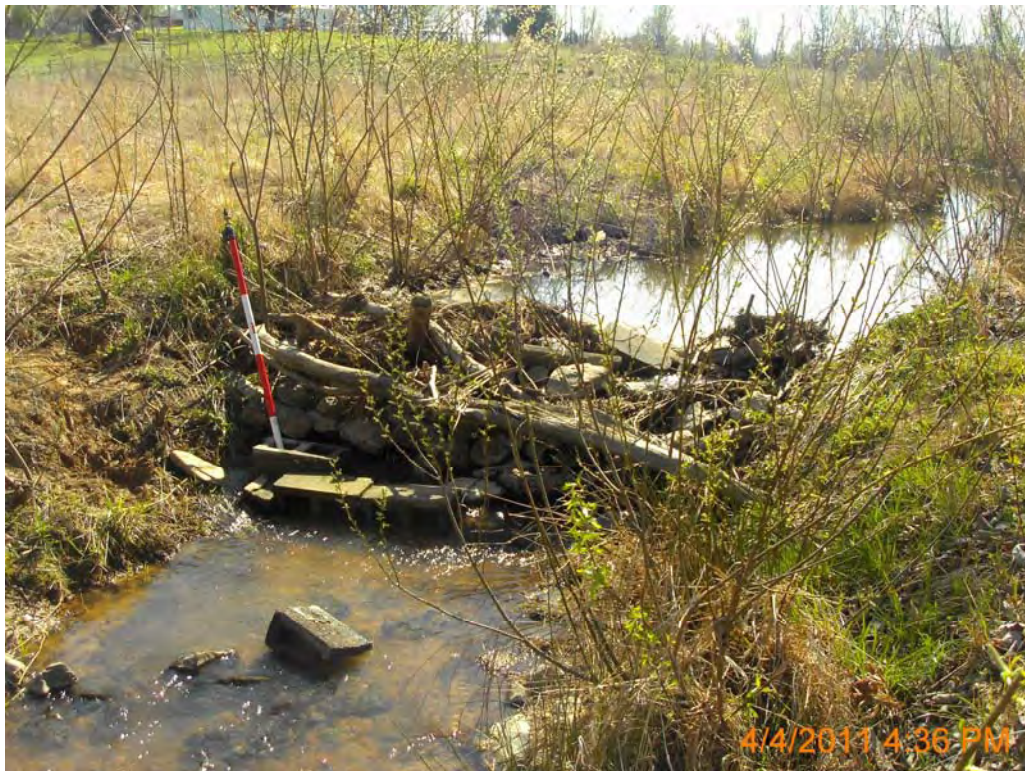
Encroachment 4 –  
Debris at end of  
rock structure

Photo taken from left bank looking upstream

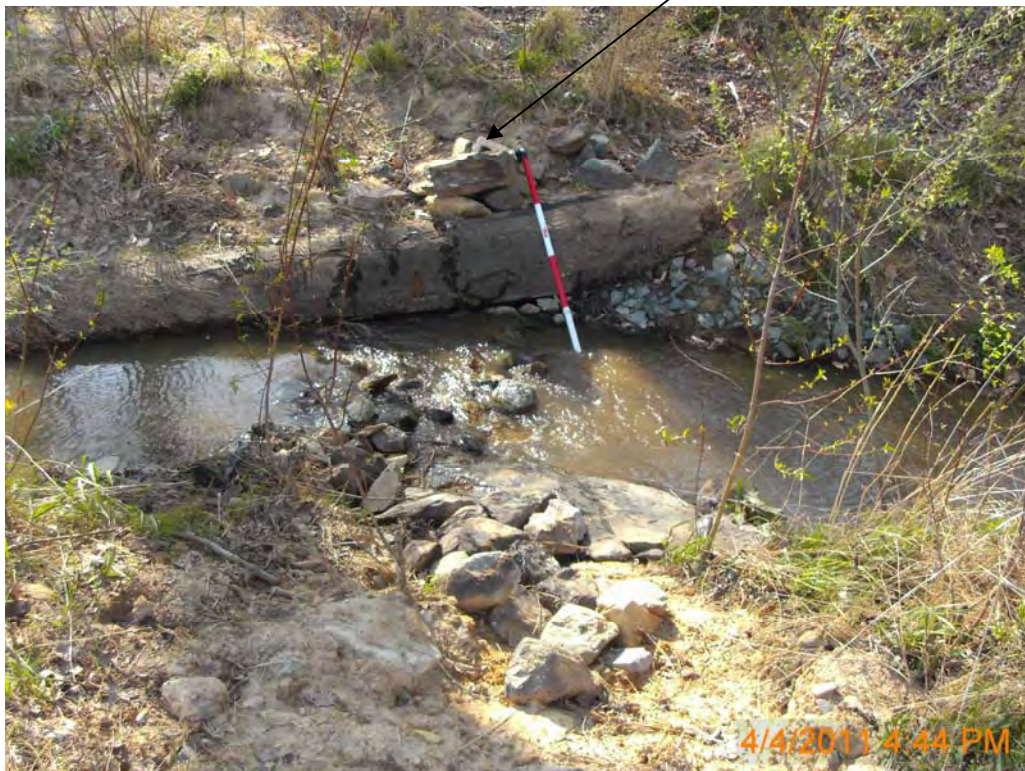
Encroachment 5: Debris pile resembling the beginning of a blockage

Photo taken from right bank looking at the log structure (note cinder block on left bank)

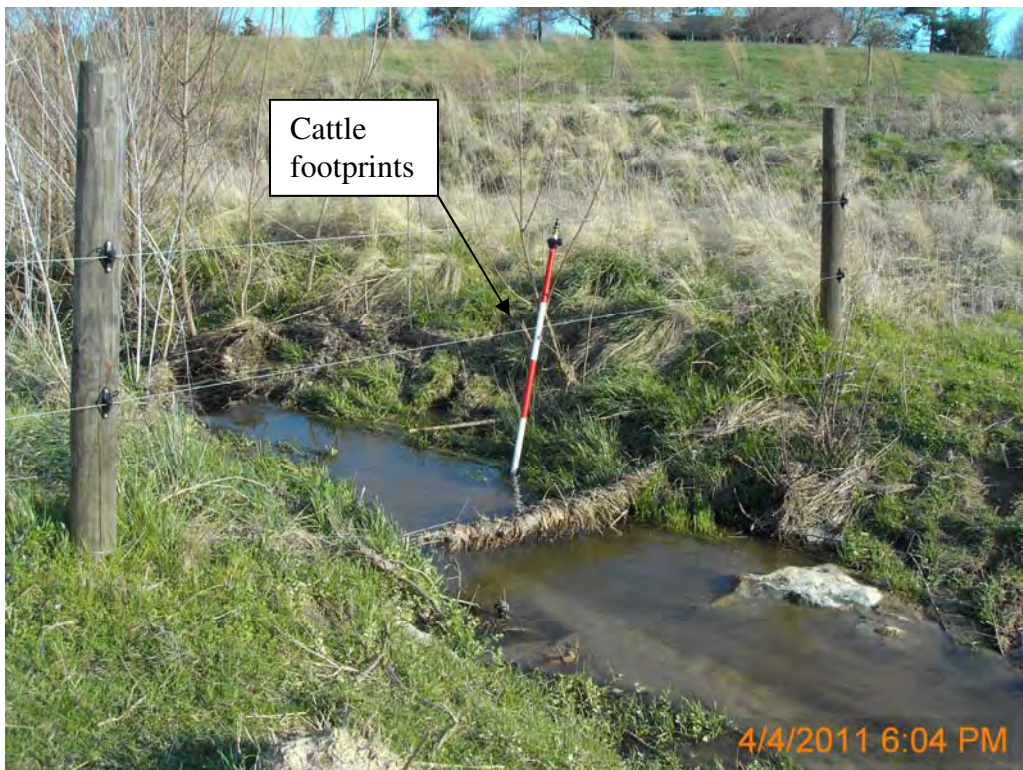
Encroachment 6 –  
Upstream side of  
stream crossing

Photo taken from stream crossing looking upstream (note cattle footprints on left bank)

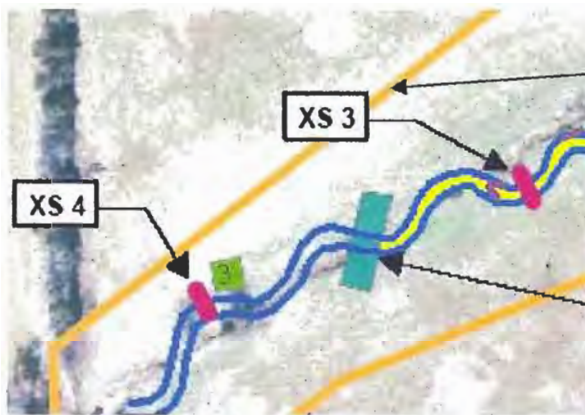
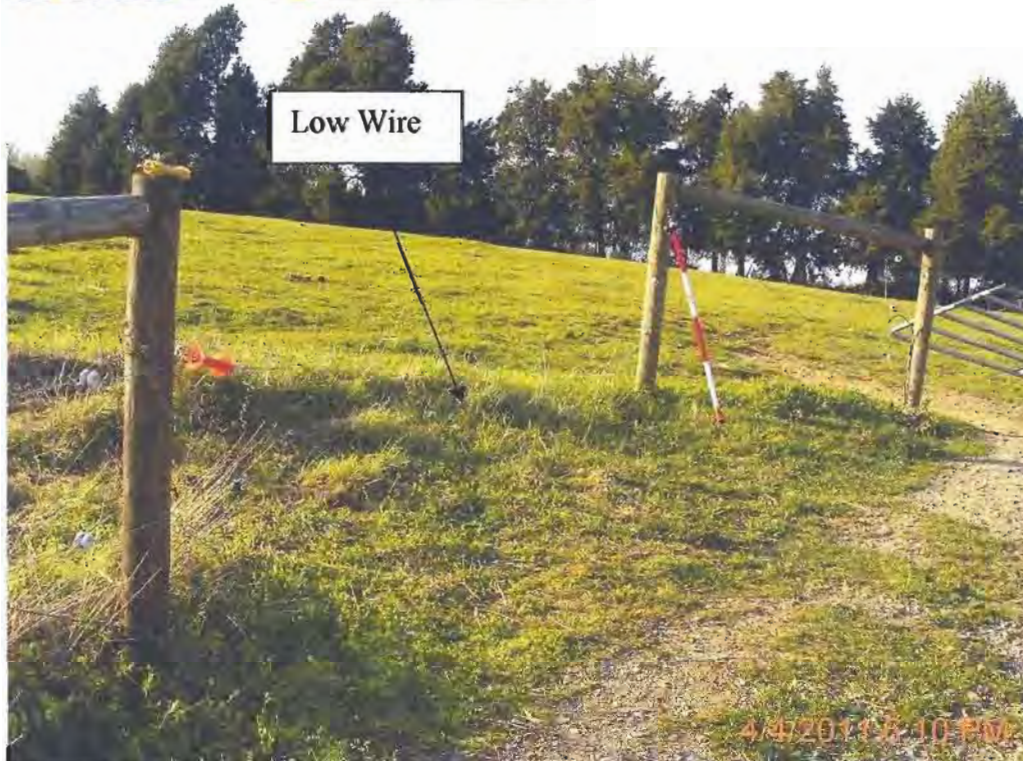
Encroachment 7: Fence wires hanging low in stream crossing near horse pasture, allowing animal access

Encroachment 7 –  
Wires on east side of  
stream crossing near  
broken pasture gate

Photo taken from stream crossing looking north toward horse pasture
