**Upper UT to Cane Creek (Pickard)
Restoration Site
Alamance County, North Carolina
EEP Project #395**

MY-04 Monitoring Report

Data Collected: September, 2012

Submitted: January, 2013

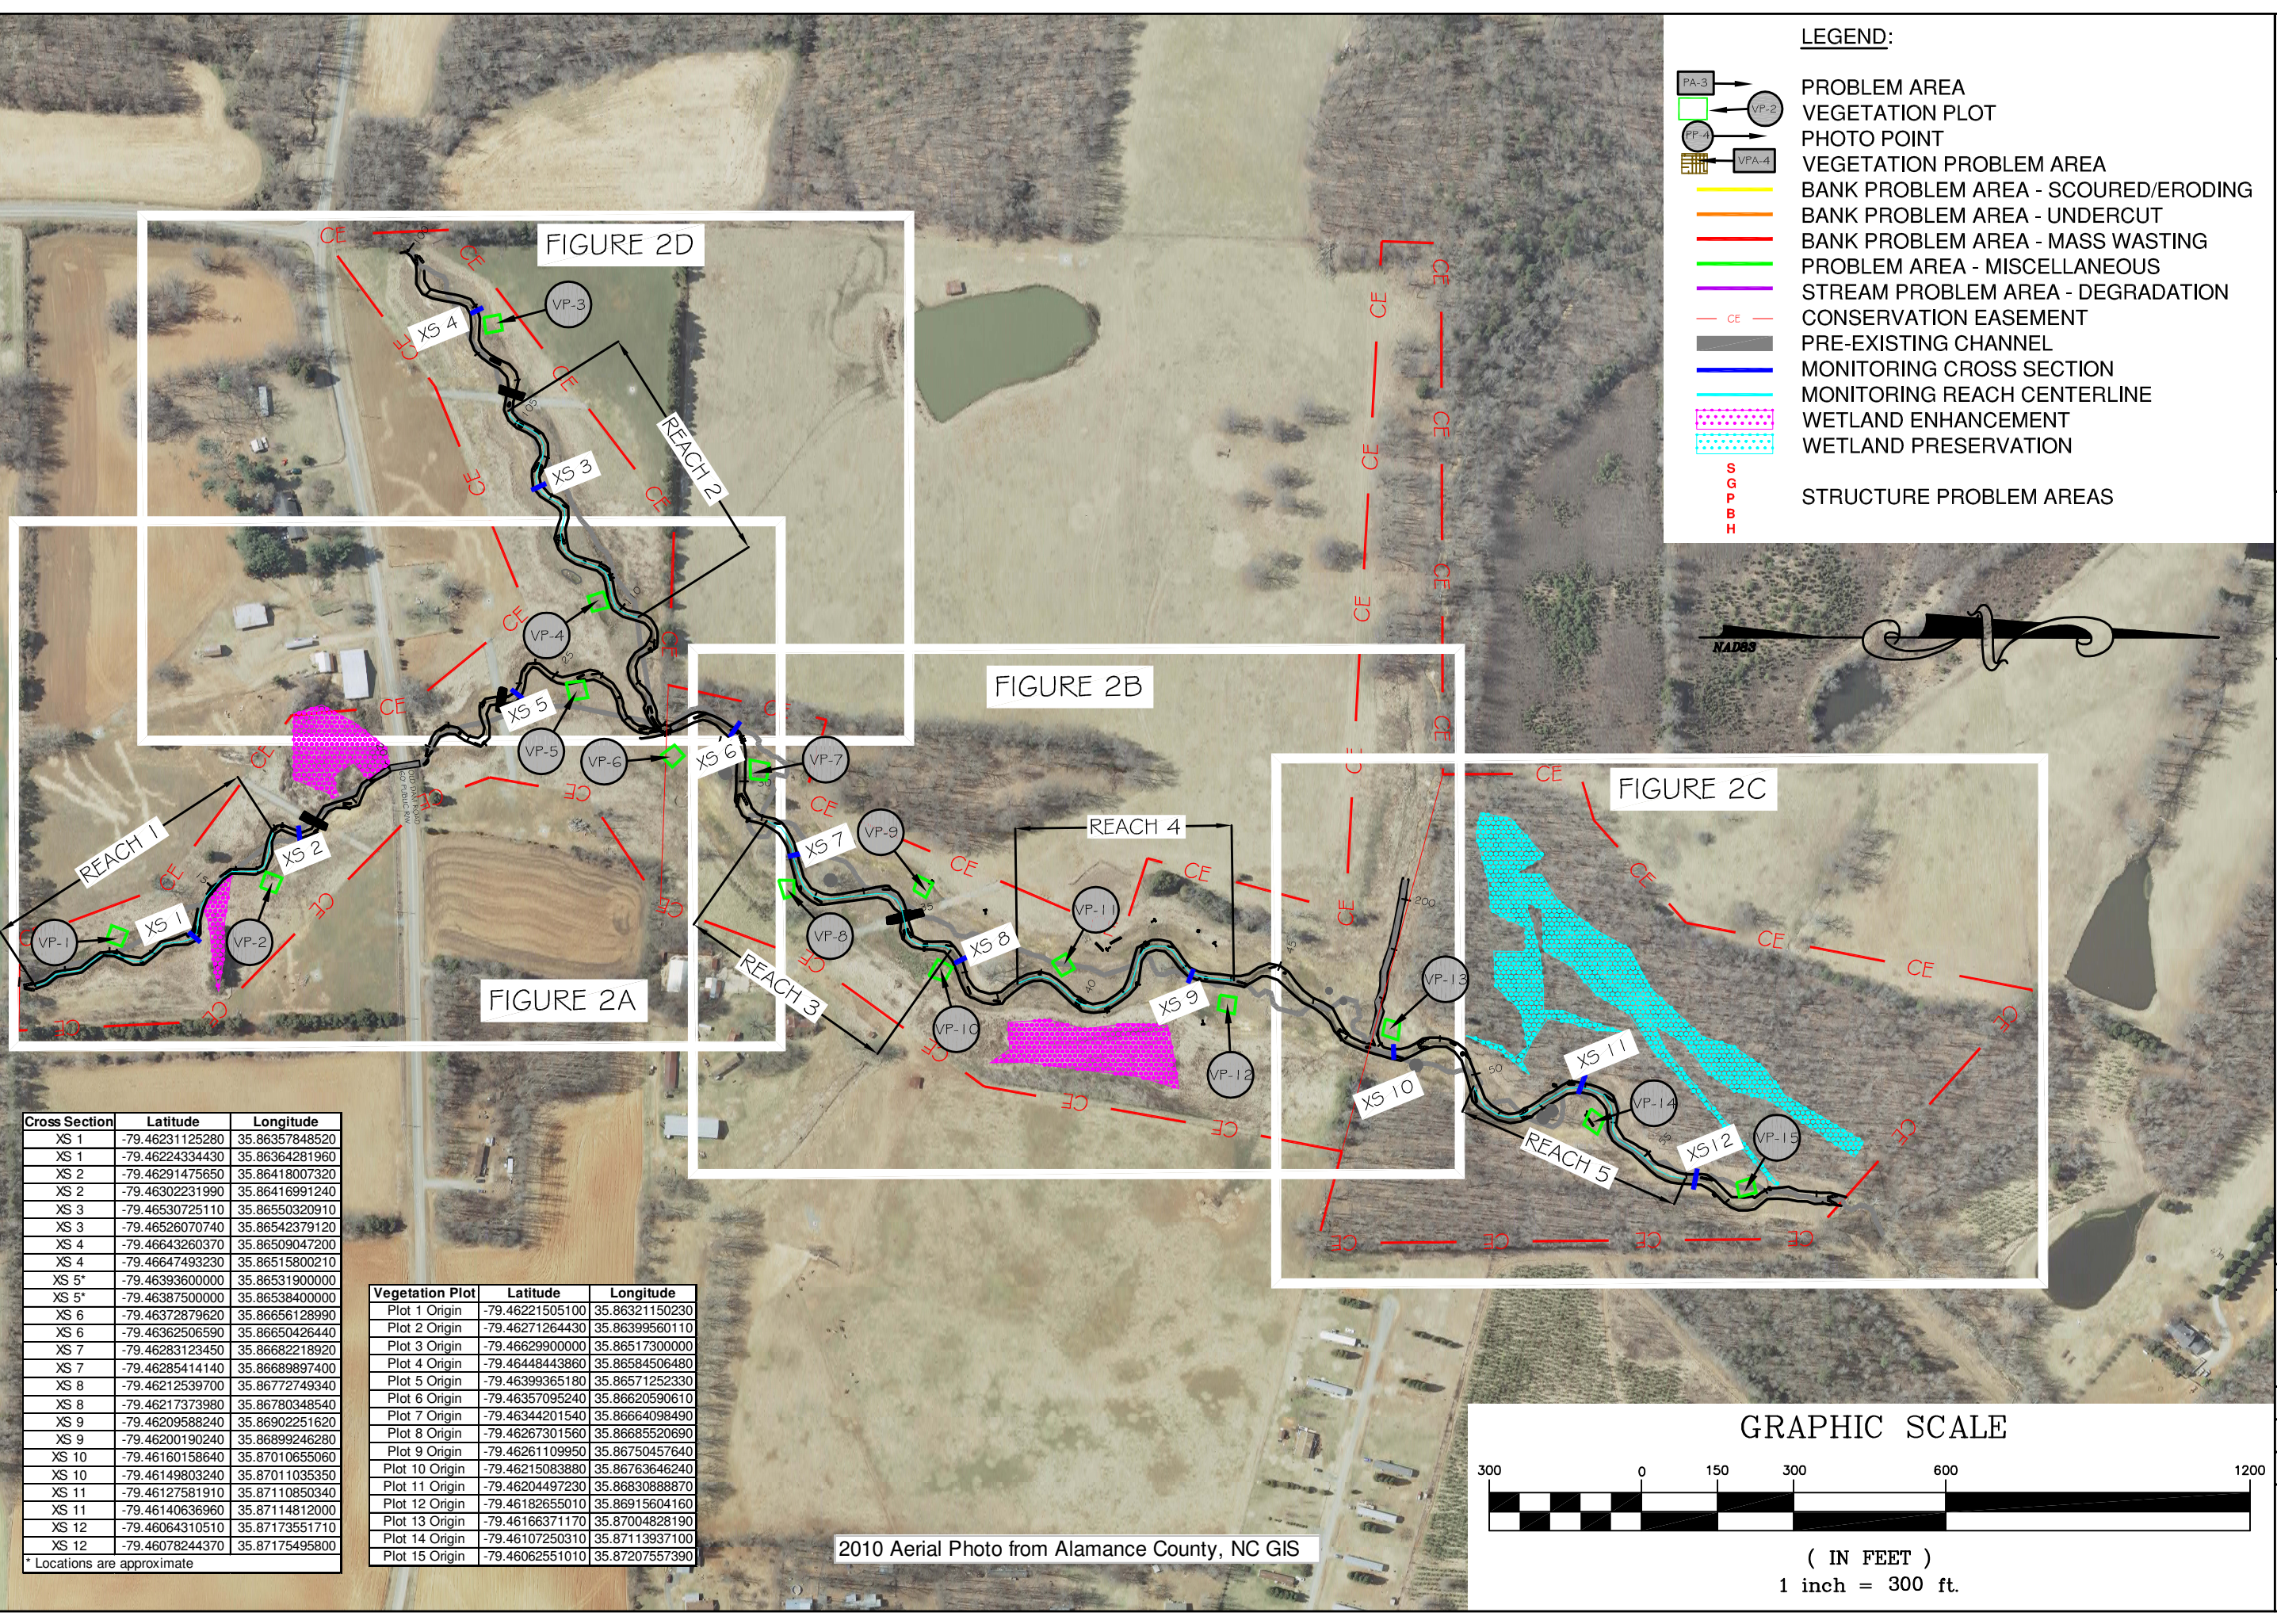
UPPER UT to CANE CREEK (PICKARD) (EEP #395) CURRENT CONDITIONS PLAN VIEW

approximately 10 feet of stream bank showing signs of instability (see CCPV). The bank instability in this location is due to livestock access along the stream crossing. The previously noted debris obstructions are still present in several locations throughout the stream. A comparison of stream cross sections to previous monitoring years shows little change to the geometry, further suggesting site stability. Pebble counts were performed in previous monitoring years through a distribution of counts throughout all the features within each reach. The reach pebble counts show slight coarsening in reaches 1 and 3, with significant coarsening in reach 2. The pebble counts for reach 4 shows slight fining, due mostly to the backwater effects of the beaver dams. The reach 5 pebble count remains consistent with the previous year data. The visual assessment concluded that the site exhibits a 100% structure integrity and function.
