UT to Clarke Creek Stream and Wetland Restoration Site Annual Final Monitoring Report

DMS # 92500
DENR Contract # 005363
USACE Action ID # SAW-2010-00471
DWR Project # 11-0409
SCO # 09-07763-01
DLR (Land Quality) Project # MECK-2012-034

Monitoring Report Year 4 of 5
Mecklenburg County, North Carolina

UT to Clarke Creek Stream and Wetland Restoration
DMS Project #92500

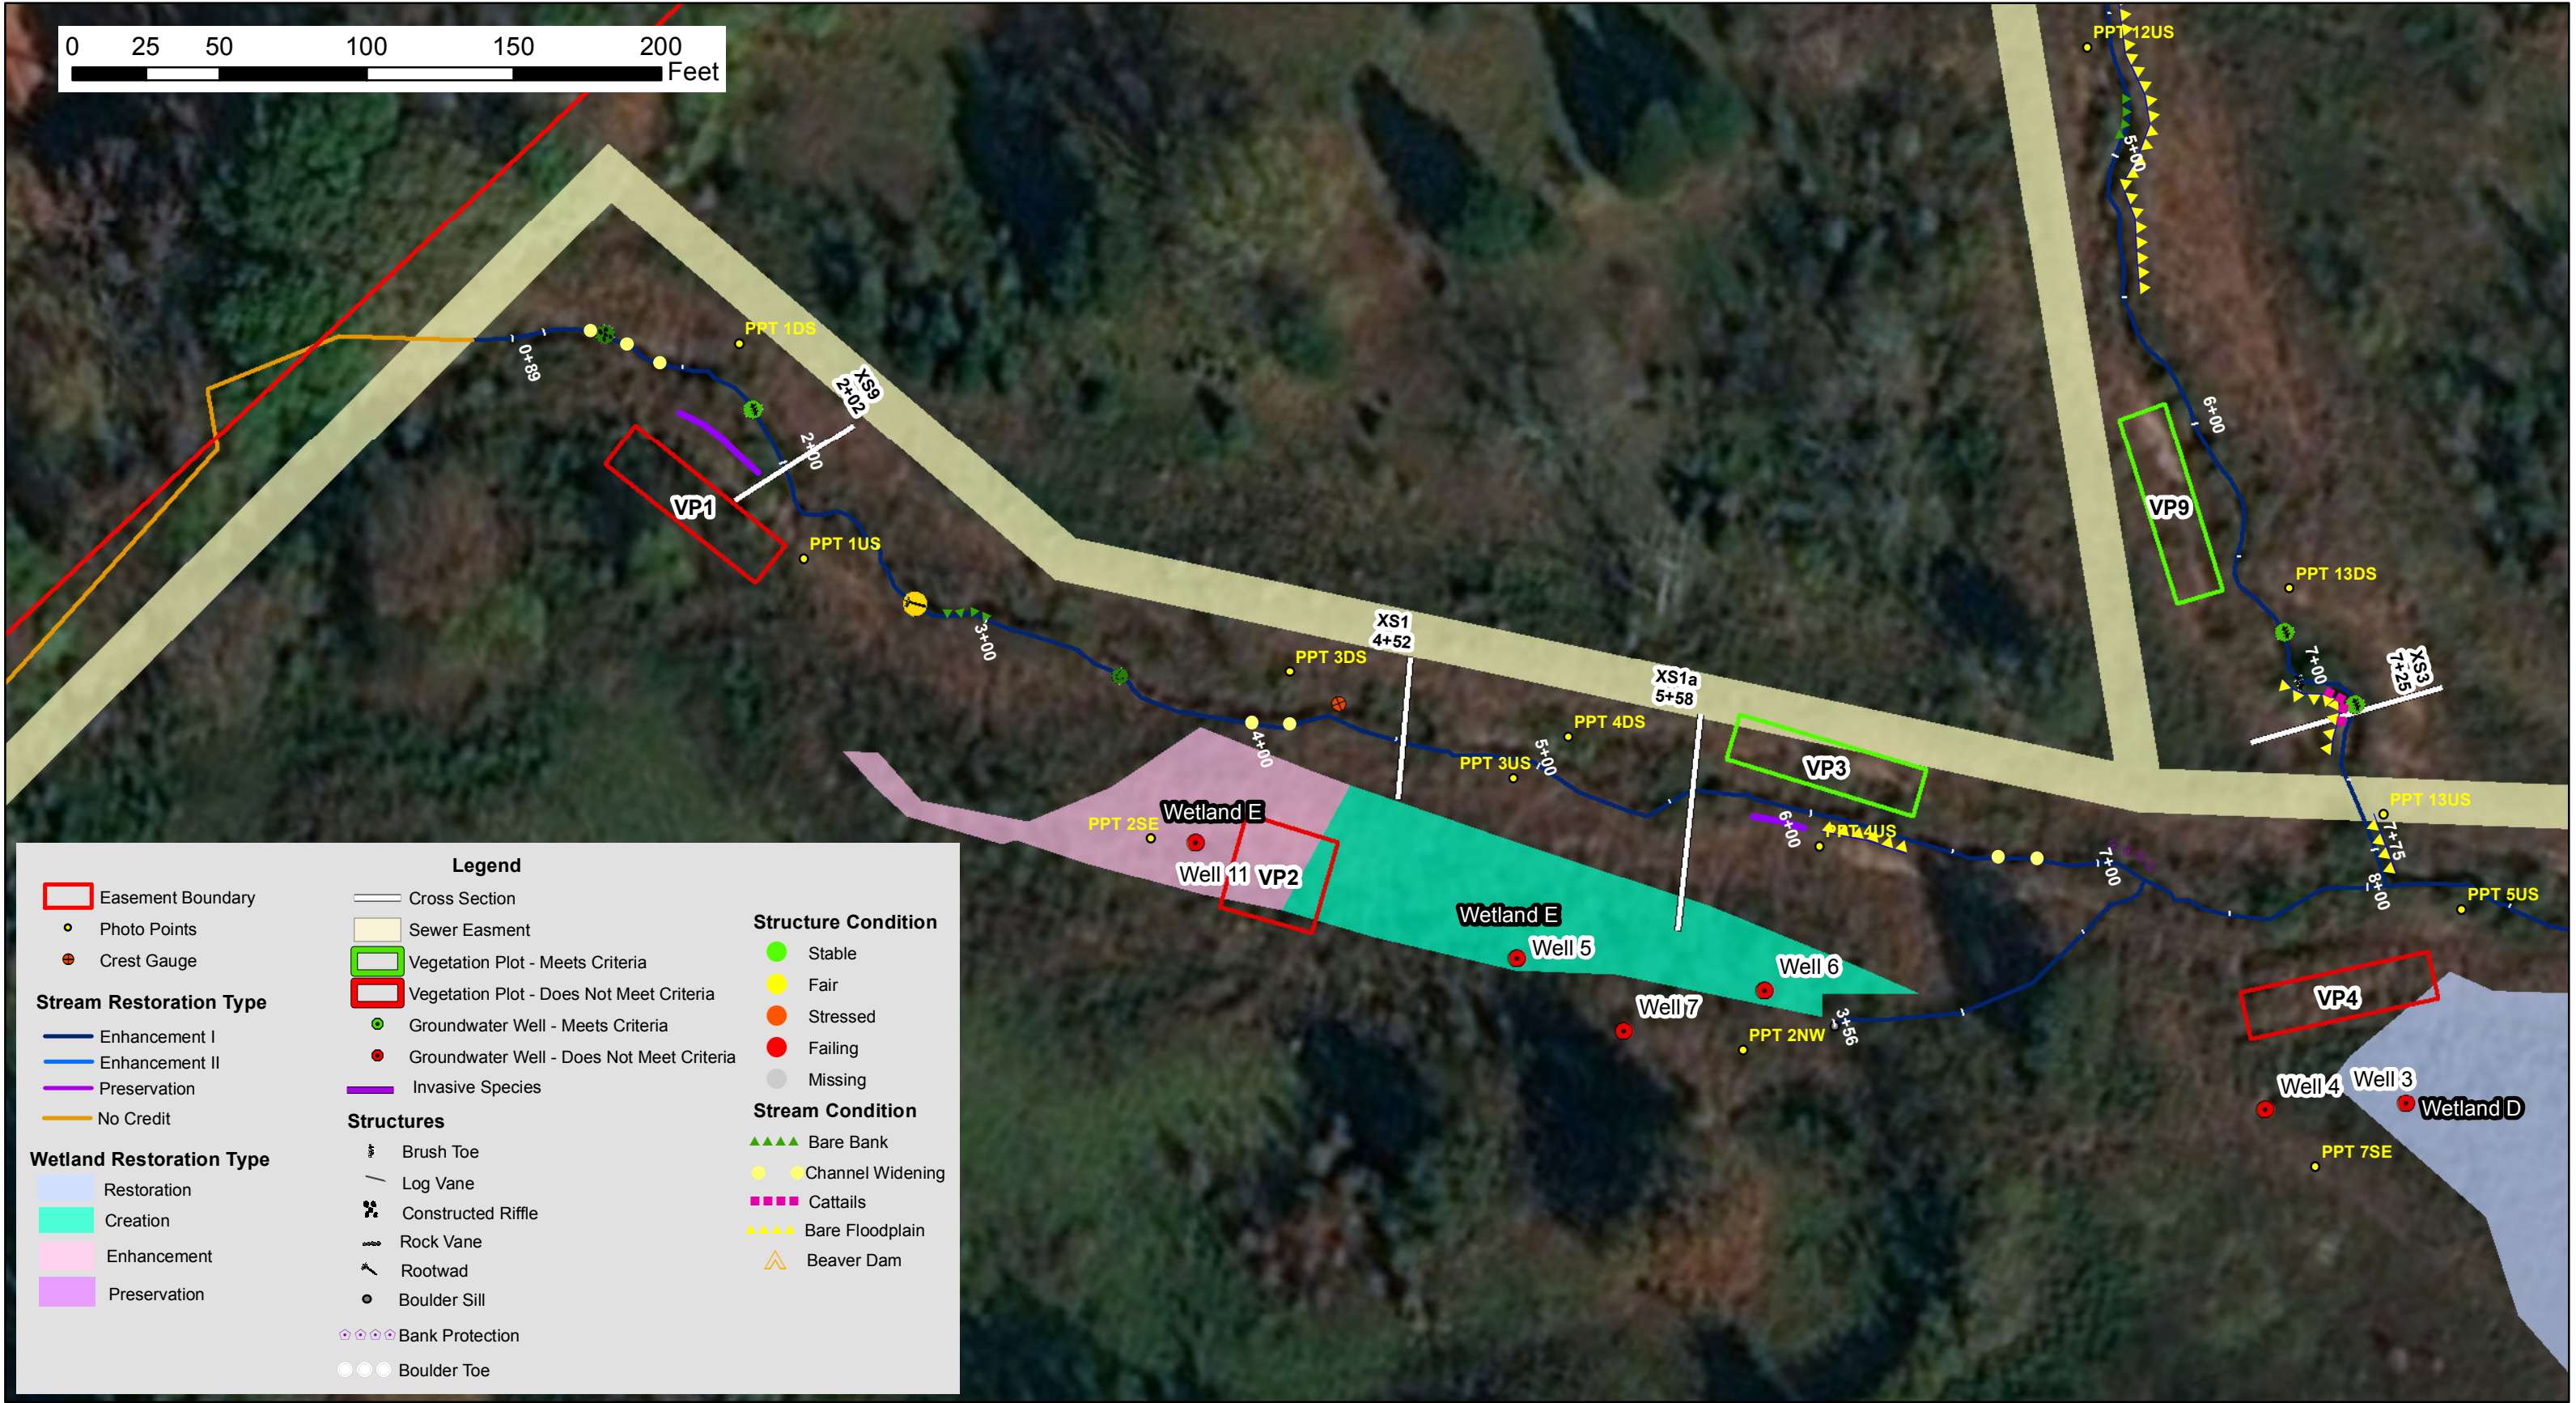
Current Conditions Plan View - UT Clarke Creek above Confluence

On UT to Clarke Creek areas of bare bank which were observed during the March 2017 Site Assessment at Stations 3+00 and 11+00 are still present, but the area at Station 5+00 has filled in and was removed from the CCPV. It is likely that the other areas of bare bank will also fill in over time and do not pose a serious threat to the overall integrity of the site. Station 2+80 continues to erode behind the placed root wad.

Beaver activity was noted throughout the site in the form of chewed stems and slides along the streambanks. Two beaver dams were observed along UT Clarke Creek at Stations 10+70 and 12+15. SEPI removed as much of these dams as possible during monitoring. The US Department of Agriculture (USDA) Animal and Plant Health Inspection Service (APHIS) visited the site in July of 2017. During their visit, they trapped beaver and removed existing dams. APHIS made a follow-up visit in November 2017 and didn’t note any fresh chewed trees or dams. APHIS will continue to monitor the site quarterly for evidence of beaver and will remove beaver and dams as necessary.

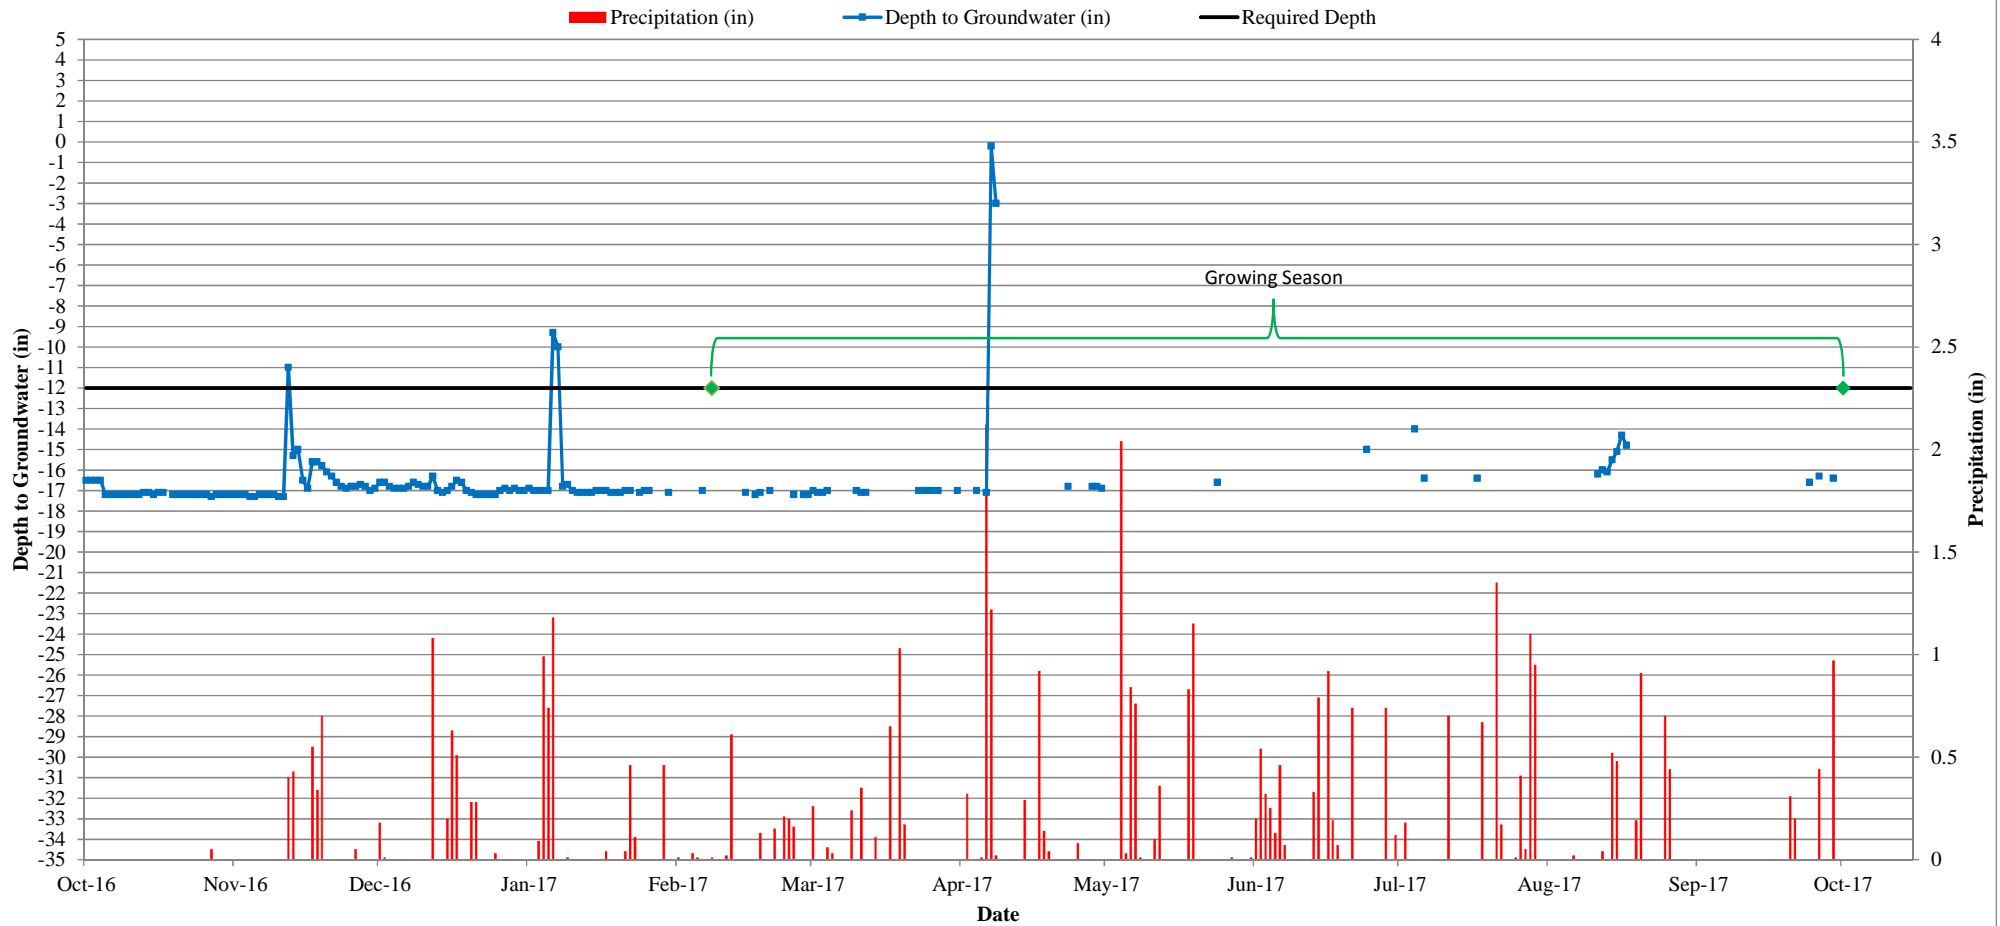
Figure 12
UT to Clarke Creek Hydrology Monitoring
Groundwater Gauge 8 - 2017
WM000013D482C8

Wells 1 and 9 met the hydrology success criteria for monitoring year 4. Wells 8 and 11 malfunctioned and only recorded 32 and 50 days of data, respectively during the 210-day growing season period recorded prior to monitoring. Batteries in Wells 8 and 11 will be replaced during the site assessment in the Spring and replaced, if needed.
