**UT to Clarke Creek Stream and Wetland Restoration Site  
Annual Final Monitoring Report  
FINAL**

DMS # 92500

Monitoring Report Year 5 of 5  
Mecklenburg County, North Carolina

Data Collection: October 2018  
Report Submission: February 2019

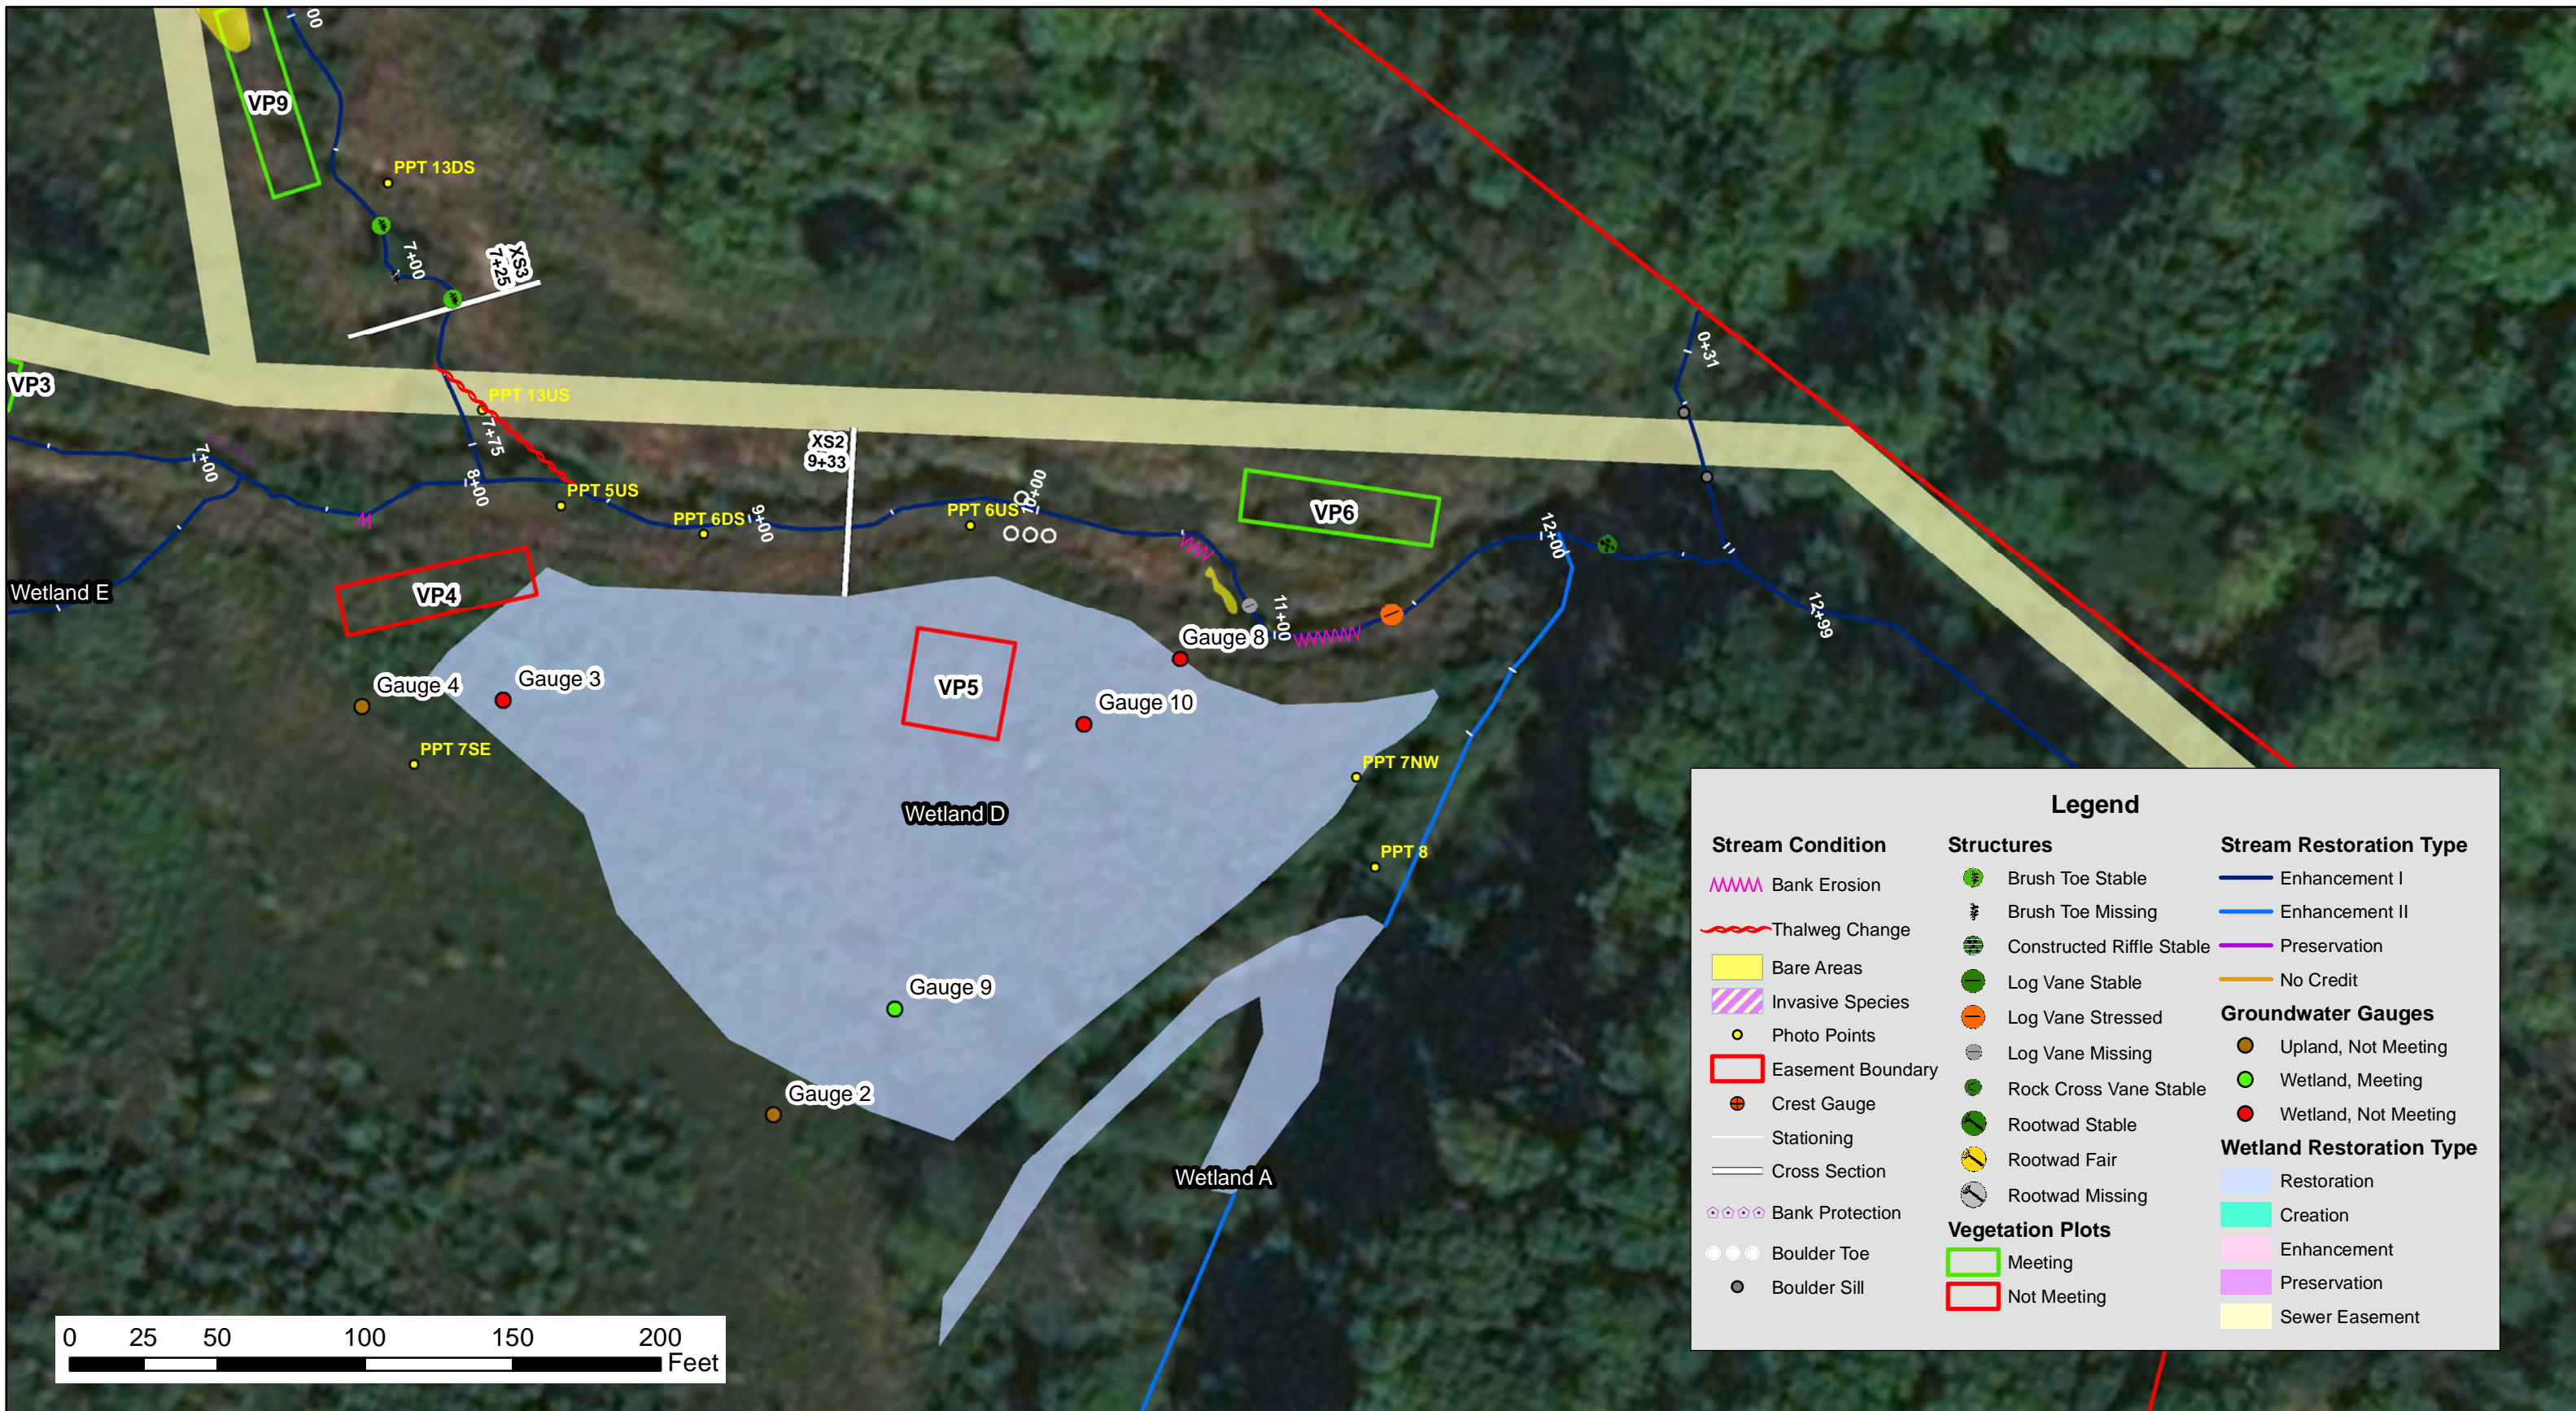
## Current Conditions Plan View - UT Clarke Creek below Confluence

During MY05 (2018), one area of sparse vegetation was observed on UT to Clarke Creek around Station 6+00. This is a depression in the floodplain that is holding water limiting the establishment of vegetation. Another small area near Sta. 11+00 is still present. These were the only areas of sparse vegetation on the floodplain observed along UT to Clarke Creek.

Minor beaver activity was noted on UT to Clarke Creek near the confluence with UT1 in the form of chewed stems and slides along the streambanks. No beaver dams were observed. The US Department of Agriculture (USDA) Animal and Plant Health Inspection Service (APHIS) visited the Site in July and October 2018, during which they trapped beaver. APHIS will continue to monitor the Site quarterly for evidence of beaver and will remove beaver and dams as necessary.

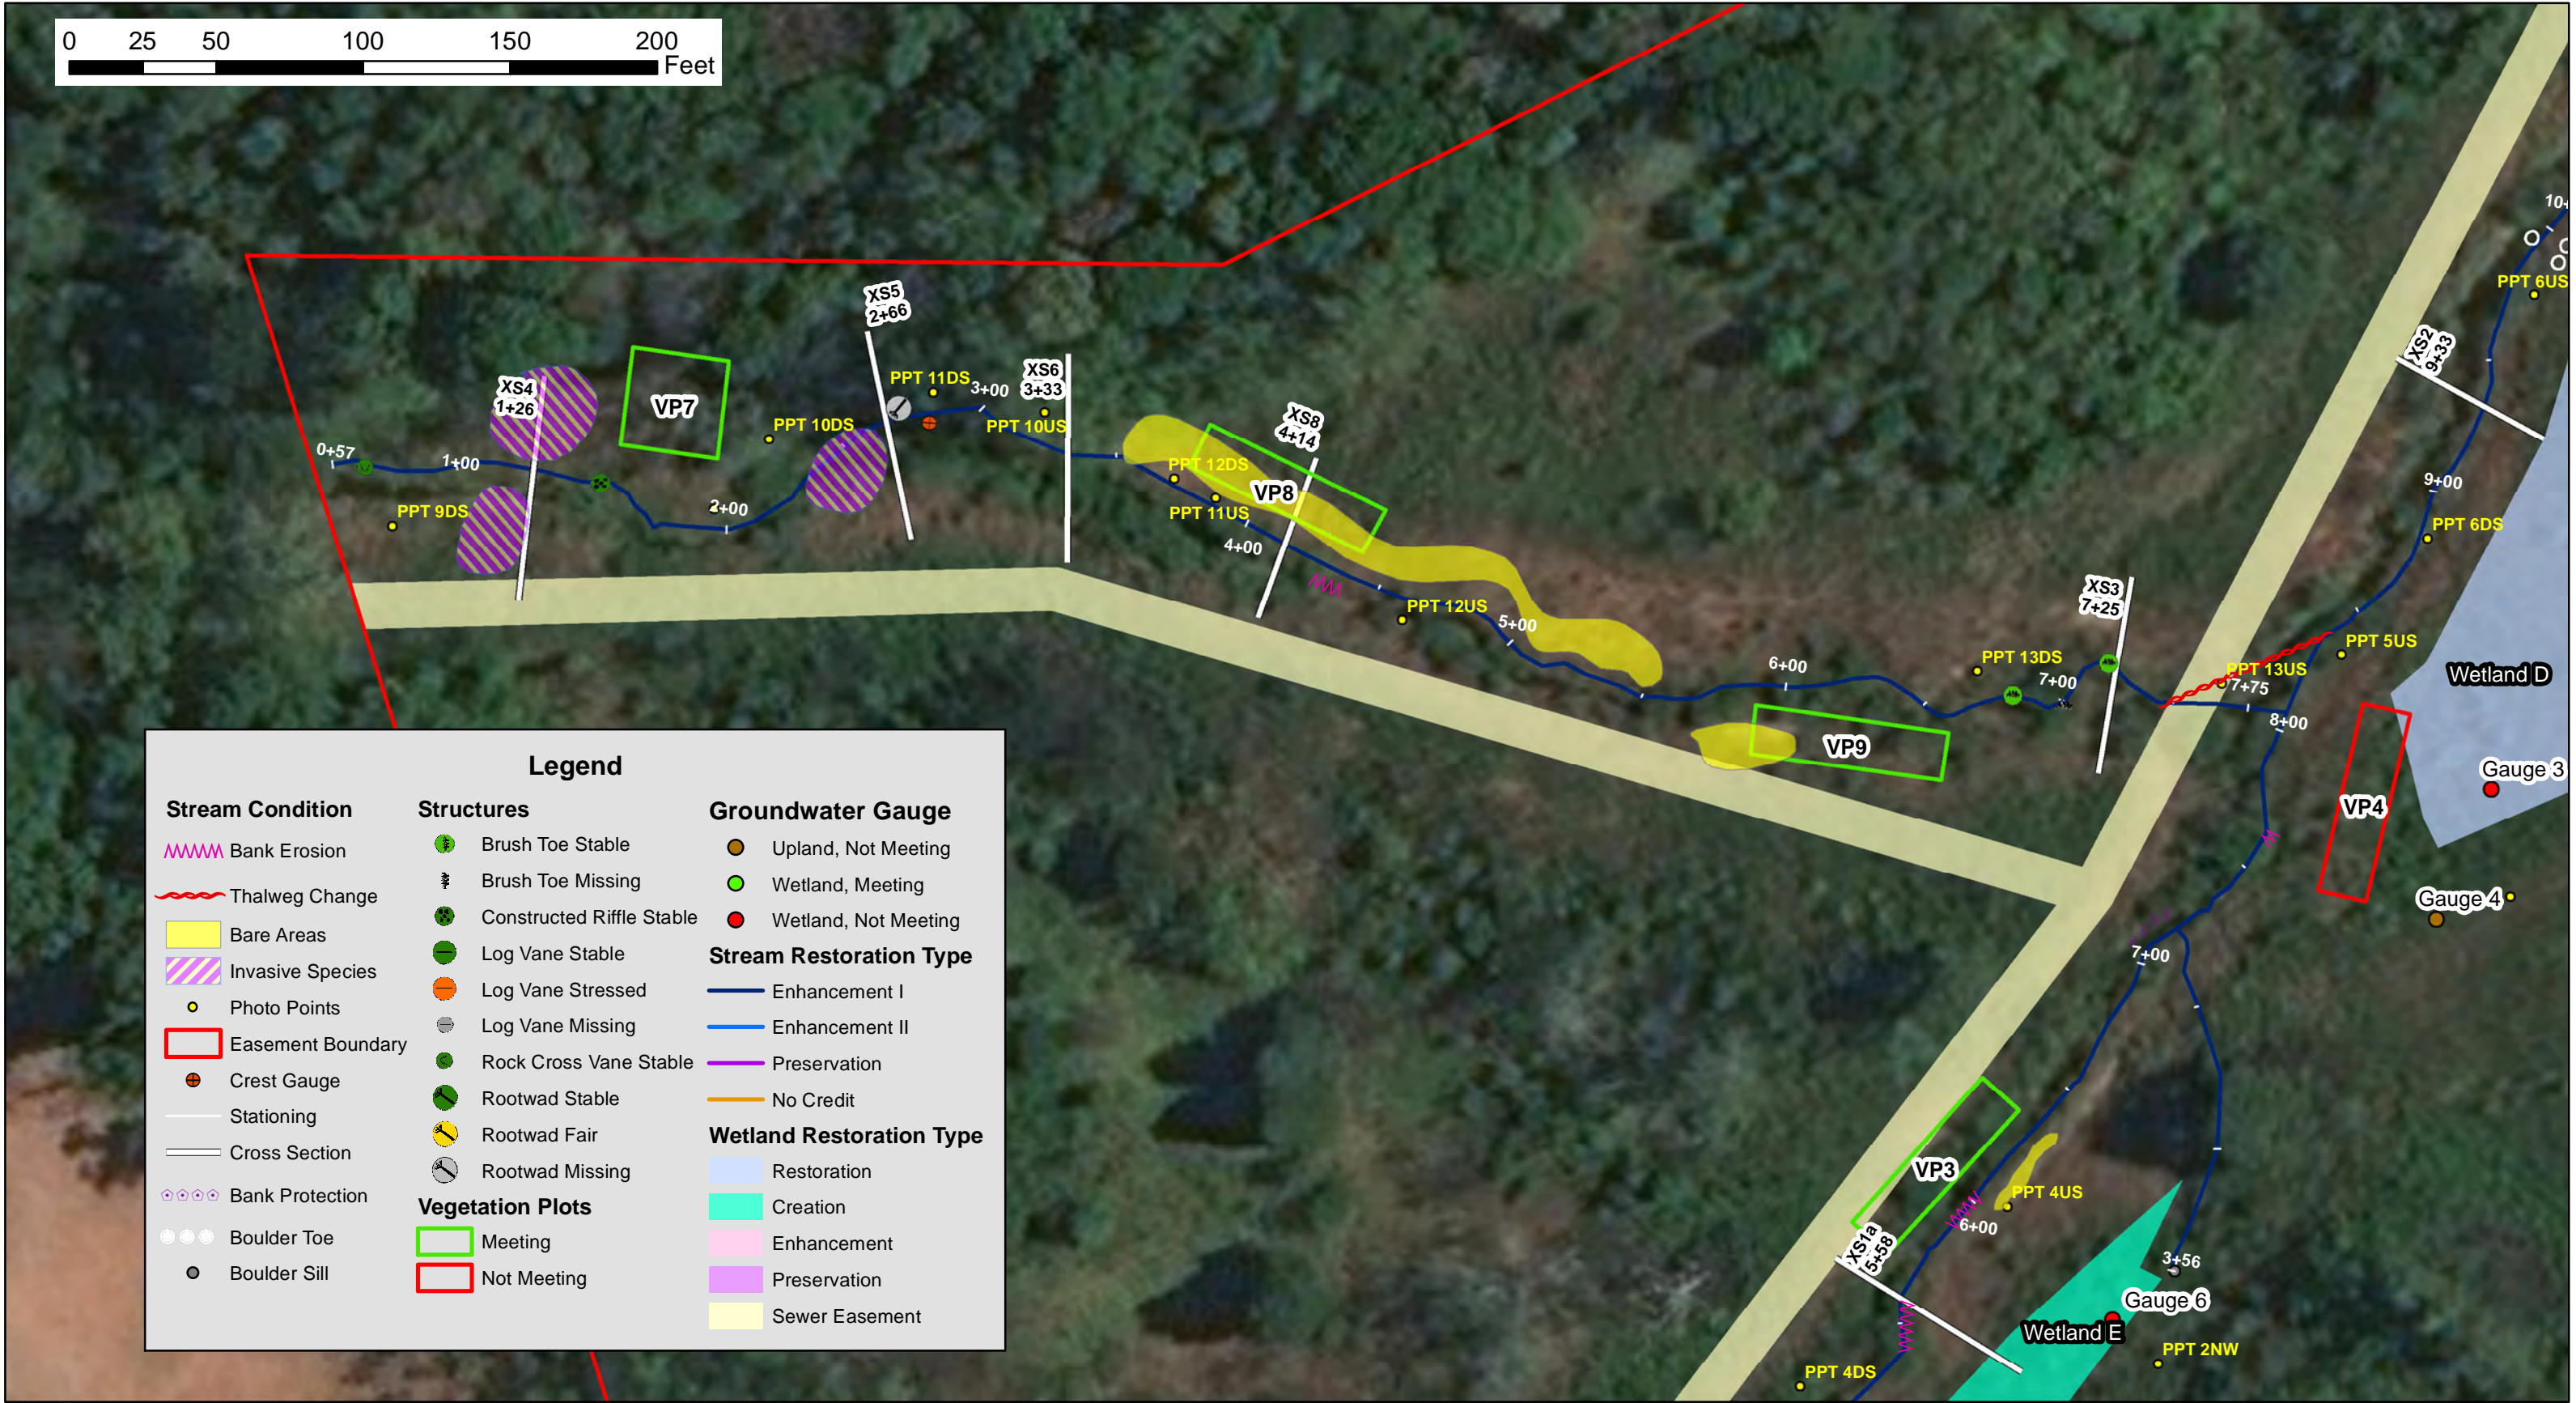
## Current Conditions Plan View - UT 1

Two areas of sparse vegetation were observed along UT1, eastern floodplain from Station 3+50 to 5+50 and around Station 6+50. These are roughly the same areas and extend as identified in the MY04 Report.

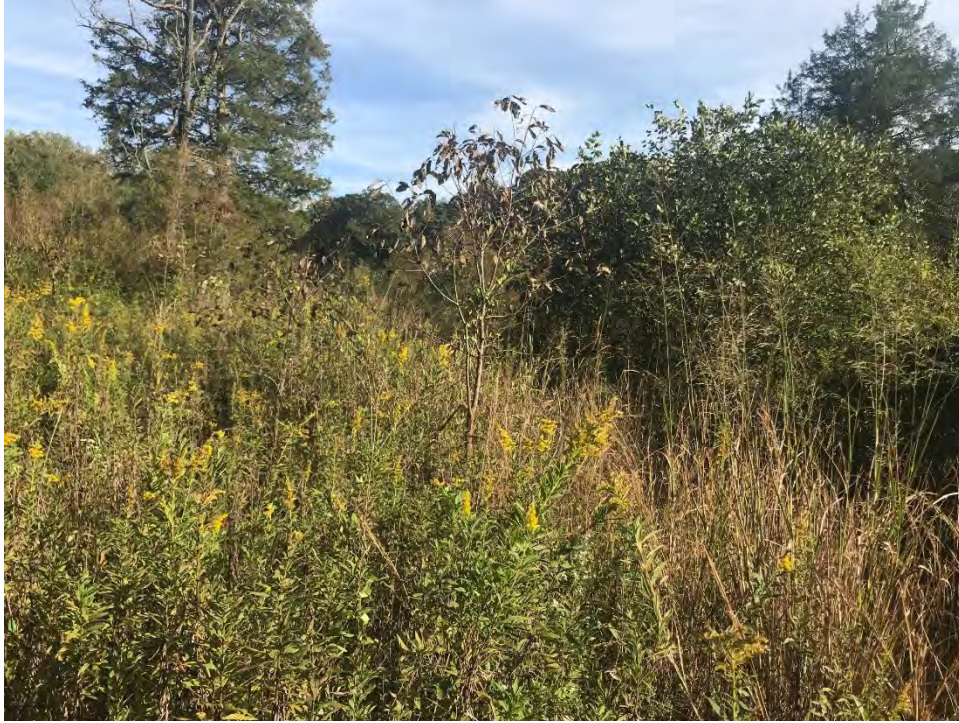
Vegetation Plot 3 – 5m x 20m (MY5 – 10/17/2018)

Invasive species observed on site include autumn olive, Japanese privet, multiflora rose, kudzu, Japanese honeysuckle and lespedeza. Kudzu is beginning to establish in vegetation plot 3. The location of autumn olive and Japanese privet are shown on the current condition plan view. Japanese honeysuckle and lespedeza are located throughout the Site. An invasive species treatment was conducted in June 2018. An additional invasive species treatment will be conducted in 2019.
