**UT to Crooked Creek
Stream Restoration Monitoring Report
EEP Project # 434
Monitoring Year 04**

**Data Collection: 2010
Construction Completed: July 2006
Submitted: December 2010**

**Project Contact: Adam Spiller
Email: adam.spiller@kci.com
KCI Project No: 12071067C_CC10**

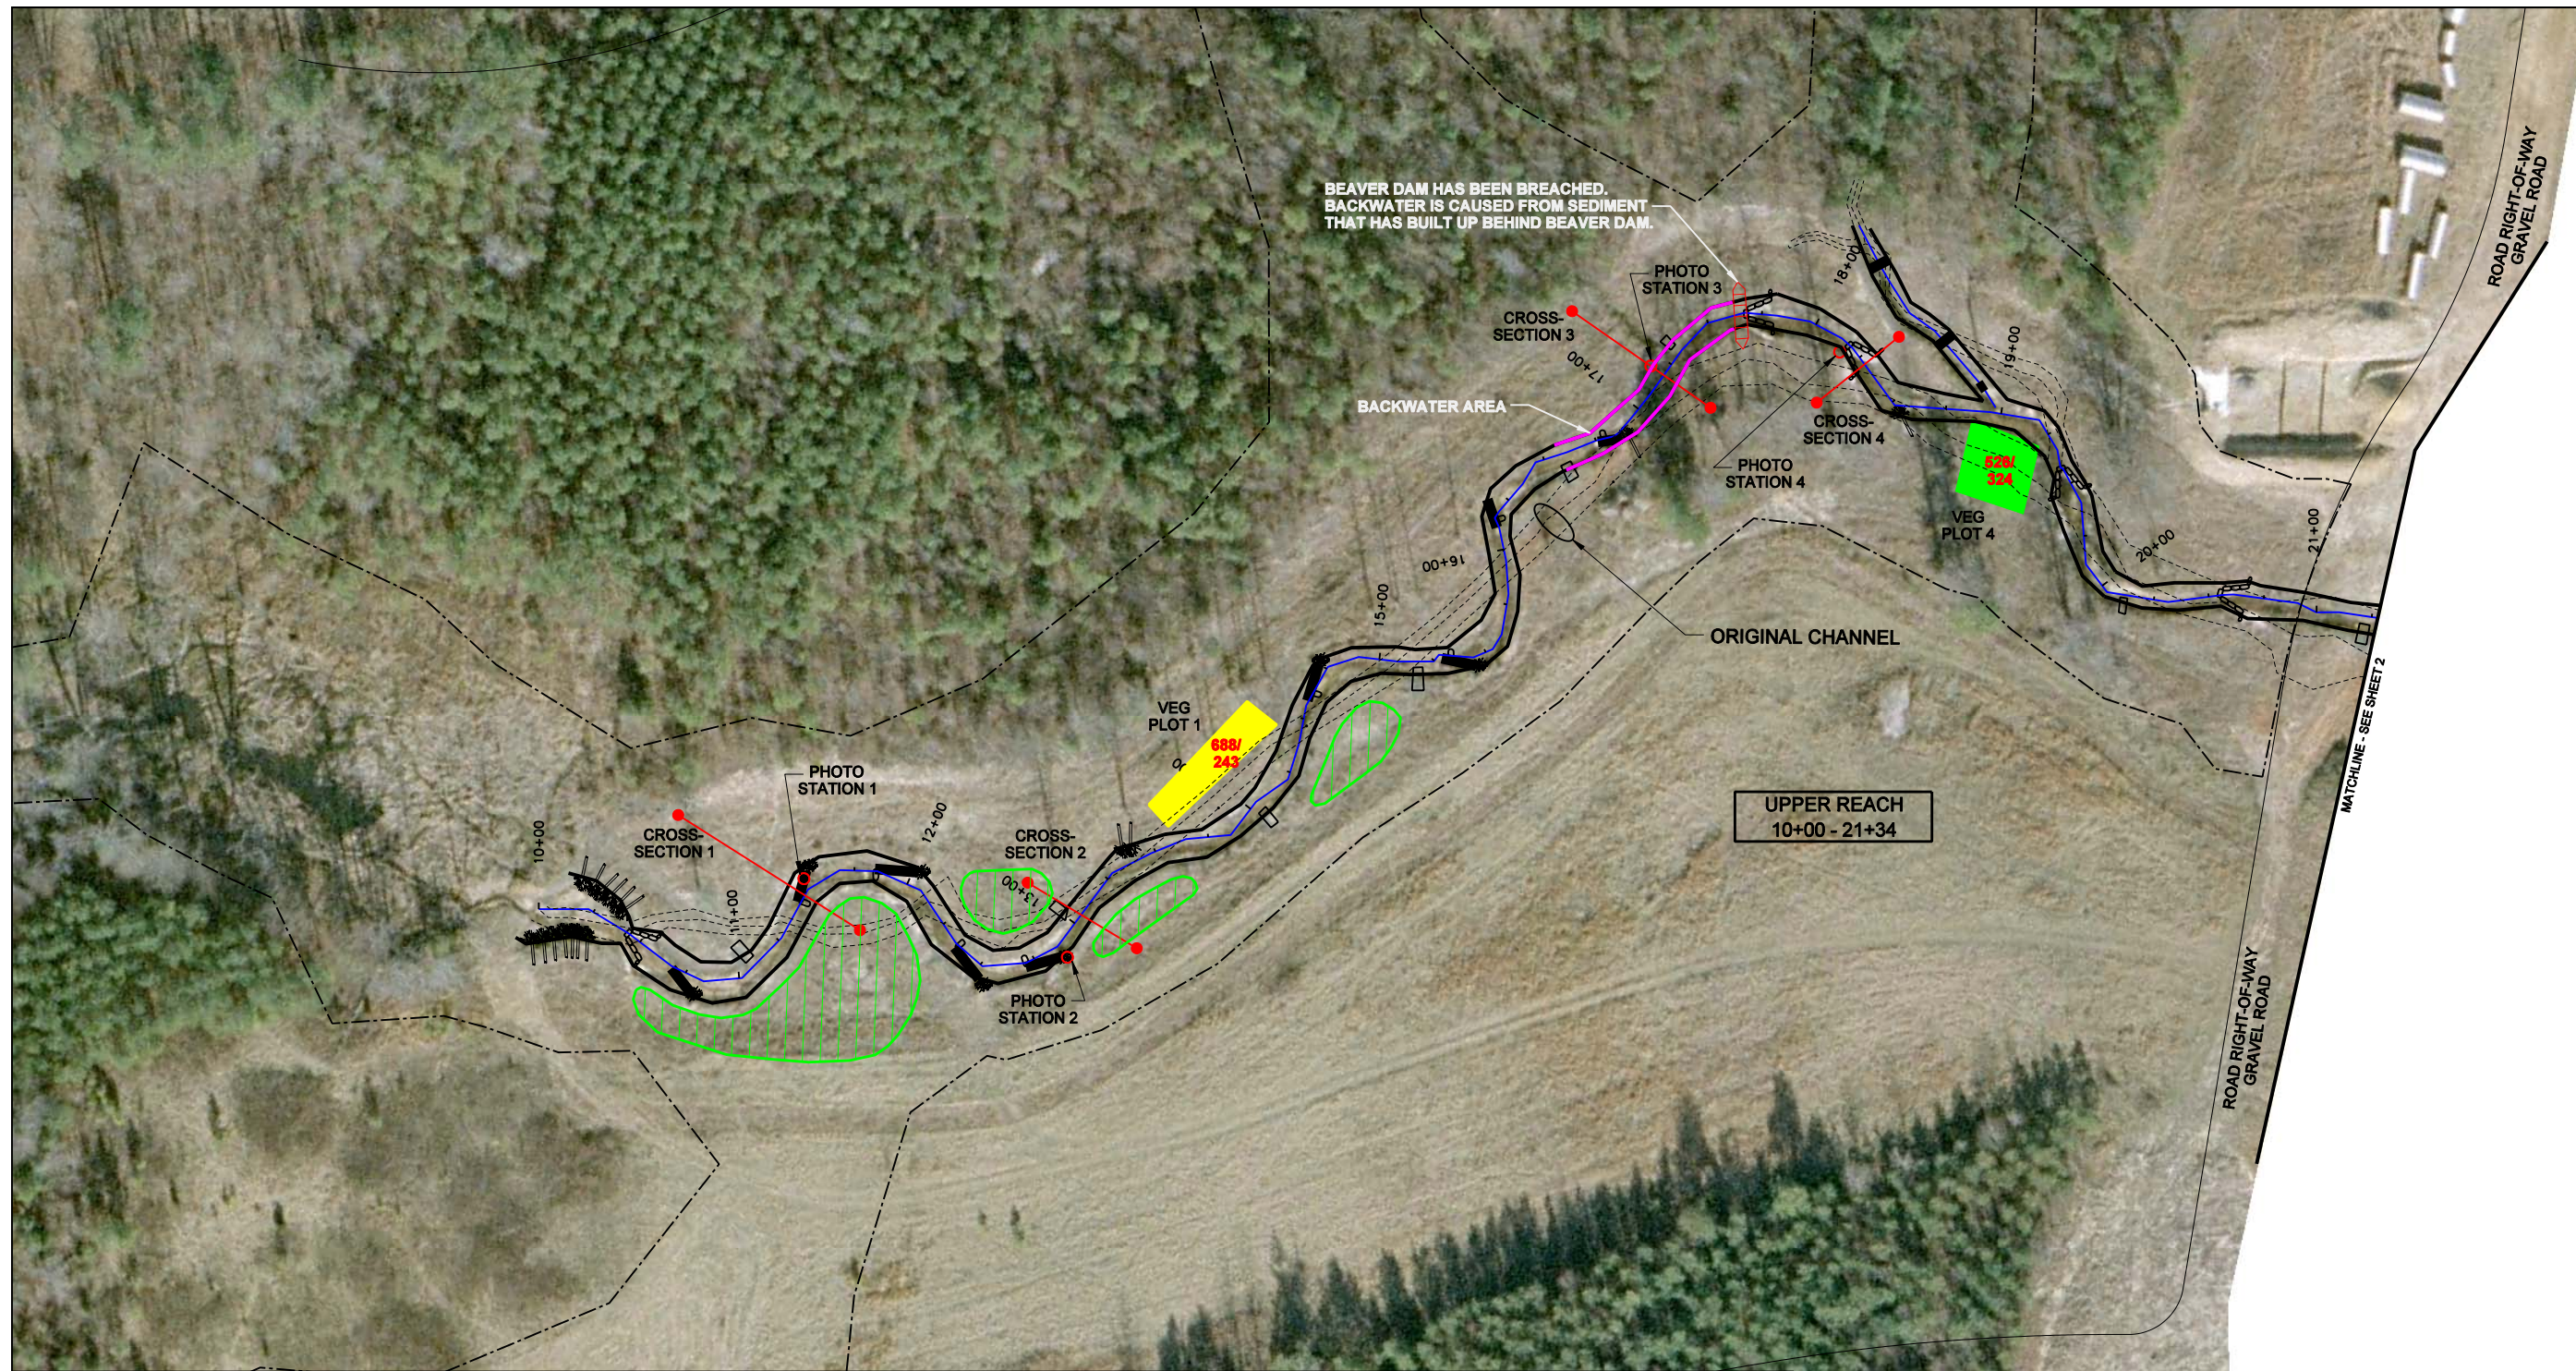
DATE: DECEMBER 2010
 SCALE: 1"=80'
 CURRENT
 CONDITION
 PLAN VIEW
 SHEET 1 OF 2

The stream monitoring at the site involves surveying eight permanent cross-sections and a longitudinal profile along the entire length of UTCC. The stream assessment completed during the fourth year of monitoring found the stream to be functioning and holding grade. The site does not have any bank erosion problems or widespread bed incision or aggradation. Throughout the monitoring history of this project there have been a series of beaver dams constructed on the project channel. The beavers have been removed and the dams have been breached. Most of these dams collected fine sediment behind them, which caused small areas of bed aggradation. These breached beaver dams still create areas of backwater in the channel, which have been mapped on the Current Condition Plan View (CCPV). Another beaver dam is located below the restored channel, and it is causing backwater conditions in the downstream

portion of the lower reach. In 2011, EEP will conduct maintenance planting and remove active and relic beaver dams at the site.

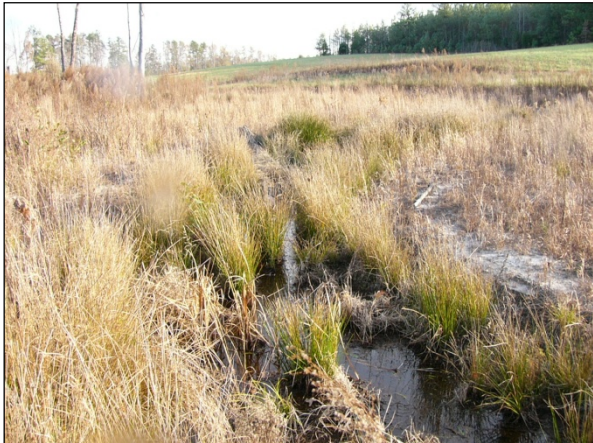
PS-1 Looking Downstream – 12/3/07 - MY 01

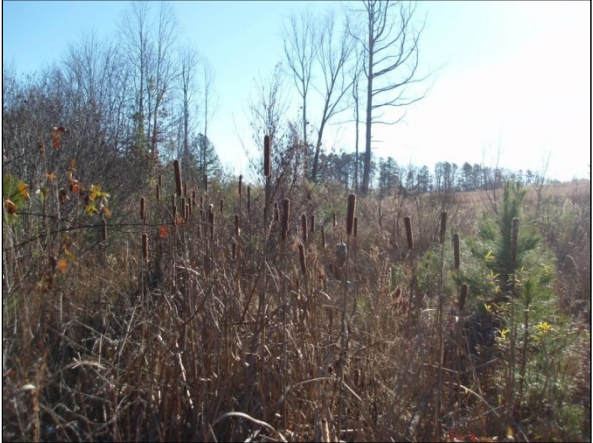
PS-1 Looking Downstream – 12/13/10 - MY 04

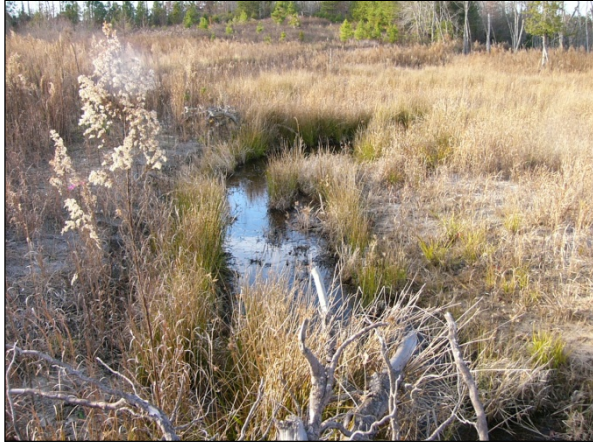
PS2 Looking Upstream– 12/3/07 - MY 01

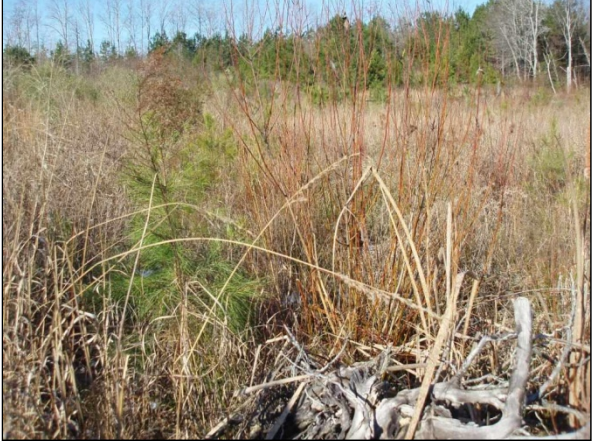
PS-2 Looking Upstream– 12/13/10 - MY 04

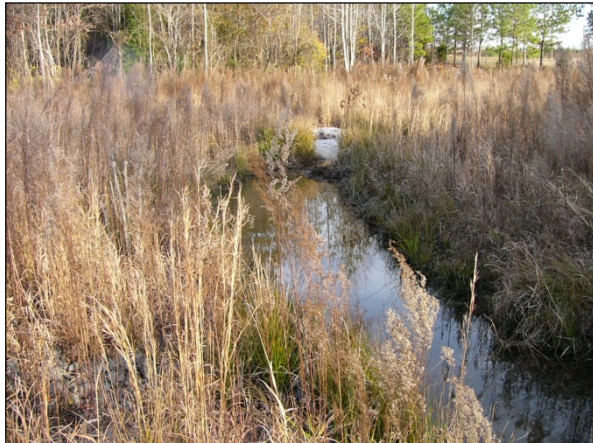
PS-3 Looking Downstream – 12/3/07 - MY 01

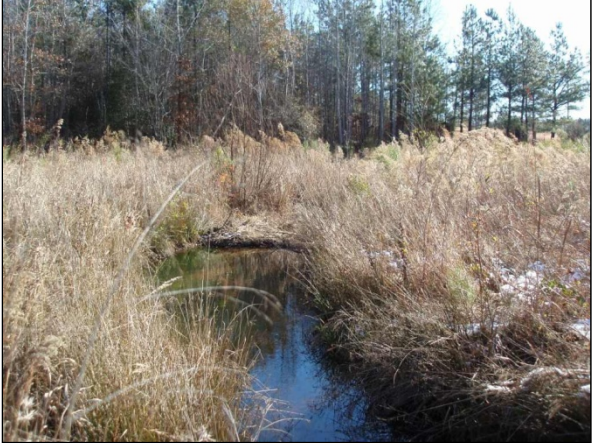
PS-3 Looking Downstream – 12/13/10 - MY 04

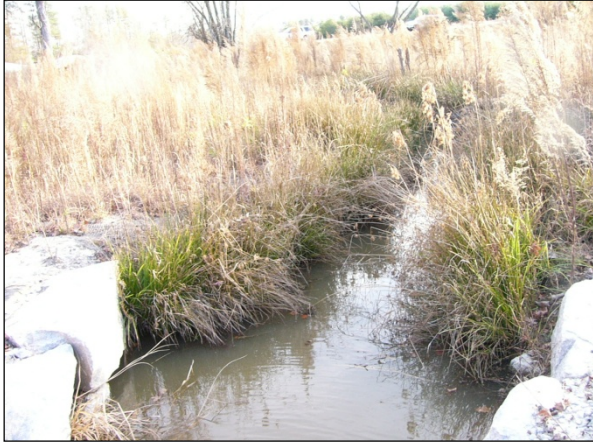
PS-4 Looking Downstream – 12/3/07 - MY 01

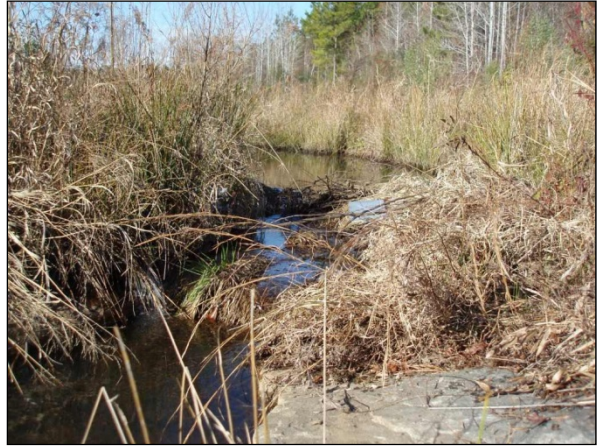
PS-4 Looking Downstream – 12/13/10 - MY 04

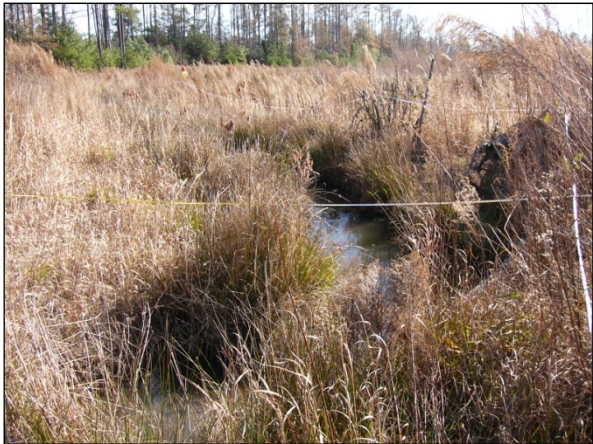
PS-5 Looking Downstream – 12/3/07 - MY 01

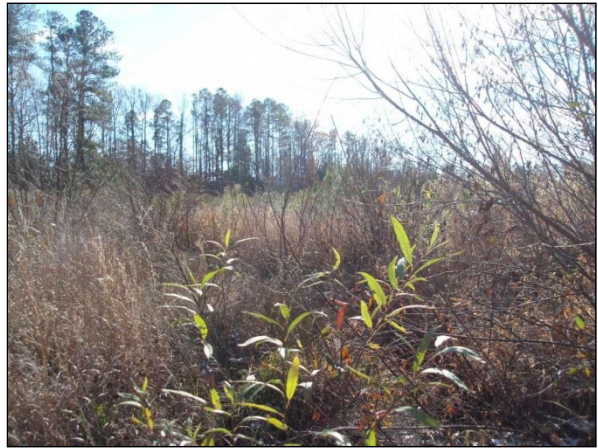
PS-5 Looking Downstream – 12/13/10 - MY 04

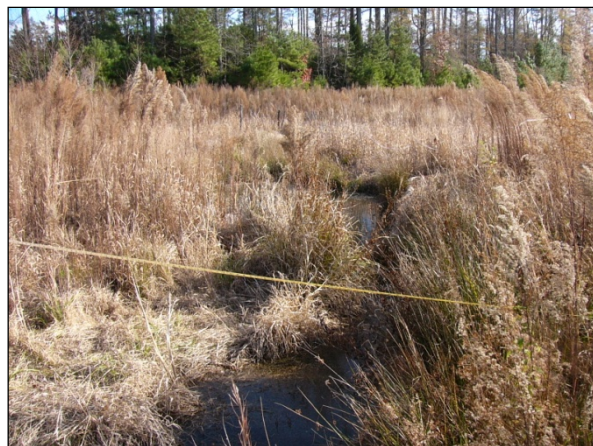
PS-6 Looking Downstream – 12/3/07 - MY 01

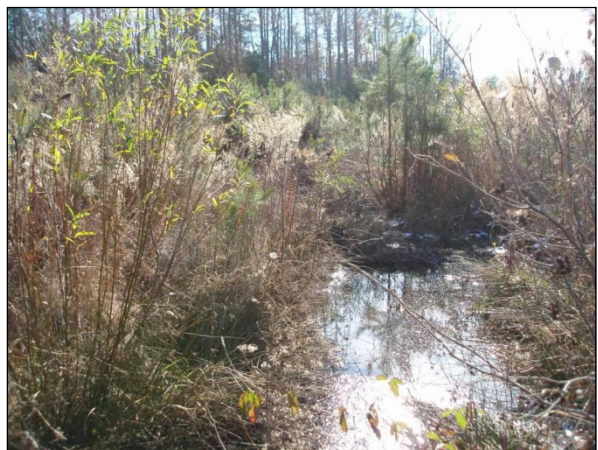
PS-6 Looking Downstream – 12/13/10 - MY 04

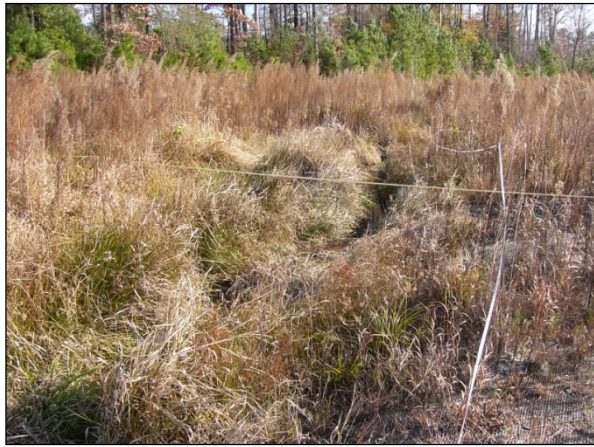
PS-7 Looking Downstream – 12/3/07 - MY 01

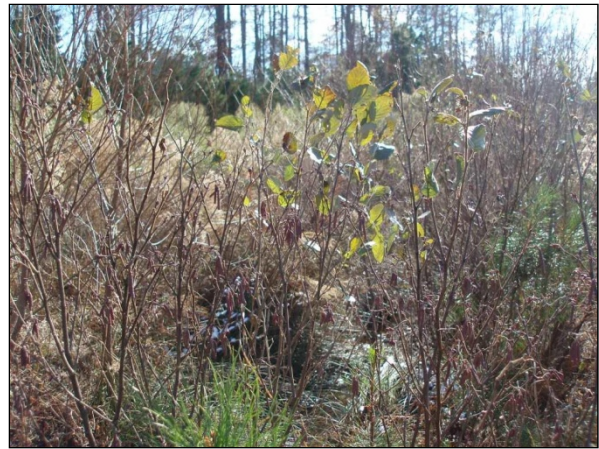
PS-7 Looking Downstream – 12/13/10 - MY 04

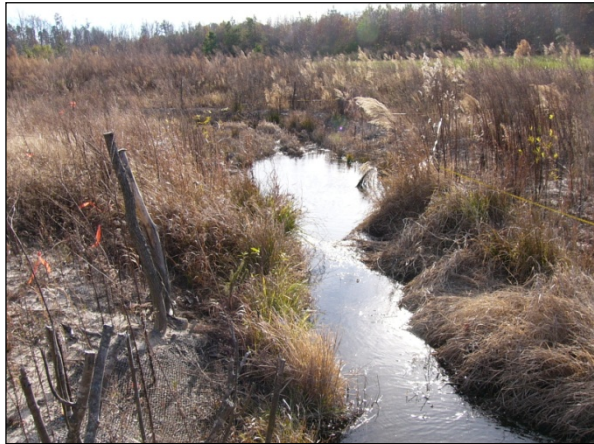
PS-8 Looking Downstream – 12/3/07 - MY 01

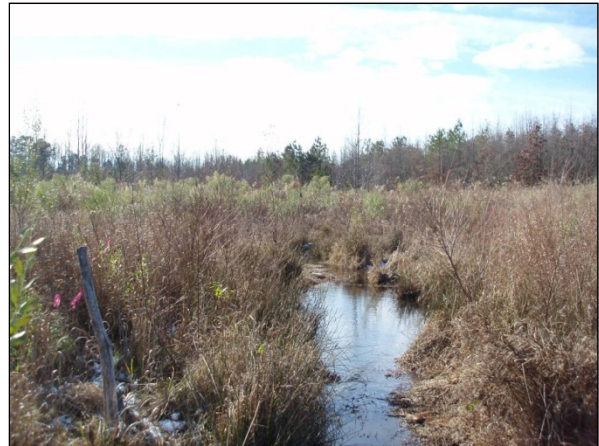
PS-8 Looking Downstream – 12/13/10 - MY 04

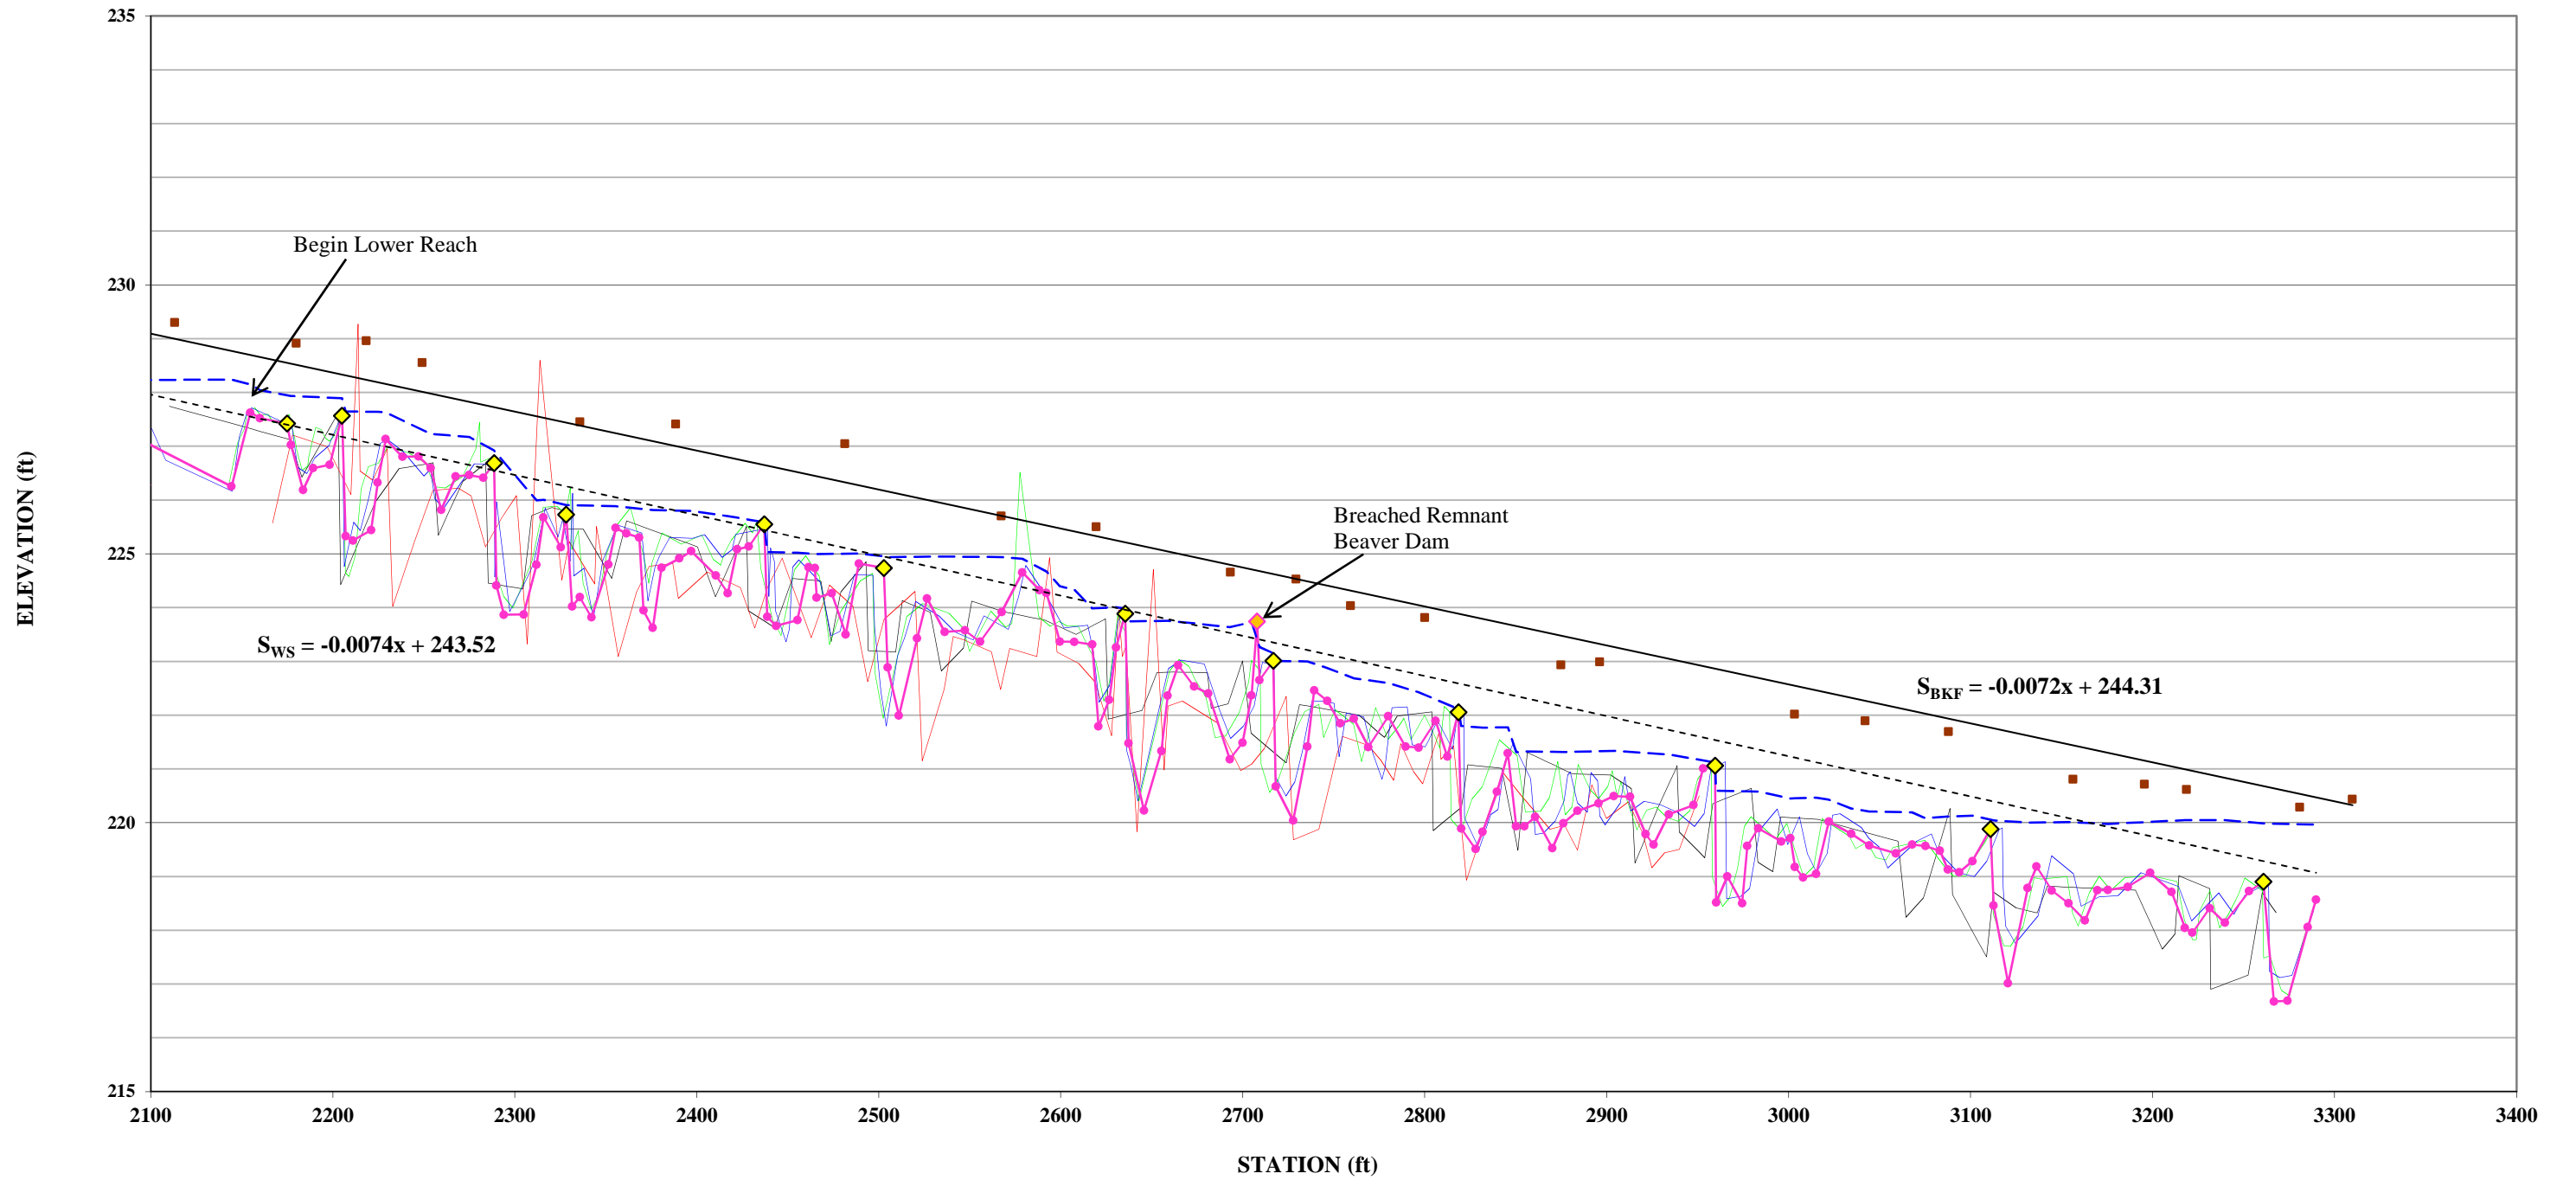
Longitudinal Profile
UT to Crooked Creek (Lower Reach), Franklin County
EEP Project Number 434 - MY04

Note: MY-01 profile data ends at Station 29+50. A survey error affected the elevations from Station 29+50 to the end of the profile.
