**UT to Crooked Creek
Stream Restoration Monitoring Report
EEP Project # 434
Monitoring Year 05**

**Data Collection: 2011
Construction Completed: July 2006
Submitted: December 2011**

UT CROOKED CREEK
 FRANKLIN COUNTY, NORTH CAROLINA
 EEP PROJECT NUMBER 434 - MY05
 STATION 10+00 TO STATION 21+28

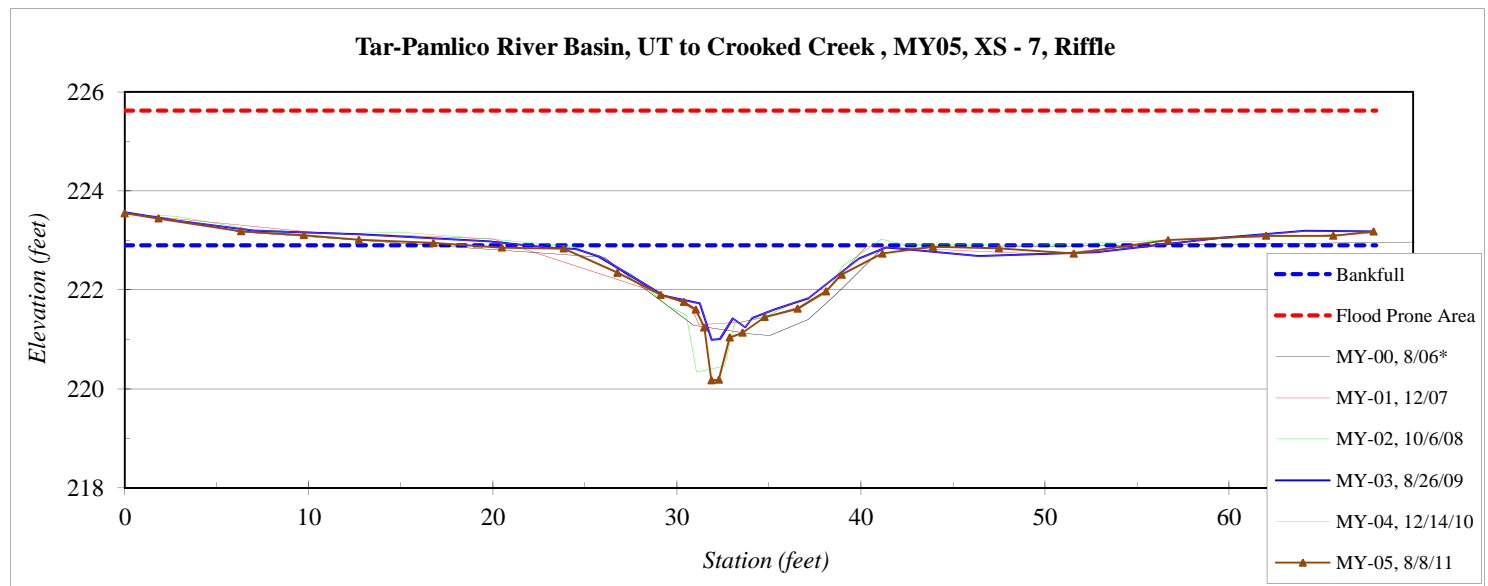
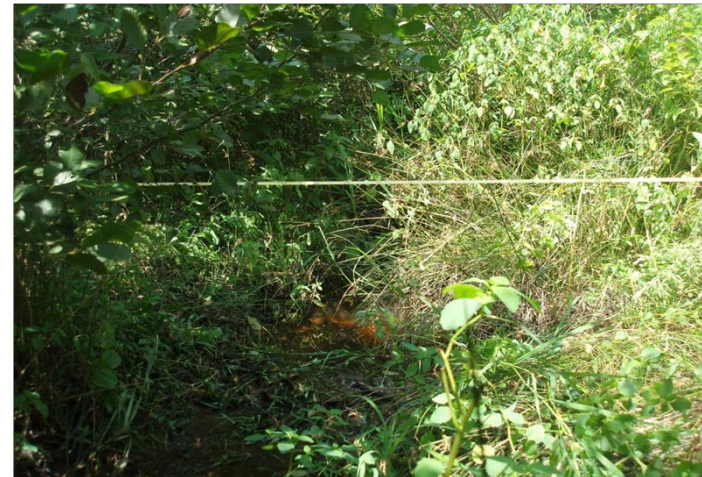
River Basin:	Tar-Pamlico
Watershed:	UT to Crooked Creek , MY05
XS ID	XS - 7, Riffle
Drainage Area (sq mi):	0.52
Date:	8/8/2011
Field Crew:	A. French, J. Anders

Note: A clump of in-stream vegetation, immediately upstream of this cross-section, has caused a small area of scour in the bed that is evident in the above cross-section plot. This is not causing any bank erosion or adjacent stream instability.
