FINAL
ANNUAL MONITORING REPORT
YEAR 1 (2012)
HAUSER CREEK STREAM RESTORATION SITE
DAVIE COUNTY, NORTH CAROLINA
(EEP Project No. 92471, Contract No. 004804)
Construction Completed August 2011

February 2013

Prepared by:
Axiom Environmental, Inc.
218 Snow Avenue
Raleigh, North Carolina 27603

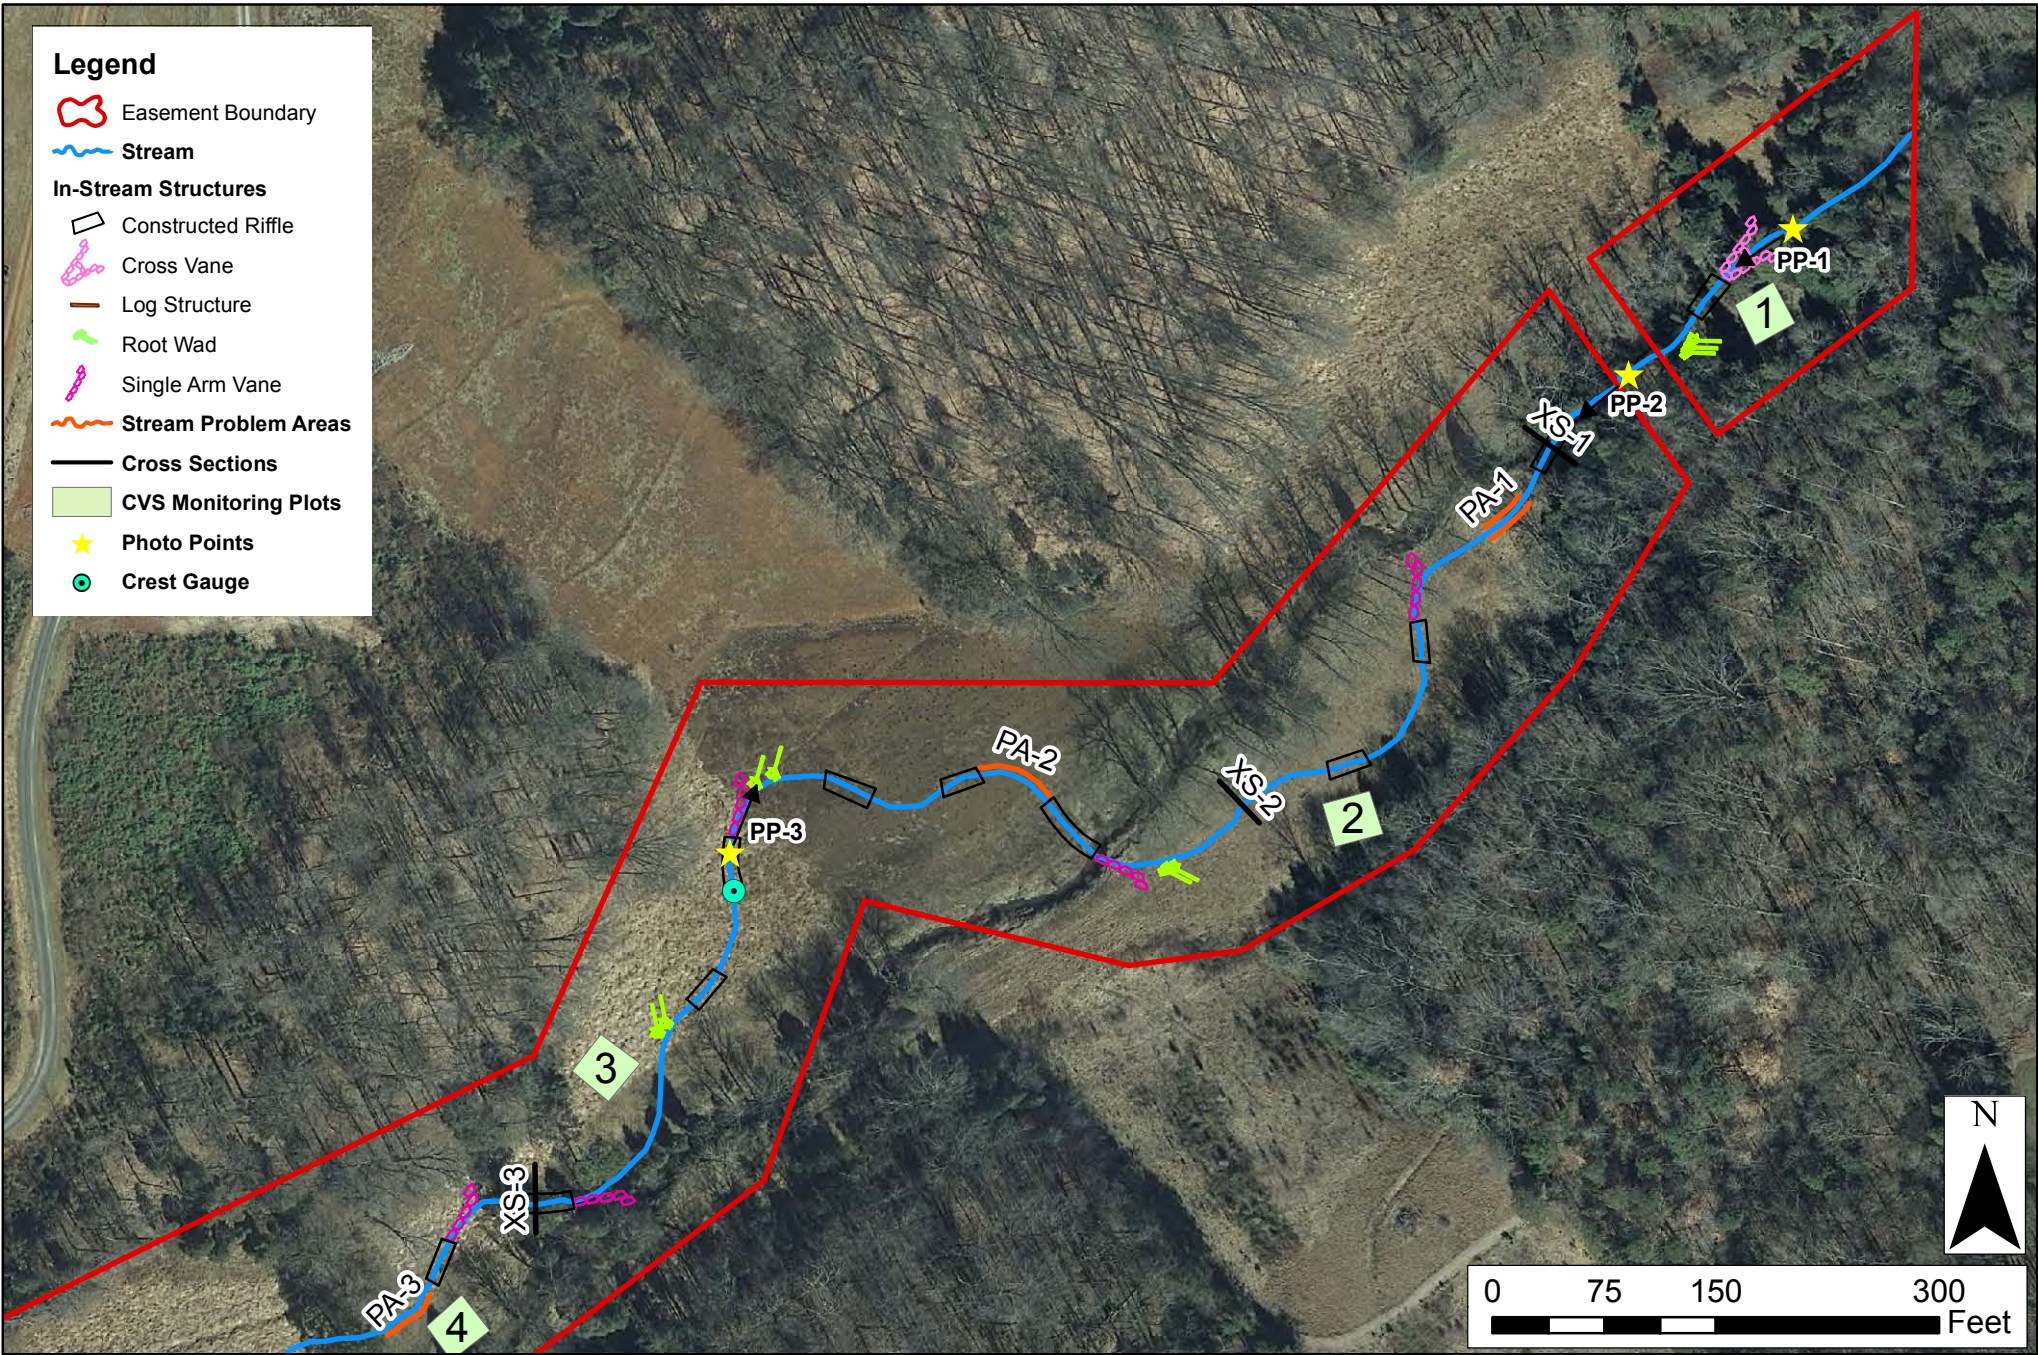
FIGURE
2A

Overall, the stream is functioning properly and as designed. Three areas of minor bank erosion were noted in Figures 2A-2B in Appendix B, but these areas are not causing additional issues up or downstream and vegetation is establishing.

Map Label*	Station	Notes
PA-1	22+50	Minor erosion on both banks; vegetation is establishing
PA-2	18+75	Minor erosion and undercut bank on outer/left bank; vegetation is establishing
PA-3	12+00	Minor undercutting on outer/right bank; vegetation is establishing

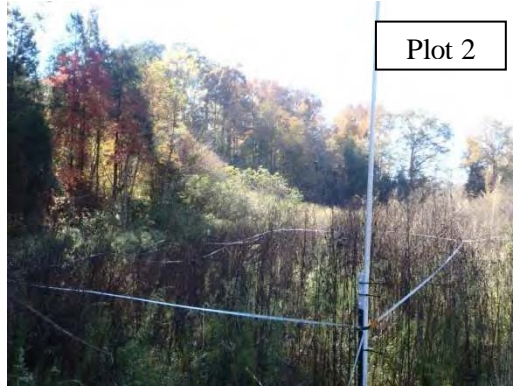
Plot 2

Seven vegetation monitoring plots were monitored on October 24, 2012 for Year 1 (2012) monitoring. Vegetation success criteria dictate that an average density of 320 stems-per-acre must be surviving in the first three monitoring years. Subsequently, 288 stems-per-acre must be surviving in year 4 and 260 stems-per-acre in year 5. Stem counts will be based on an average of the evaluated vegetation plots. Based on the number of stems counted, average densities were measured at 422 stems-per-acre surviving in Year 1 (2012). The dominant species identified at the Site were planted stems of sycamore (*Platanus occidentalis*), green ash (*Fraxinus pennsylvanica*), and silky dogwood (*Cornus amomum*). Five of the seven individual plots met success criteria based on planted stems alone. Plots 2 and 6 were each one

stem shy of success criteria based on planted stems alone; however, when including naturally recruited stems of box elder (*Acer negundo*) and sweetgum (*Liquidambar styraciflua*) Plots 2 and 6 were above 320 stems per acre.
