**FINAL**  
**ANNUAL MONITORING REPORT**  
**YEAR 2 (2013)**  
**HAUSER CREEK STREAM RESTORATION SITE**  
**DAVIE COUNTY, NORTH CAROLINA**  
**(EEP Project No. 92471, Contract No. 004804)**  
**Construction Completed August 2011**

Submitted to:  
North Carolina Department of Environment and Natural Resources  
Ecosystem Enhancement Program  
Raleigh, North Carolina

November 2013

Prepared by:  
Axiom Environmental, Inc.  
218 Snow Avenue  
Raleigh, North Carolina 27603

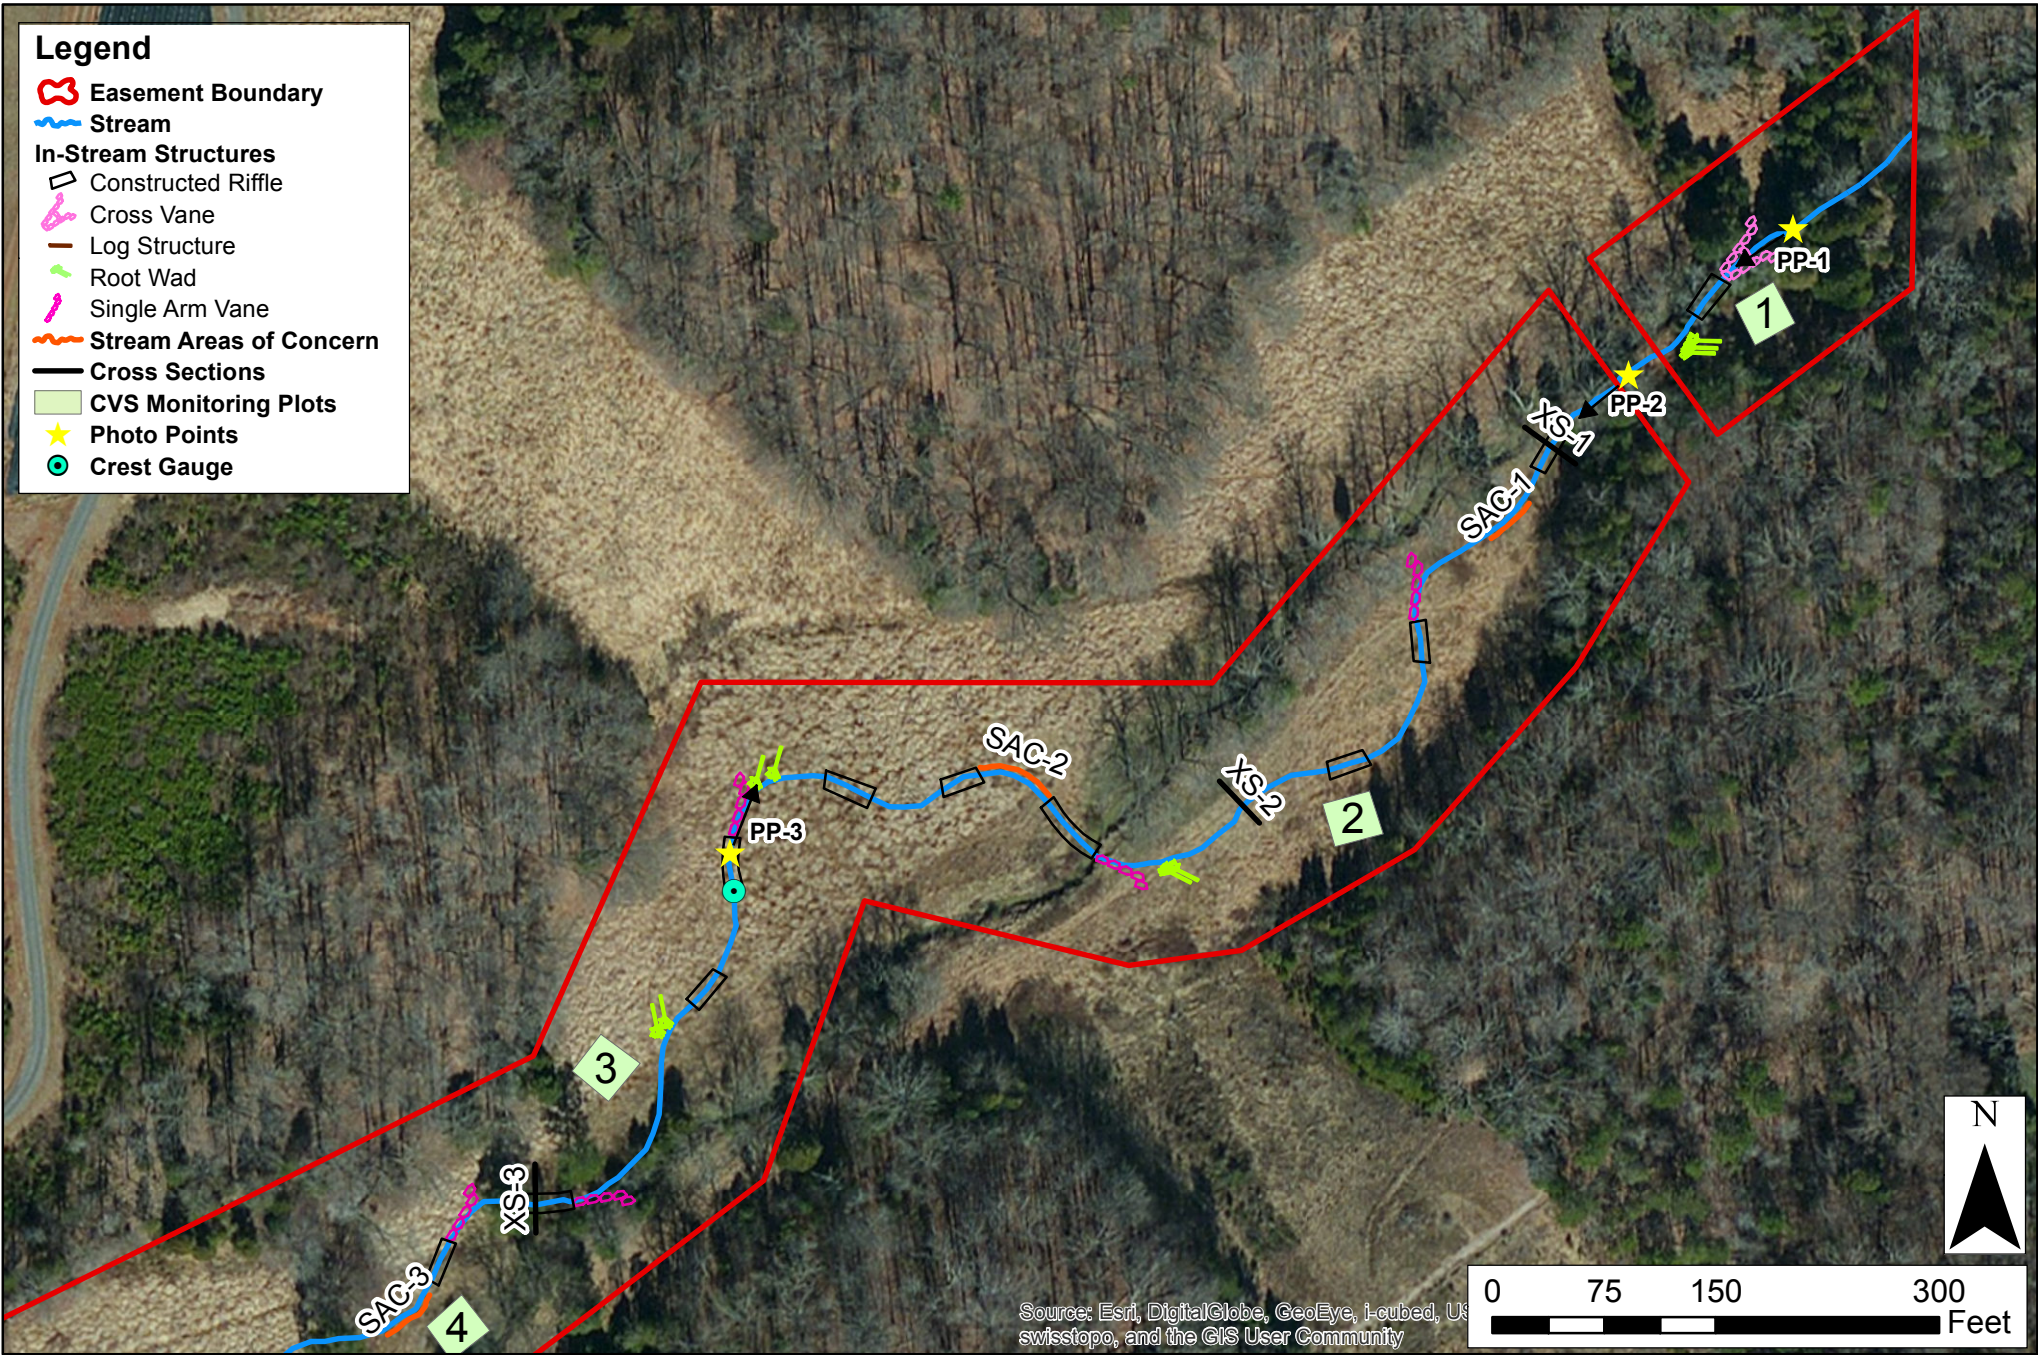
FIGURE  
**2A**

Overall, the stream is functioning properly and as designed. Three areas of minor bank erosion were noted in Figures 2A-2B (Appendix B); however, these areas are not causing additional issues up or downstream and vegetation is establishing.

Map Label*	Station	Notes
SAC-1	22+50	Erosion and sloughing of approximately 10 feet along the right bank of an outer bend
SAC-2	18+75	Erosion and sloughing of approximately 15 feet along the left bank of an outer bend
SAC-3	12+00	Erosion and sloughing of approximately 10 feet along the right bank of an outer bend

\*Map labels on Figures 2A-2B, Appendix B

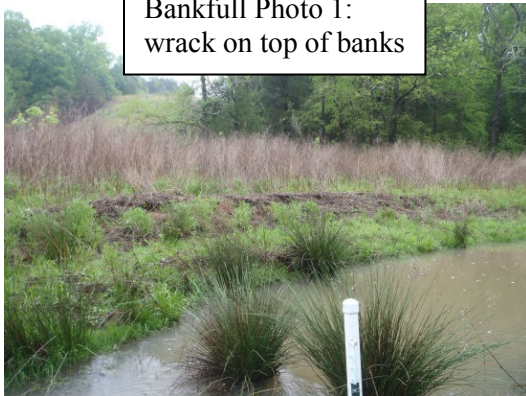
Bankfull Photo 1:  
wrack on top of banks

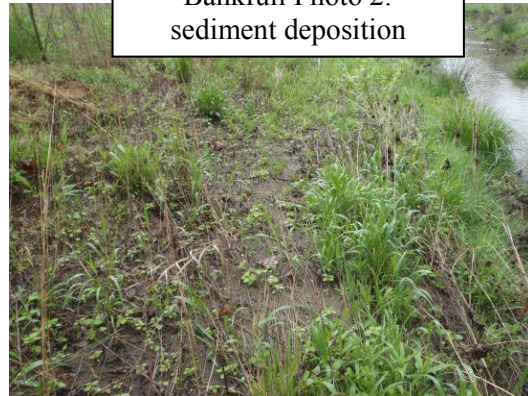
Bankfull Photo 2:  
sediment deposition

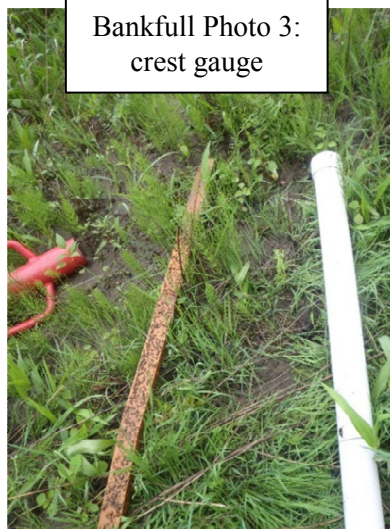
Bankfull Photo 3:  
crest gauge
