FINAL
ANNUAL MONITORING REPORT
YEAR 3 (2014)
HAUSER CREEK STREAM RESTORATION SITE
DAVIE COUNTY, NORTH CAROLINA
(EEP Project No. 92471, Contract No. 004804)
Construction Completed August 2011

October 2014

Prepared by:
Axiom Environmental, Inc.
218 Snow Avenue
Raleigh, North Carolina 27603

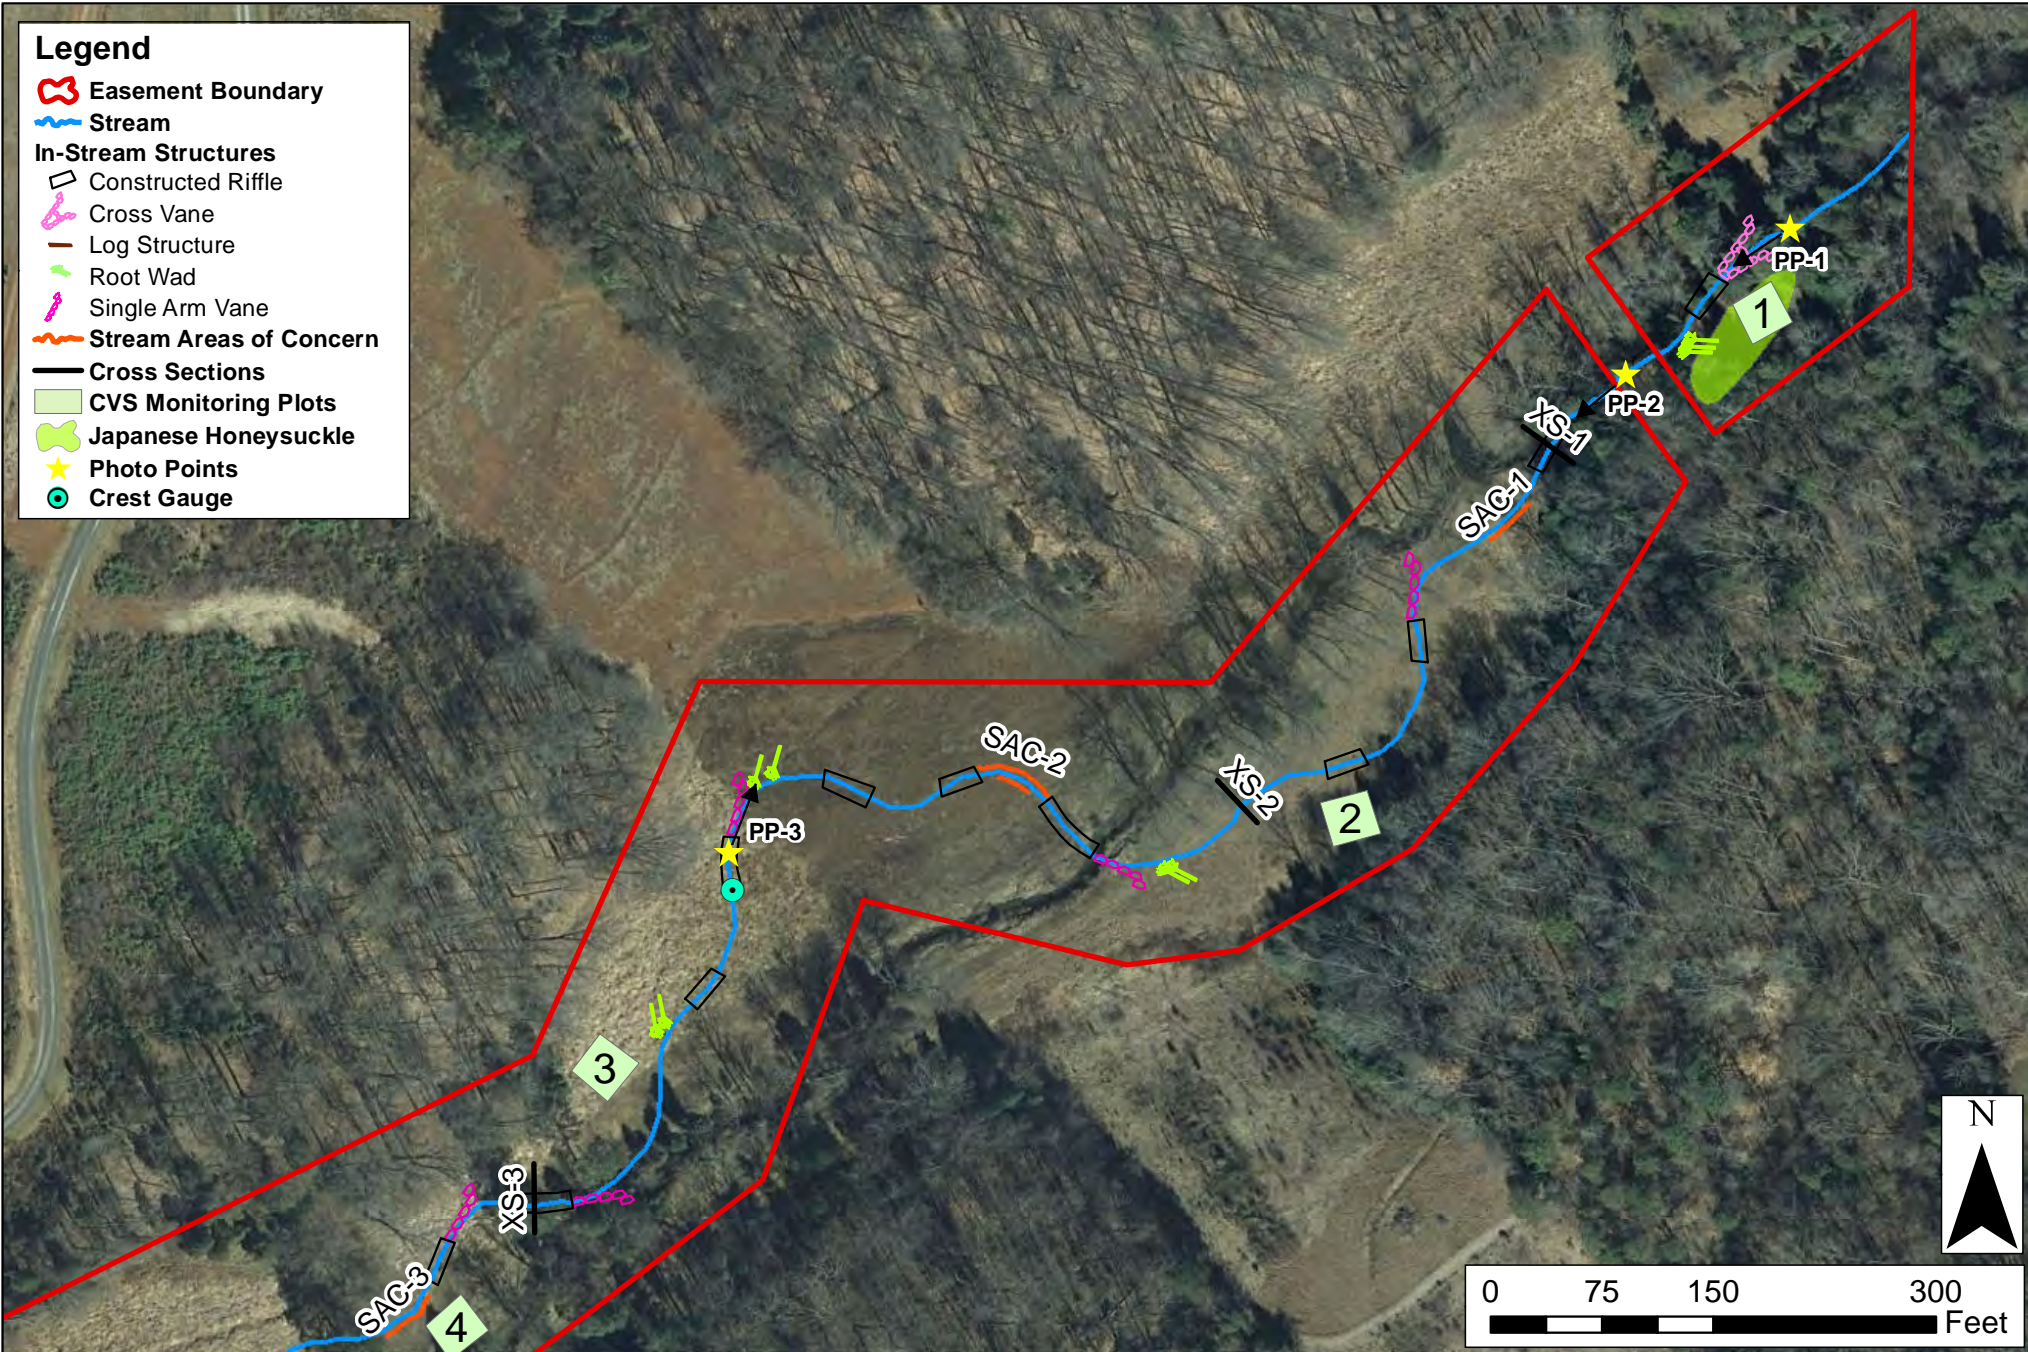
FIGURE
2A

Overall, vegetation on the Site is thriving. One small population of Japanese honeysuckle was observed near and in vegetation plot 1 (Figure 2A, Appendix B). This area will continue to be closely monitored during subsequent monitoring years to determine if remedial activities should occur.

Overall, the stream is functioning properly and as designed. Three areas of bank erosion were noted in Figures 2A-2B (Appendix B).

Map Label*	Station	Notes
SAC-1	22+50	Minor erosion and sloughing of approximately 20 feet along the right bank of an outer bend
SAC-2	18+75	Moderate erosion and sloughing of approximately 25 feet along the left bank of an outer bend as well as approximately 10 feet of the inner bend
SAC-3	12+00	Minor erosion and sloughing of approximately 15 feet along the right bank of an outer bend

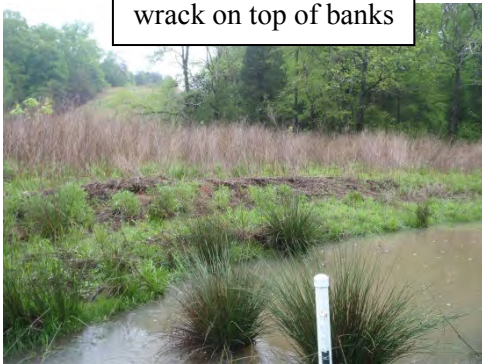
Bankfull Photo 1:
wrack on top of banks

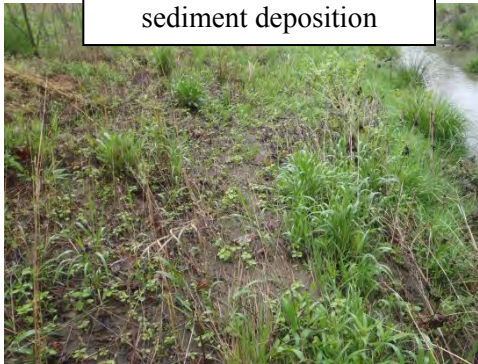
Bankfull Photo 2:
sediment deposition

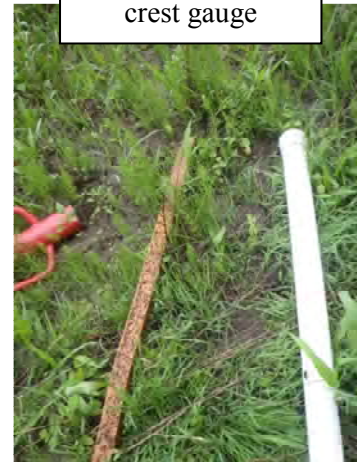
Bankfull Photo 3:
crest gauge
