FINAL
ANNUAL MONITORING REPORT
YEAR 4 (2015)
HAUSER CREEK STREAM RESTORATION SITE
DAVIE COUNTY, NORTH CAROLINA
(DMS Project No. 92471, Contract No. 004804)
Construction Completed August 2011

December 2015

Prepared by:
Axiom Environmental, Inc.
218 Snow Avenue
Raleigh, North Carolina 27603

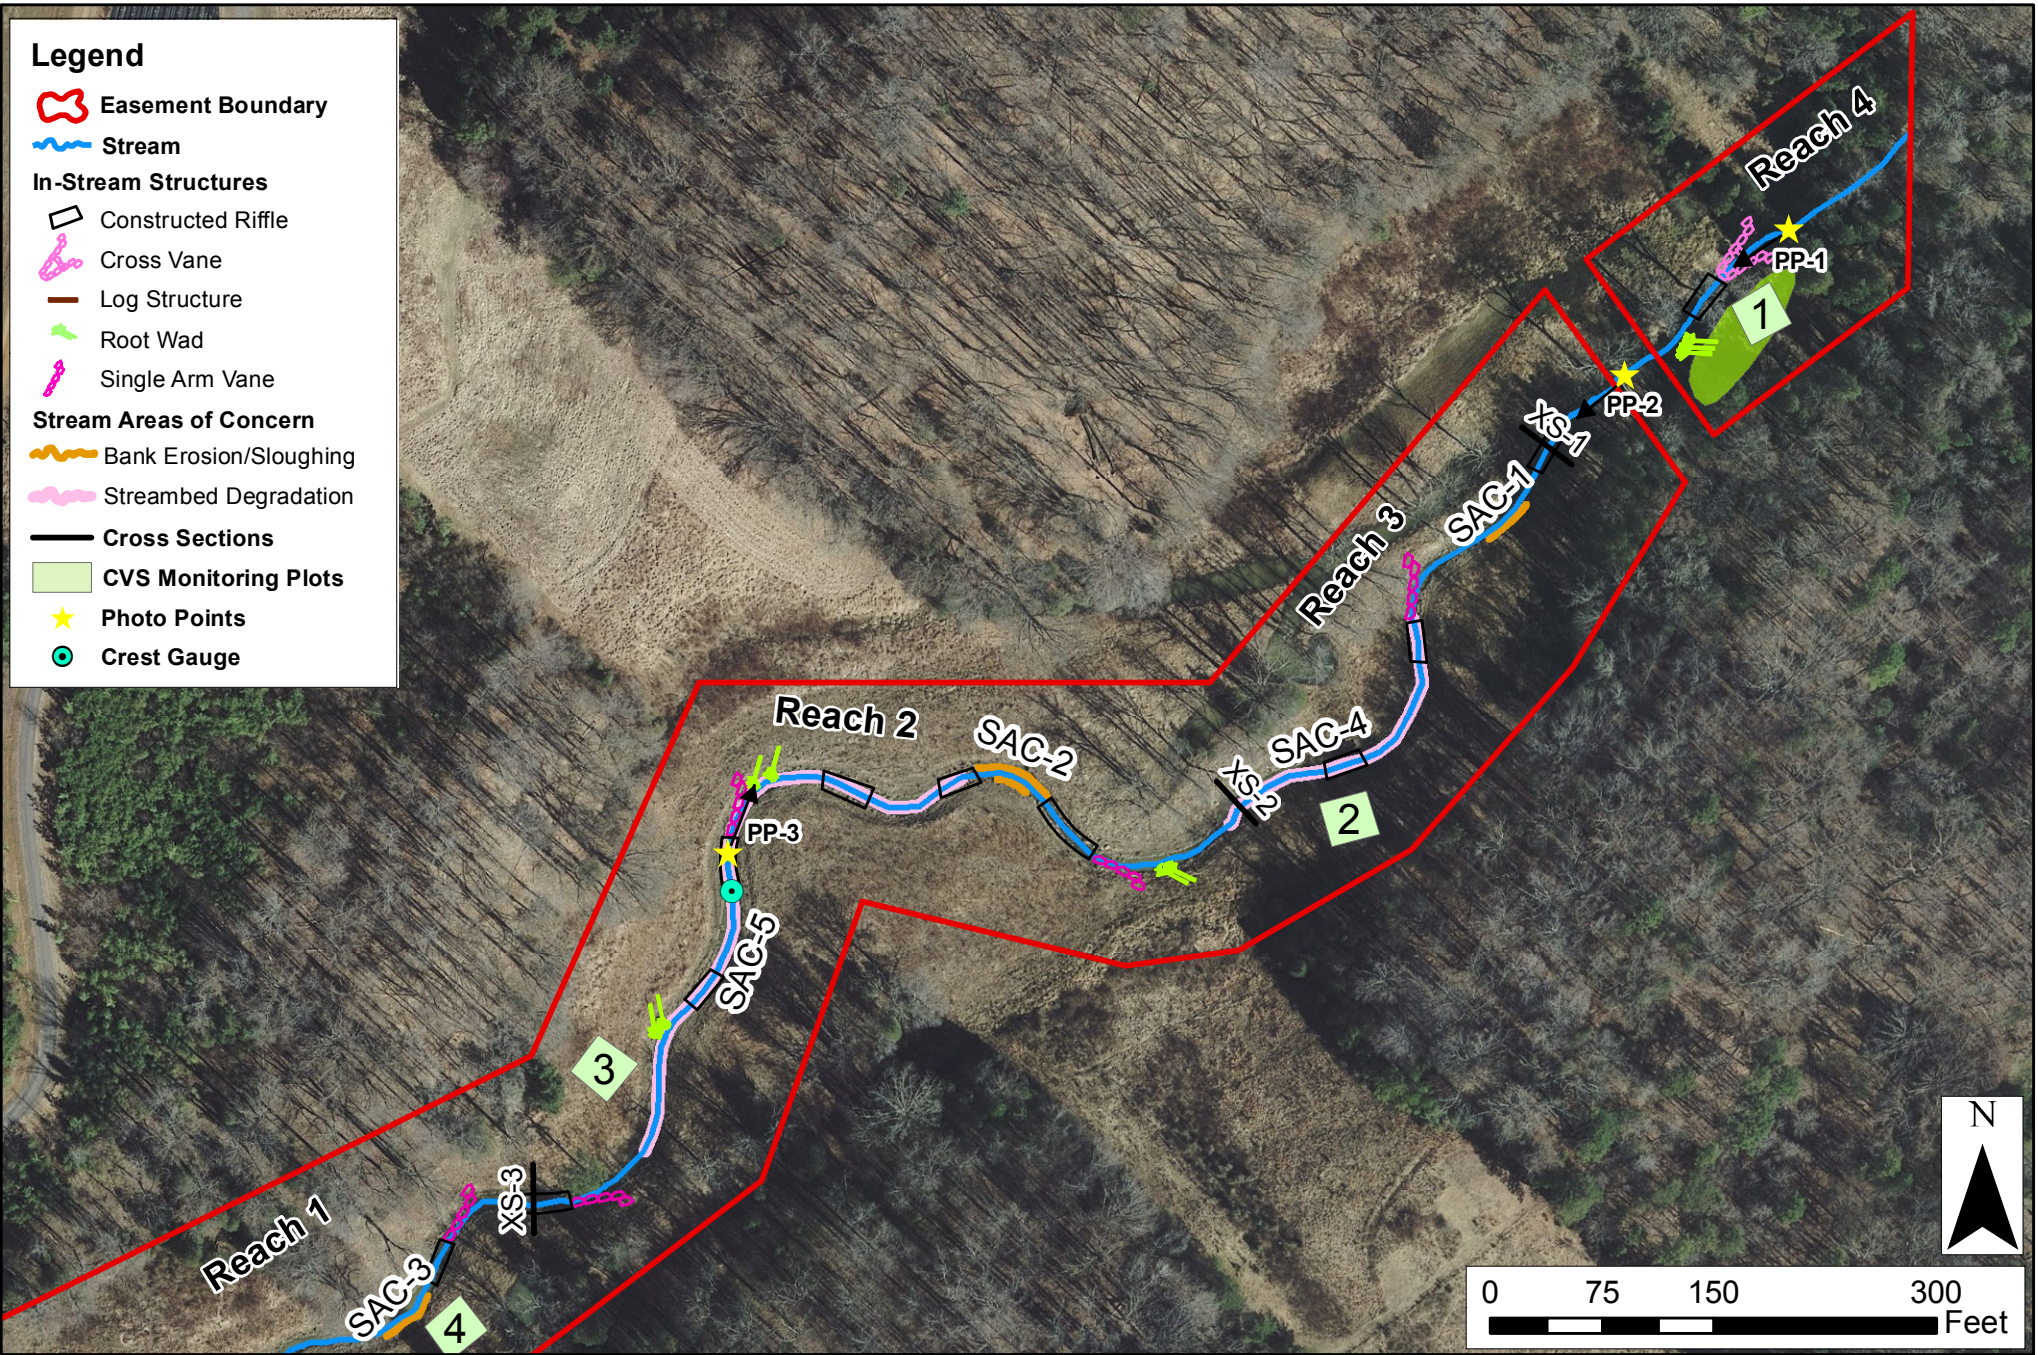
FIGURE
2A

Overall, vegetation at the Site is thriving. One small population of Japanese honeysuckle was observed near and in vegetation plot 1 (Figure 2A, Appendix B). This area is small and does not appear to have spread during Year 4 (2015). It will continue to be closely monitored during subsequent monitoring years to determine if remedial activities should occur.

Map Label*	Station	Notes
SAC-1	22+50	Moderate erosion and sloughing of approximately 25 feet along the right bank of an outer bend
SAC-2	18+75	Severe erosion and sloughing of approximately 30 feet along the left bank of an outer bend as well as approximately 10 feet of the inner bend
SAC-3	12+00	Moderate erosion and sloughing of approximately 15 feet along the right bank of an outer bend
SAC-4	20+30 to 22+45	Streambed degradation – riffle and pool scour and loss of bed material throughout reach due to high flow events on approximately 215 feet of stream
SAC-5	14+05 to 18+20	Streambed degradation – riffle and pool scour and loss of bed material throughout reach due to high flow events on approximately 415 feet of stream

Additionally, two beaver dams were observed during an October 2015 walkthrough (Figures 2A-2B, Appendix B). Beaver activity will continue to be monitored throughout Year 5 (2016).

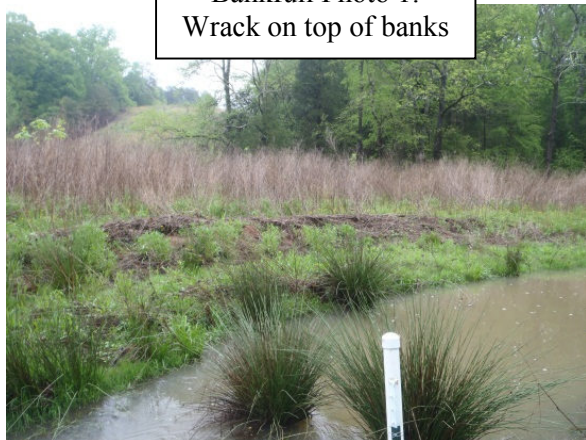
**Bankfull Photo 1:
Wrack on top of banks**

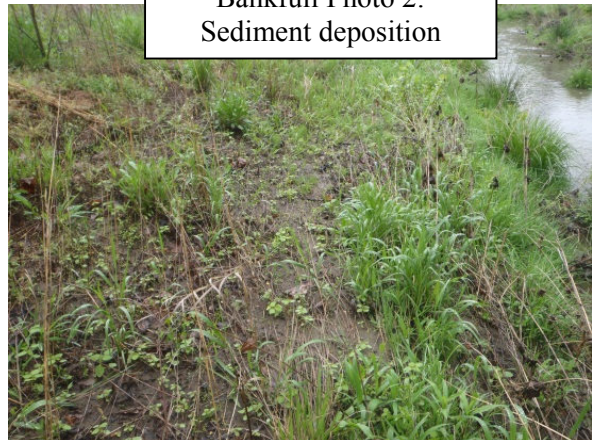
**Bankfull Photo 2:
Sediment deposition**

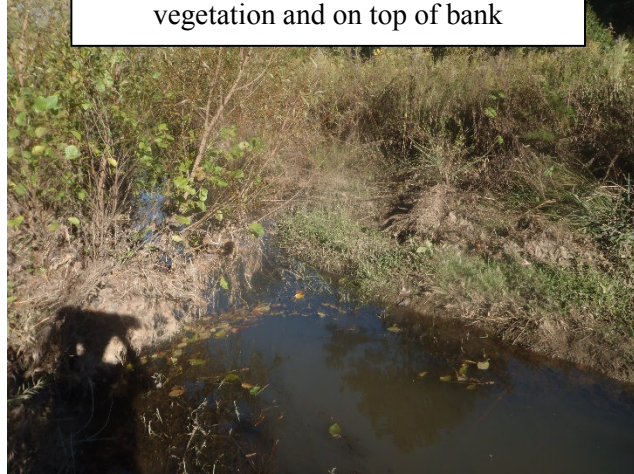
Bankfull Photo 4: Wrack in streamside
vegetation and on top of bank
