FINAL
ANNUAL MONITORING REPORT
YEAR 5 (2016)
HAUSER CREEK STREAM RESTORATION SITE
DAVIE COUNTY, NORTH CAROLINA
(DMS Project No. 92471, Contract No. 004804)
Construction Completed August 2011

November 2016

Prepared by:
Axiom Environmental, Inc.
218 Snow Avenue
Raleigh, North Carolina 27603

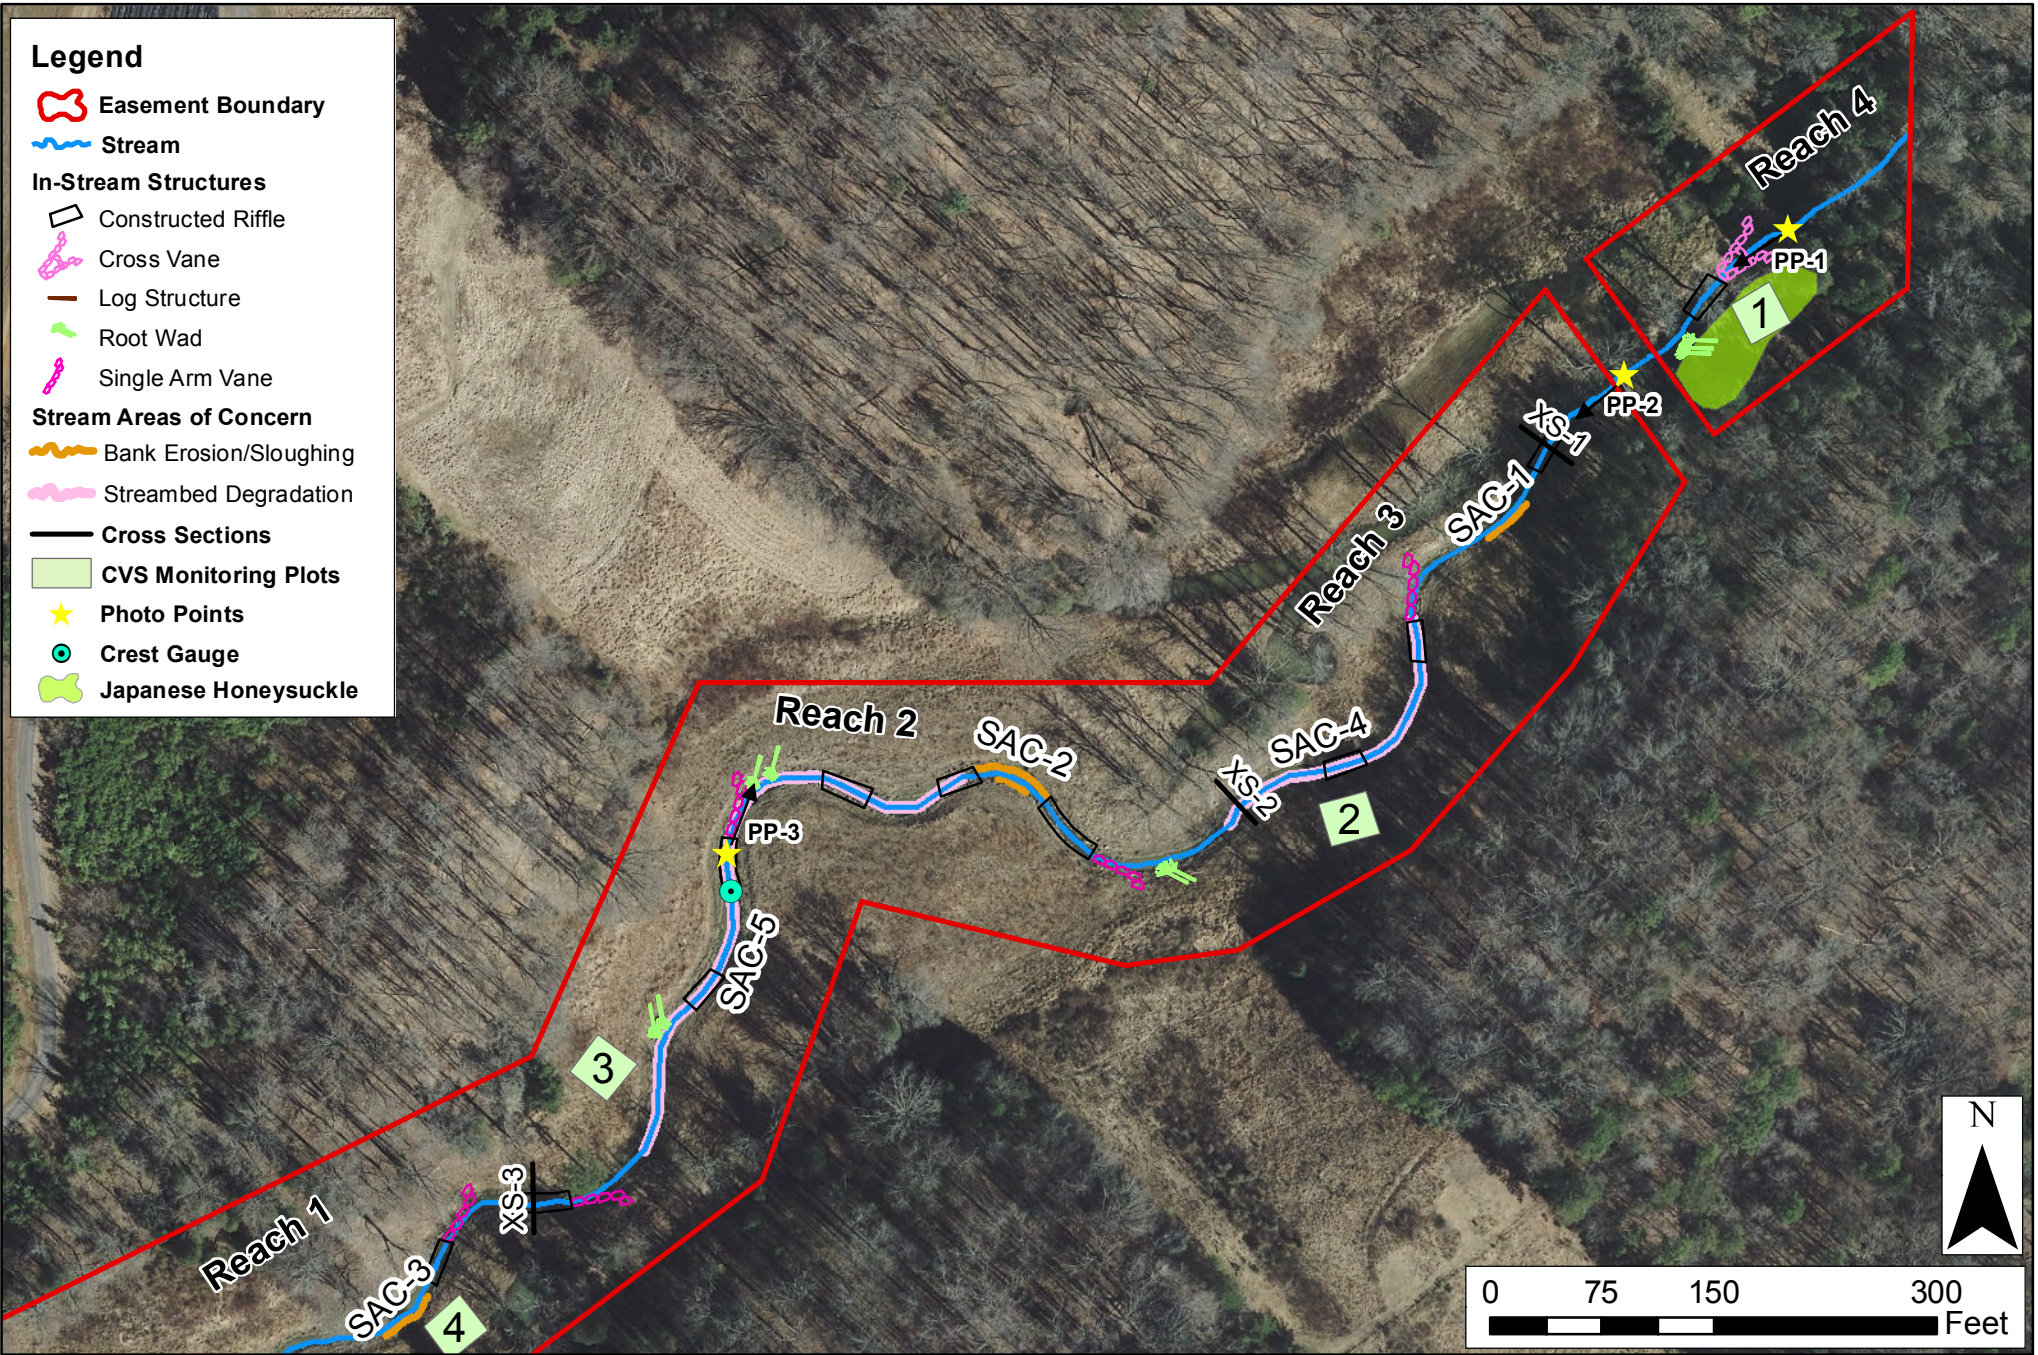
FIGURE
2A

Overall, vegetation at the Site is thriving. One small population of Japanese honeysuckle (*Lonicera japonica*) was observed during Year 3 (2014) near and in vegetation plot 1 (Figure 2A, Appendix B). This area is small and does not appear to have spread during Years 4 (2015) and 5 (2016).

Map Label*	Station	Notes
SAC-1	22+50	Moderate erosion and sloughing of approximately 25 feet along the right bank of an outer bend
SAC-2	18+75	Severe erosion and sloughing of approximately 35 feet along the left bank of an outer bend as well as approximately 10 feet of the inner bend
SAC-3	12+00	Moderate erosion and sloughing of approximately 15 feet along the right bank of an outer bend
SAC-4	20+30 to 22+45	Streambed degradation – riffle and pool scour and loss of bed material throughout reach due to high flow events on approximately 215 feet of stream
SAC-5	14+05 to 18+20	Streambed degradation – riffle and pool scour and loss of bed material throughout reach due to high flow events on approximately 415 feet of stream

Additionally, beaver activity has been an ongoing issue throughout the monitoring period. Two beaver dams were observed during an October 2016 Site visit (Figures 2A-2B, Appendix B).

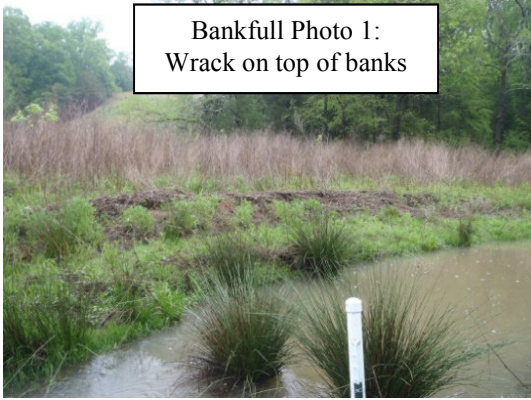
Bankfull Photo 1:
Wrack on top of banks

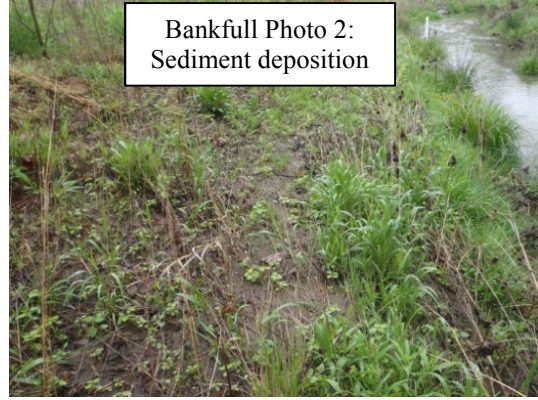
Bankfull Photo 2:
Sediment deposition

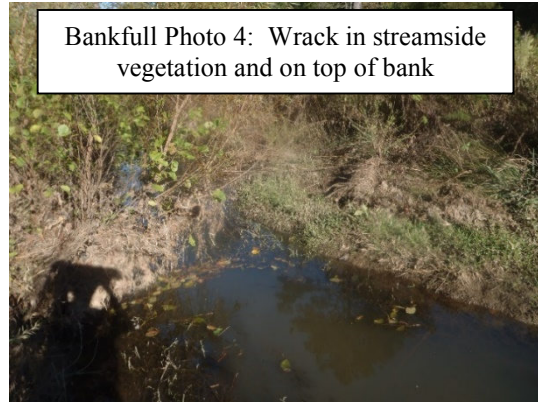
Bankfull Photo 4: Wrack in streamside
vegetation and on top of bank

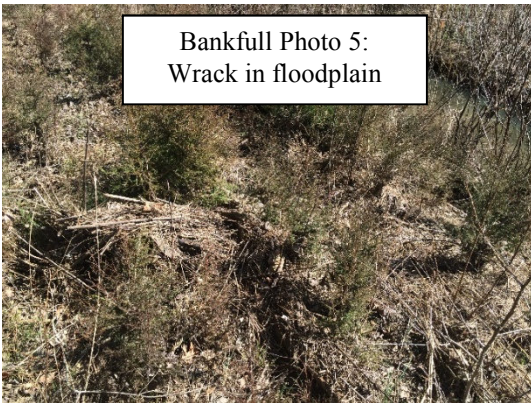
Bankfull Photo 5:
Wrack in floodplain

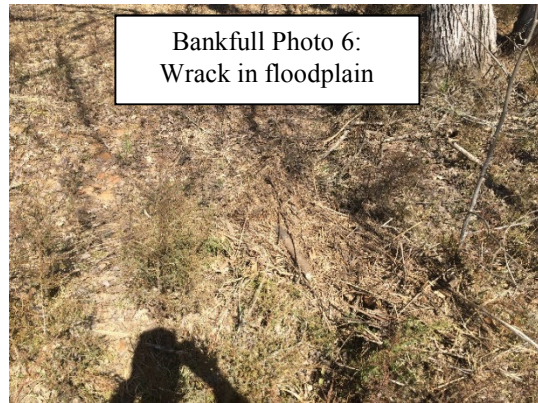
Bankfull Photo 6:
Wrack in floodplain

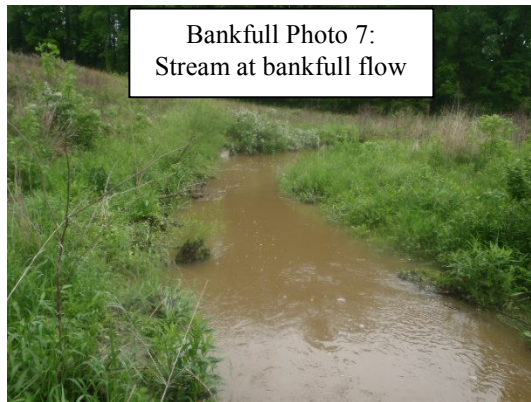
Bankfull Photo 7:
Stream at bankfull flow
