**FINAL
ANNUAL MONITORING REPORT
UT TO HAW (GWYNN) SITE
ALAMANCE COUNTY, NORTH CAROLINA
(EEP Project No. 92753, Contract No. 004543)**

Monitoring Year 4 of 5 (2013)

Prepared by:
Axiom Environmental, Inc.
218 Snow Avenue
Raleigh, North Carolina 27603

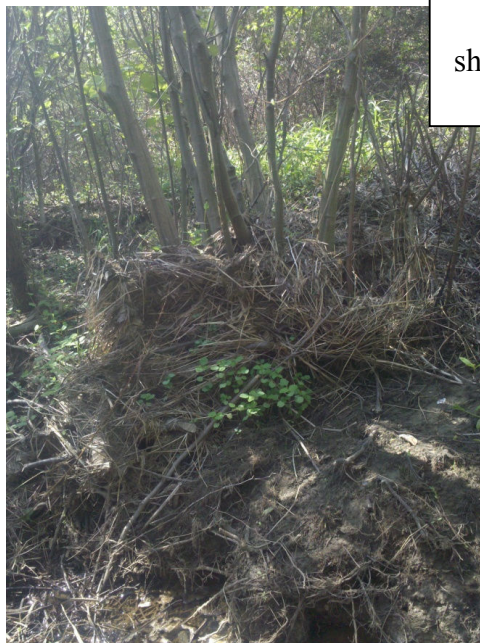
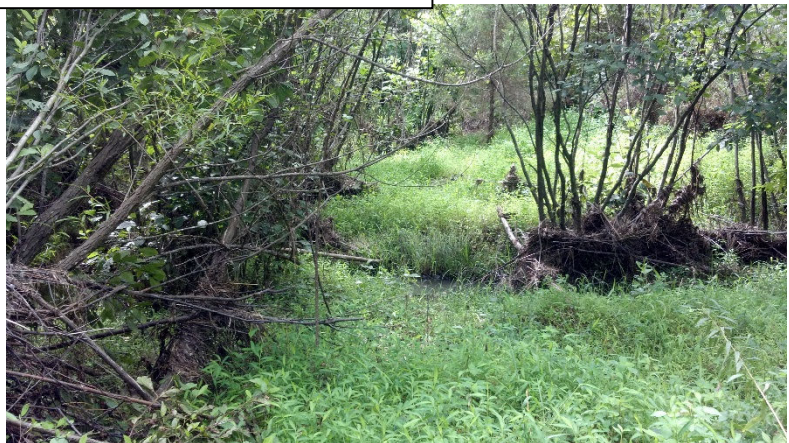
July 18, 2012	July 11, 2012	Total of 4.84 inches* of rain reported to fall over 3 days (July 9-11, 2012)	--
July 26, 2013	June 31, 2013	Visual observations of overbank event including wrack lines and sediment deposition resulting from 14 days (June 25-July 8) of heavy rainfall totaling 6.27 inches.	2

Bankfull Event Photos 1 and 2 showing wrack lines resulting from overbank events
