# Year 2 Annual Monitoring Document

UT to Haw River (#747)

Alamance County

Data Collection Period: October 16, 2013

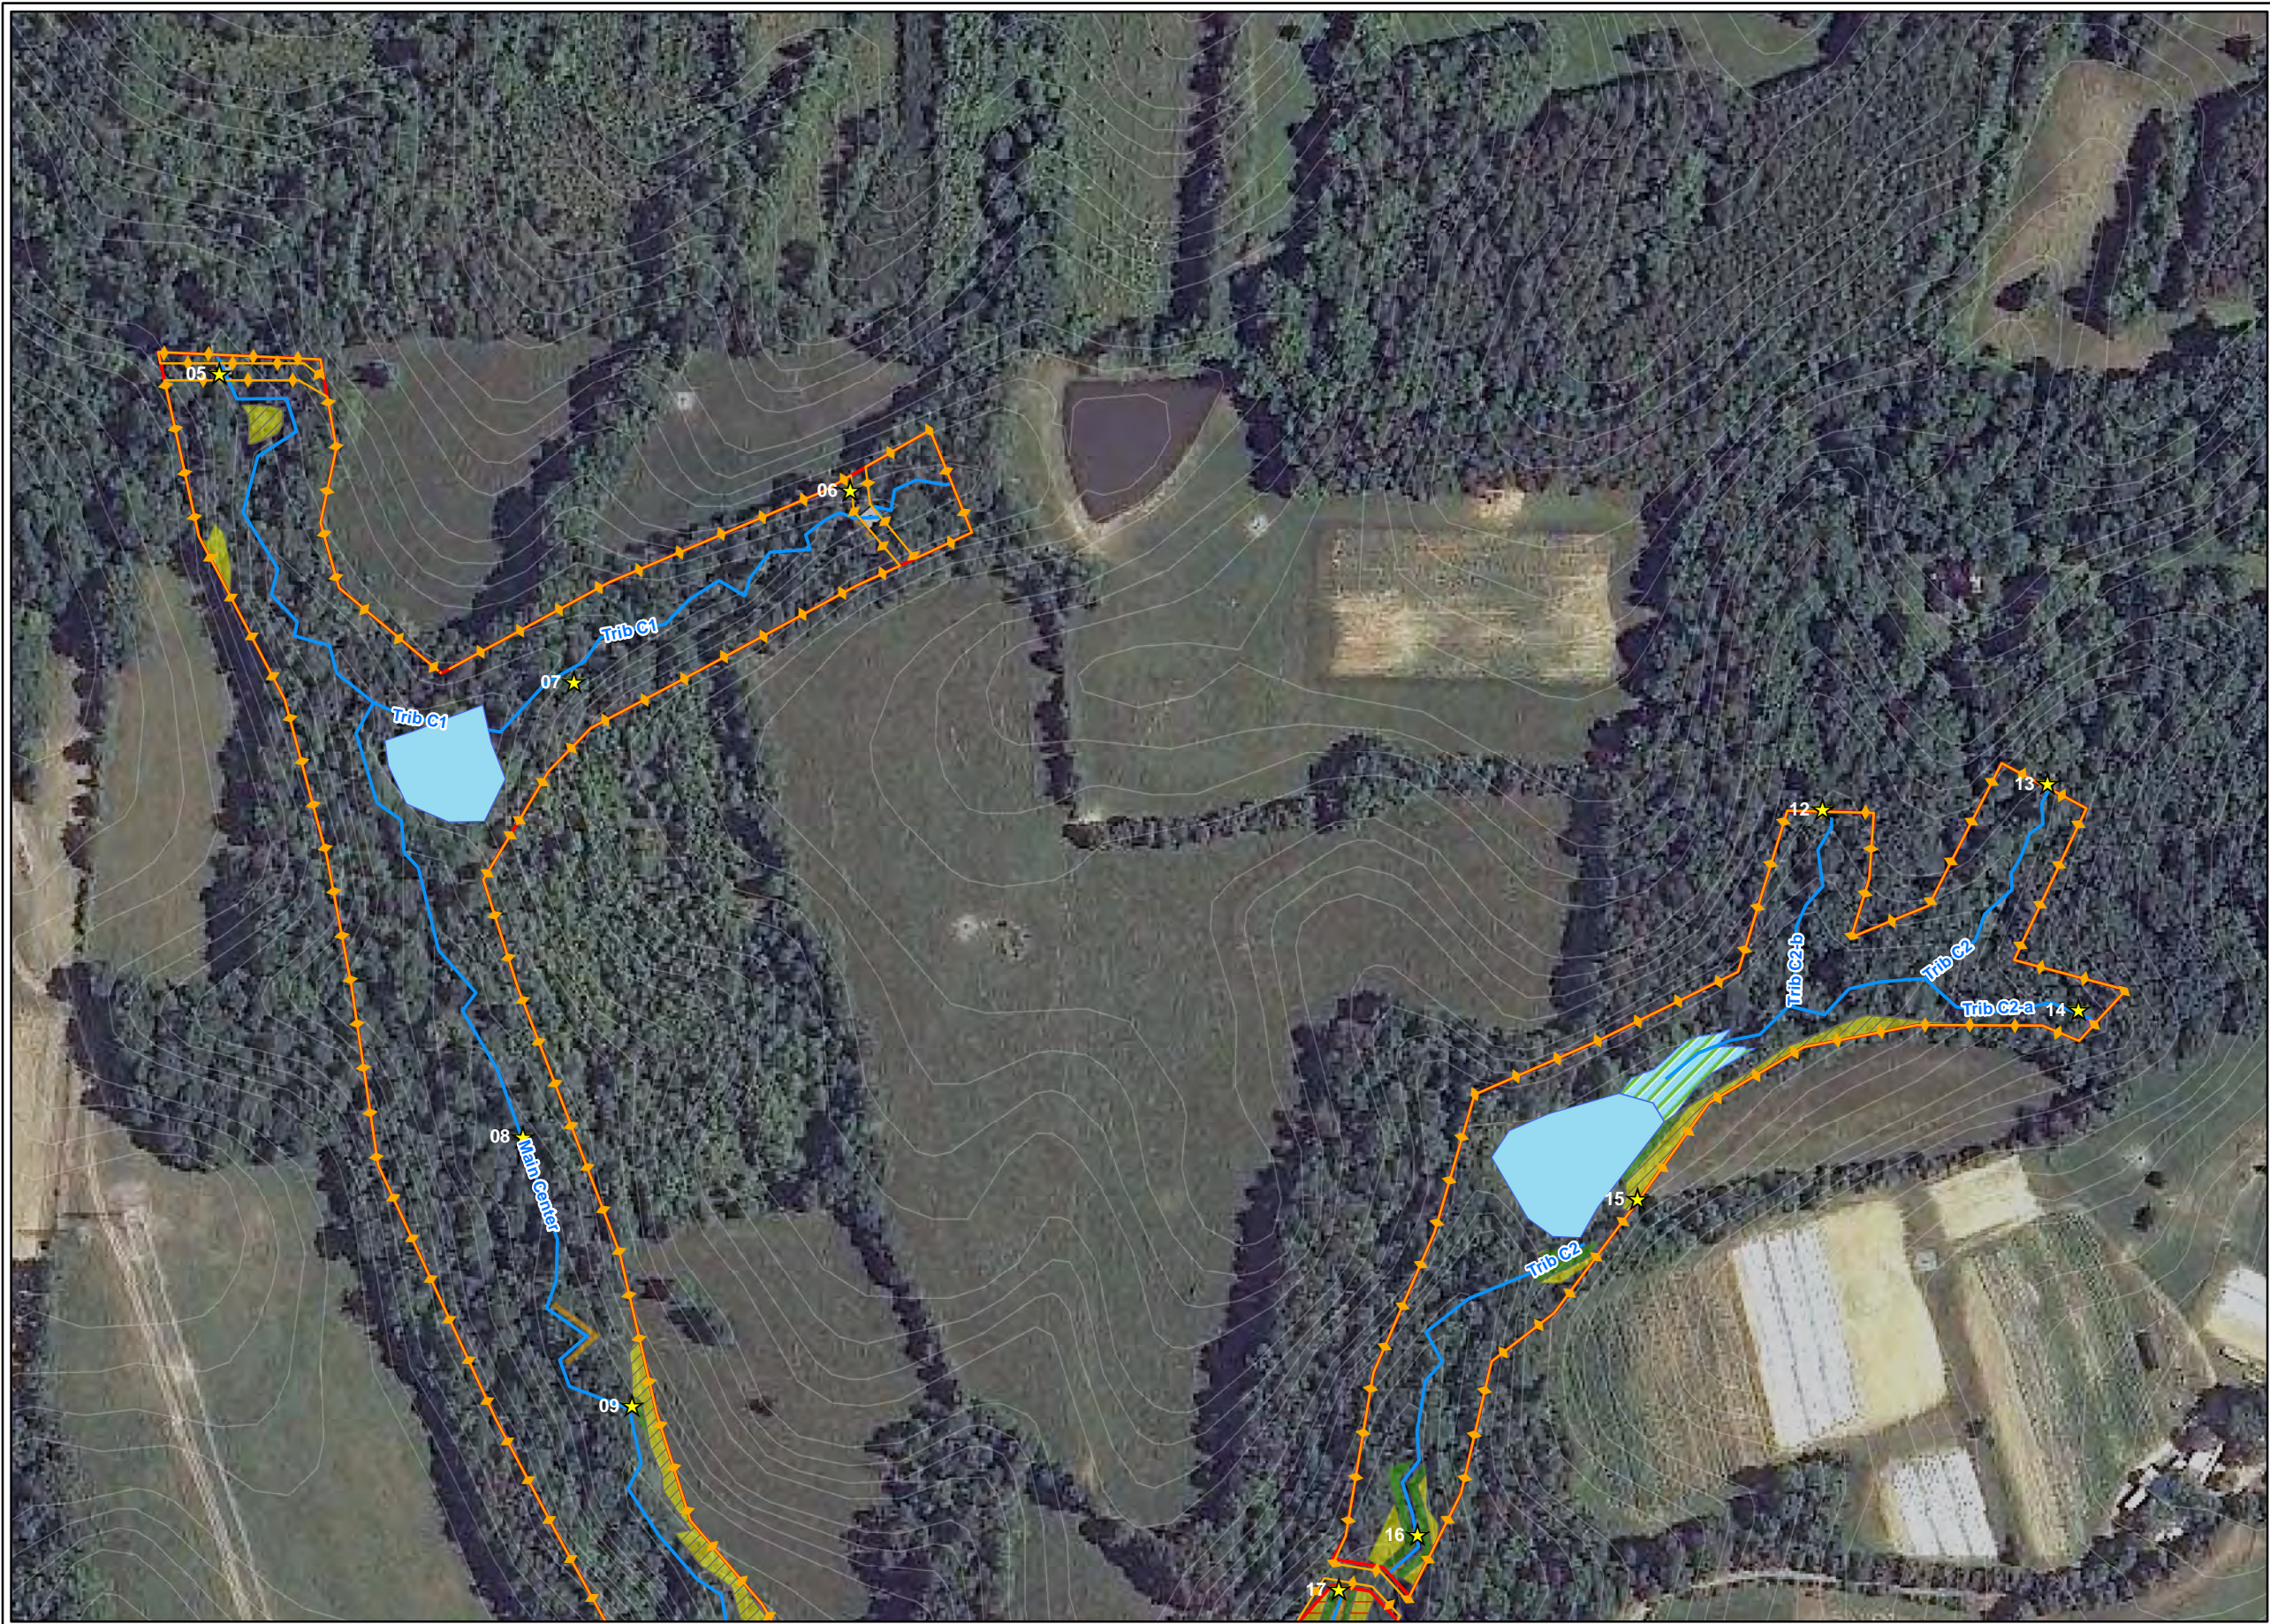
2-2

Planting areas are present where woody stem densities are below Year 3, 4, and 5 requirements

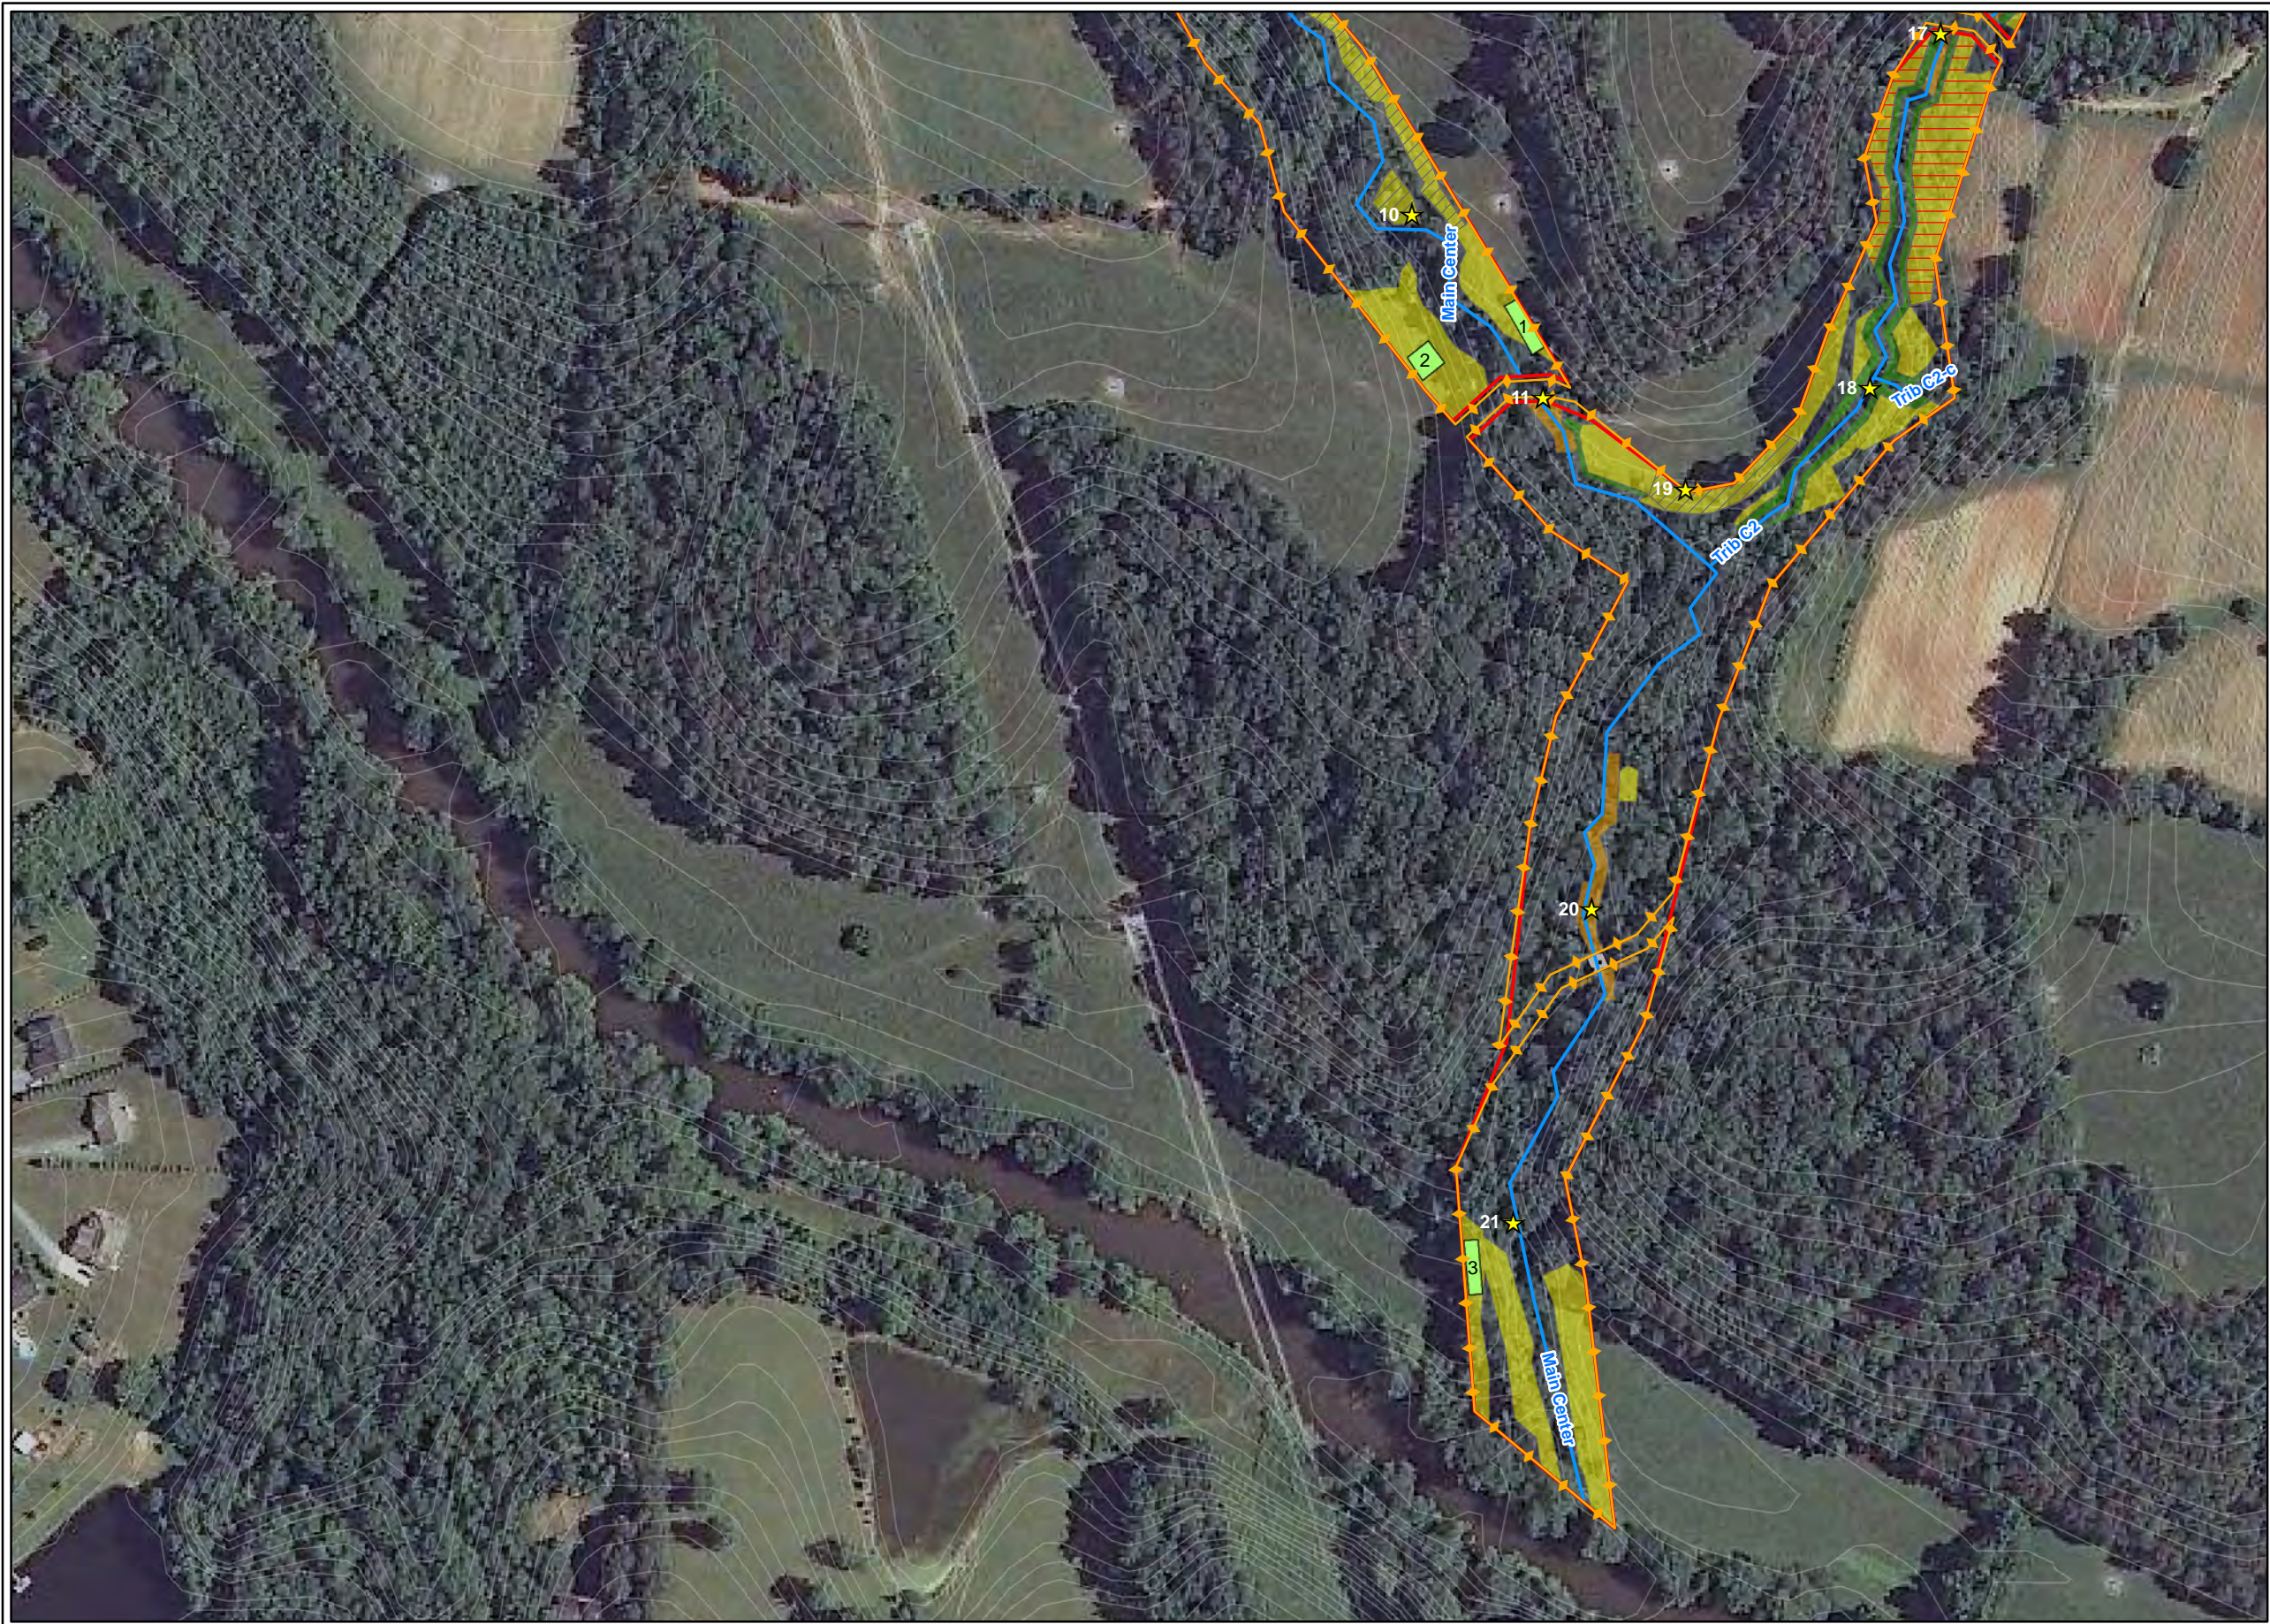
2-3

Numerous small stems of Chinese privet (*Ligustrum sinense*) are located inside the easement boundary along Trib C2 north of Trib C2-c. The locations of these populations are mapped on the Current Condition Plan View (CCPV) map (Figure 2). Additionally, sporadic stems of multiflora rose (*Rosa multiflora*) are located along Trib C2 south of the pond, however, these stems are isolated and very small in size. Invasive/exotic vegetation is not currently compromising the vegetative success of the site.

Invasive species observed consisted of *Ligustrum sinense* (Chinese privet). This area of the easement was dense with Chinese privet prior to construction and needs to be observed closely during the monitoring period.

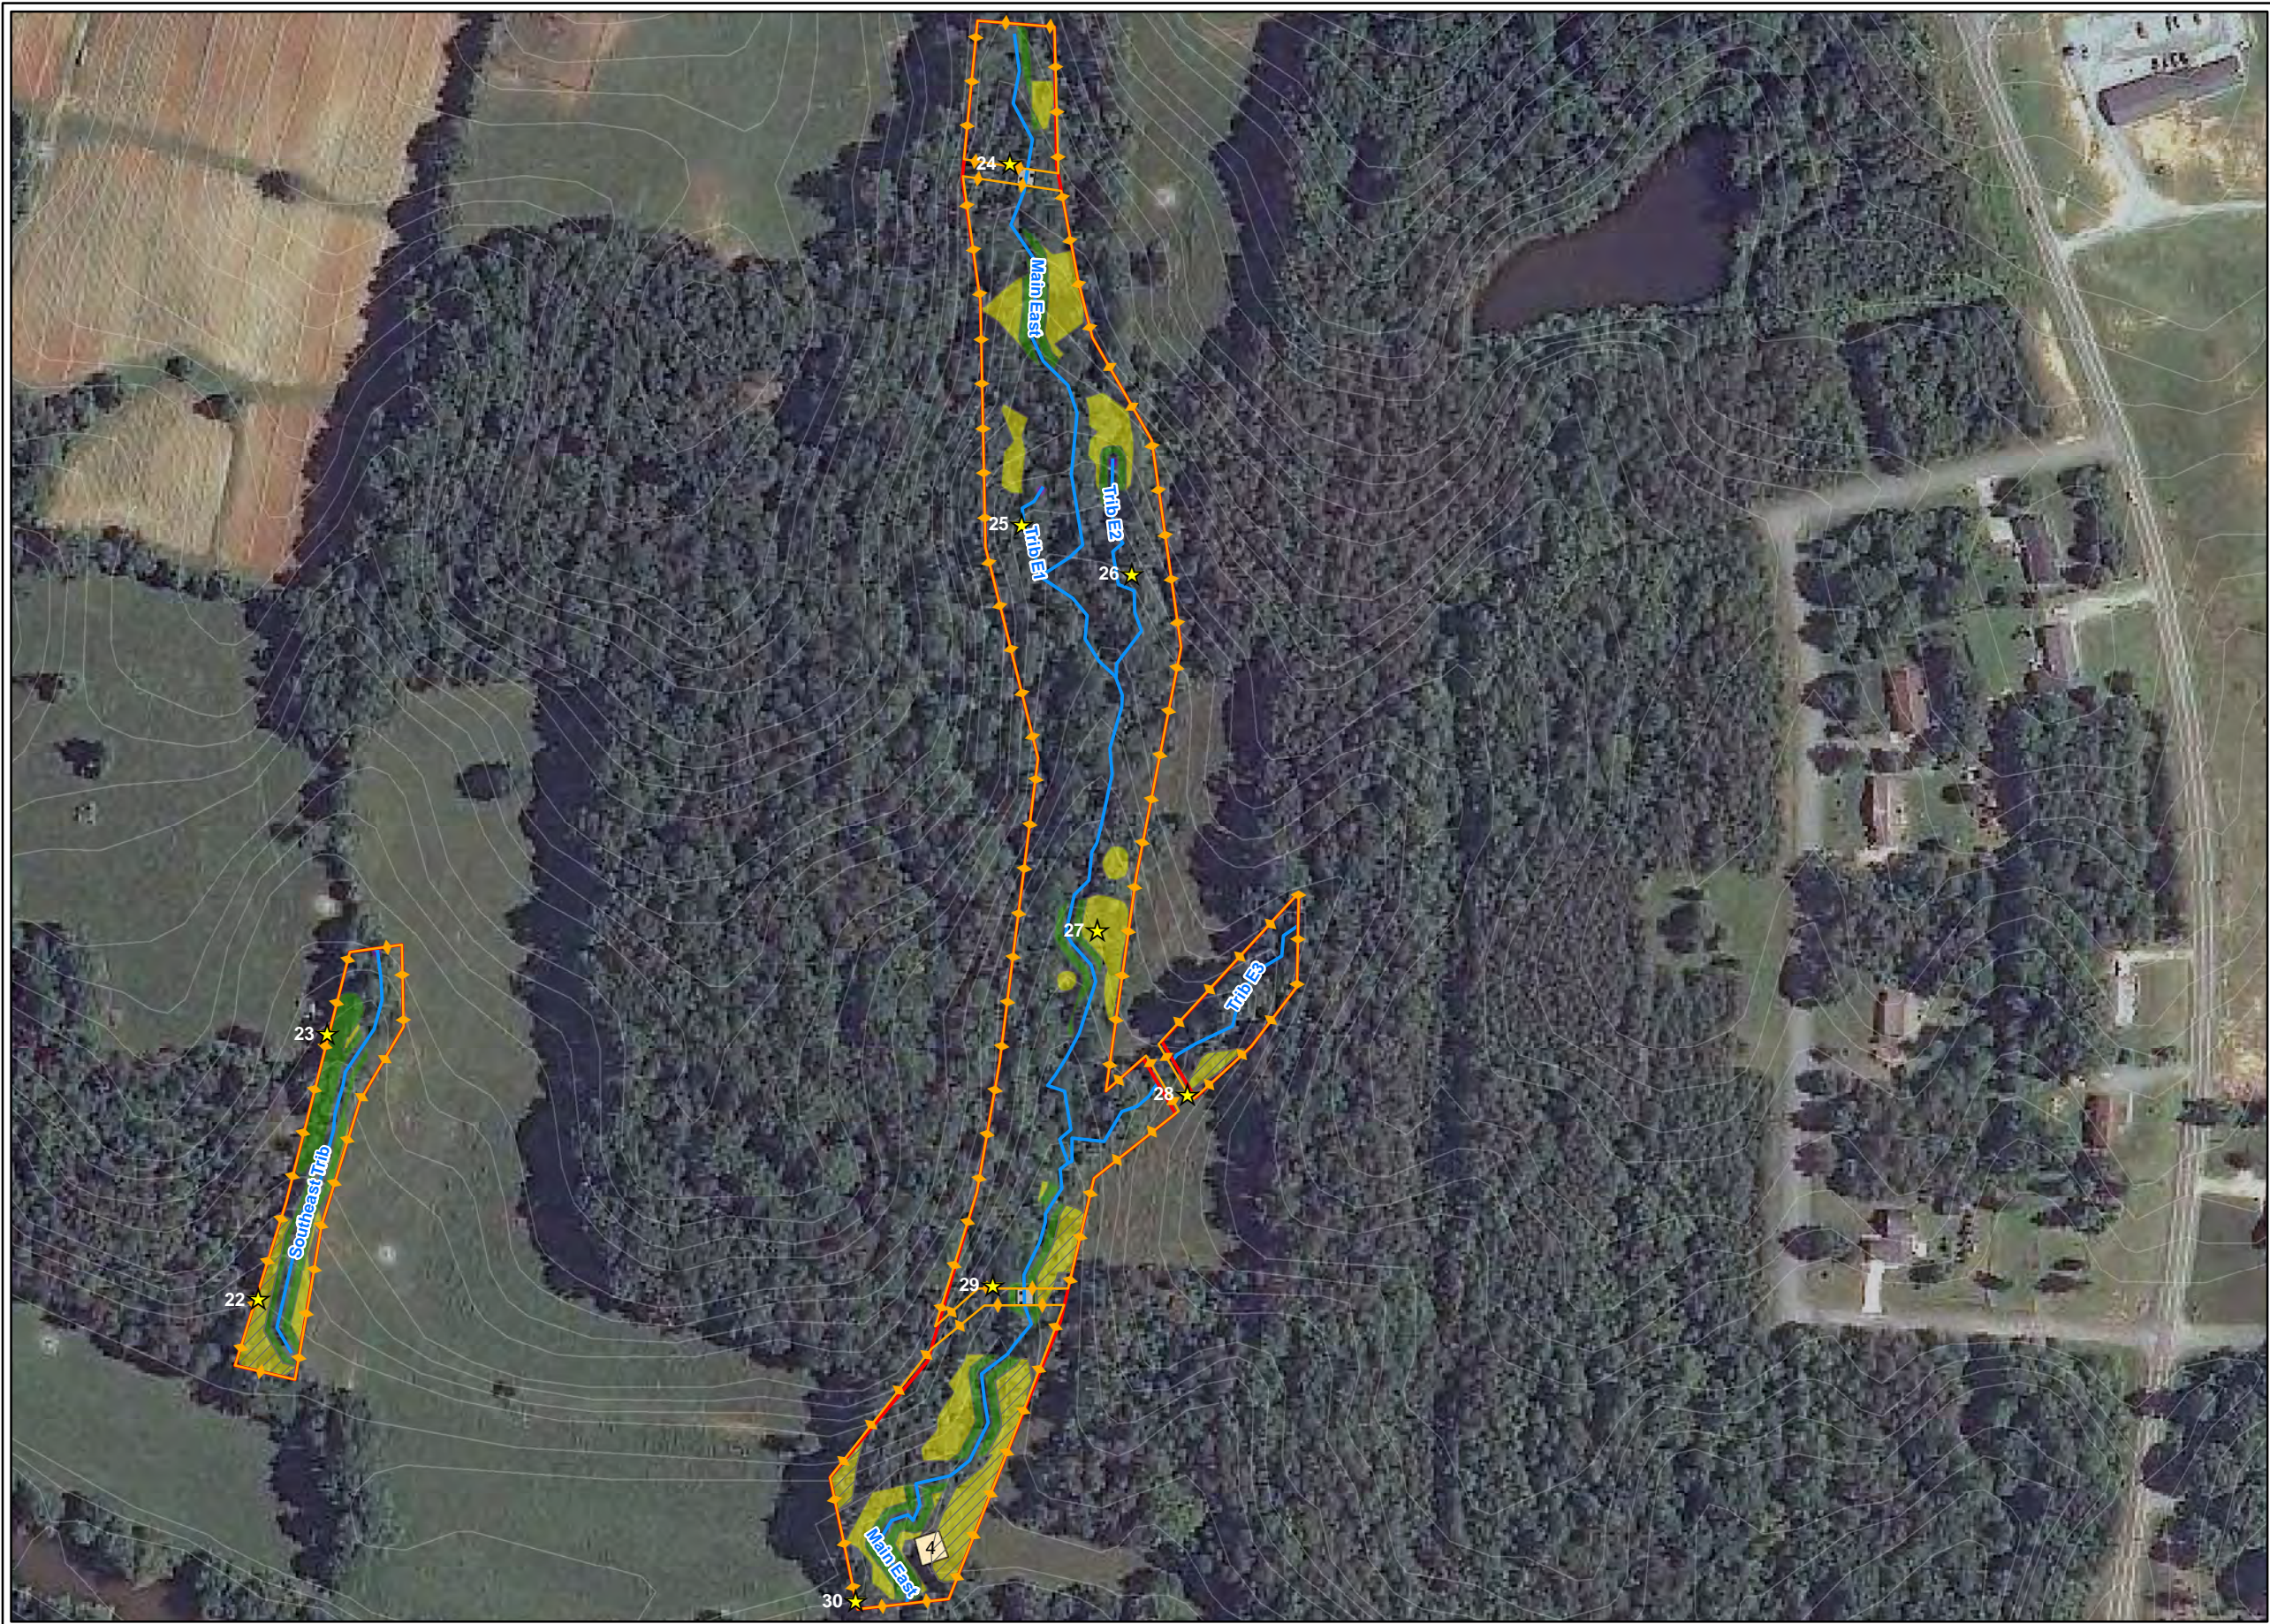
2-4

Three of the four individual vegetation plots met success criteria by greater than ten percent when counting planted stems alone. Plot 4 did not meet success criteria based on planted stems alone, nor when including appropriate naturally recruited stems.

Planting areas are present where woody stem densities are below Year 3, 4, and 5 requirements

Veg Plot 4 placement was chosen as a representative location of planted woody stems observed during Baseline/MY1 data collection. Planting Zone 3 boundary was enlarged during construction and the boundaries shown are approximations only.
