FINAL
Year 5 Annual Monitoring Document

UT to Haw River (#747)

Alamance County

Data Collection Period: September 2016
Submission Date: January 2017

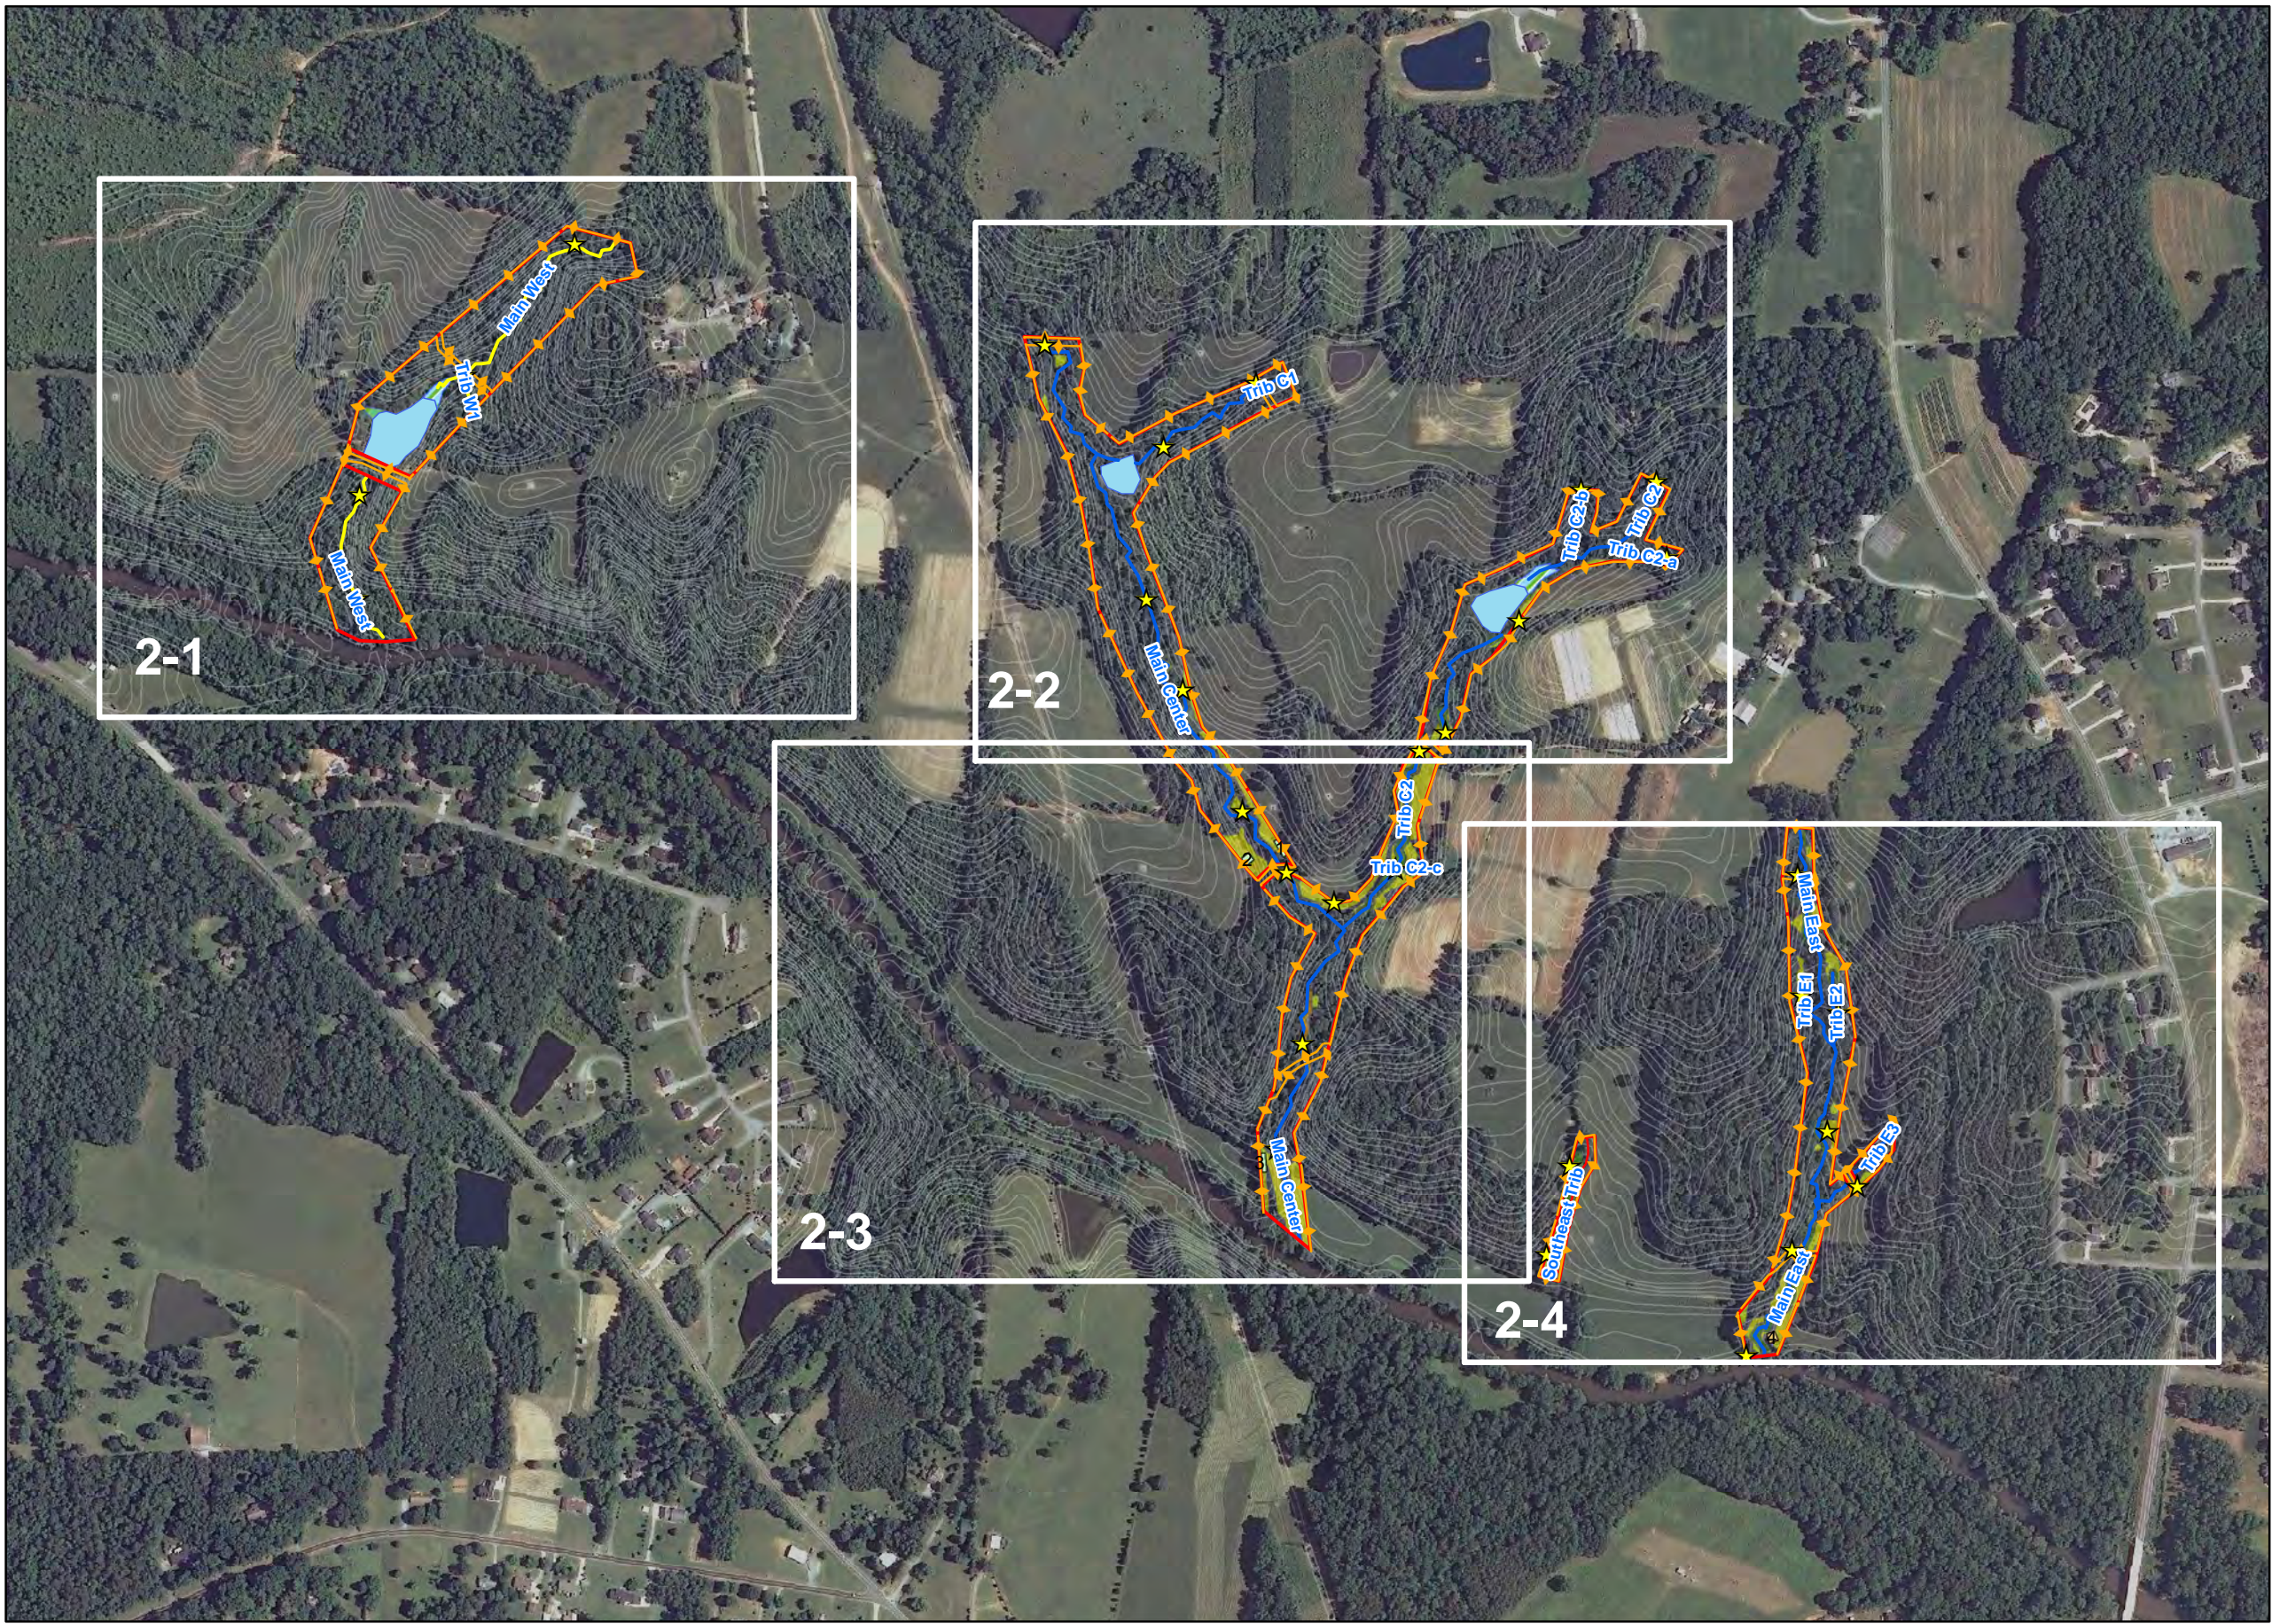
CURRENT CONDITION PLAN VIEW
 UT TO HAW RIVER STREAM ENHANCEMENT PROJECT
 EEP PROJECT #747
 ALAMANCE COUNTY, NC

Six at-grade stream crossings and one rock structure to stabilize an existing crossing were installed on project reaches at the Site during construction. The conditions of these features were observed during the site visit in September 2016. All of these features are stable and functioning properly as depicted on the CCPV.

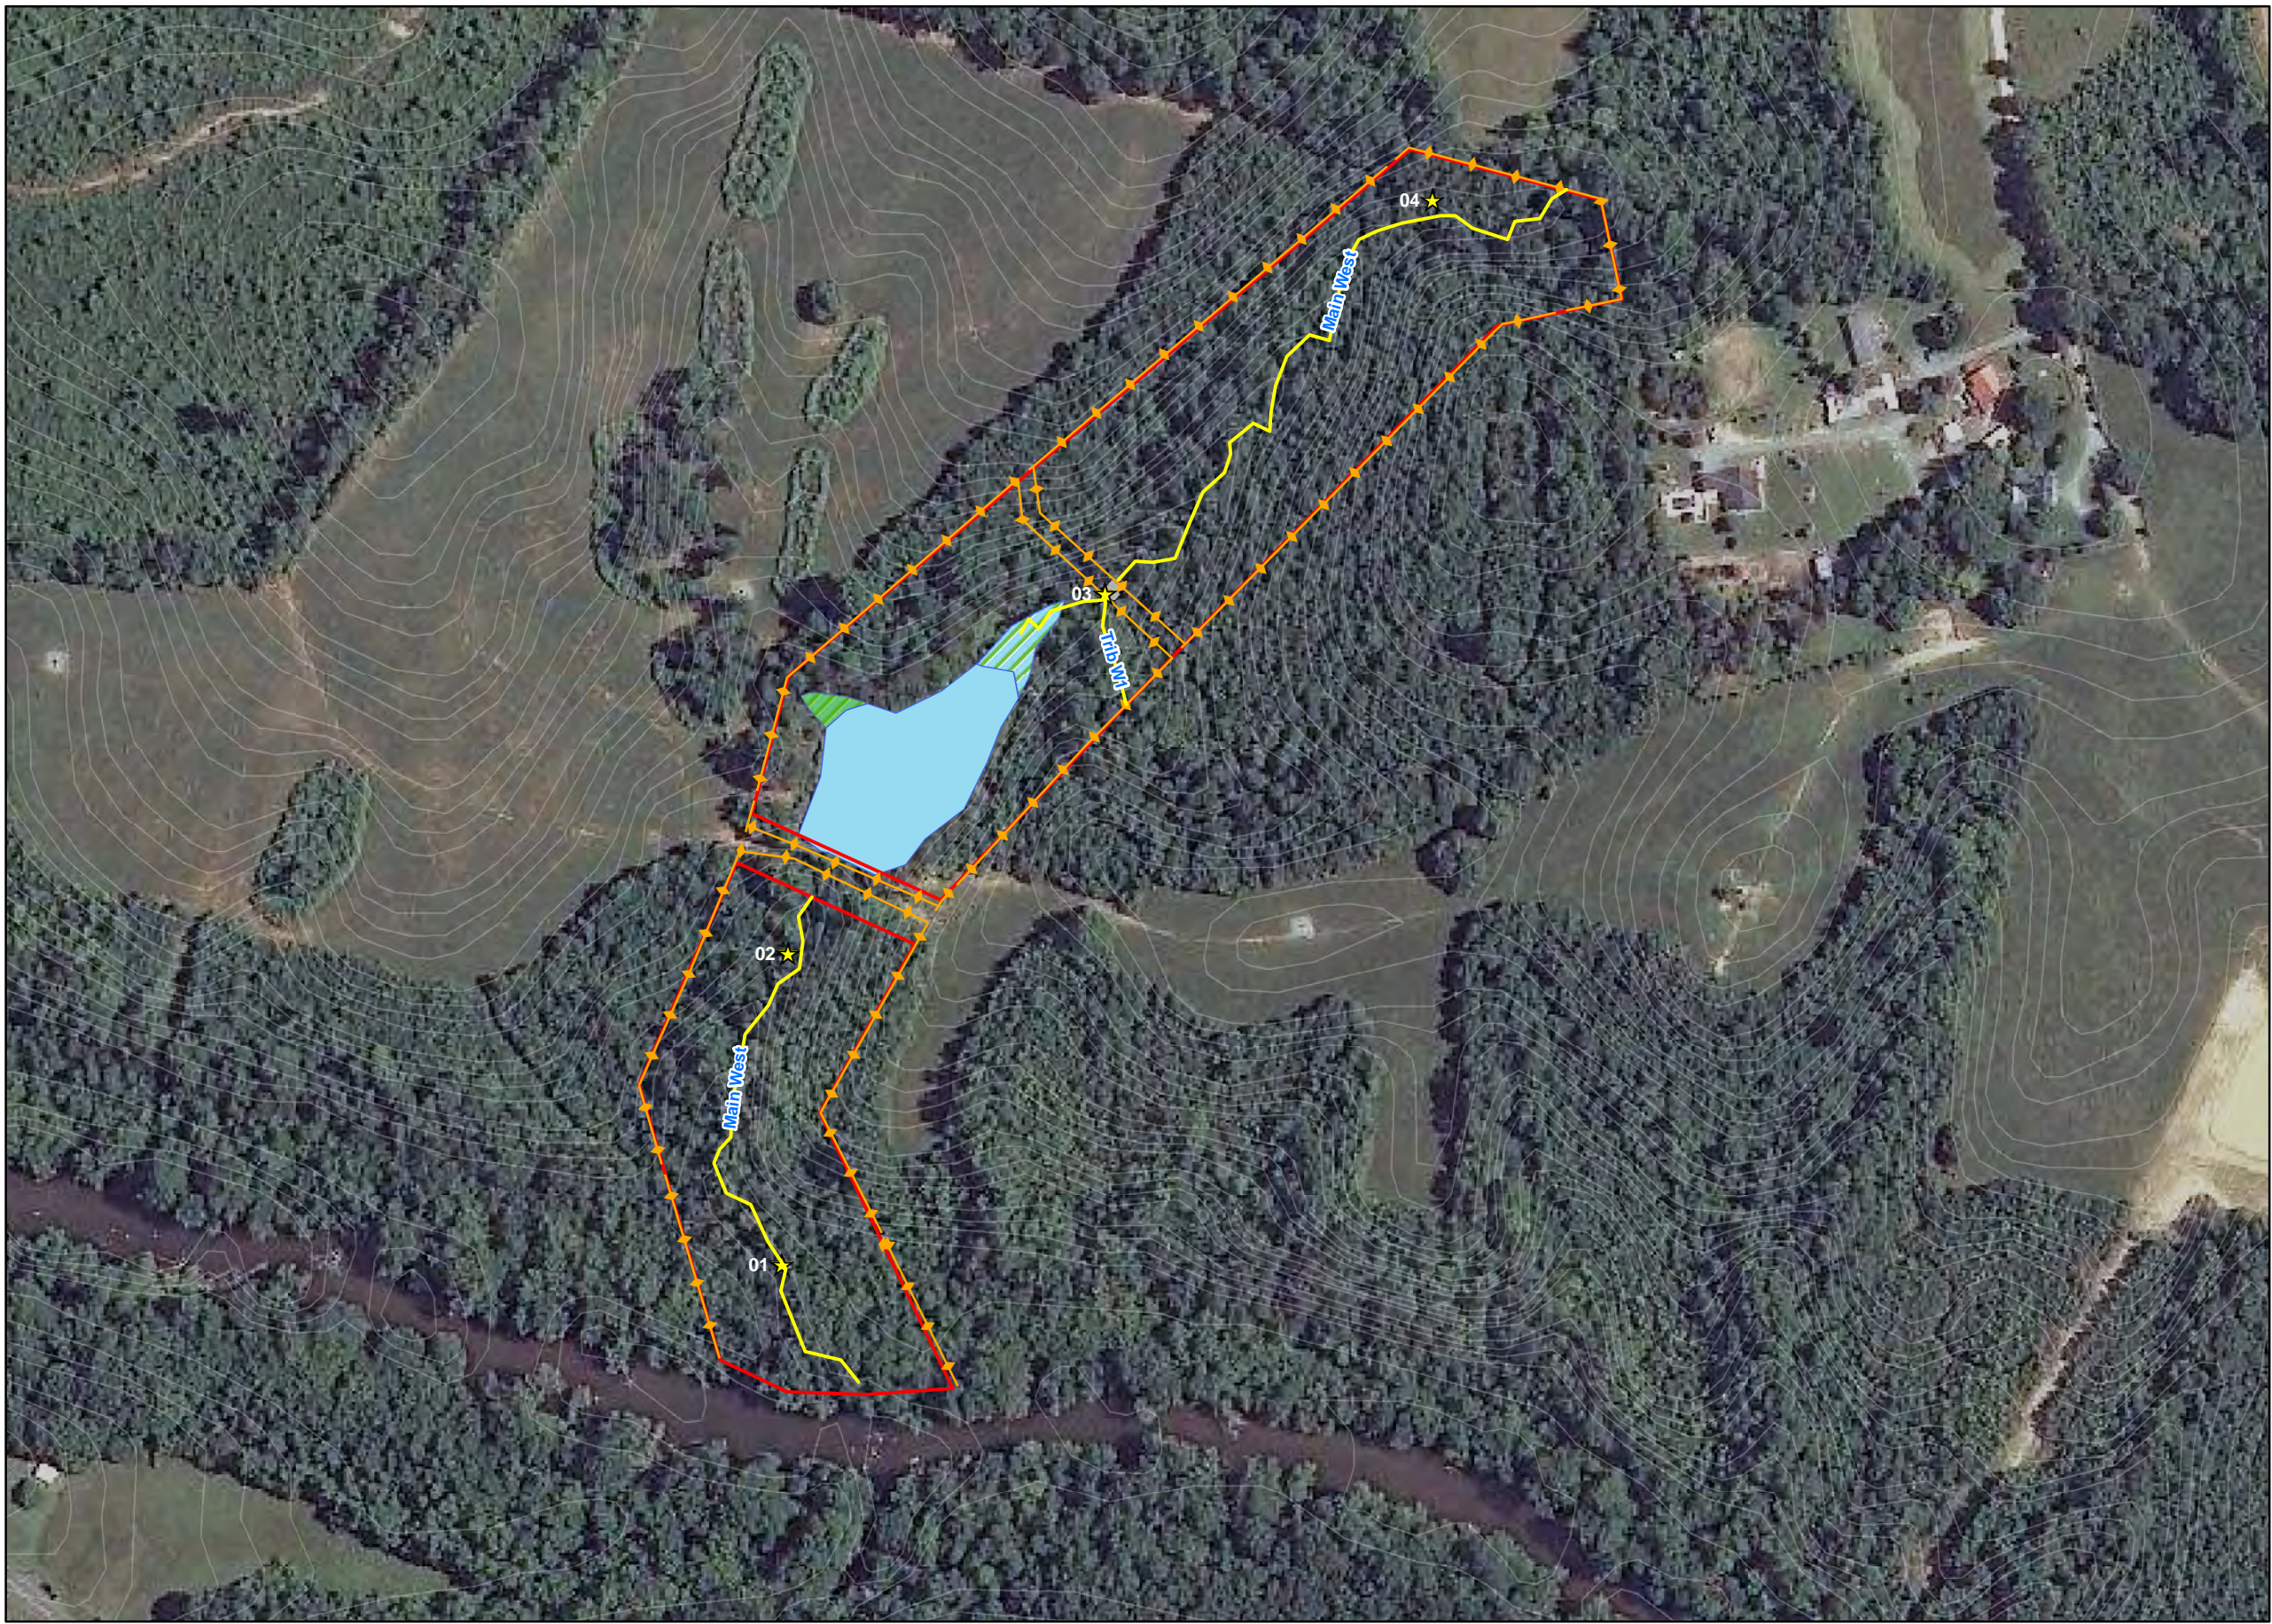
CURRENT CONDITION PLAN VIEW
 UT TO HAW RIVER STREAM ENHANCEMENT PROJECT
 EEP PROJECT #747
 ALAMANCE COUNTY, NC

Veg Plot 4 placement was chosen as a representative location of planted woody stems observed during Baseline/MY1 data collection. Planting Zone 3 boundary was enlarged during construction and the boundaries shown are approximations only.
