UT to Lilliput Creek (Hog Branch Ponds) Stream and Wetland Restoration Project

SCO No. 07-07155-01
DENR Contract No. D08049S
EEP Project No. 290
Brunswick County North Carolina

Year 2 of 5 Monitoring Report
Data Collection: January through December 2011
Submission Date: February 29, 2012

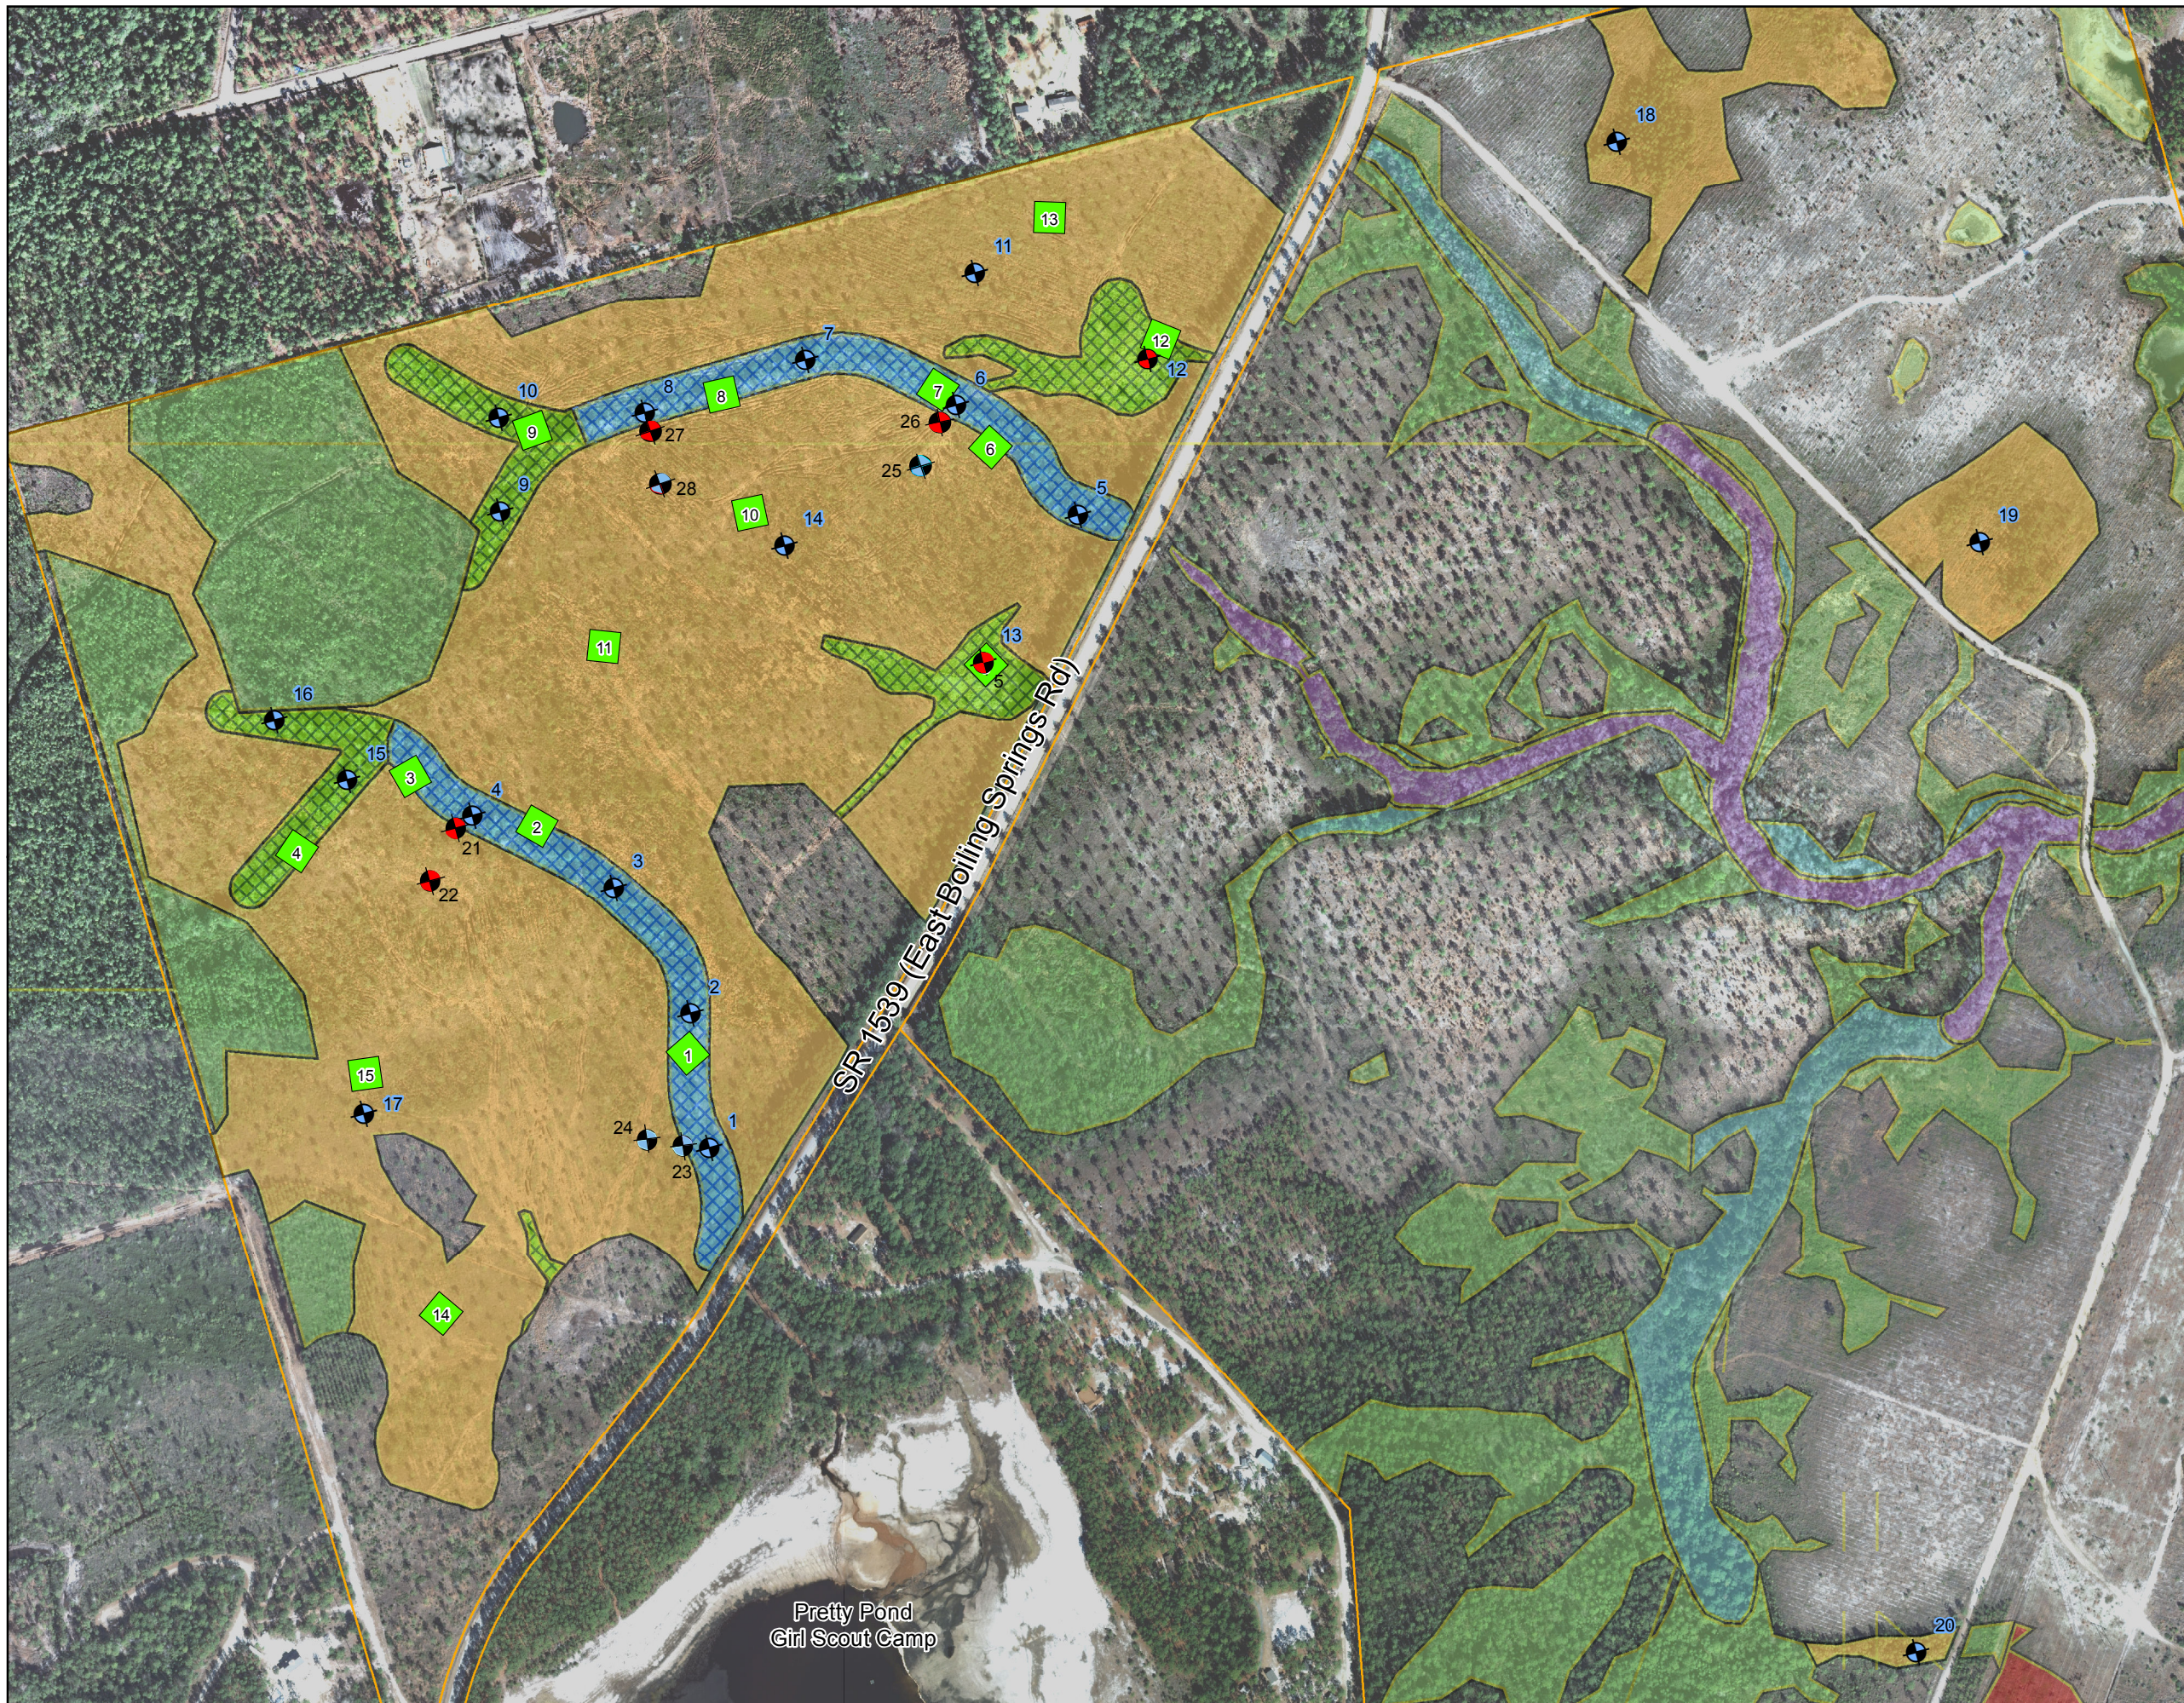
FIGURE 2

Twenty-two of the 28 groundwater monitoring gauges located within the restoration site exhibited groundwater within 12 inches of the soil surface for a duration in excess of the 12% hydrologic success criterion. Six gauges (12, 13, 21, 22, 26, and 27) did not meet the success criterion and exhibited groundwater within 12 inches of the soil surface for between 7% and 9% of the growing season. The hydrographs of these six gauges show groundwater levels were within 12 inches of the soil surface for much of the 2011 growing season. However, water levels were spiky and occasionally fell below 12 inches so that the criterion of 33 consecutive days was not achieved. Three of the six gauges that did not meet the success criterion were positioned on the shoulder of the stream valley (#21, #26, and #27). Groundwater is continuously being discharged to the low part of the valley, resulting in fluctuating water levels. Please see Figure 2 for gauge locations.

Four transects that each contain three gauges were installed perpendicular to the two stream channels on site (Figure 2). Pre-construction and post-construction data from these gauges have been compared to document the hydrologic improvement along and outward from the restored stream channel. For each transect, one gauge is located within a stream restoration area and the other two are located within a wetland enhancement area. The post-construction hydroperiod for all four gauges located within the stream restoration area (#1, #4, #6, & #8) was significantly longer than the gauges' pre-construction hydroperiod. In 2011, these gauges exhibited groundwater within 12 inches of the soil surface for between 108 and 126 consecutive days while the 2005 pre-construction hydroperiod ranged from 1 day to 35 consecutive days. Of the eight gauges located within the wetland enhancement area, six demonstrated a longer post-construction hydroperiod (ranged between 19 and 116 consecutive days) than the pre-construction hydroperiod (ranged between 10 and 58 consecutive days). Only gauges #26 and #28 exhibited groundwater within 12 inches of the soil surface for fewer consecutive days post-construction compared to pre-construction (#26: 25 days in 2011 vs. 58 days in 2005; #28: 40 days in 2011 vs. 43 days in 2005). It is important to note that 2005 was an exceptionally wet year and experienced above-normal rainfall (Appendix D). In comparison, 2011 was fairly dry, except for a hurricane that elevated groundwater levels

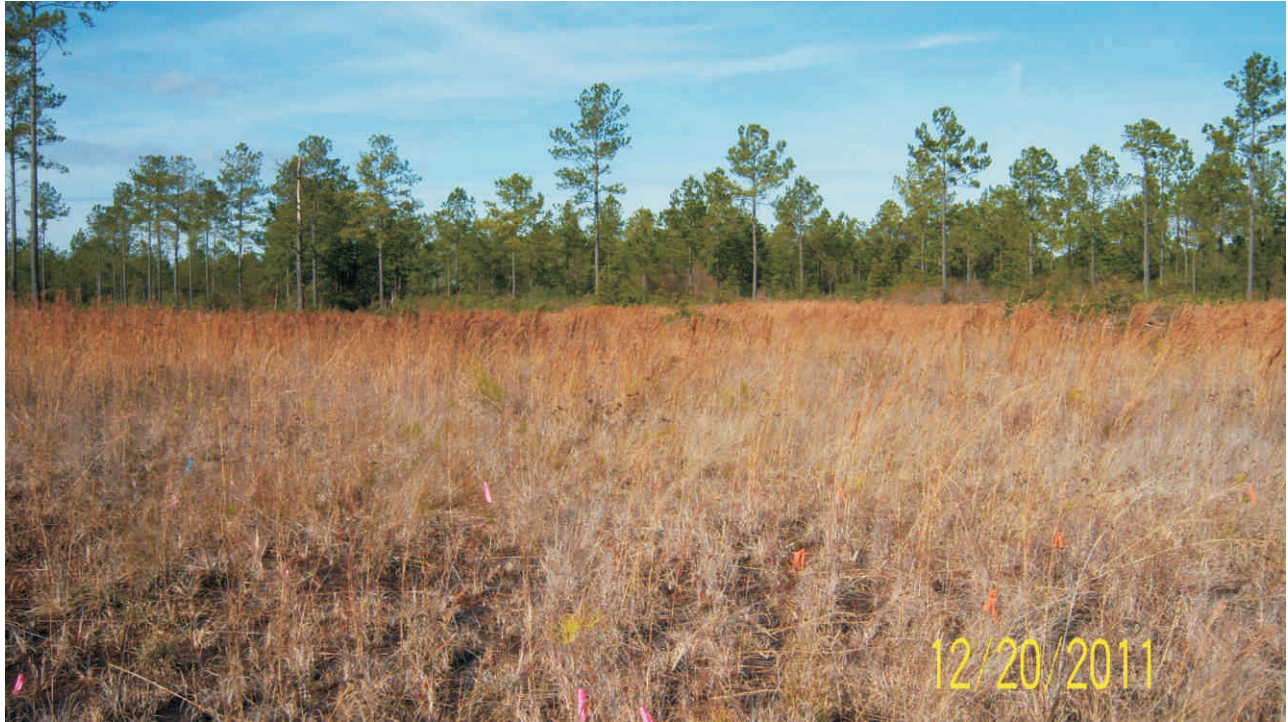
Photo Station 1. Southern Tributary Station 15+00 - SCX4 - Looking Upstream

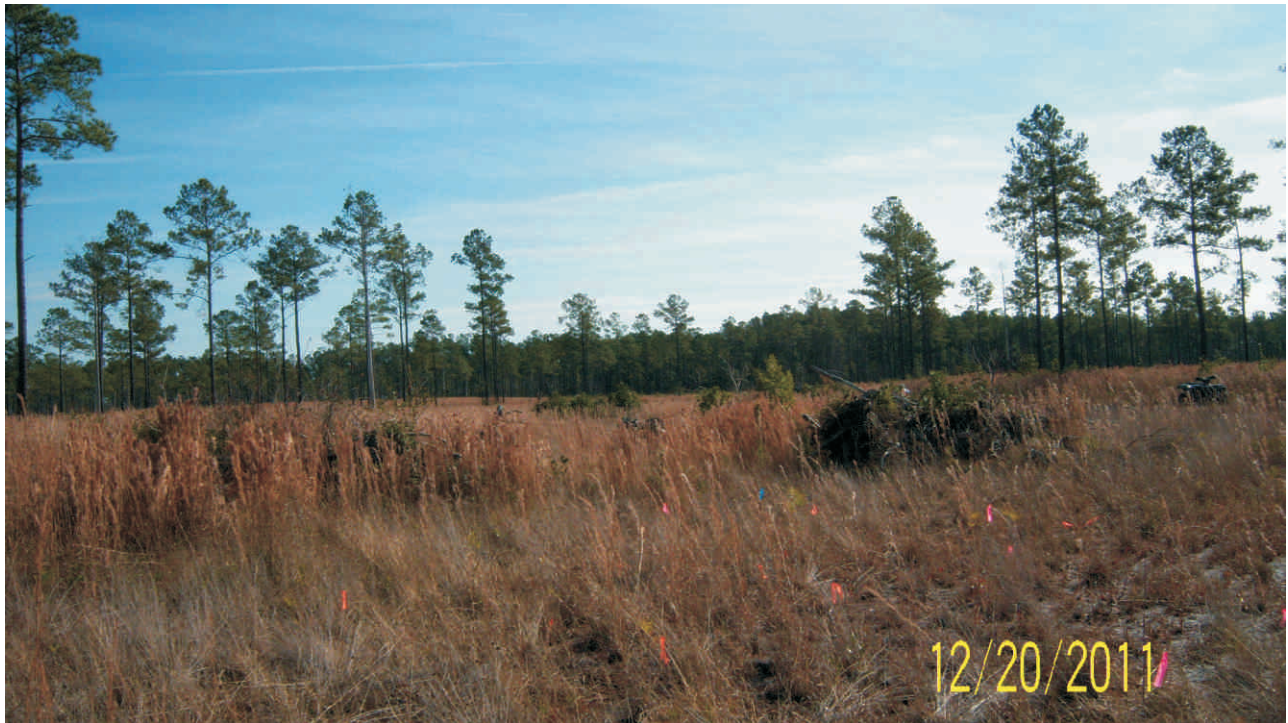
Photo Station 2. Southern Tributary Station 15+00 - SCX4 - Looking downstream

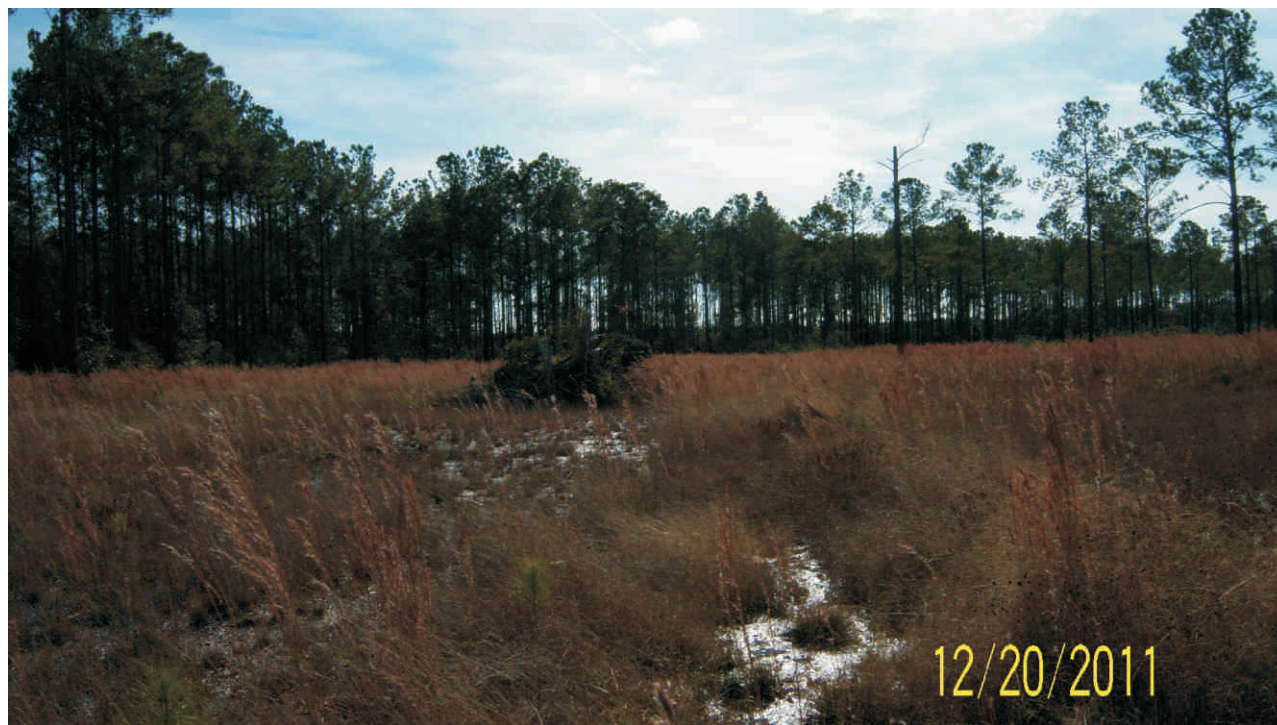
Photo Station 4. Southern Tributary Station 23+00 - SCX2 - Looking downstream

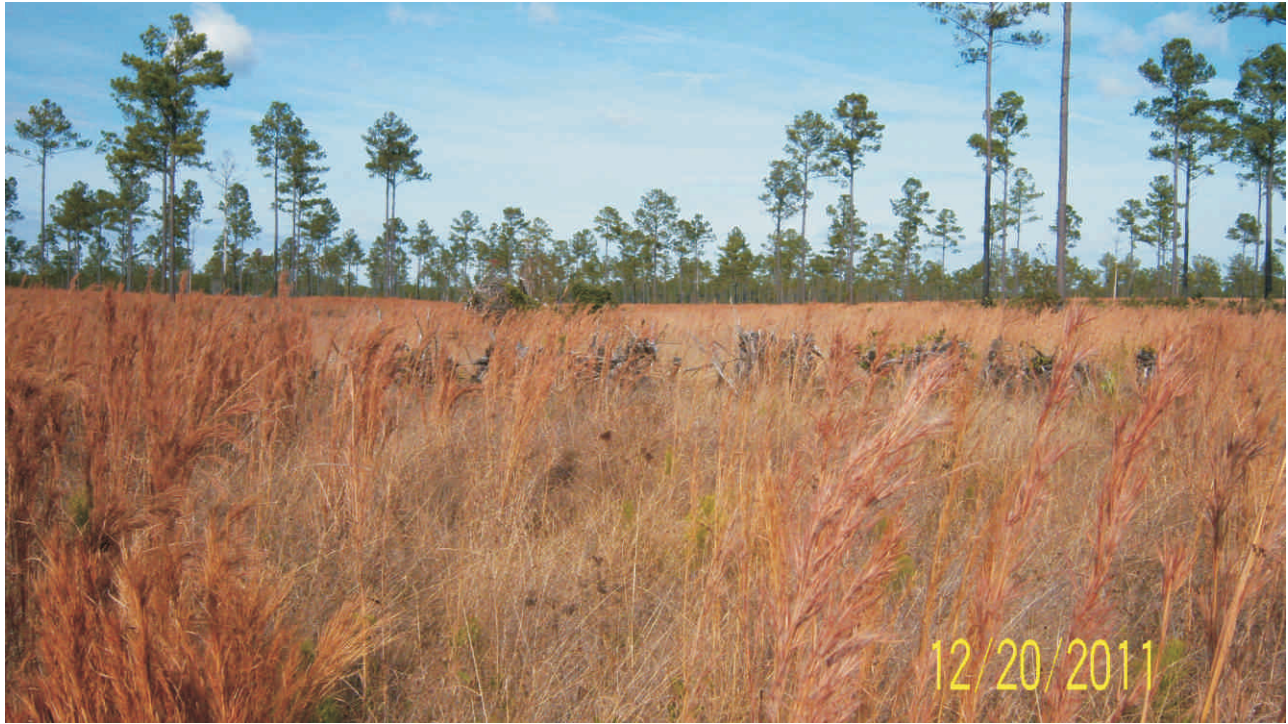
Photo Station 5. Southern Tributary Station 29+00 - SCX1 - Looking upstream

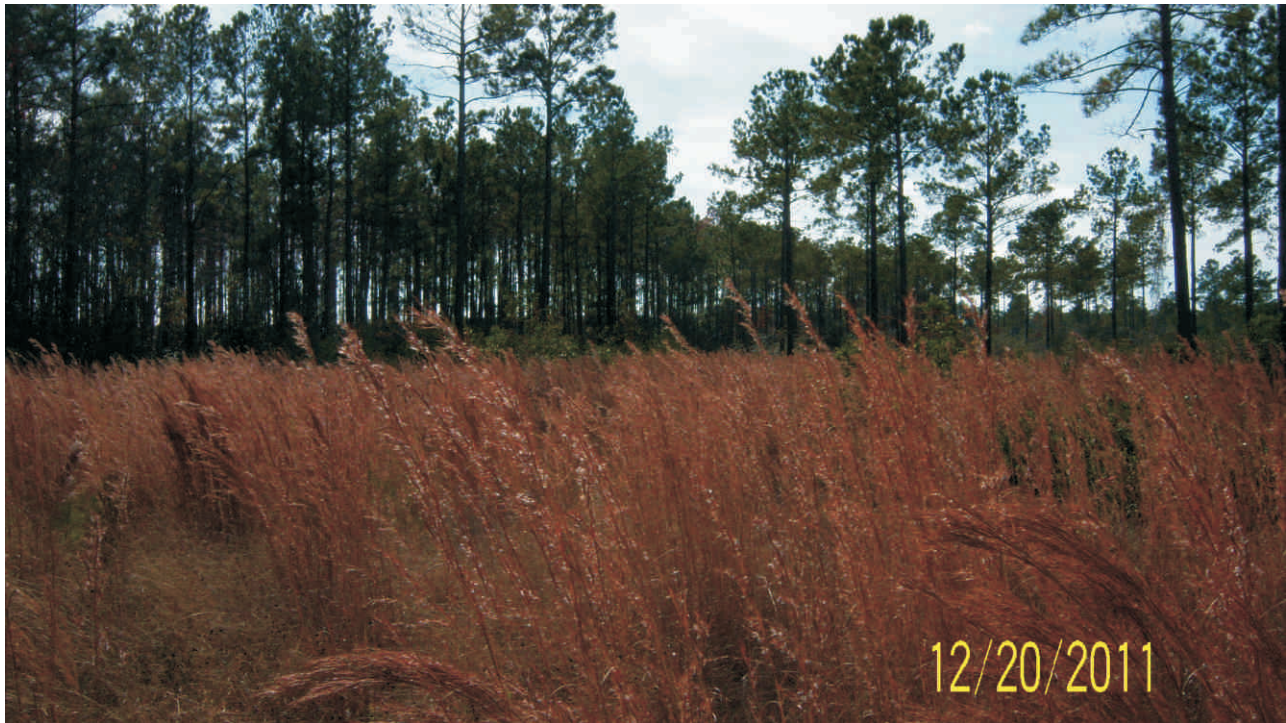
Photo Station 6. Southern Tributary Station 29+00 - SCX1 - Looking downstream

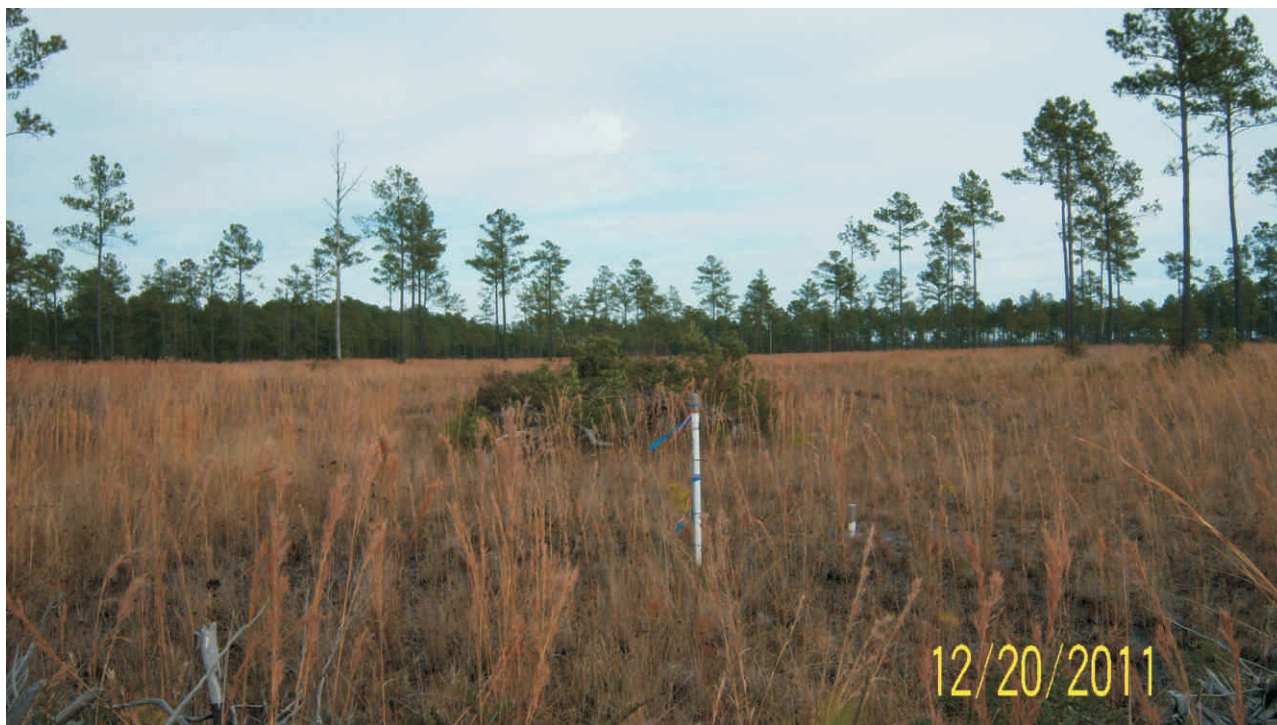
Photo Station 7. Northern Tributary Station 14+00 - NCX4 - Looking downstream

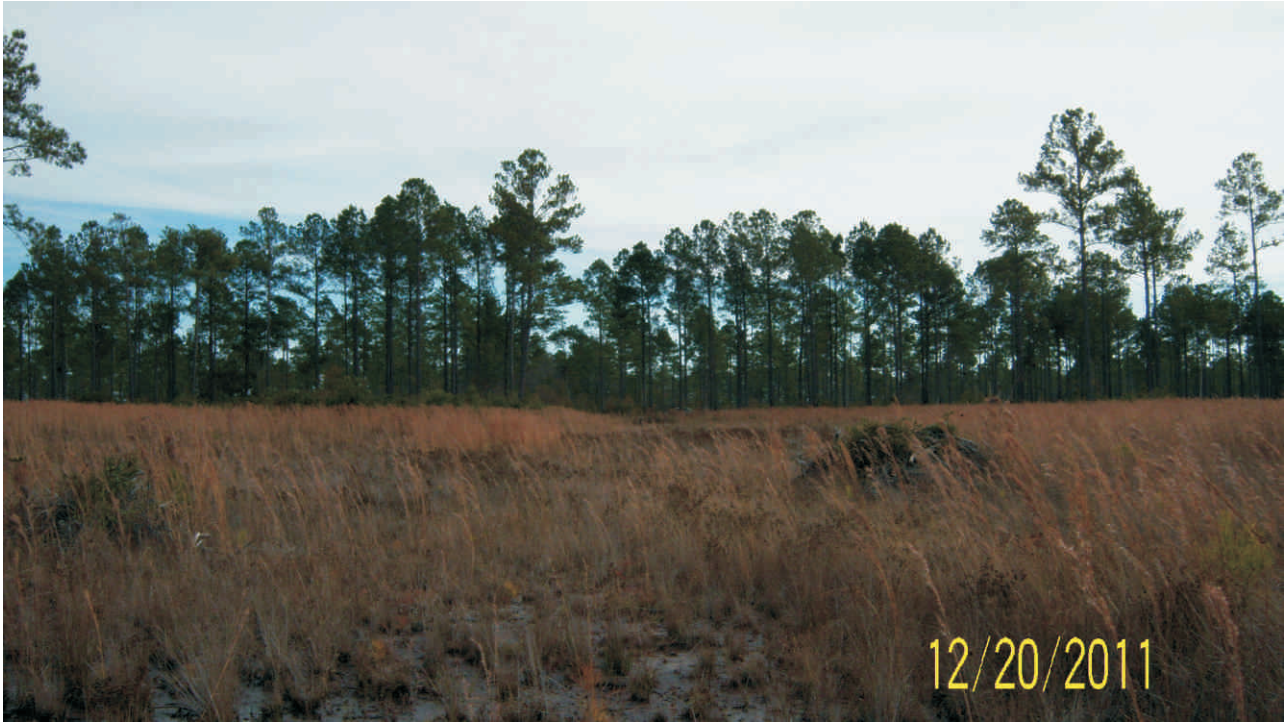
Photo Station 9. Northern Tributary Station 21+00 - NCX2 - Looking downstream

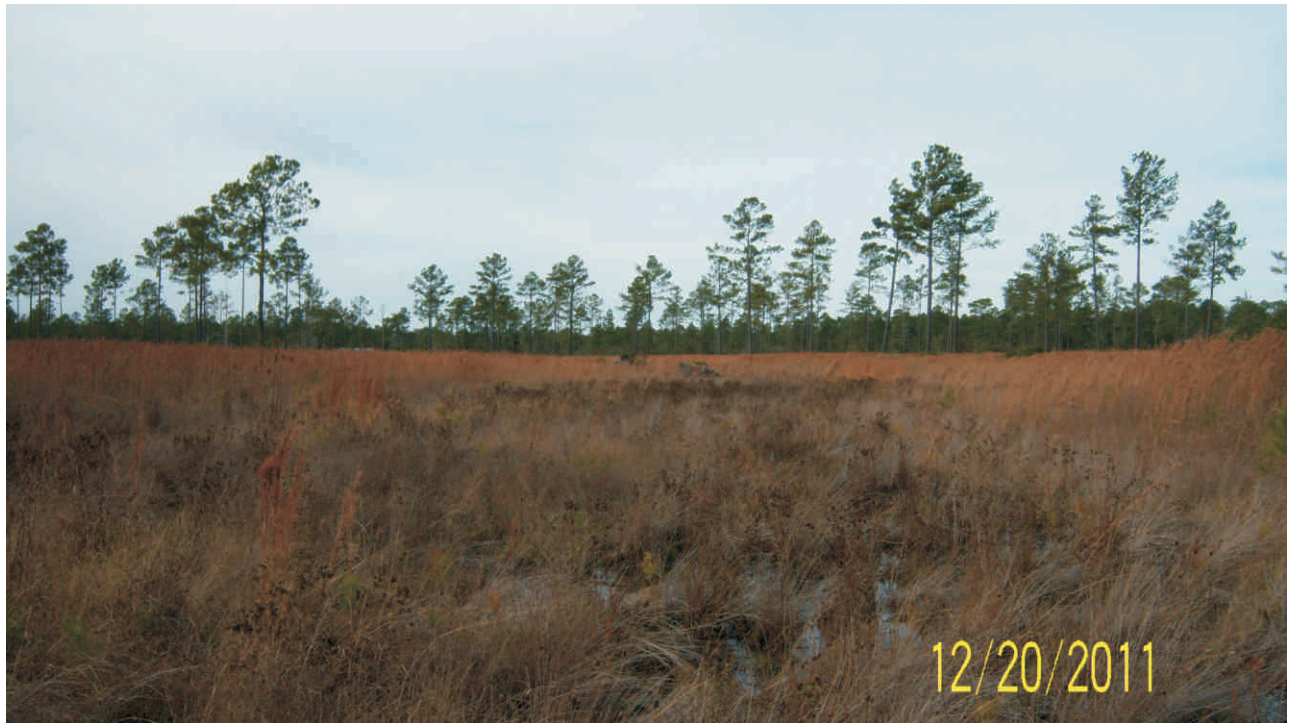
Photo Station 10. Northern Tributary Station 28+25 - NCX1 - Looking upstream

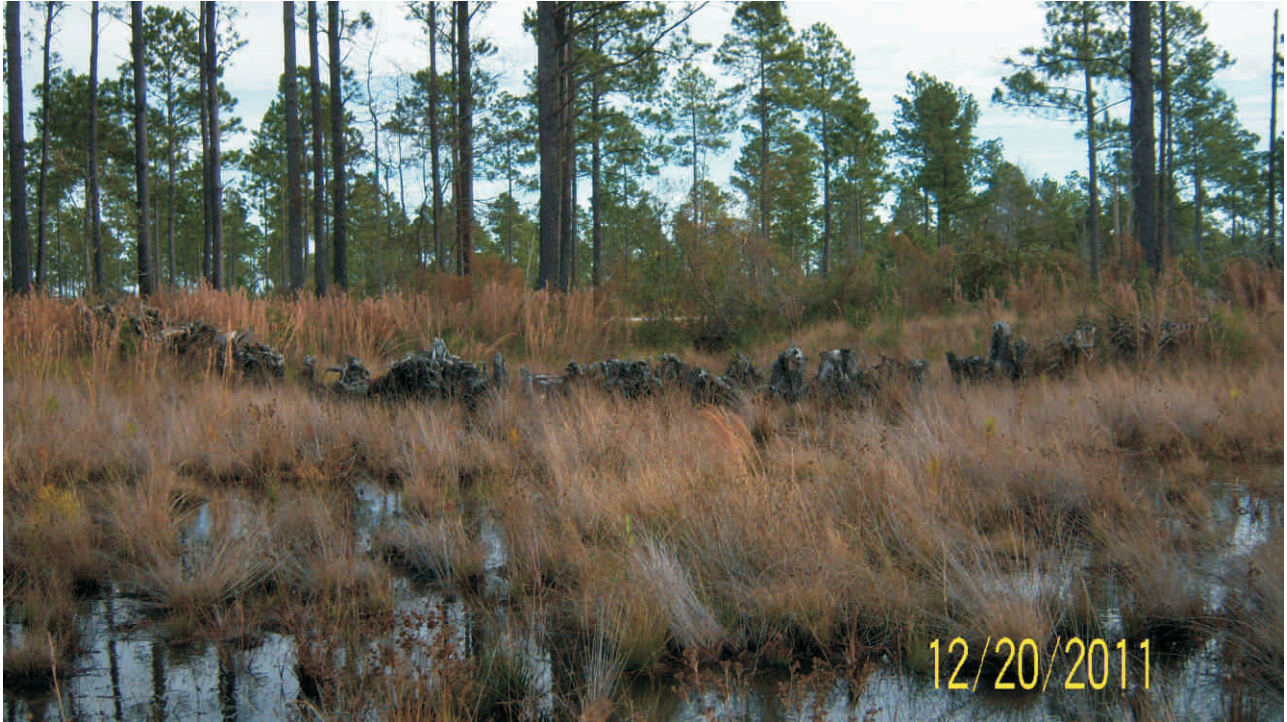
Photo Station 11. Northern Tributary Station 28+25 - NCX1 - Looking downstream

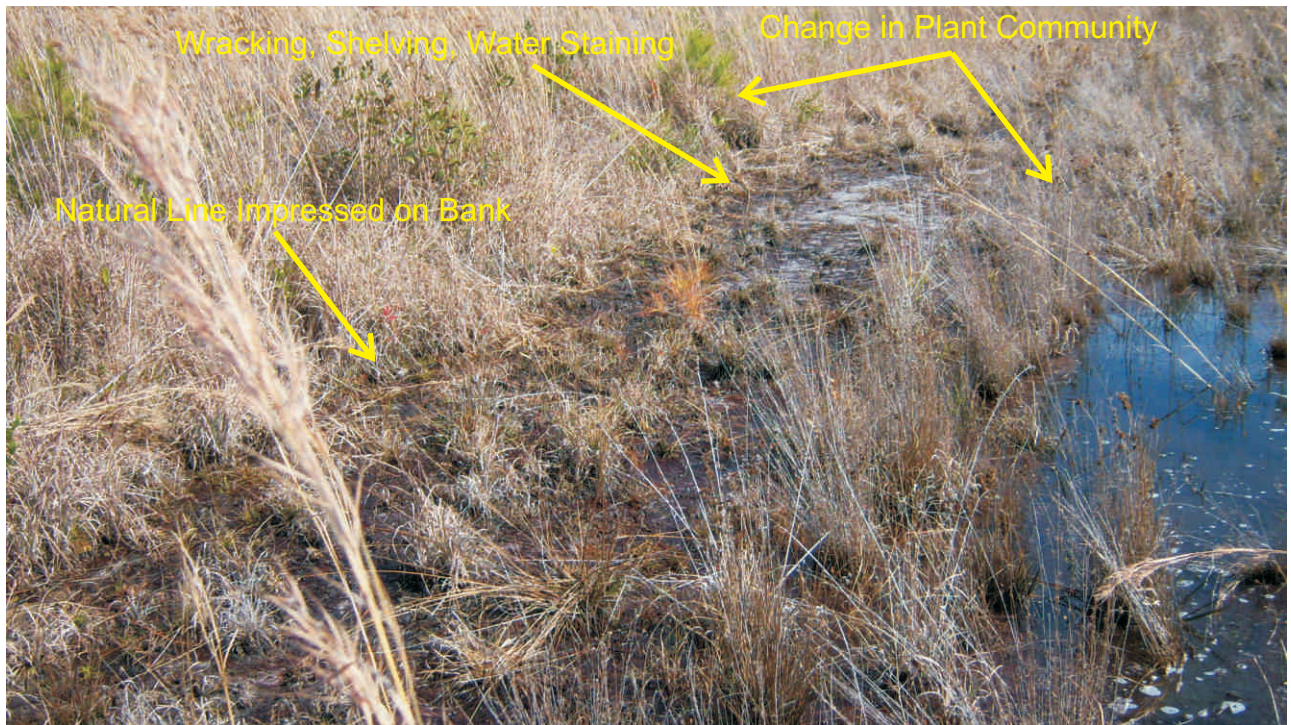
**View of OHWM near Gauge 6 (Northside & facing Southwest) -
North Tributary**

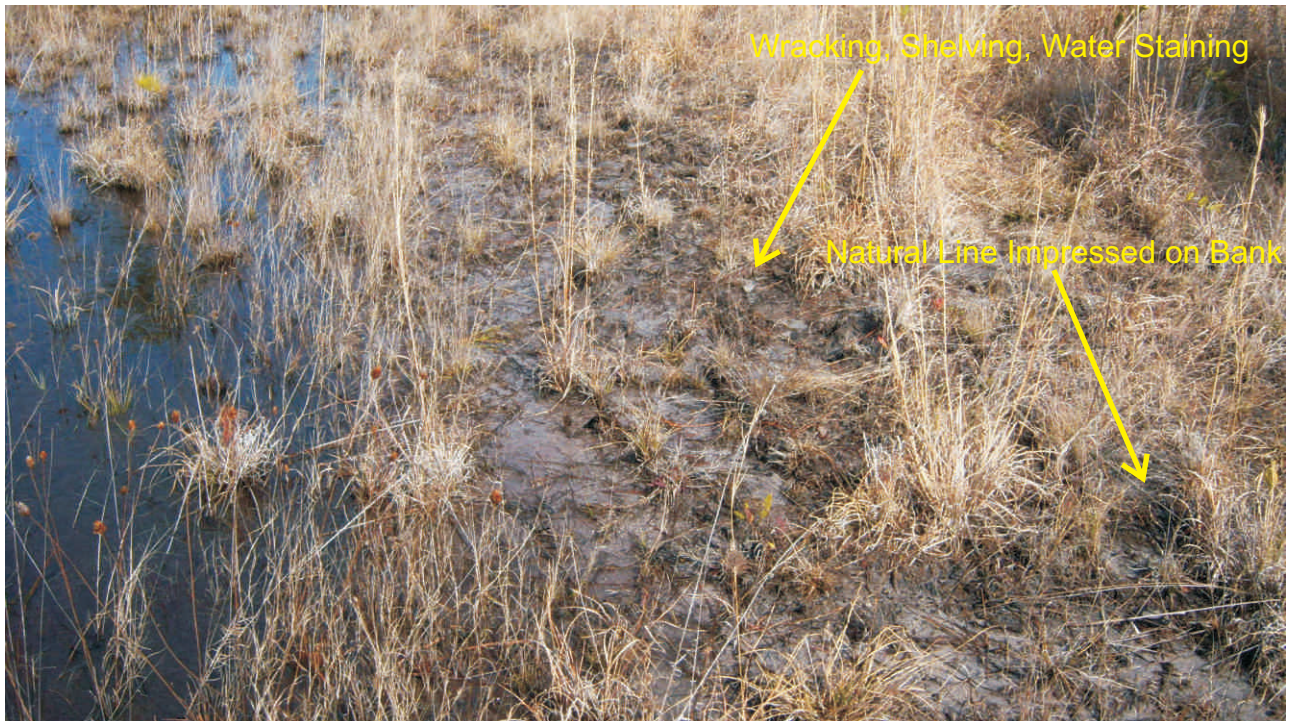
**View of OHWM near Gauge 7S (Southside & facing Southwest) -
North Tributary**

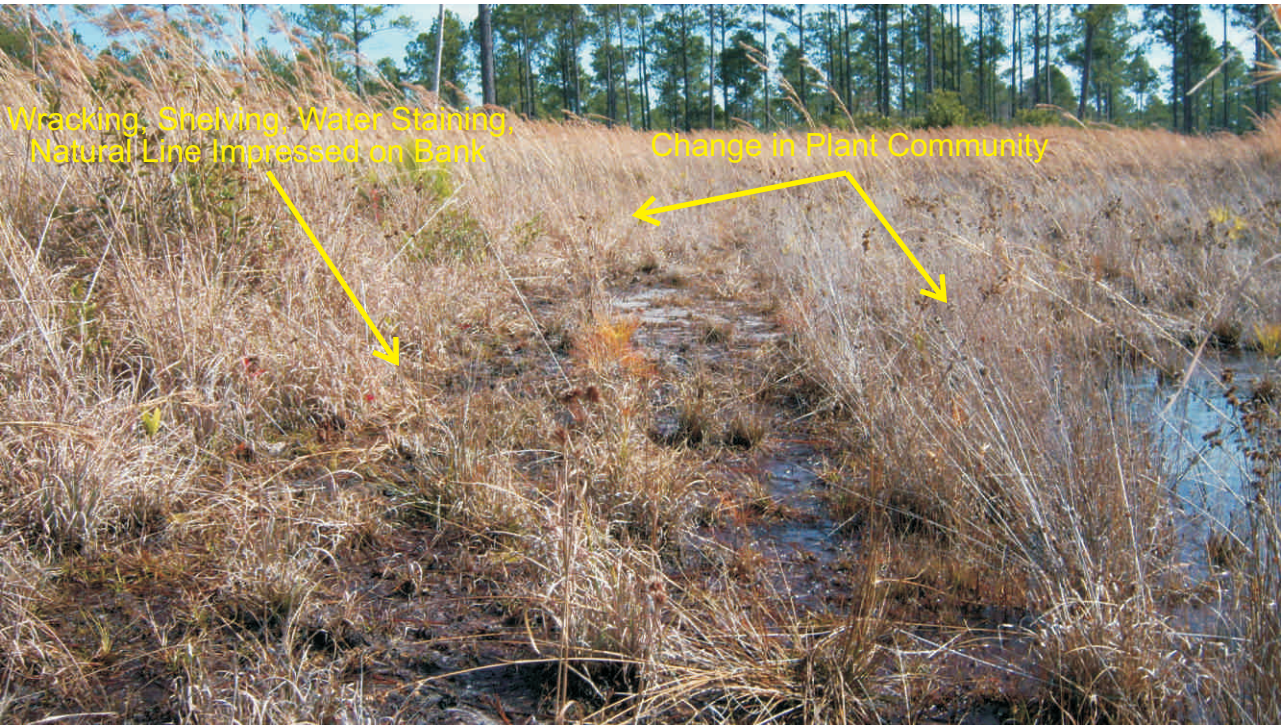
**View of OHWM near Photostation 10 (Northside & facing Southwest) -
North Tributary**

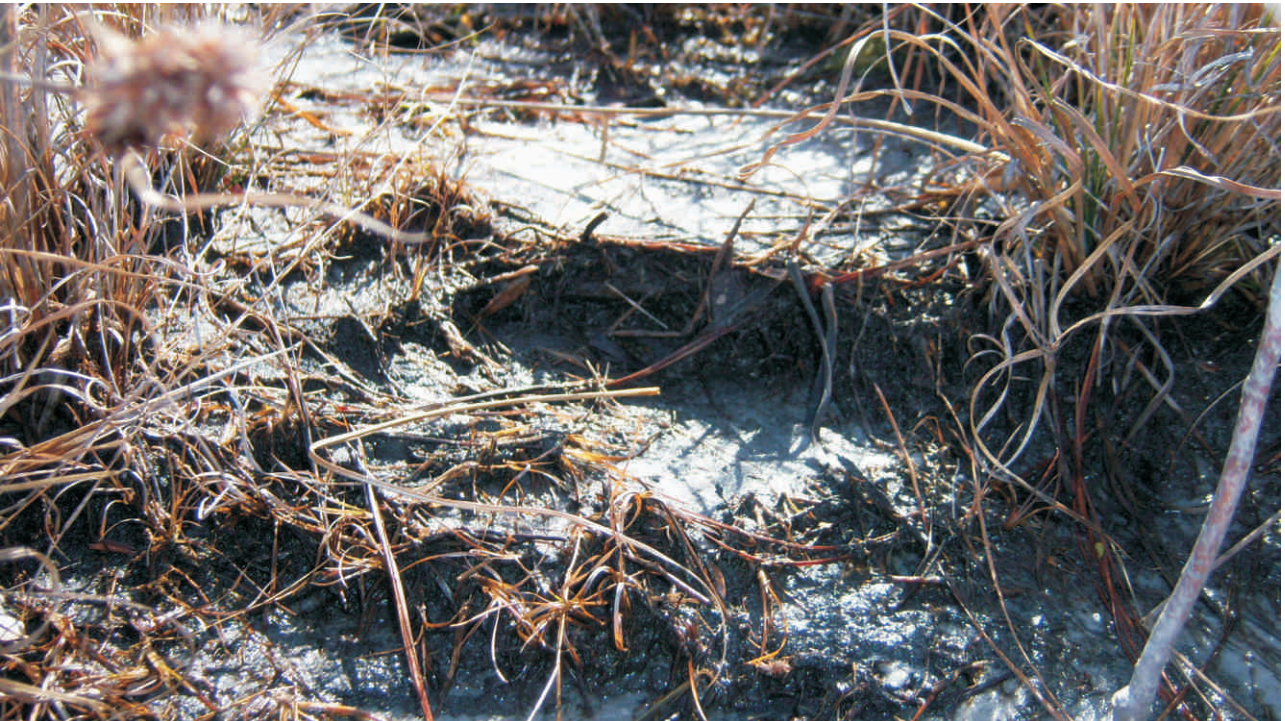
**Close-up View of Wracking & Shelving (Southside of North Tributary) -
North Tributary**

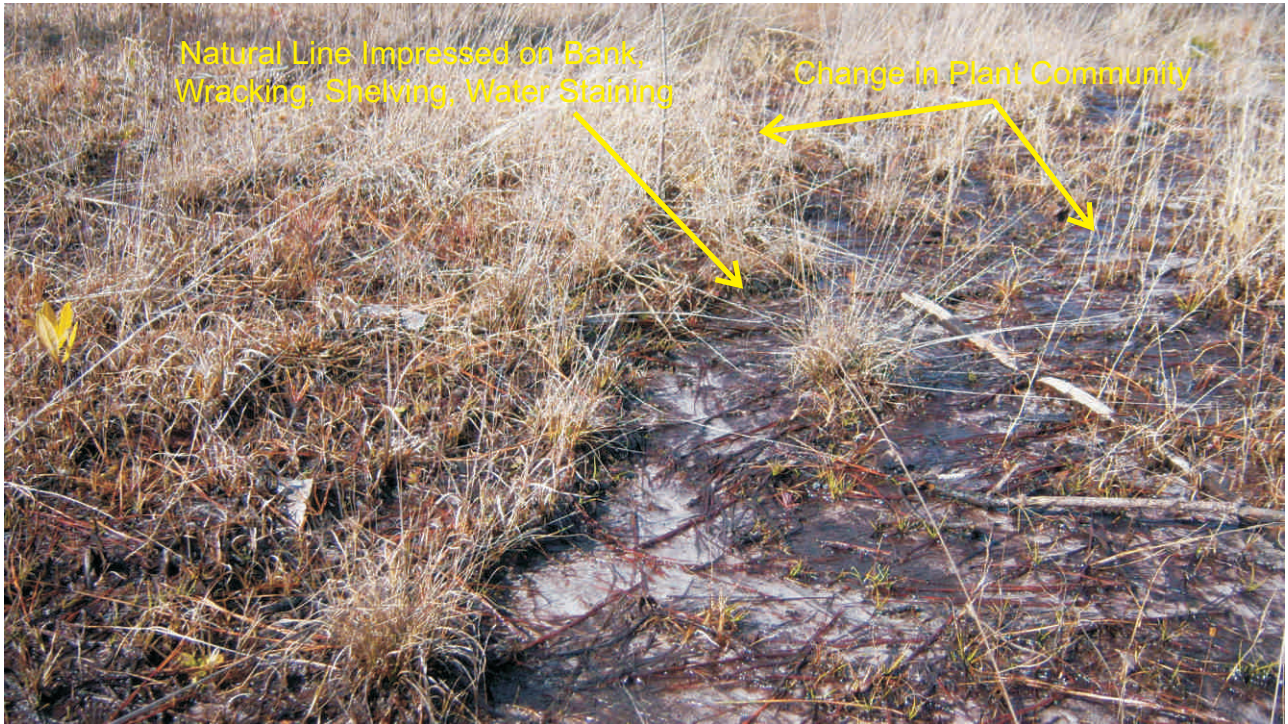
**View of OHWM near Gauge 2 (Westside & facing North) -
South Tributary**

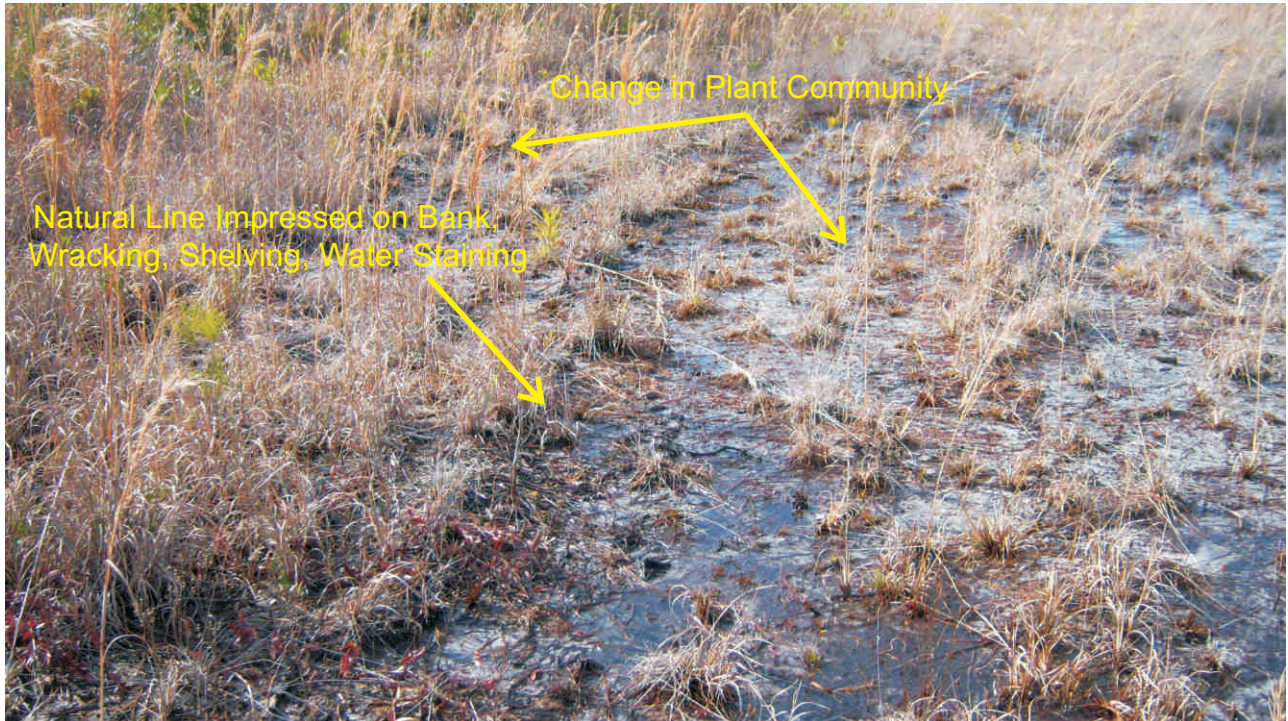
**View of OHWM near Gauge 2S (Eastside & facing South) -
South Tributary**

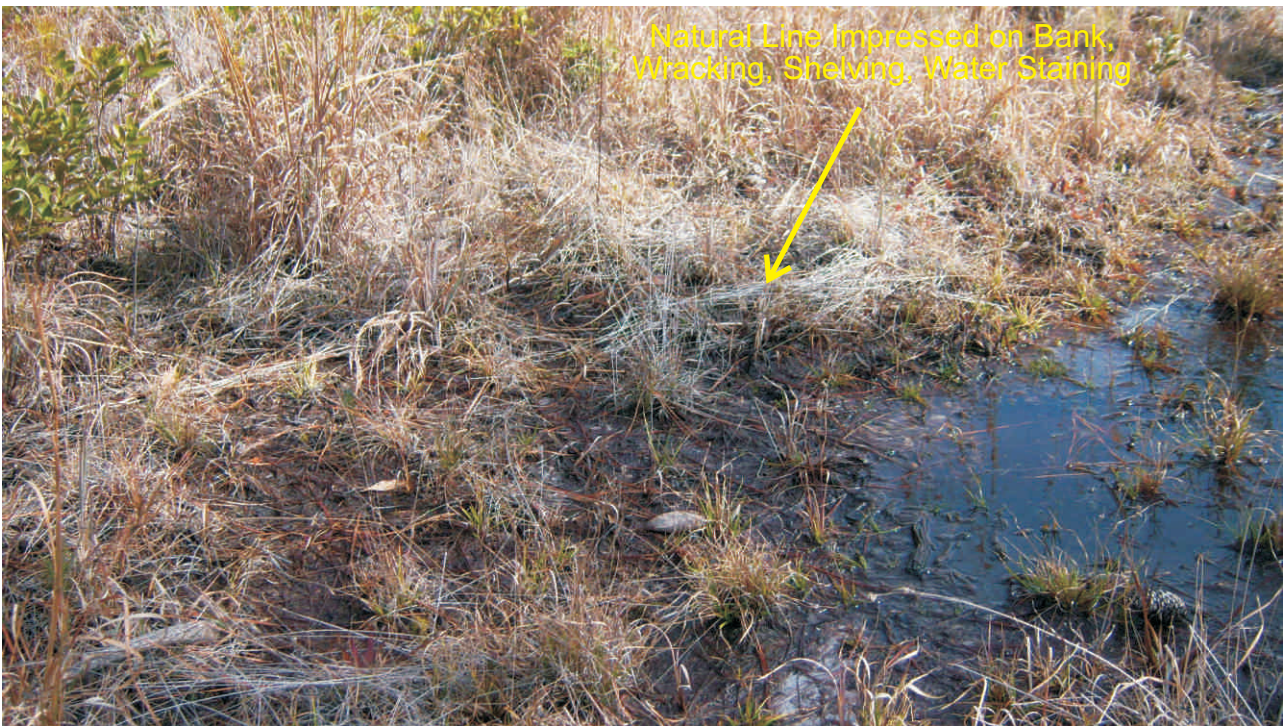
**View of OHWM near Photostation 21 (Northside & facing East) -
South Tributary**

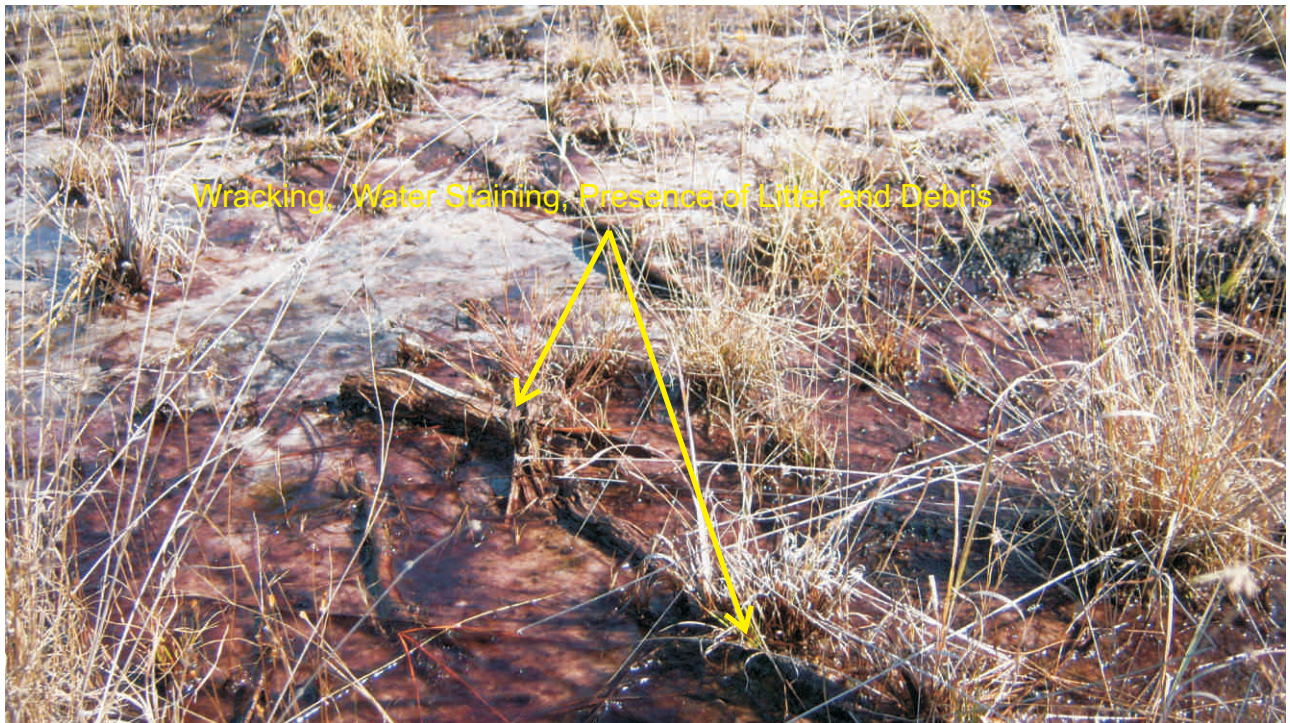
**Close-up of OHWM near Gauge 23 (Westside & facing West) -
South Tributary**
