**UT to Little Coharie Creek
(Roseboro Site)
Stream Restoration Project
Sampson County
North Carolina**

**CU: 030030006
SCO# 040634201A
EEP Project No. 314**

**Monitoring Year 2 of 5
Data Collection: June through October 2010
Submission Date: March 31, 2011**

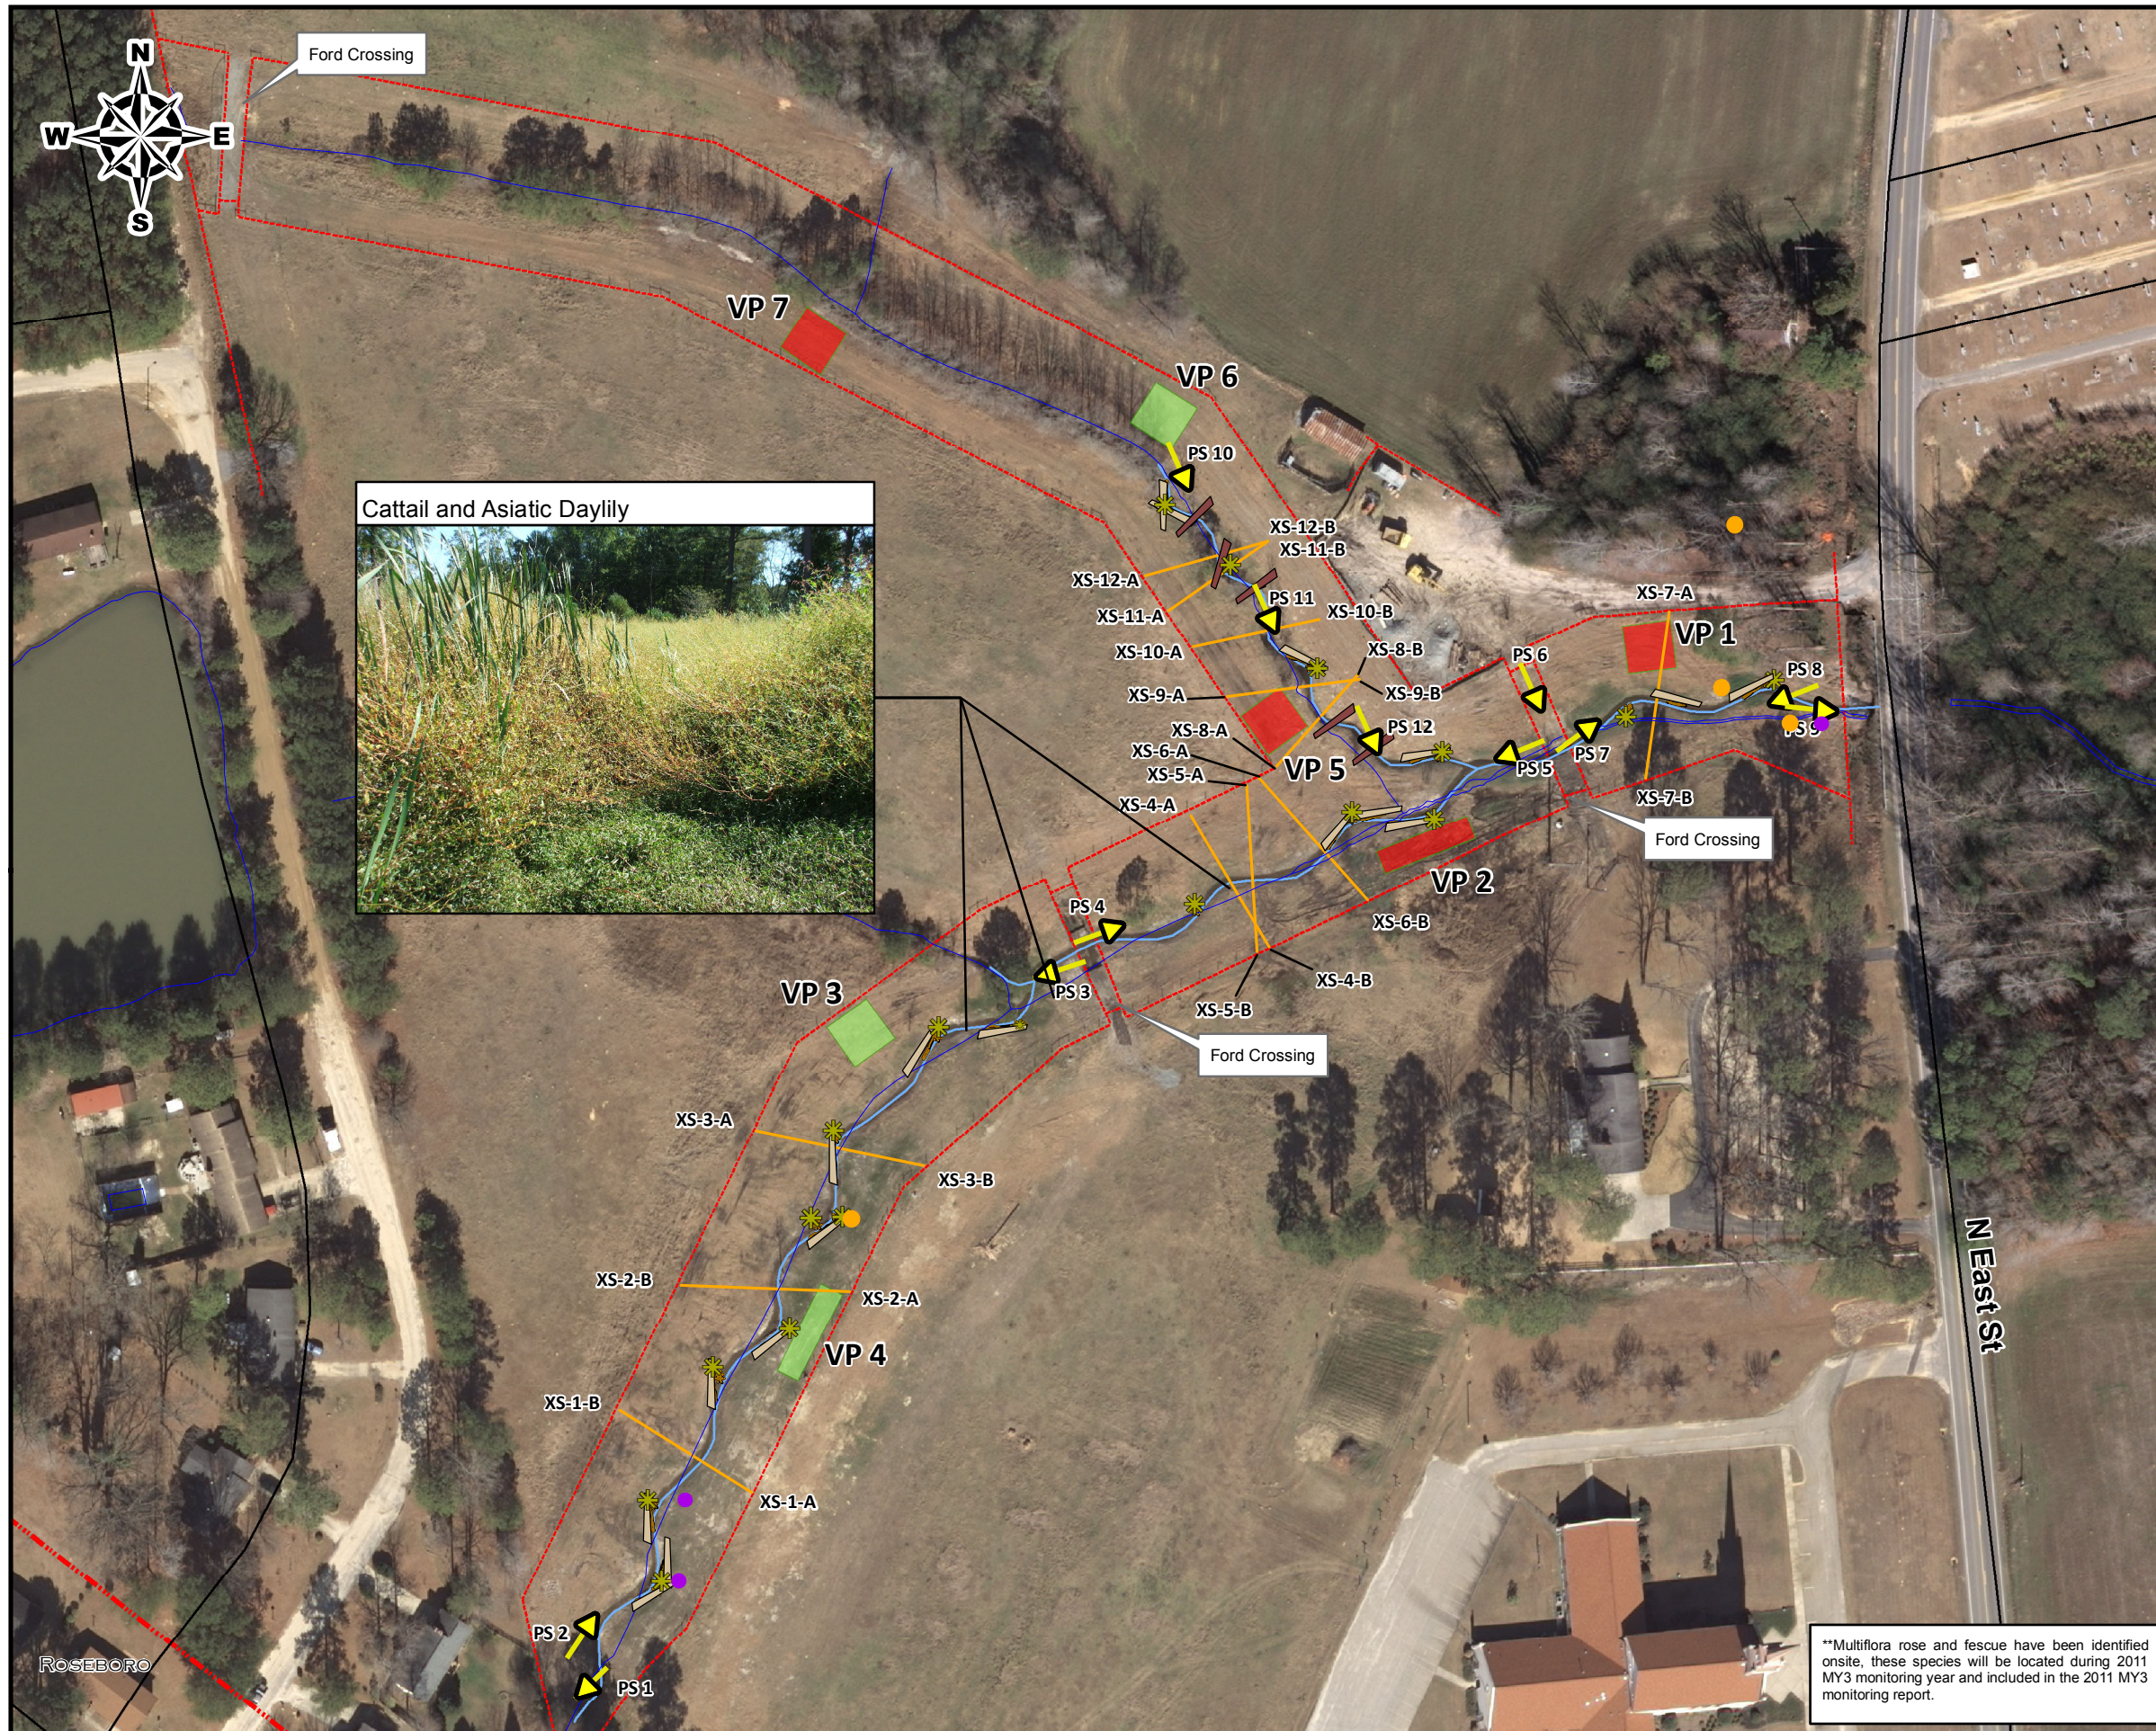
FIGURE 2

Stream Problem Areas			
UT to Little Coharie Stream Restoration Project - EEP No. 314			
Feature Issue	Station Number	Suspected Cause	Photo Number
Aggradation	Northern 11+40 to 12+40	Trapped Sediment/Low Flow	Figure 2

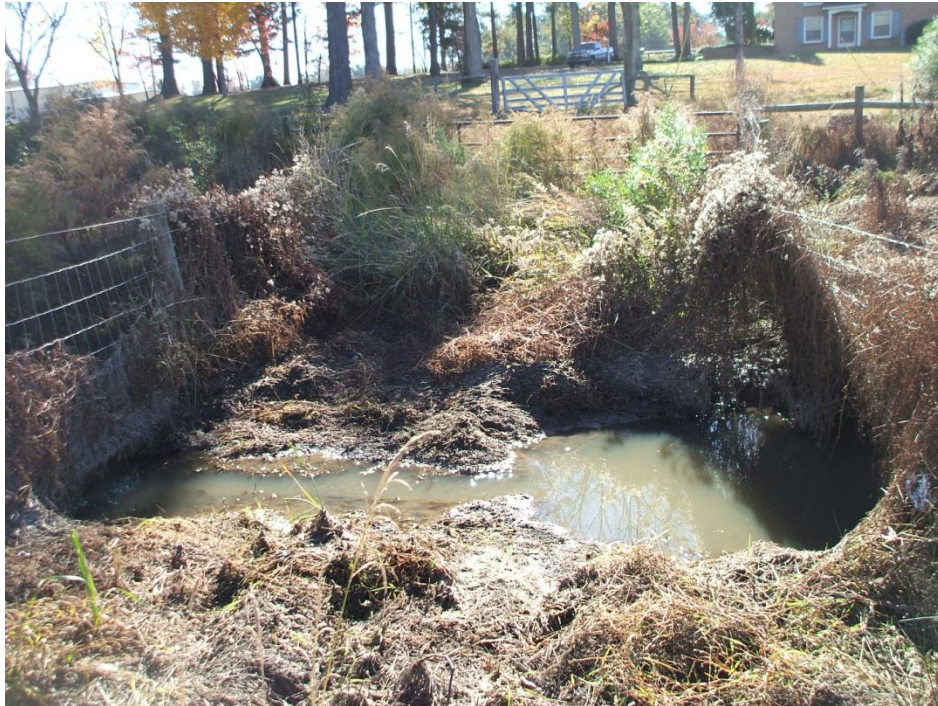
6 - Main Reach Station 10+50 – Stream Crossing

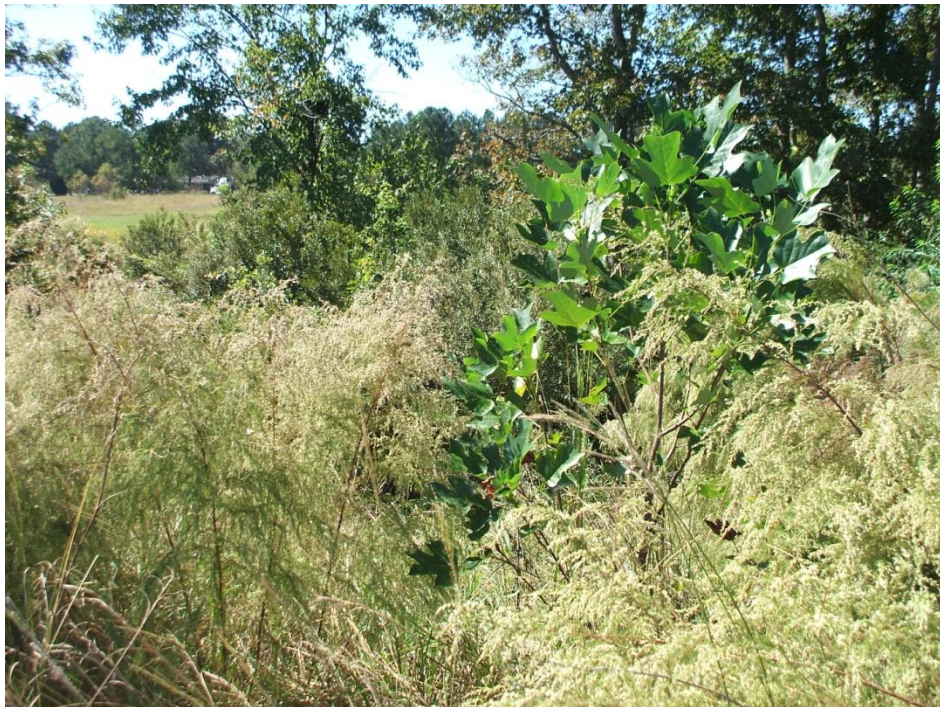
Vegetation Plot 6

Table 7. Vegetation Plot Criteria Attainment UT to Little Coharie Stream Restoration Project – EEP No. 314			
Tract	Vegetation Plot ID	Vegetation Survival Threshold Met?	Tract Mean
Reach 2	VP1	N	43%
Reach 2	VP2	N	
Reach 2	VP3	Y	
Reach 2	VP4	Y	
Reach 1	VP5	Y	
Reach 1	VP6	N	
Reach 1	VP7	N

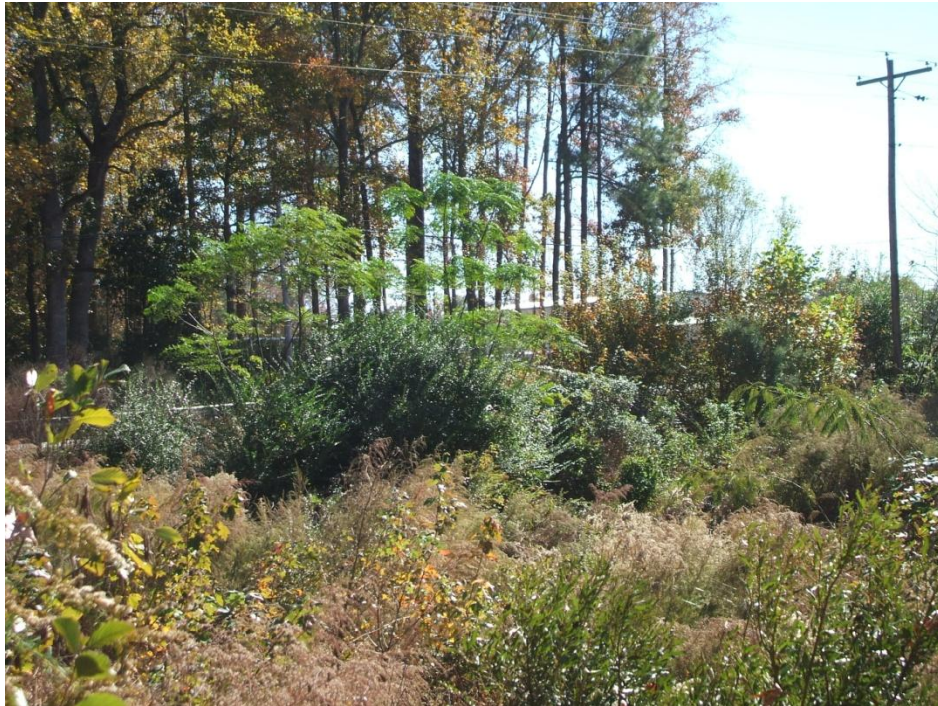
Vegetation Problem Areas			
UT to Little Coharie Stream Restoration Project - EEP No. 314			
Feature Category	Station Number	Suspected Cause	Photo Number
Cattail	Throughout	Low Flow Conditions	Figure 2
Invasive Vegetation	Various, Refer to Figure to for Location	Offsite seed source	VPA1

VPA1 – Chinese privet and mimosa
