**UT to Little Coharie Creek
(Roseboro Site)
Stream Restoration Project
Sampson County
North Carolina**

**CU: 030030006
SCO# 040634201A
EEP Project No. 314**

**Monitoring Year 3 of 5
Data Collection: June through October 2011
Submission Date: February 21, 2012**

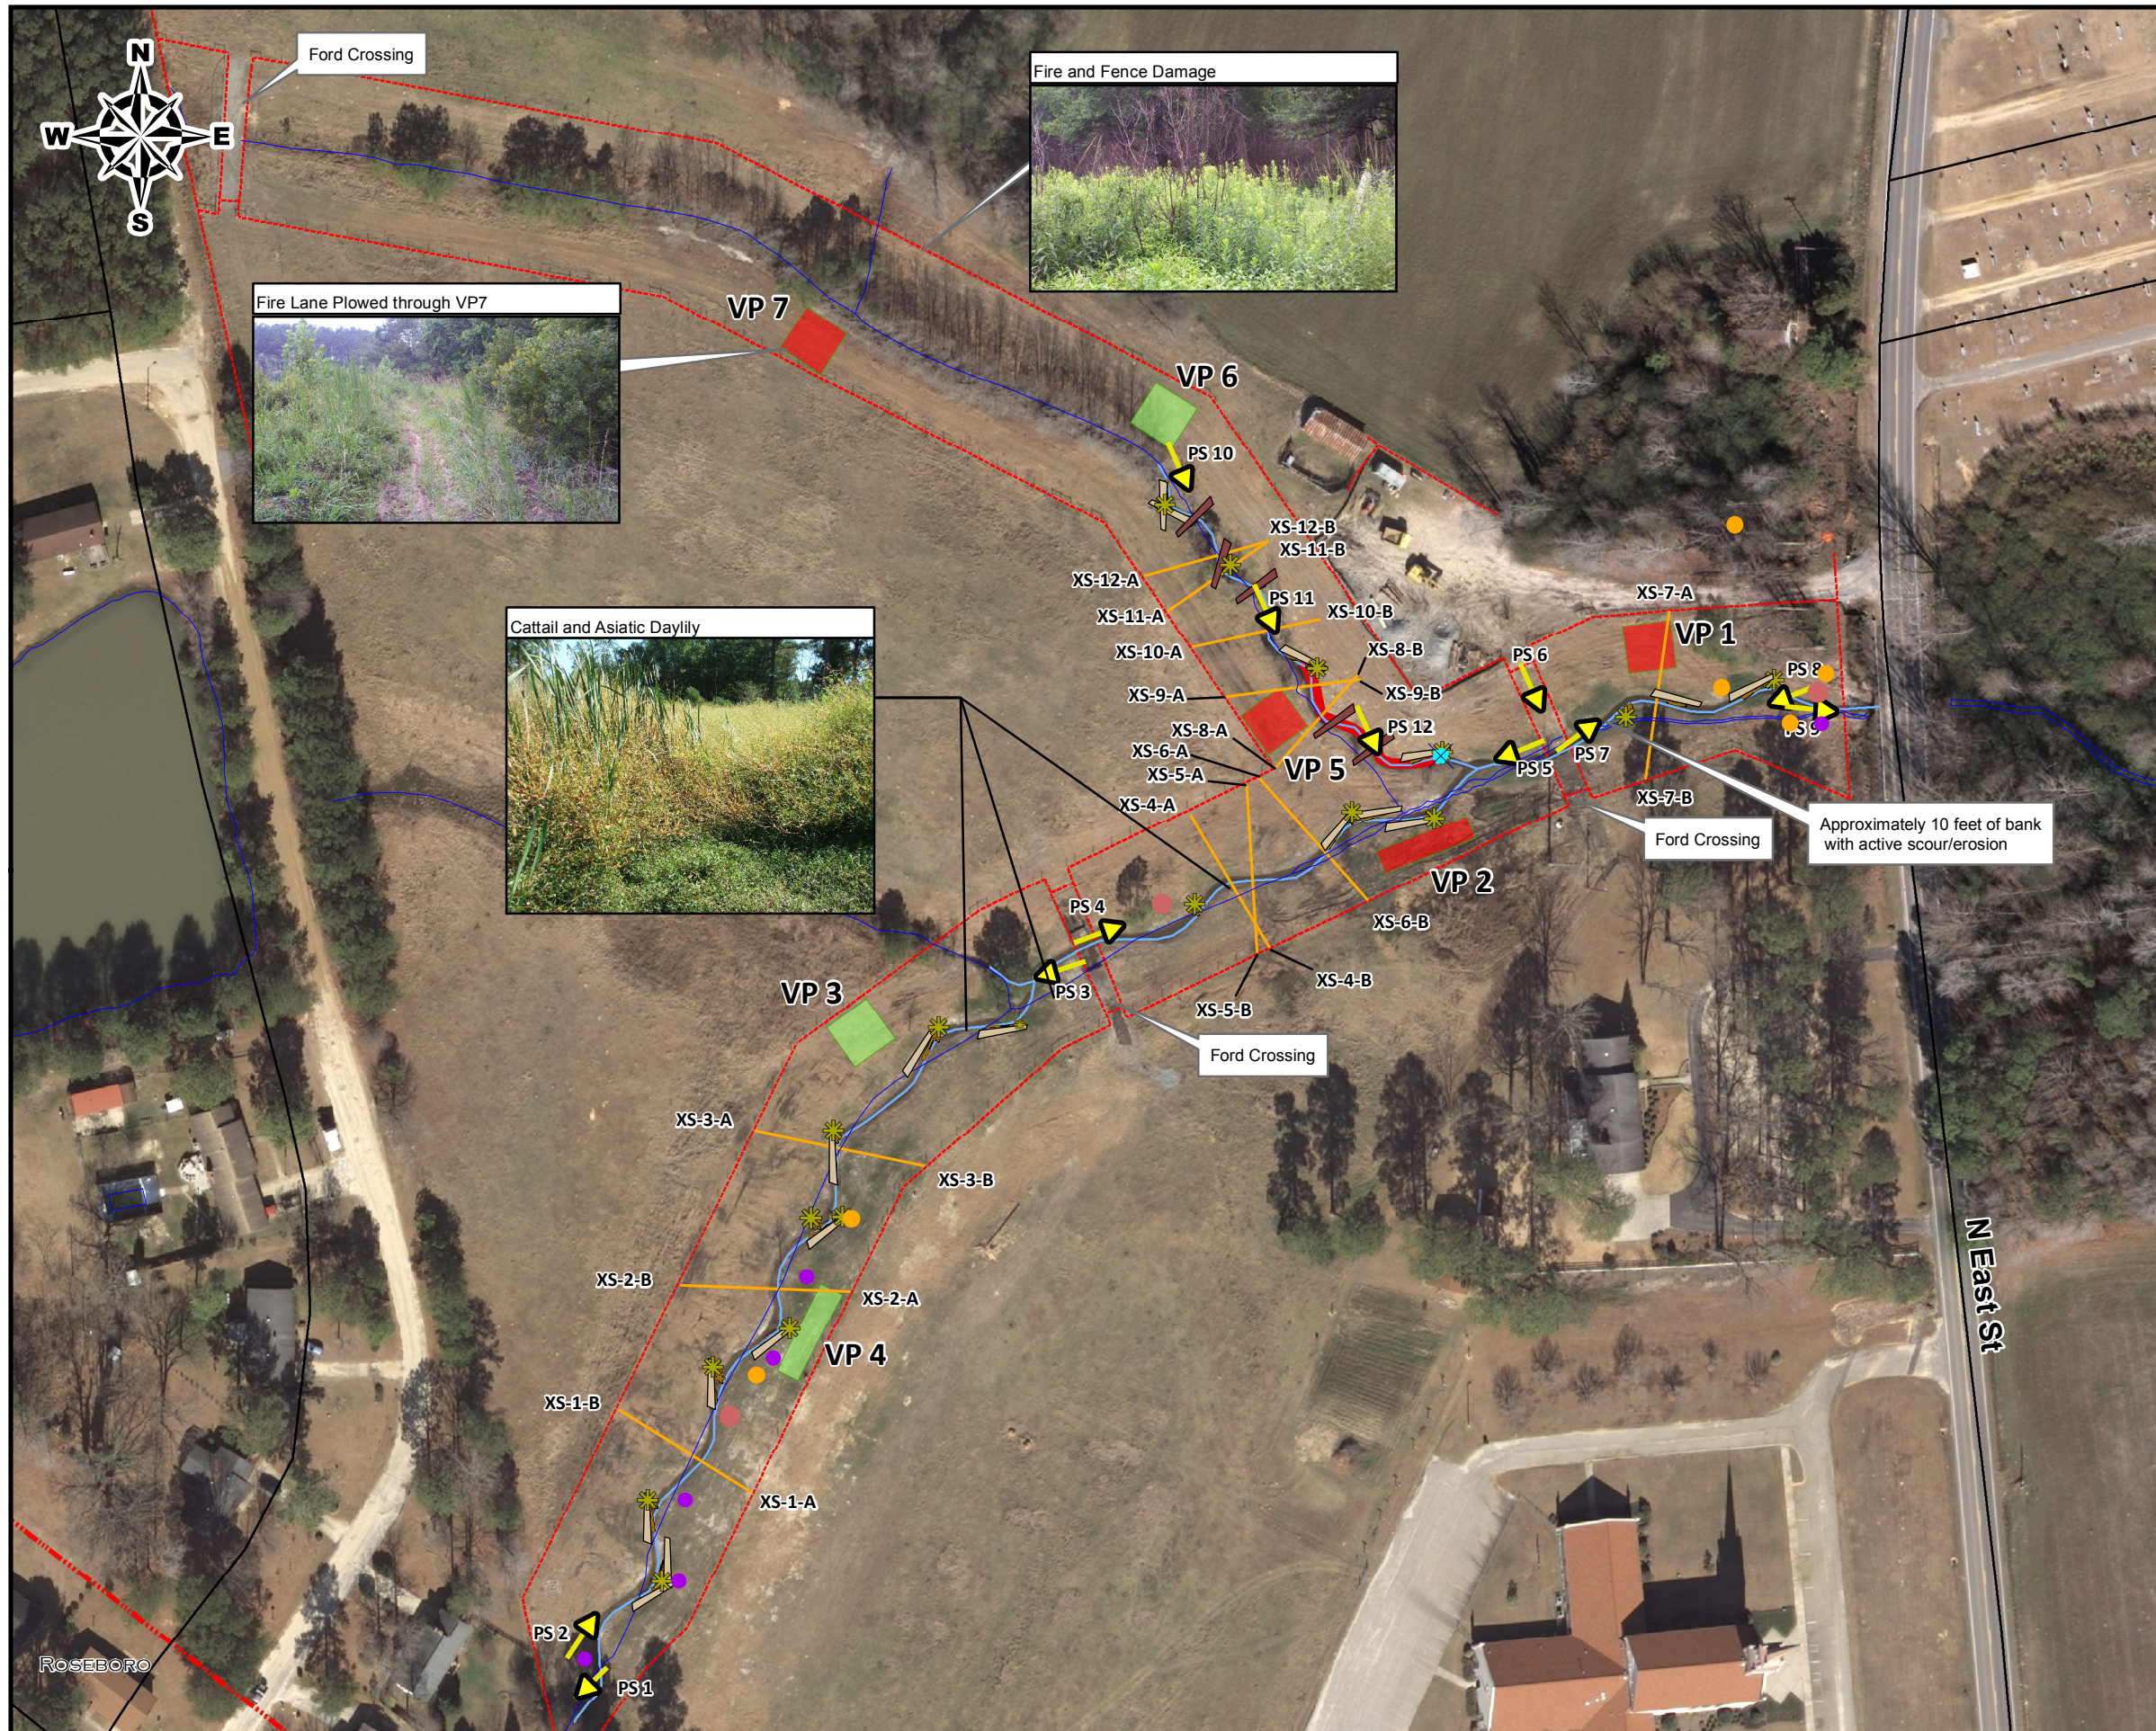
FIGURE 3

Stream Problem Areas			
UT to Little Coharie Stream Restoration Project - EEP No. 314			
Feature Issue	Station Number	Suspected Cause	Photo Number
Aggradation	Northern 11+40 to 12+40	Trapped Sediment/Low Flow	Figure 2

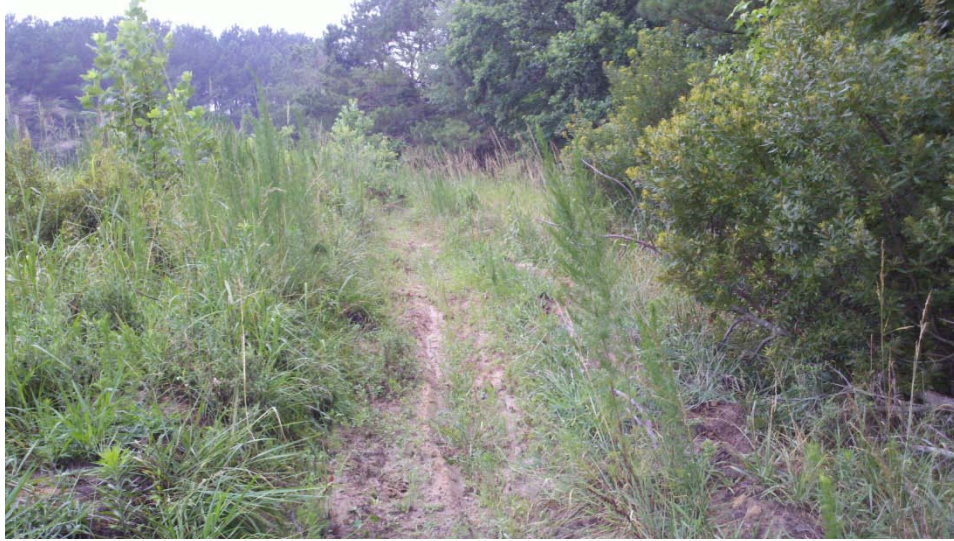
Vegetation Plot 7

In the Winter/Spring of 2011, a wild fire from an adjacent land parcel to the north of the Northern Tributary, caused damage to planted areas as well as easement fencing west of vegetation plot 6. Site damage was minimal but remedial repairs to easement fencing and vegetation plot 7 are required (Figure 2).

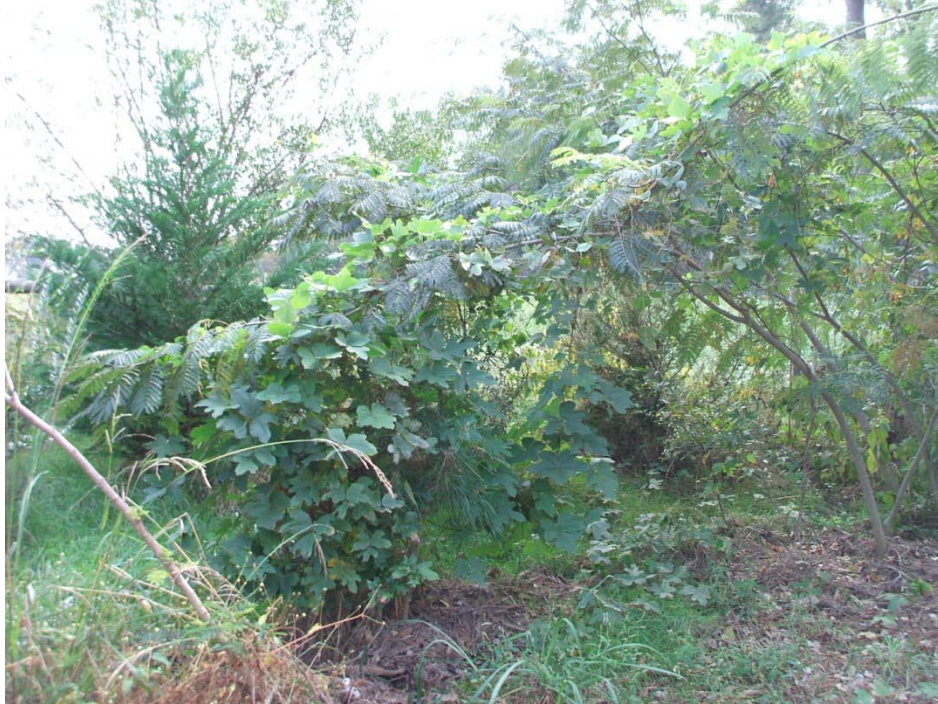
VPA1 – Kudzu Encroachment (Figure 2)

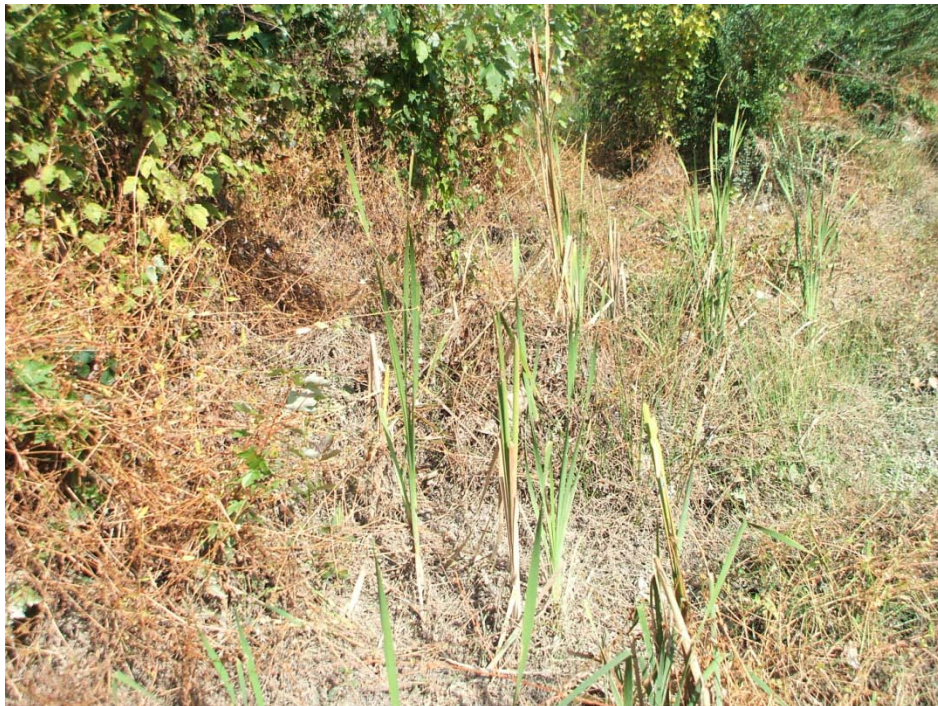
drought. The drought has caused low flow periods resulting in vegetation growing within the stream channel. Asiatic daylily and cattail are growing within the stream bed, causing disruption of sediment transport on parts of the project. Fencing along the ford crossings has trapped debris and may cause stream widening (Photo Station 6). It is recommended that fencing along the ford crossings be maintained annually to prevent additional damage.

VPA2 – Cattail (Figure 2)

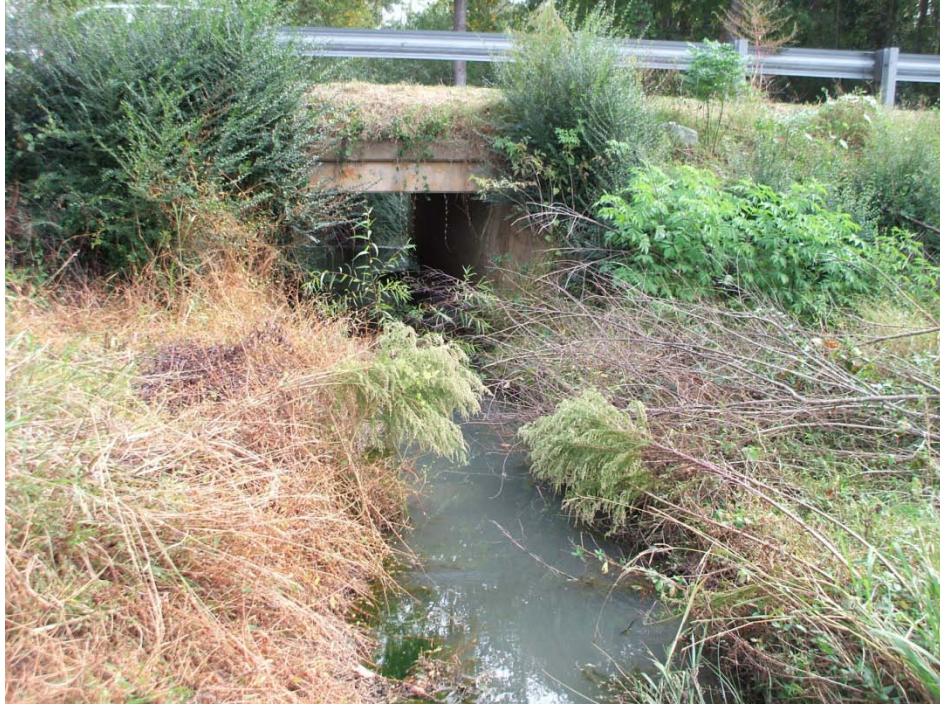
VPA3 – Chinese privet and mimosa (Figure 2)
