YEAR 1 MONITORING REPORT

UT TO THE LUMBER RIVER SITE

Robeson County, North Carolina

Contract No. 002027

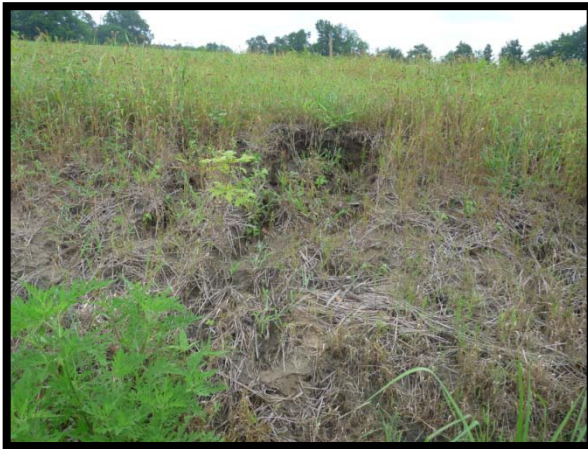
Several areas along the terrace cut slopes (terrace side slopes) have not obtained acceptable ground cover (grass). It appears that much of the temporary and permanent seed that was broadcast during construction either did not germinate or was washed away during precipitation events. Rill erosion has occurred in several areas due to the absence of ground stabilizing grasses.

3.15 Area of poor vegetation growth

F&H is currently contracting Land Mechanics Designs (the contractor who constructed the Site) to remobilize to the Site to establish acceptable growth rates of ground cover. The scope of work

includes regrading areas of severe rill erosion, applying temporary and permanent seeding, straw, and matting bare and regraded areas with non-woven bio netting. Additionally, soil amendments including fertilizer and organic supplements are anticipated to be spread on bare areas to assist the establishment of grass. We are confident that our remediation plan will produce an acceptable stand of grass that will provide sufficient ground cover to reduce and eliminate rill erosion.

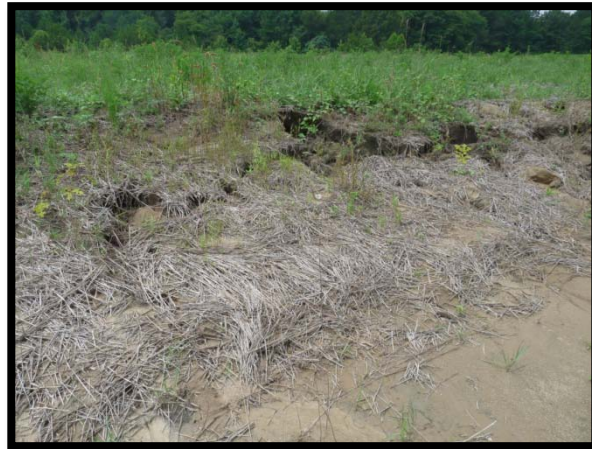
3.16 Bare area on terrace slope

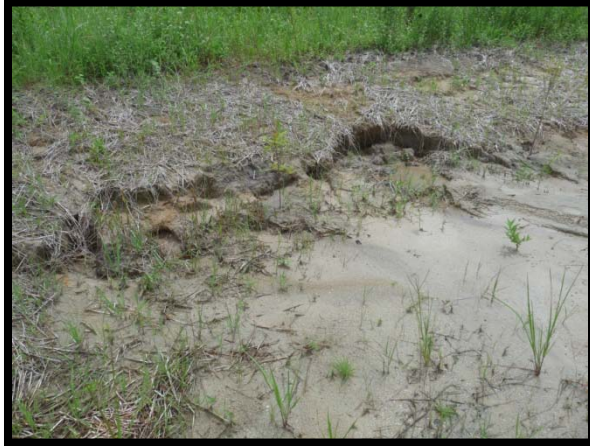
3.17 Bare area on terrace slope

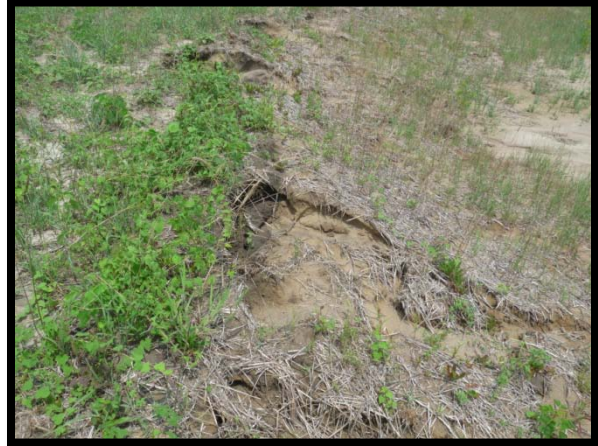
3.18 Poor vegetation growth on terrace slope

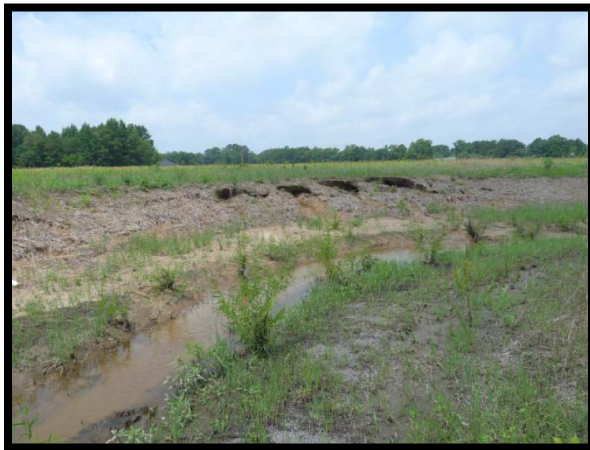
3.19 Wash areas on terrace slope

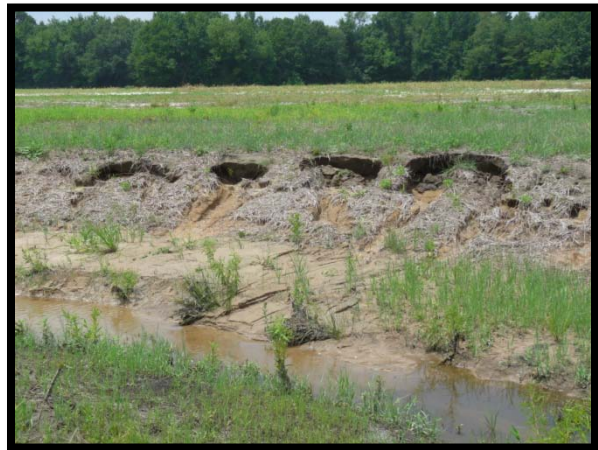
3.20 Wash areas on terrace slope
