# ***YEAR 2 MONITORING REPORT***

## **UT TO THE LUMBER RIVER SITE**

Robeson County, North Carolina

Contract No. 002027, EEP IMS No. 94068

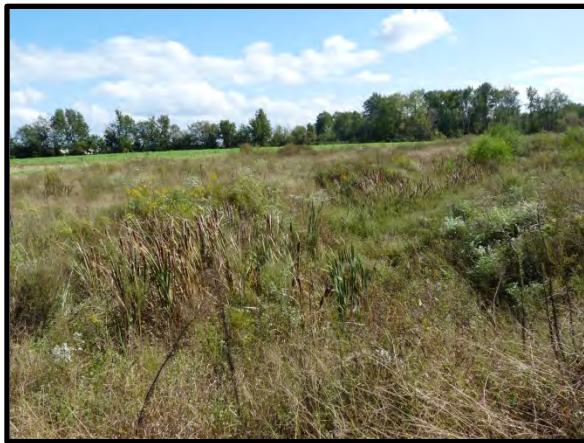
Four small clusters of cattail (*Typha latifolia*) were observed in the floodplain and are noted on the Current Condition Plan View (CCPV) map. Sericea lespedeza (*Lespedeza cuneata*) was also

**3.15 Cluster of cattail adjacent to VP 12**

observed adjacent to Vegetation Plot 4 and is depicted on the CCPV. No corrective action is recommended at this time. Invasive/exotic vegetation is not currently compromising the vegetative success of the site.

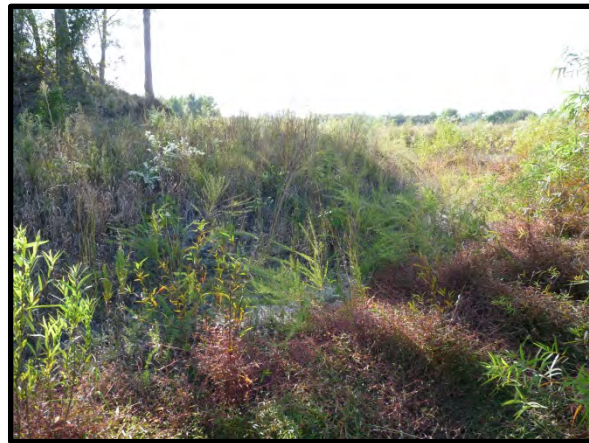
**3.16 Sericea lespedeza near VP 4**

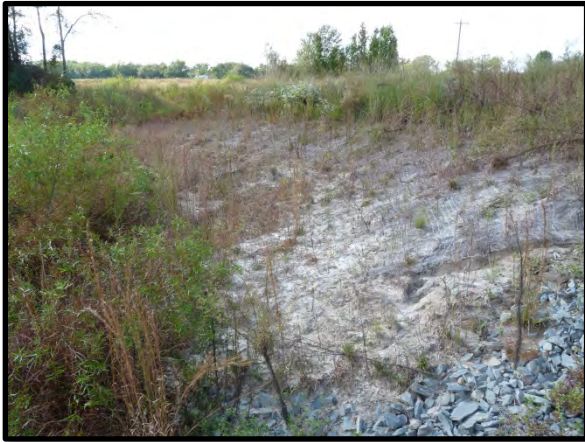
Repairs to bare ground and rill erosion areas documented in the Year 1 Monitoring Report were completed in December, 2010. Several areas along the terrace cut slopes (terrace side slopes) still have sparse ground cover. However, the erosion control matting, installed in December 2010, has prevented rill erosion along the majority of side slopes. It is anticipated that permanent grass germination will occur in the next growing season. Additional seeding is not recommended.

**3.17 Sparse vegetation on terrace slope**

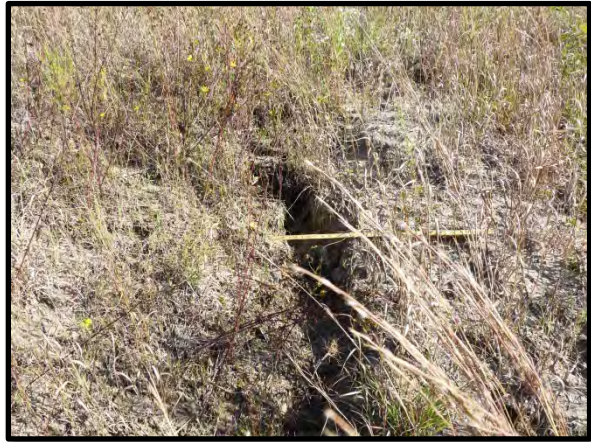
**3.18 Small gully on terrace slope**

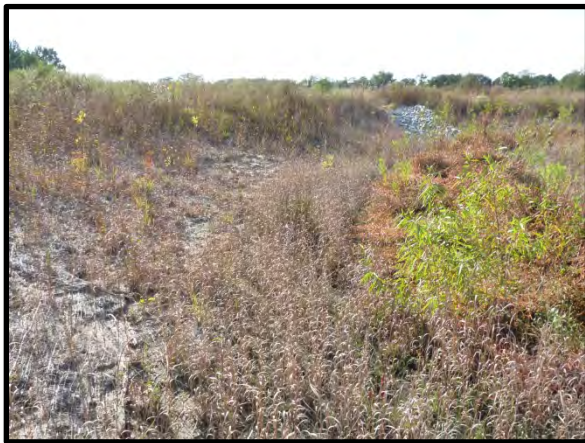
**3.19 Sparse vegetation on terrace slope**

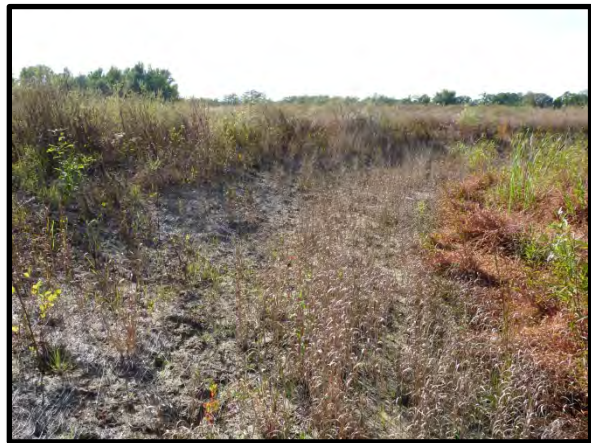
**3.20 Minor wash on terrace slope**

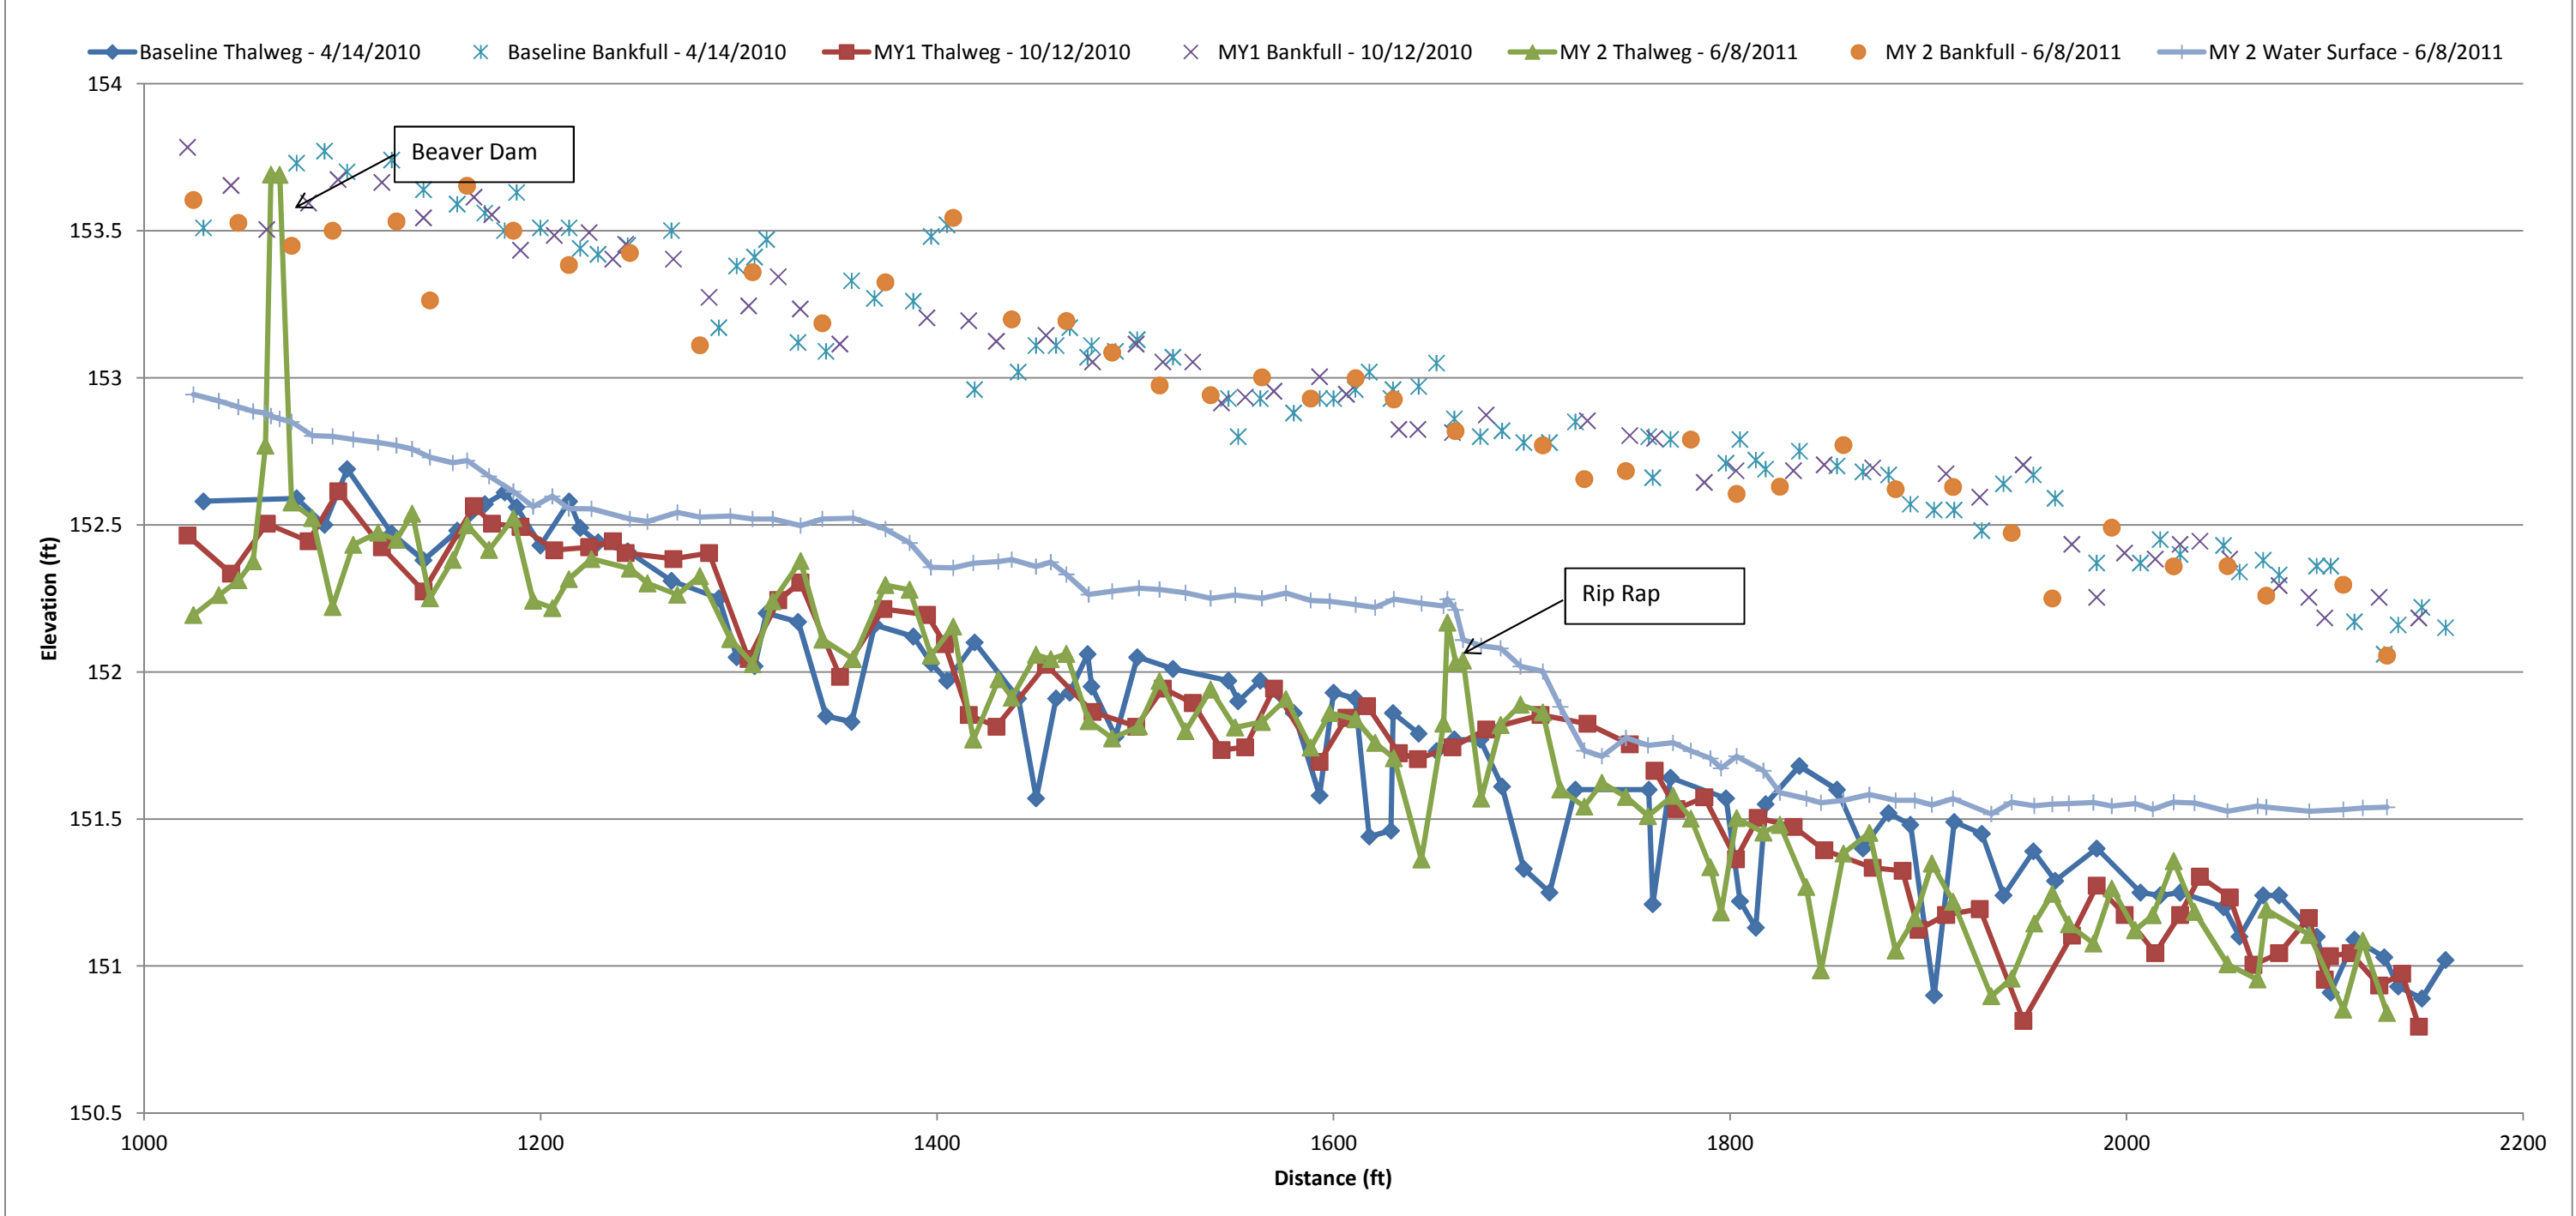
Figure 5.1 UT to the Lumber River, 002027, Upper Reach Longitudinal Profile

An overall visual assessment of the channel appears to confirm morphological data, in that there are no substantial areas of concern within the bankfull channel. A small beaver dam was observed near station 10+43, approximately 20 feet downstream of Cross-section 1. The beaver dam has not had a significant impact on the stability of the stream, but it will be removed prior to Year 3 Monitoring surveys. After the repair of a floodplain interceptor near station 16+65, some of the smaller rip-rap used during the repair washed into the channel and raised the bed elevation. The rap-rap has not resulted in stream degradation and it will be removed from the channel prior to Year 3 Monitoring surveys. The beaver dam and rip-rap are identified on Figure 5.1.

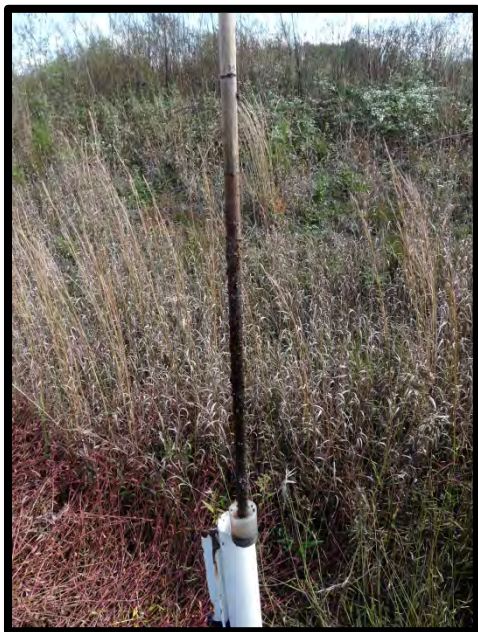
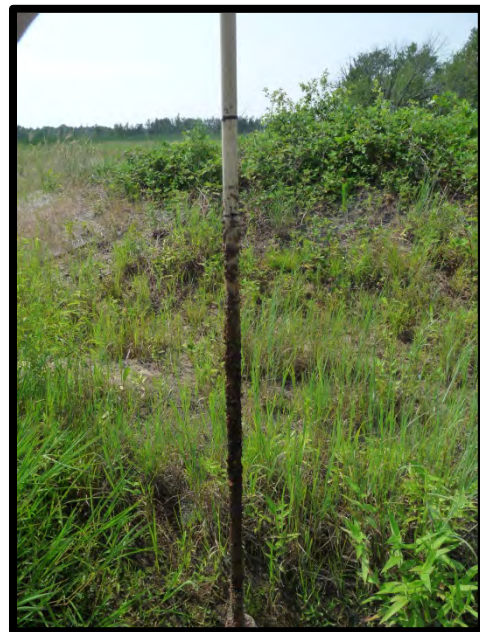
Figures 6.1 & 6.2 Crest Gauge Photos

The site has experienced several bankfull flows throughout the first monitoring year. Crest gauges installed on-site were inspected on 9 June 2011 and 13 October 2011. The crest gauges revealed that a bankfull event occurred at least twice during 2011 (Table 13). Additional overbank evidence includes debris lines, and vegetation bent in the downstream direction. Evidence of bankfull events can be found in Appendix E.
