YEAR 3 MONITORING REPORT

UT TO THE LUMBER RIVER SITE

Robeson County, North Carolina

Contract No. 002027, EEP IMS No. 94068

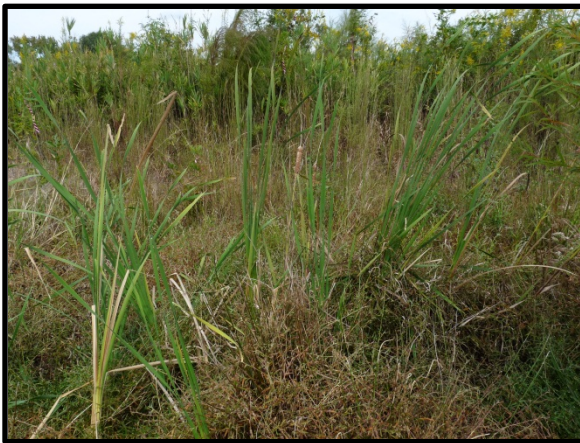
Eight small clusters of cattail (*Typha latifolia*) were observed in the floodplain and are noted on the Current Condition Plan View (CCPV) map. *Sericea lespedeza* (*Lespedeza cuneata*) was also observed adjacent to Vegetation Plot 4 and is depicted on the CCPV. No corrective action is recommended at this time. Invasive/exotic vegetation is not currently compromising the vegetative success of the site.

3.15 Cluster of cattail adjacent to VP 7

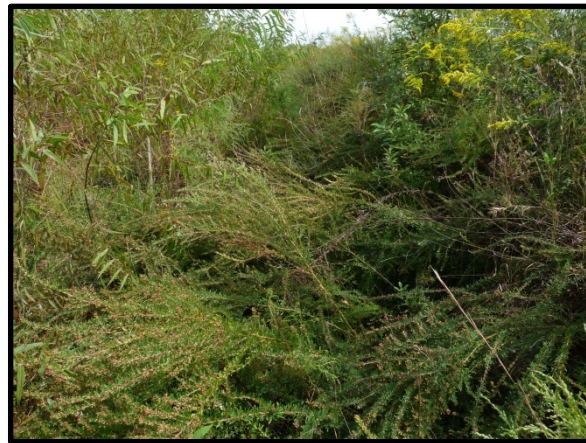
3.16 Sericea lespedeza near VP 4

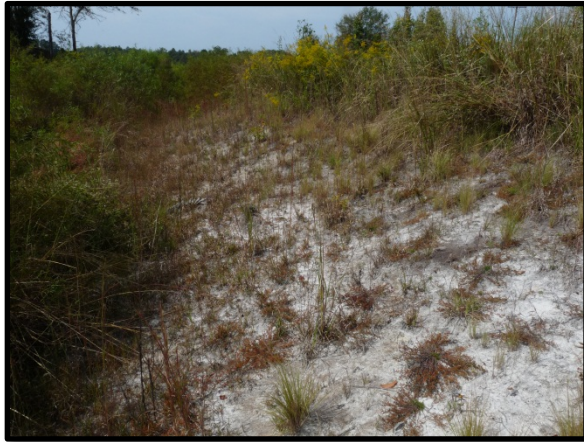
As noted in Year 1 and Year 2 monitoring reports, several areas of the terrace side slopes have sparse ground cover and are experiencing minor erosion (see CCPV). All areas previously documented as experiencing major erosion have stabilized. The majority of bare root plants along the side slopes are surviving and will provide additional root mass to help stabilize the side slopes as they mature. Minor erosion areas will be watched closely over the next monitoring year to ensure they do not progress to more severe erosion. Additional seeding is not recommended at this time.

3.17 Sparse vegetation on terrace slope near station 24+50

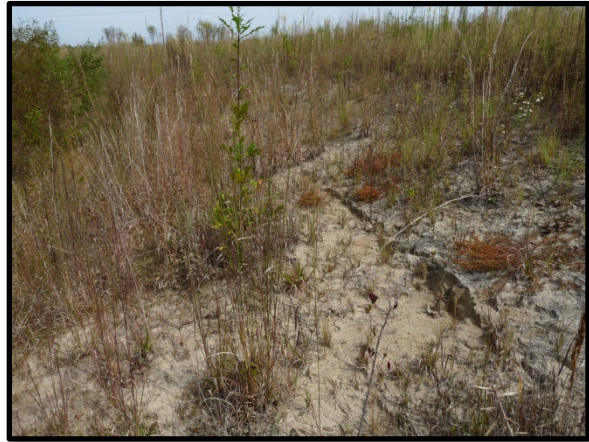
3.18 Minor wash on terrace slope near station 27+50

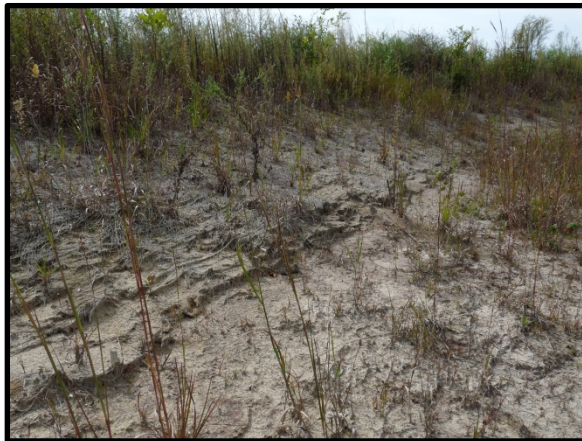
3.19 Minor wash on terrace slope near station 35+00.

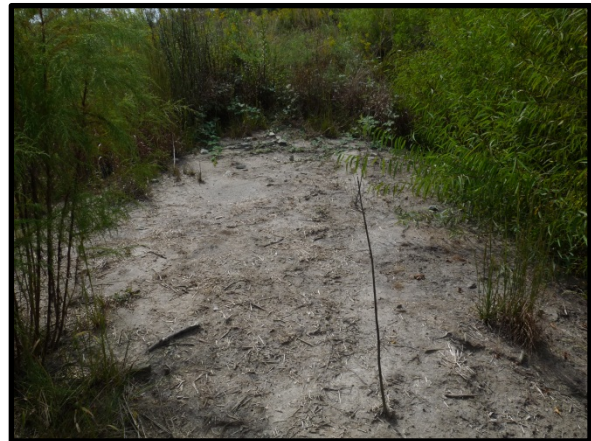
3.20 Area with no grass near station 49+00.

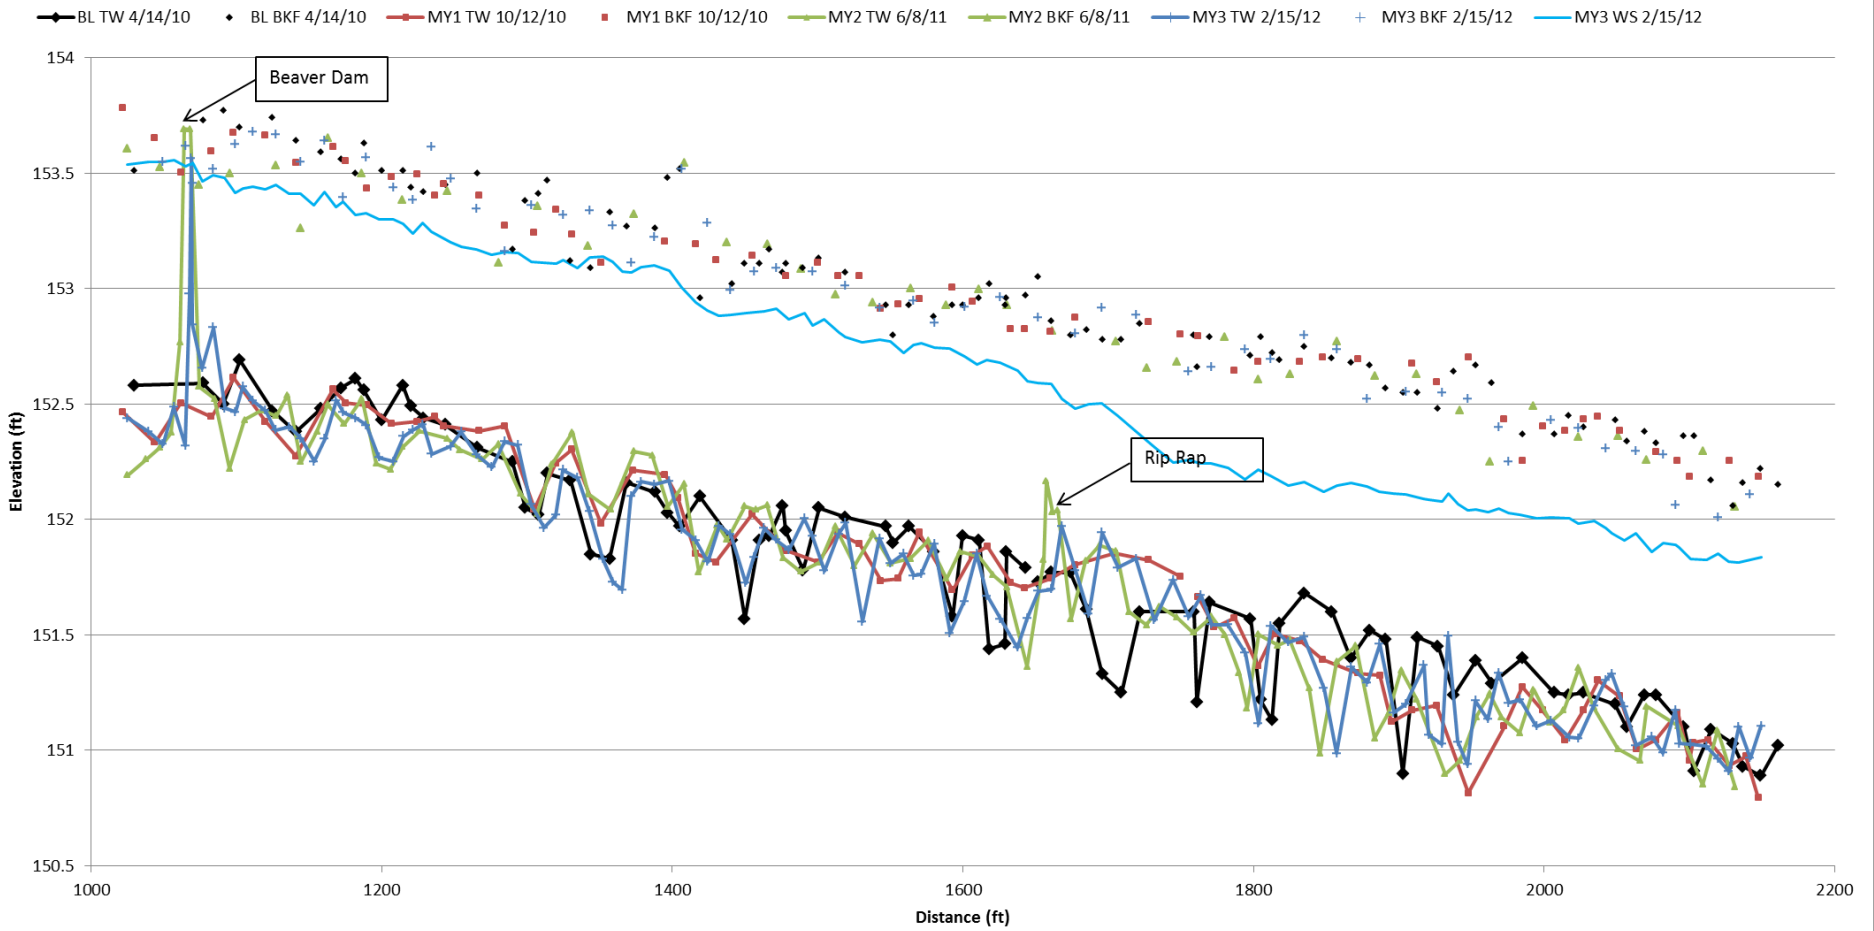
Figure 5.1 UT to the Lumber River, 002027, Upper Reach Longitudinal Profile

An overall visual assessment of the channel appears to confirm morphological data, in that there are no substantial areas of concern within the bankfull channel. A small beaver dam was observed near station 10+43, approximately 20 feet downstream of Cross-section 1. The beaver dam has not had a significant impact on the stability of the stream, but it will be removed prior to Year 4 Monitoring surveys. After the repair of a floodplain interceptor near station 16+65, some of the smaller rip-rap used during the repair washed into the channel and raised the bed elevation. The rap-rap has not resulted in stream degradation and it will be removed from the channel prior to Year 4 Monitoring surveys. The beaver dam and rip-rap are identified on Figure 5.1.

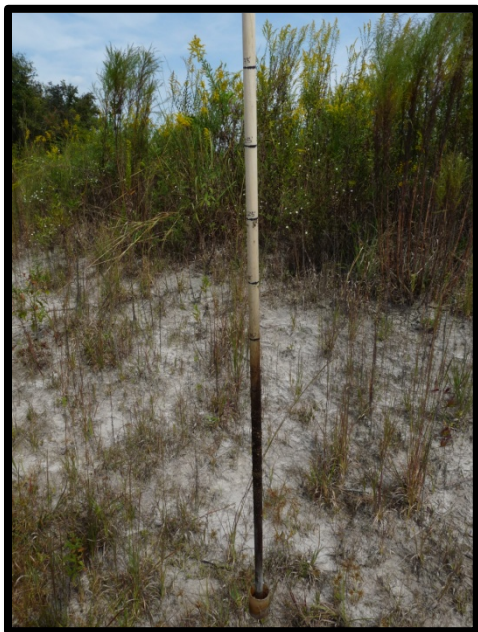
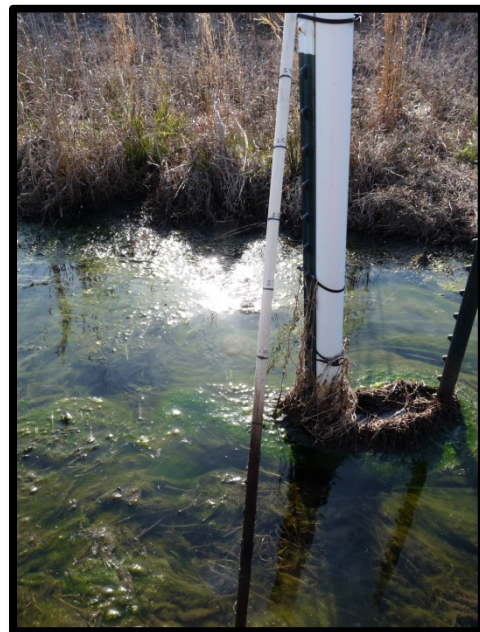
Figures 6.1 & 6.2 Crest Gauge Photos

The site has experienced several bankfull flows throughout the first monitoring year. Crest gauges installed on-site were inspected on February 16 & 23, 2012 and September 28, 2012. The crest gauges revealed that a bankfull event occurred at least twice during 2012 (Table 13). Additional overbank evidence includes debris lines, and vegetation bent in the downstream direction. Evidence of bankfull events can be found in Appendix E.

Date	Crest Gauge Info		Gauge Reading (ft)	Gauge Elevation (ft)	Crest Elevation (ft)	Bankfull Elevation (ft)	Height above Bankfull (ft)	Photo
	Site	Sta.						
9/28/2012	XS 16	48+13	2.2	146.9	149.1	148.4	0.7	6.1
2/16/2012	XS 8	30+90	1.5	149.5	151.0	150.8	0.2	6.2
