YEAR 4 MONITORING REPORT

UT TO THE LUMBER RIVER SITE

Robeson County, North Carolina

Contract No. 002027, EEP IMS No. 94068

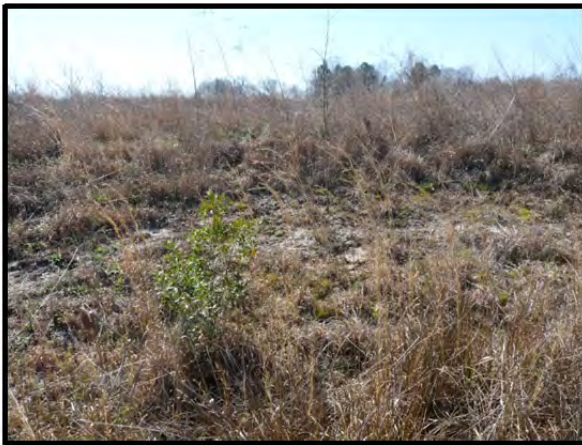
Sparse ground cover and minor erosion along the side slopes is noted along the terrace slopes. These areas are continuing to fill in with herbaceous vegetation (see Current Condition Plan View (CCPV) map and Figure 3.15). The majority of bare root plants along the side slopes are surviving and will provide additional root mass to help stabilize the side slopes as they mature.

**3.15 Representative sparse side slope
(near Station 15+00)**

Minor erosion areas will be watched closely over the next monitoring year to ensure they do not progress to more severe erosion. Additional seeding is not recommended at this time.

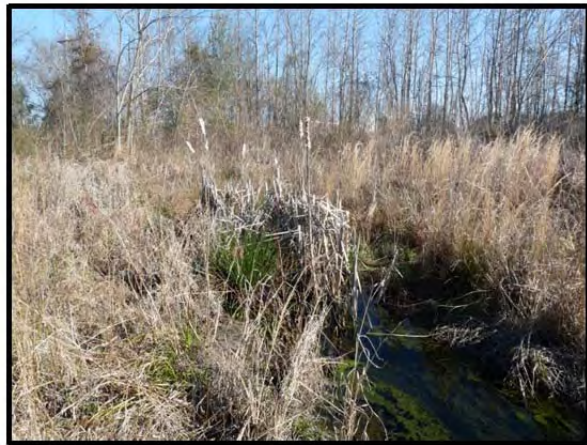
Nine small clusters of cattail (*Typha latifolia*) were observed in the floodplain and are noted on the CCPV map and Figure 3.16. *Sericea lespedeza* (*Lespedeza cuneata*) was also observed adjacent to Vegetation Plot 4 and is depicted on the CCPV. No corrective action is recommended at this time. Invasive/exotic vegetation is not currently compromising the vegetative success of the site.

**3.16 Representative cluster of cattail
(Station 10+70) facing upstream**

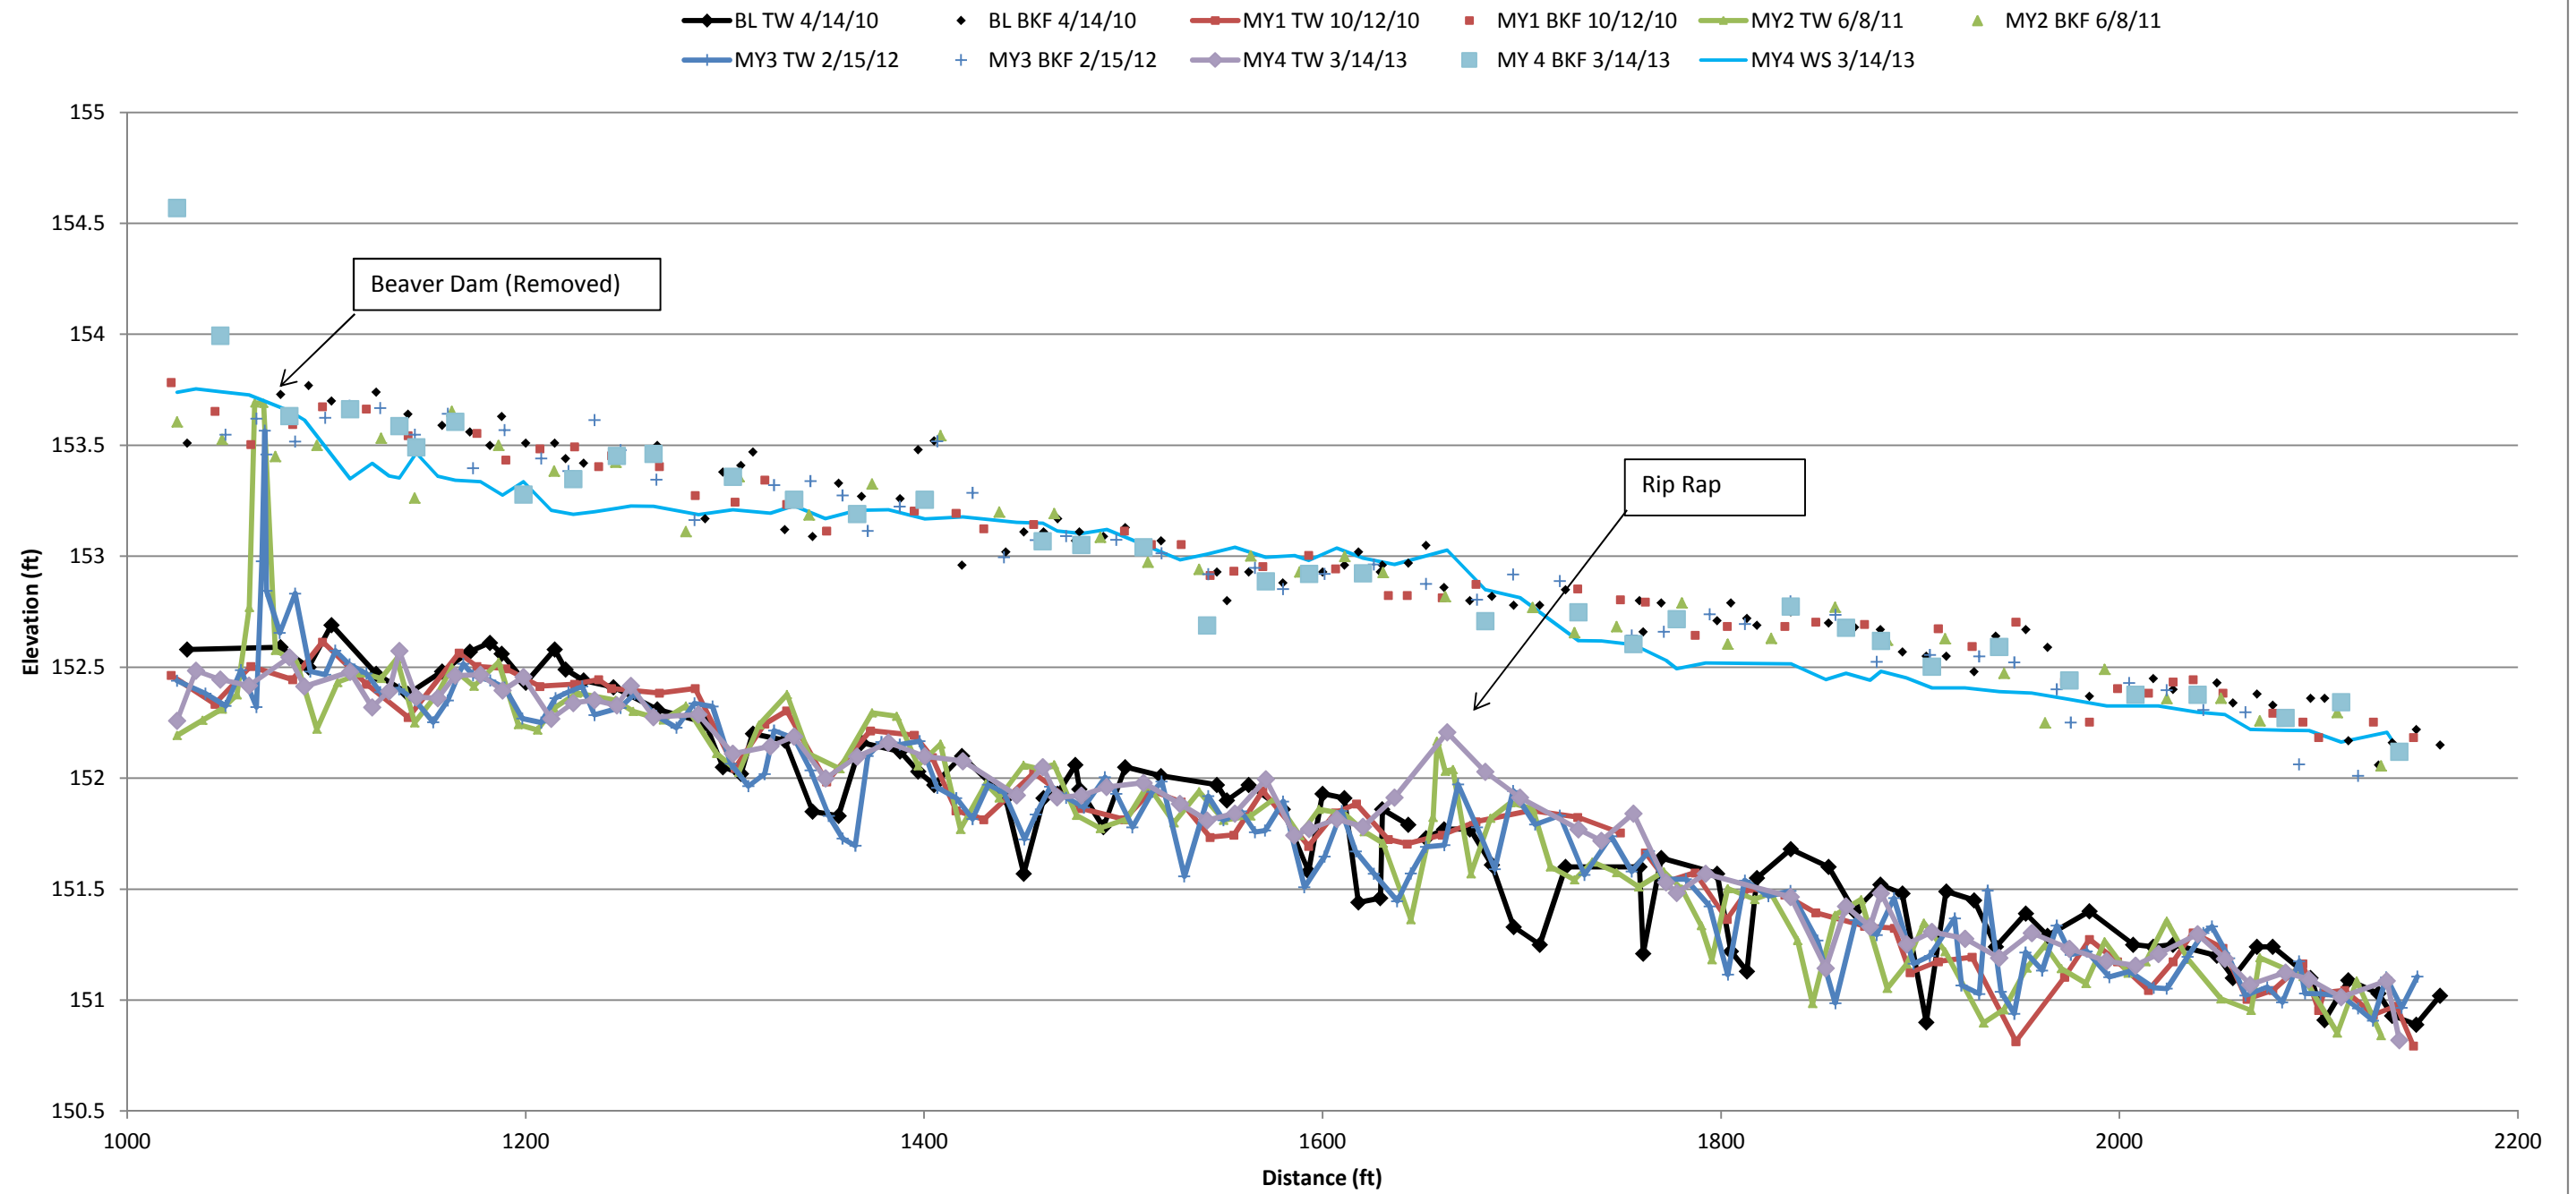
Figure 5.1 UT to the Lumber River, 002027, Upper Reach Longitudinal Profile

An overall visual assessment of the channel appears to confirm morphological data, in that there are no substantial areas of concern within the bankfull channel. The two areas of minor erosion shown on the CCPV depict bare areas on the terrace slope. A small beaver dam was observed near station 10+43, approximately 20 feet downstream of Cross-section 1 during Year 3 monitoring and has been removed prior to Year 4 Monitoring. The beaver dam has not had a significant impact on the stability of the stream. After the repair of a floodplain interceptor near station 16+65, some of the smaller rip-rap used during the repair washed into the channel and raised the bed elevation. The rip-rap has not resulted in significant stream degradation. The beaver dam and rip-rap are identified on Figure 5.1.
