YEAR 5 MONITORING REPORT

UT TO THE LUMBER RIVER SITE

Robeson County, North Carolina

Contract No. 002027, EEP IMS No. 94068

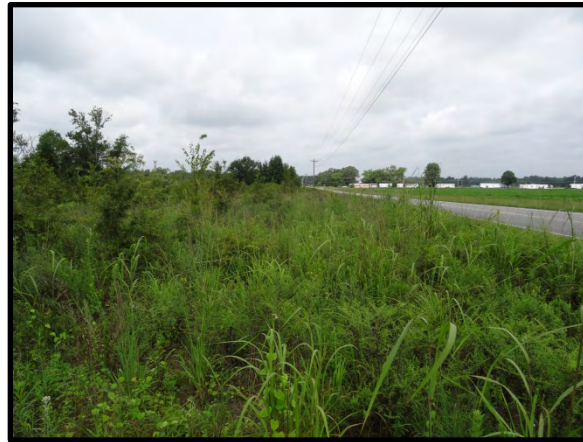
Previous mowing occurring within the easement along Deep Branch Road underneath the power line appears to have ceased.

Figure 1.0 Evidence that mowing has ceased underneath power line

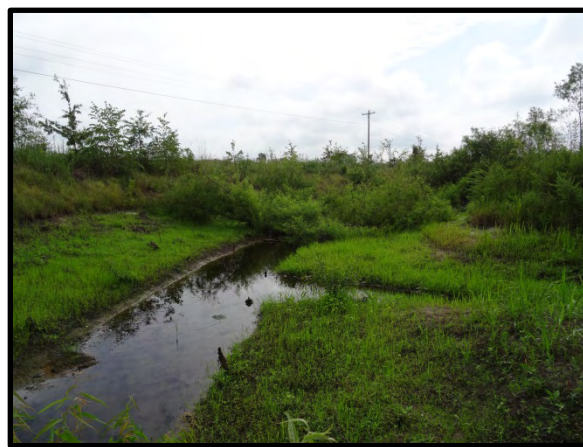
Beaver activity was observed in the channel near station 24+50, and a small beaver dam affected vegetation between stations 24+50 and 25+25. The beavers were removed in the spring of 2014 and woody vegetation is expected to regenerate in the absence of the beaver dam. Additional planting is not recommended at this time.

Figure 1.1 Vegetation affected by beaver compound

During Year 5 stream surveys a beaver dam was identified near station 24+50. This dam backed water up throughout the upper reach, leading to a water surface slope that is not indicative of normal circumstances. The dam was removed in the spring of 2014 and had no effect on the stability of the stream after Year 5 Monitoring.

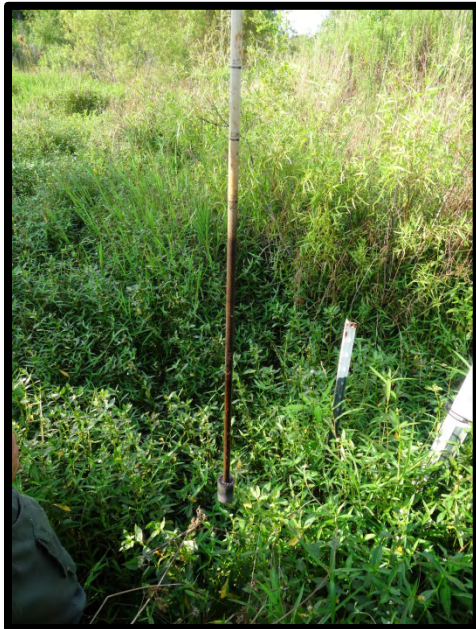
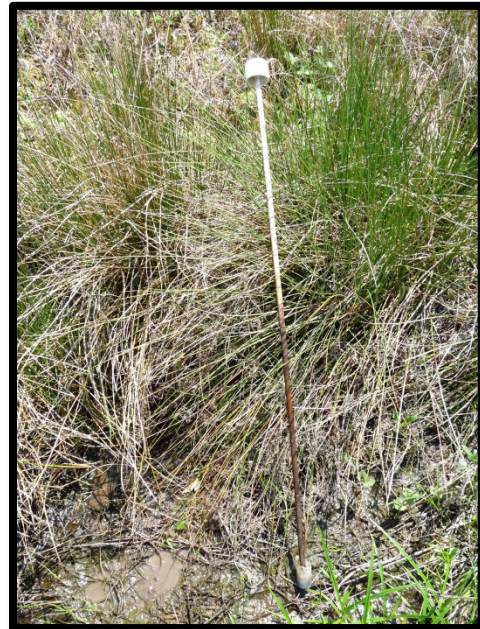
Figures 7.0 & 7.1 2014 Crest Gauge Photos

The site has experienced several bankfull flows throughout the fifth year of monitoring. On-site crest gauges revealed that a bankfull event occurred at least twice during 2014. Rainfall exceeded one inch three separate times (January 12, February 13, and March 7) in the first quarter of 2014 and precipitation totaled 0.902 inches on April 19, 2014. Because bankfull events were not witnessed in person, dates can only be estimated based on rainfall data. Evidence of bankfull events can be found in Appendix E.
