**FINAL**  
**YEAR 1 MONITORING REPORT**  
**UT TO MARTIN'S CREEK (CONTRERAS) MITIGATION PROJECT**  
Cherokee County, North Carolina  
EEP Project No. 92766 (Contract No. 005717)  
USACE Action ID No. 2010-00961/DWR Project No. 2010-00448  
SCO No. 08-07249-01

**Data Collection – March-October 2014**

Hiwassee River Basin  
Cataloging Unit 06020002170010

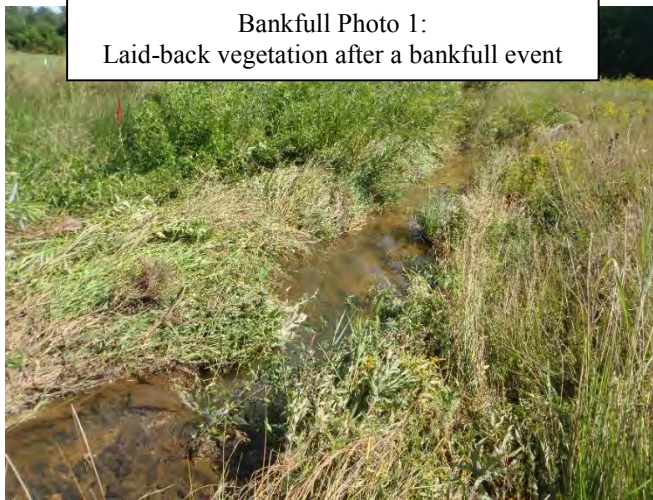
Bankfull Photo 1:  
Laid-back vegetation after a bankfull event

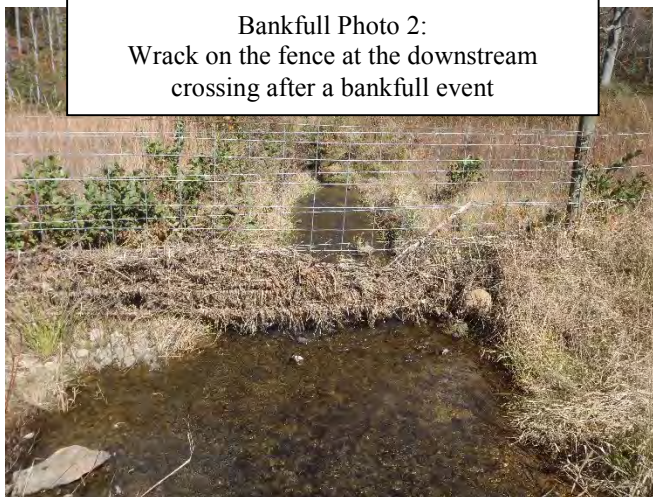
Bankfull Photo 2:  
Wrack on the fence at the downstream crossing after a bankfull event
