**FINAL**  
**YEAR 4 (2017) MONITORING REPORT**  
**UT TO MARTIN'S CREEK (CONTRERAS) MITIGATION PROJECT**  
Cherokee County, North Carolina  
DMS Project No. 92766 (Contract No. 005717)  
USACE Action ID No. 2010-00961/DWR Project No. 2010-00448  
SCO No. 08-07249-01

**Data Collection – March-November 2017**

Hiwassee River Basin  
Cataloging Unit 06020002170010

**December 2017**

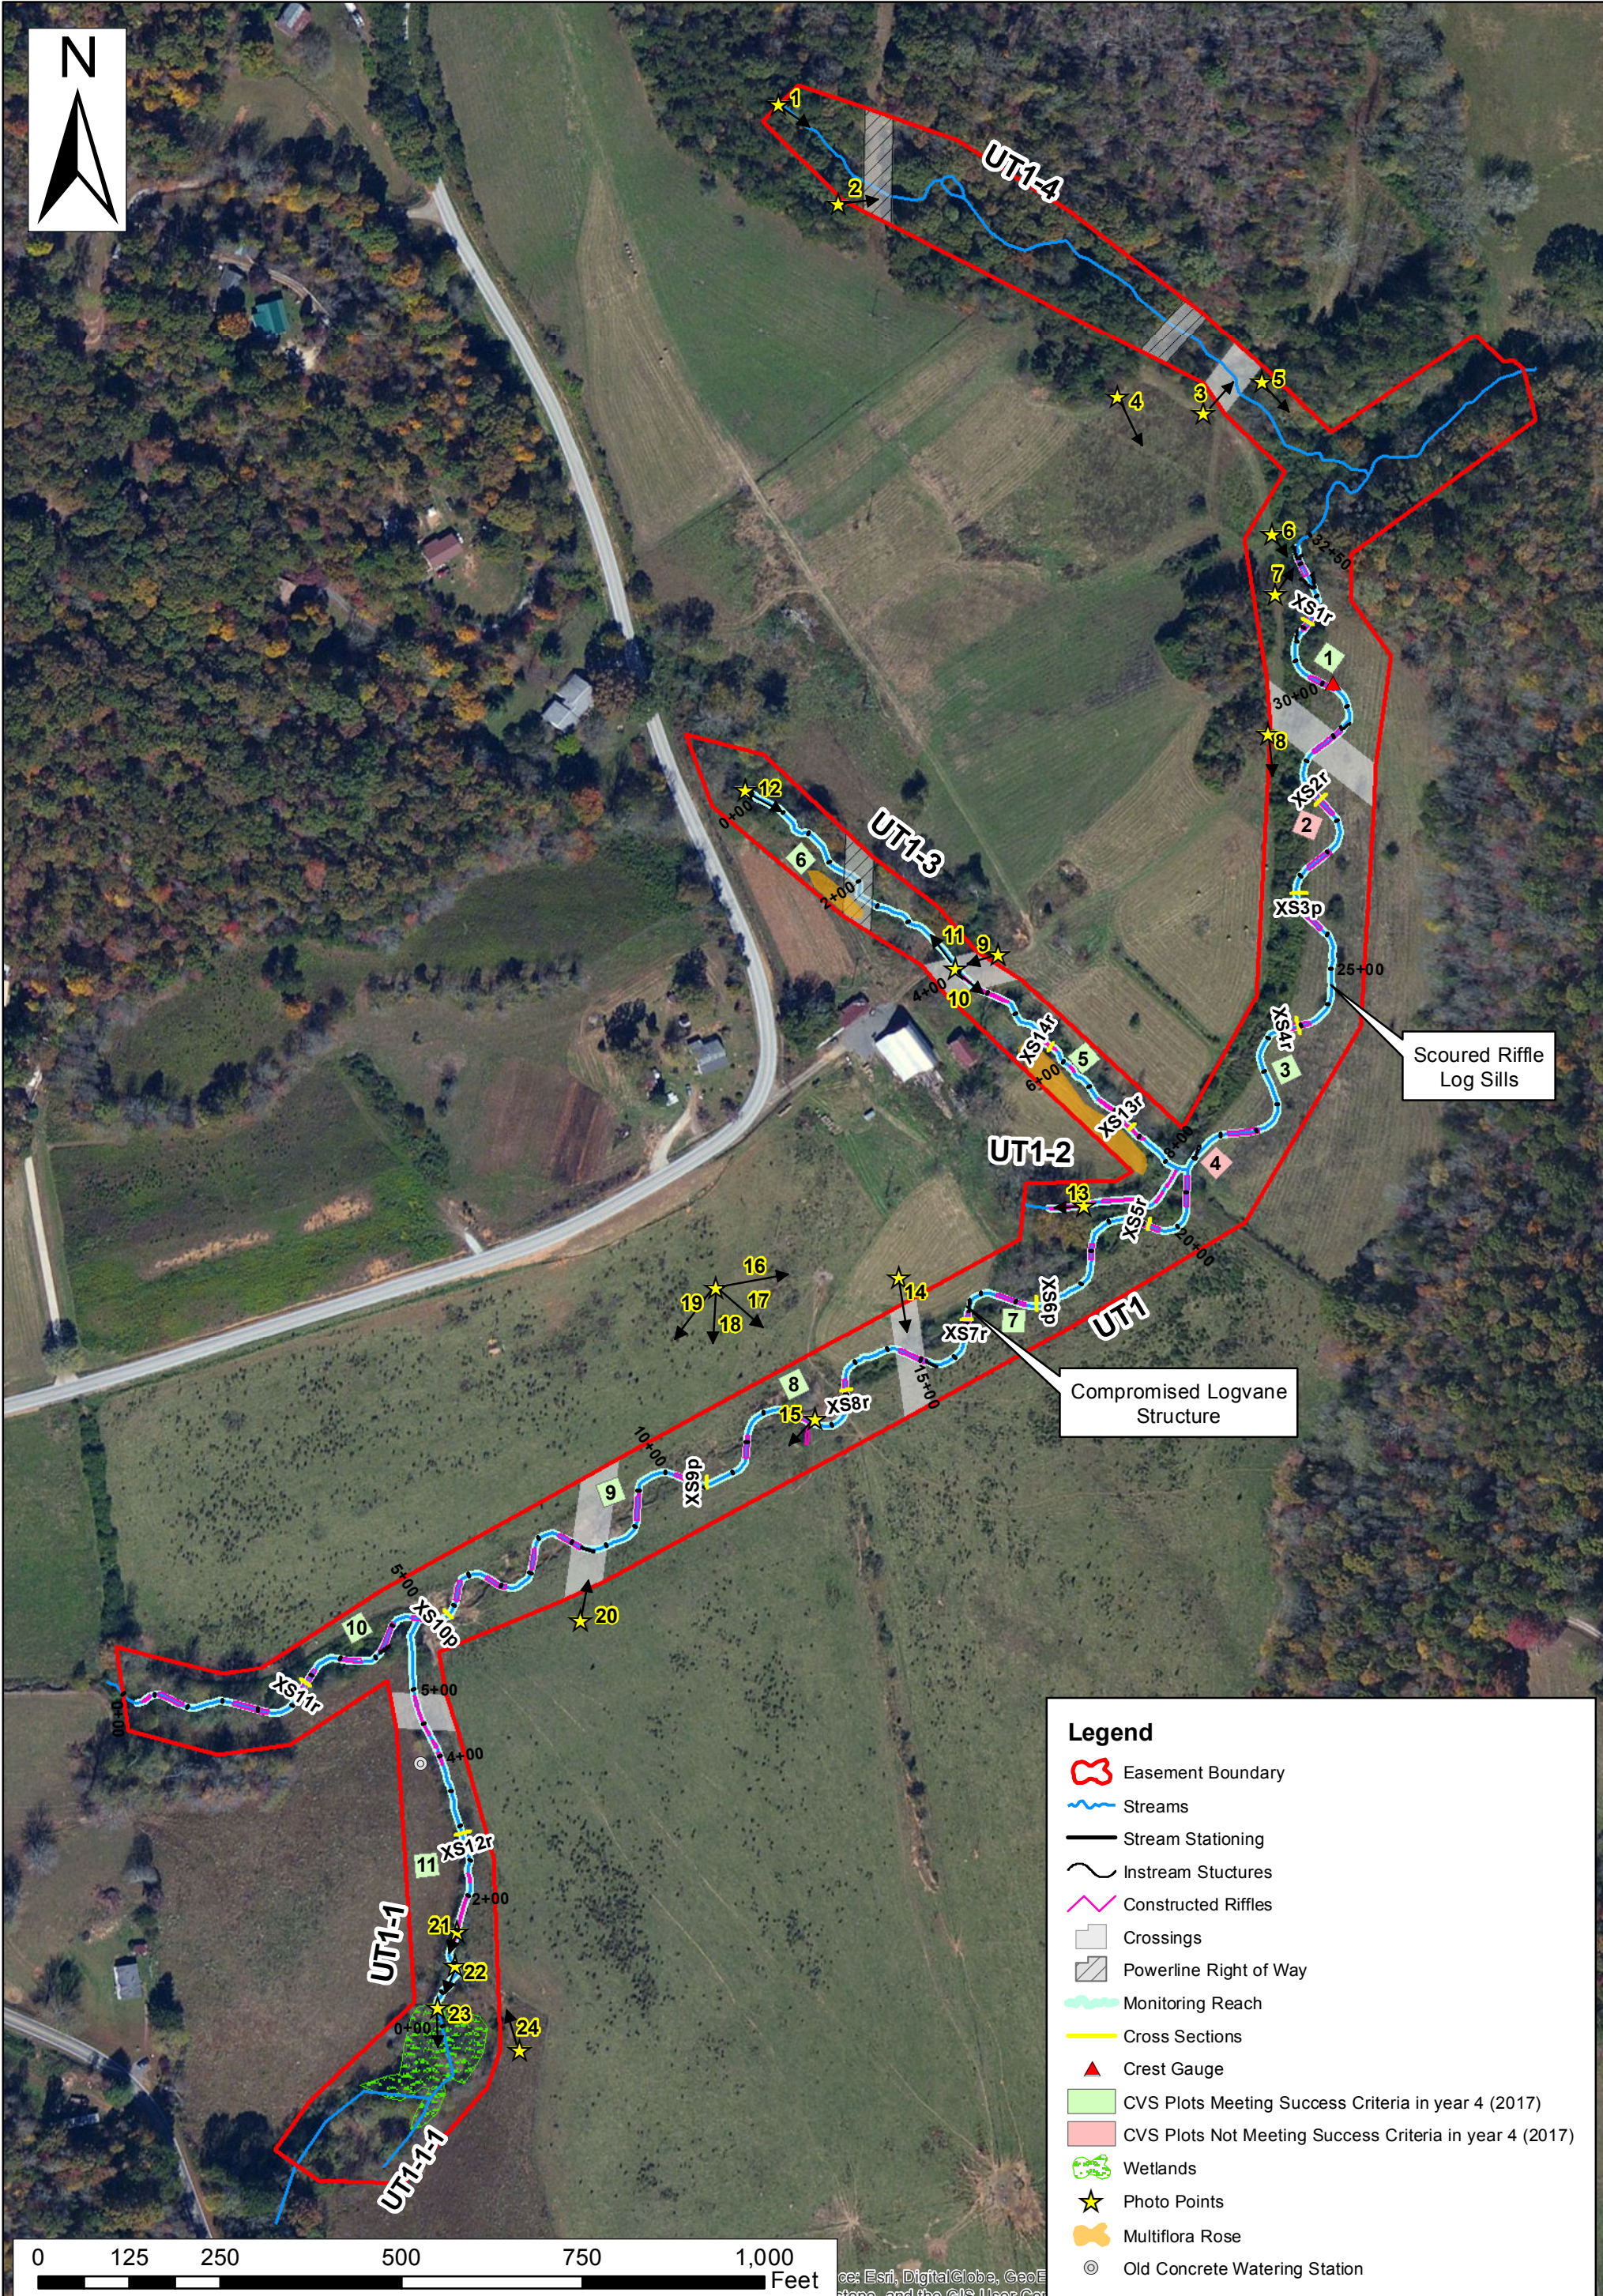
**CURRENT CONDITIONS PLAN VIEW  
UT TO MARTINS CREEK (CONTRERAS)  
DMS PROJECT # 92766  
Cherokee County, North Carolina**

Two areas of concern were noted along UT-1 during Year 3 (2016), and both remained relatively unchanged during Year 4 (2017). One area consists of a section of log sills constructed within a riffle near station 25+00. The riffle bed material surrounding the log structures has scoured resulting in pools through this section of stream. This issue was first identified during Year 3 (2016), and it continues to appear unstable; however, it has not worsened significantly in the past year which may indicate more stability than originally assumed. An additional area of concern includes a log vane structure along the right bank of UT-1, just downstream from cross-section 7. The footer log of the structure has failed and become partially dislodged, and the downstream end of the log appears to move freely with the flow of the stream. However, it has continued to maintain grade along the upstream riffle, and it appears to be in a similar state as it was originally observed. Thus, the structure may be more stable than was reported during Year 3 (2016). These areas of concern will be closely monitored during the remainder of the monitoring period. Stream areas of concern are depicted on Figure 2 and quantified in Table 5A (Appendix B).

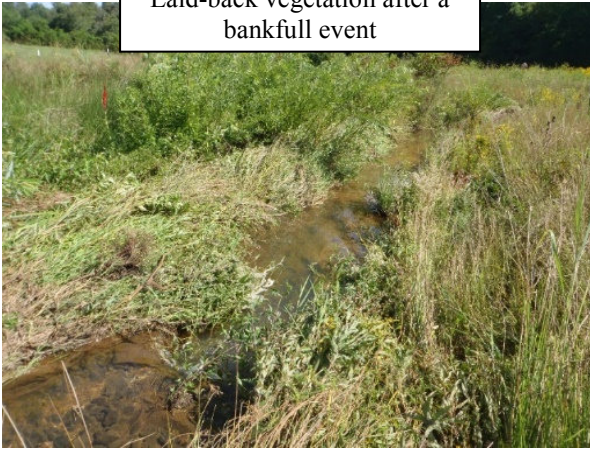
Bankfull Photo 1:  
Laid-back vegetation after a  
bankfull event

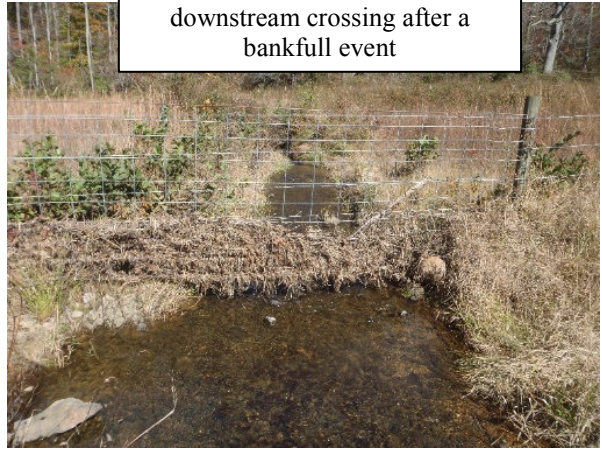
Bankfull Photo 2:  
Wrack on the fence at the  
downstream crossing after a  
bankfull event

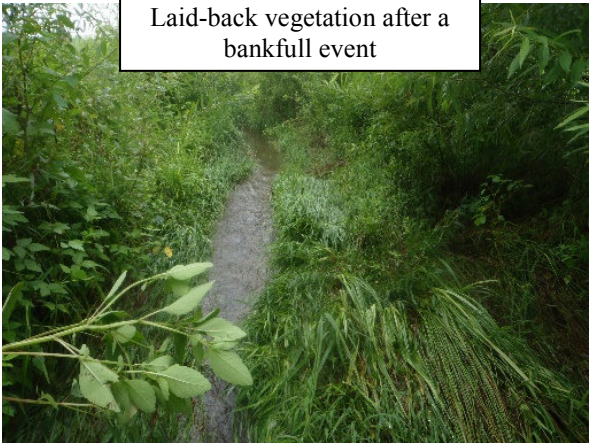
Bankfull Photo 3:  
Laid-back vegetation after a  
bankfull event

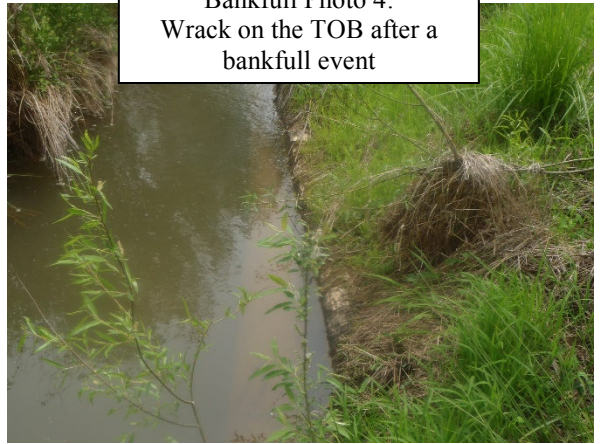
Bankfull Photo 4:  
Wrack on the TOB after a  
bankfull event

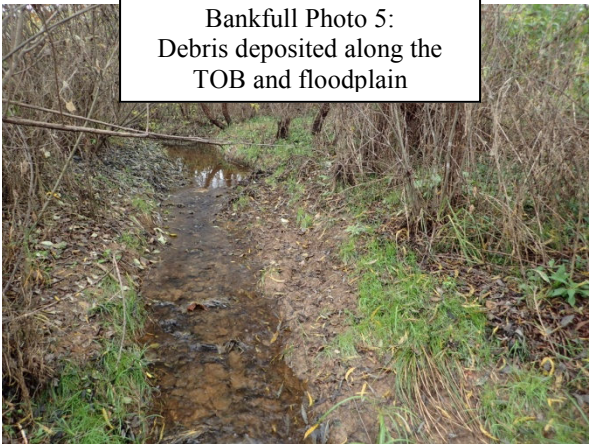
Bankfull Photo 5:  
Debris deposited along the  
TOB and floodplain

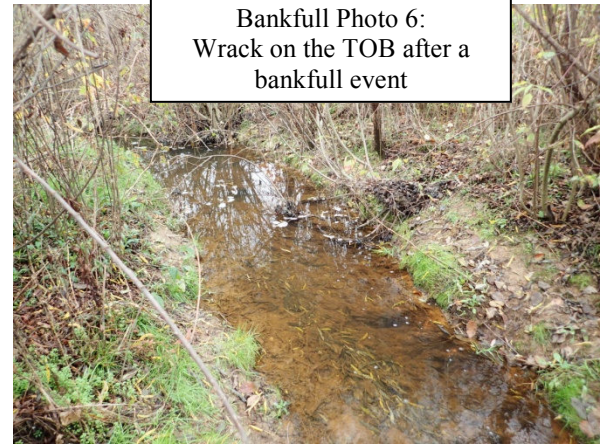
Bankfull Photo 6:  
Wrack on the TOB after a  
bankfull event
