CANE & MARYS STREAM RESTORATION PROJECTS

MONITORING REPORT (YEAR 1 OF 5)

Alamance County, North Carolina
SCO Project Number 01055150A
EEP Project Number CMC/CPF/02

Status of Plan: Draft
Submission Date: March 2007

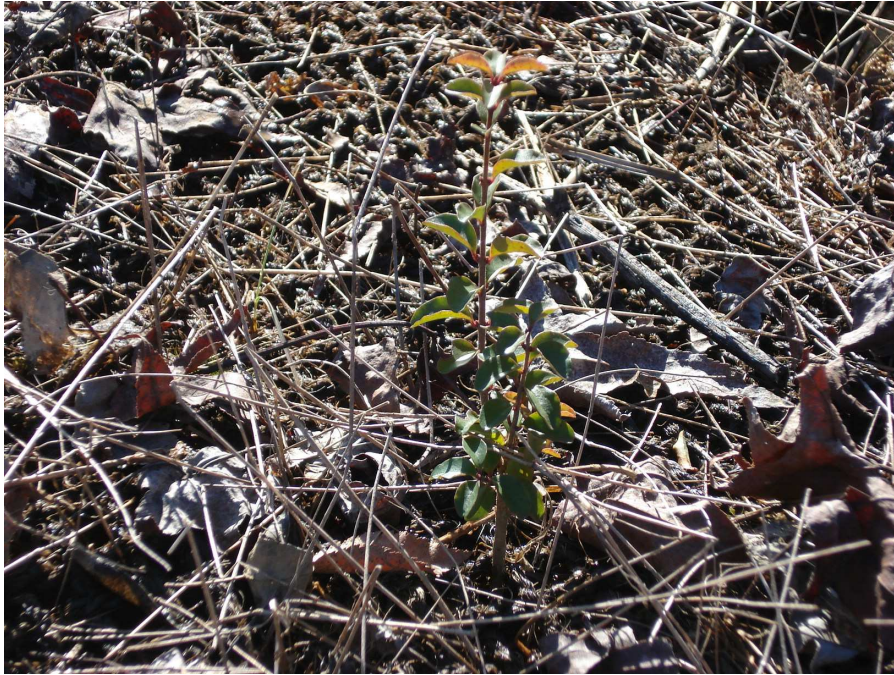
Photo VPA1: Small privet sapling at UT to Marys Creek Tributary Vegetation Plot

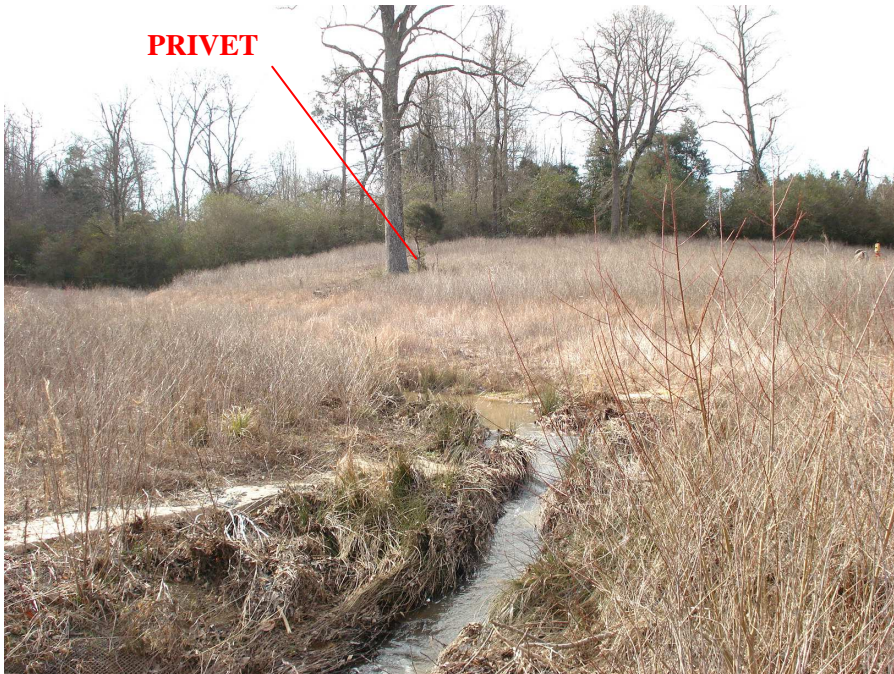
Photo VPA2: Larger privet near UT to Marys Creek Tributary Vegetation Plot

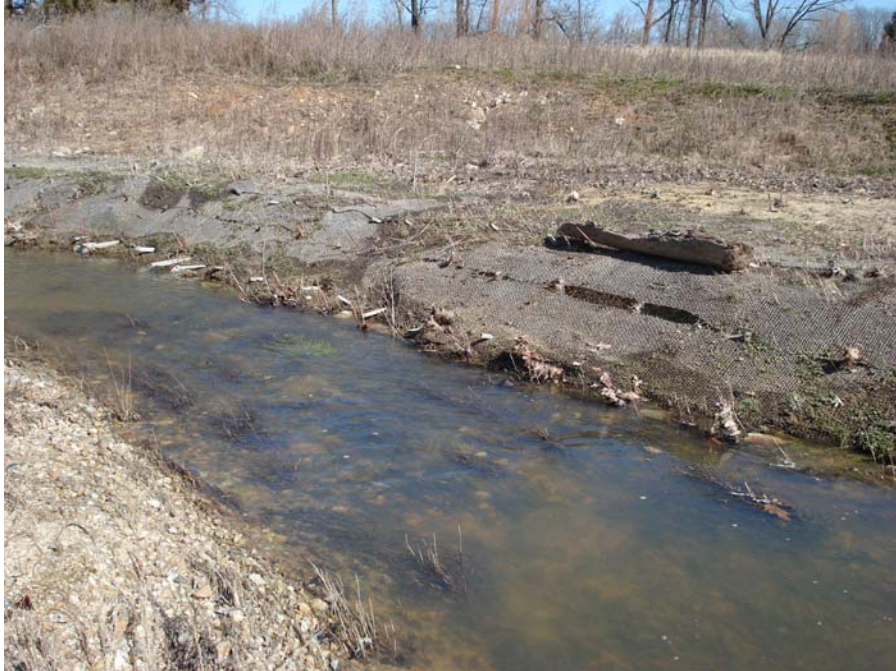
Right Bank STA 11+50 – The outside of this meander bend has very poor establishment of vegetation, that has led to excess bank erosion underneath a degrading erosion control matting. The causes of the instability might be due to over compaction of the soil during construction.

Photo VPA3: Corresponds to SP4 – bare banks and floodplain on UT Cane Creek

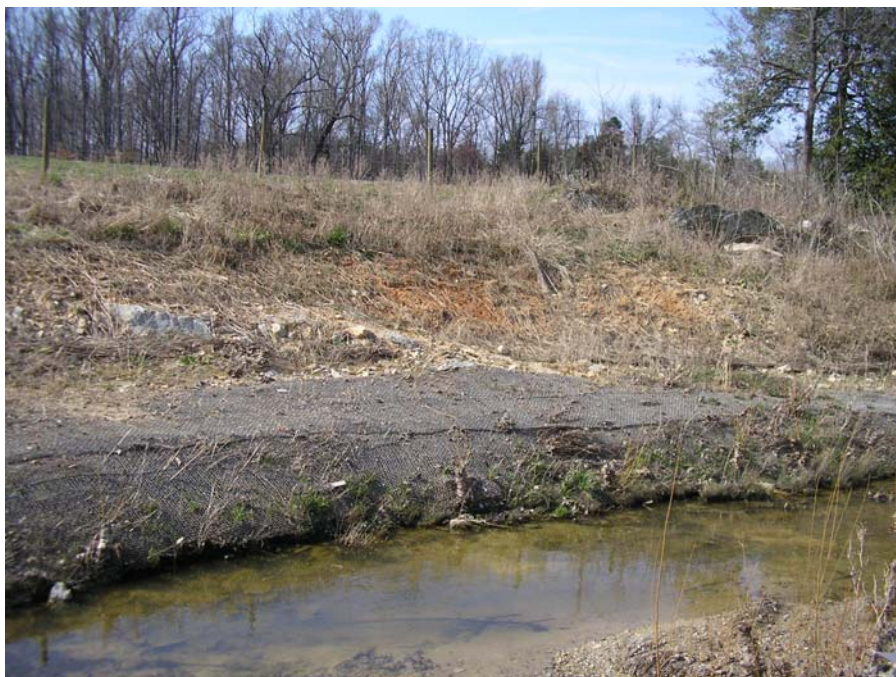
Photo VPA4: Bare left bank on UT Cane Creek

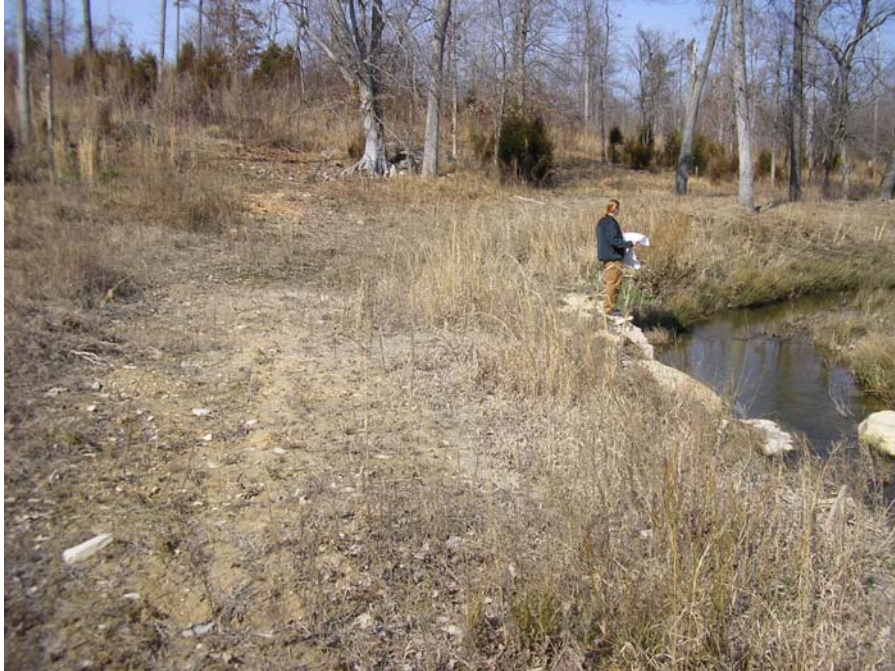
Photo VPA5: Bare left floodplain on UT Cane Creek

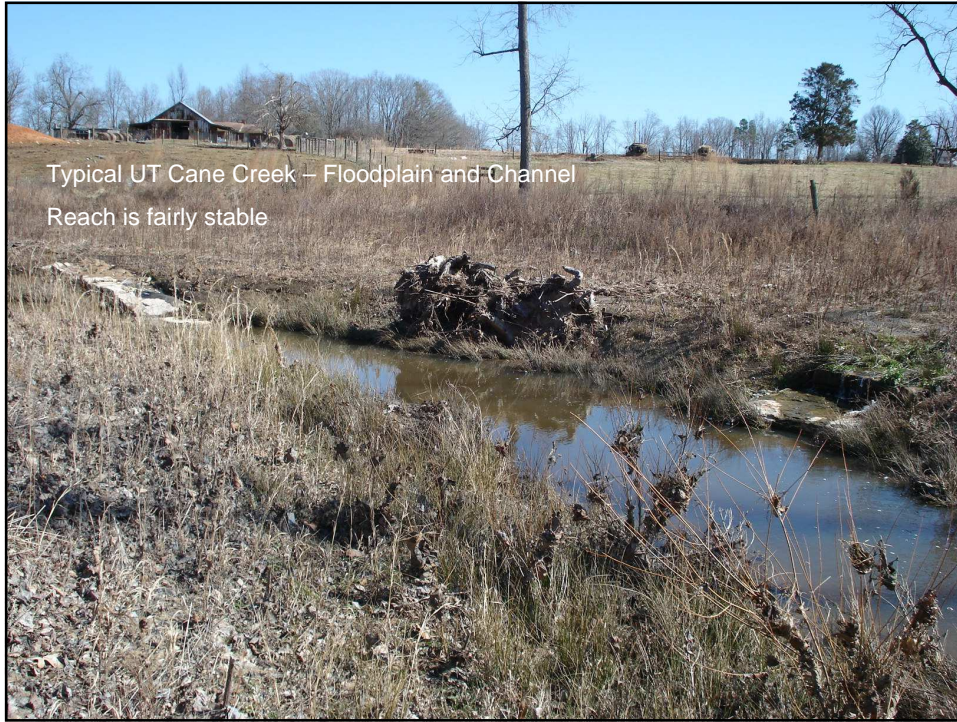
Typical UT Cane Creek – Floodplain and Channel
Reach is fairly stable

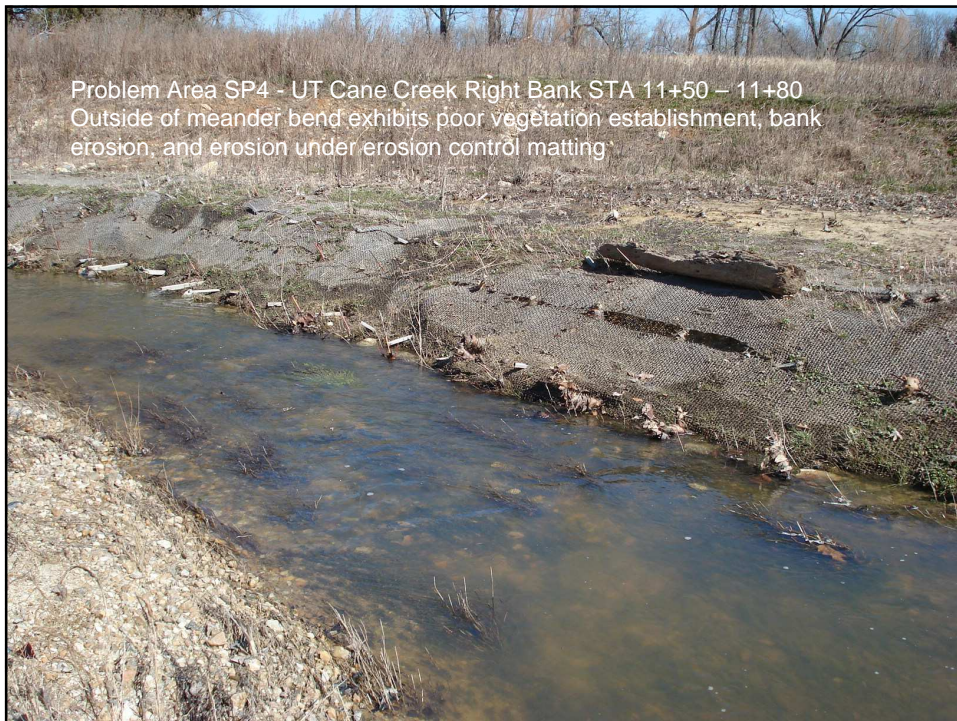
Problem Area SP4 - UT Cane Creek Right Bank STA 11+50 – 11+80
Outside of meander bend exhibits poor vegetation establishment, bank erosion, and erosion under erosion control matting
