UT to Mary's Creek Stream Restoration Site

2008 Annual Monitoring Report (Year 2)

Alamance County
EEP Project No. 241
Design Firm: Stantec Consulting Services, Inc.

May 2009

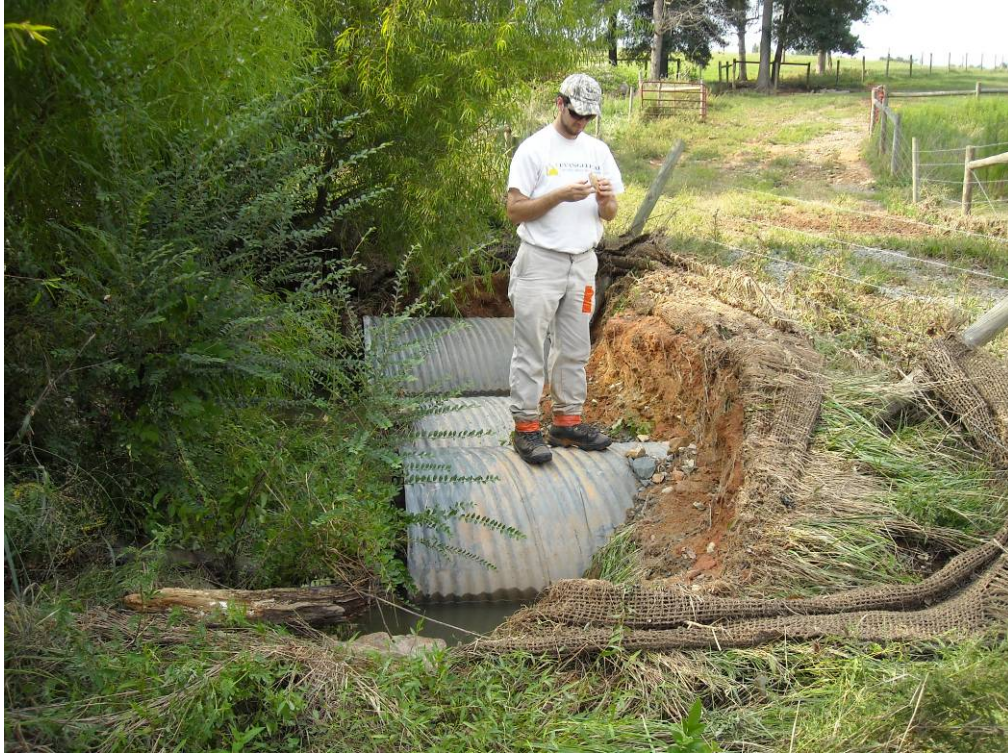
Photo 1. Erosion occurred around culverts during bankfull event in September 2008. Notice on the left the one of many invasive exotic Chinese privet (*Ligustrum sinense*) shrubs observed on site.

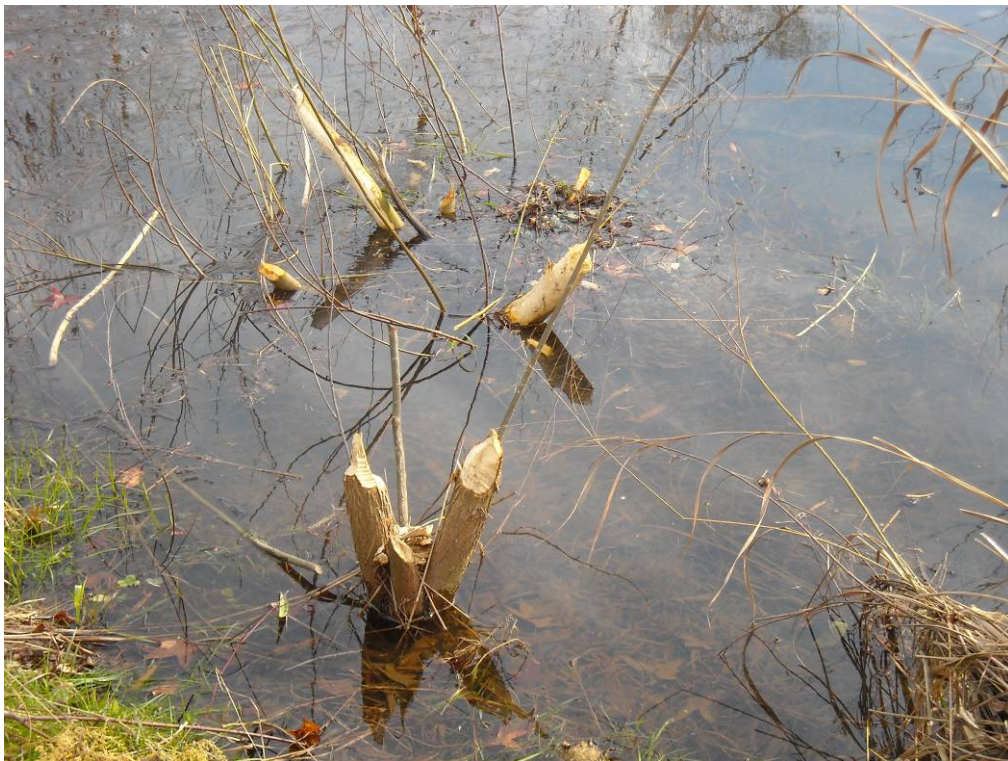
Photo 2. Beaver gnawed limestakes used for lodge and dam construction.

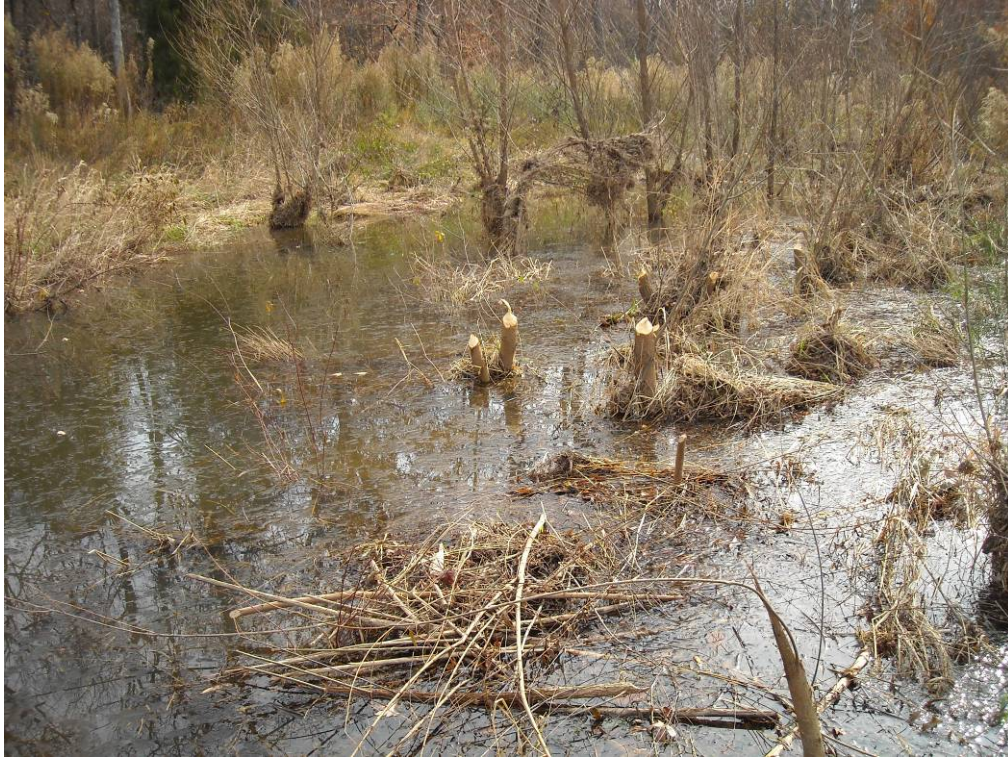
Photo 3. Beaver gnawed livestakes downstream of the cattle crossing.

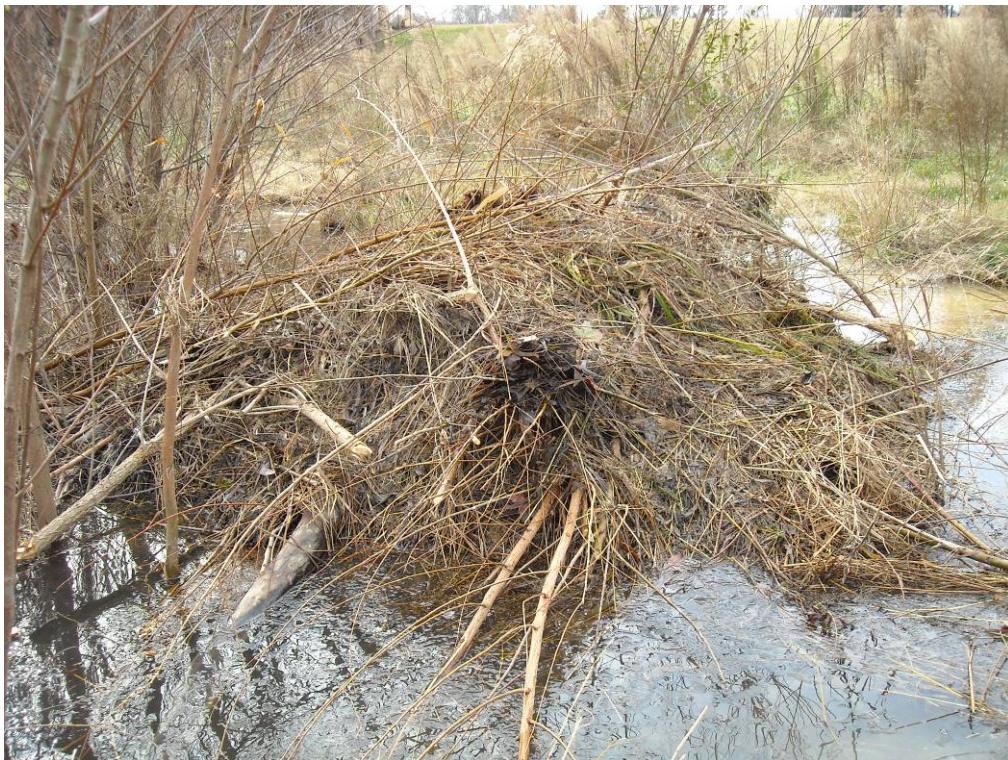
Photo 4. A beaver lodge constructed of a mix of livestakes planted along the stream.

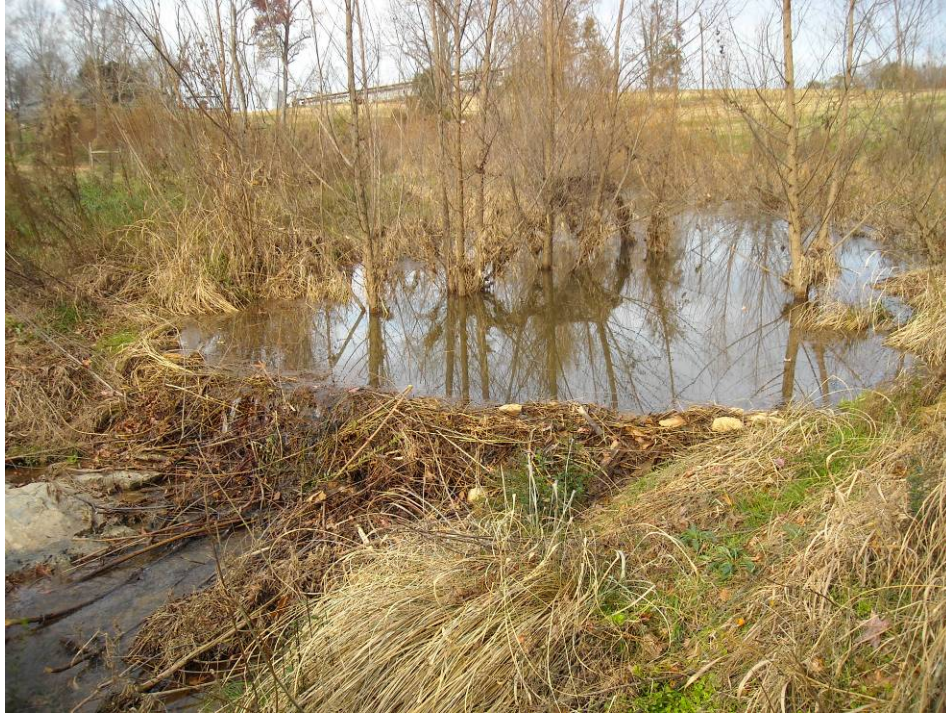
Photo 5. Beaver dam constructed of livestakes gnawed by beaver upstream.

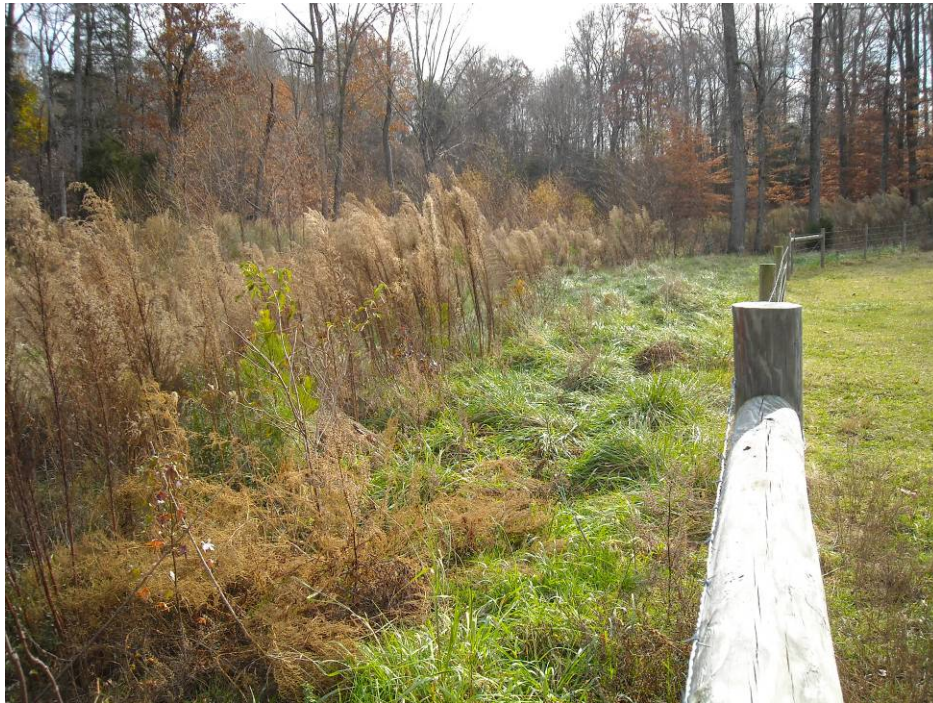
Photo 6. Tall fescue encroaching the conservation easement on the south side of the stream downstream of the cattle crossing.

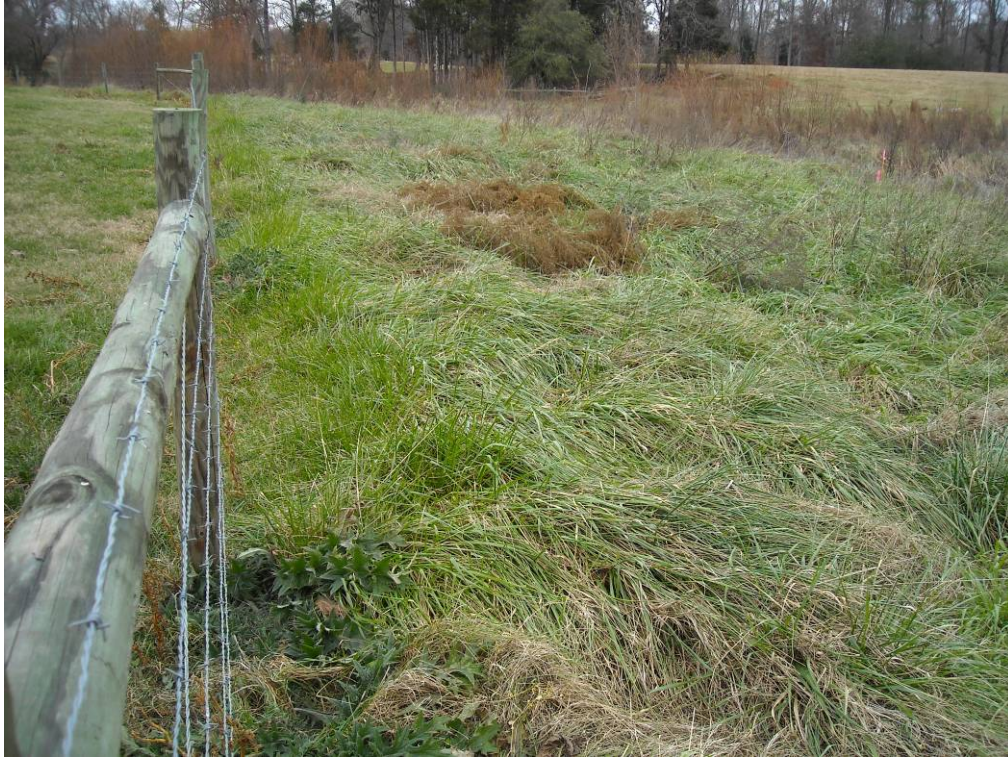
Photo 7. Tall fescue encroaching conservation easement on the north side of the stream upstream of the confluence with the tributary.

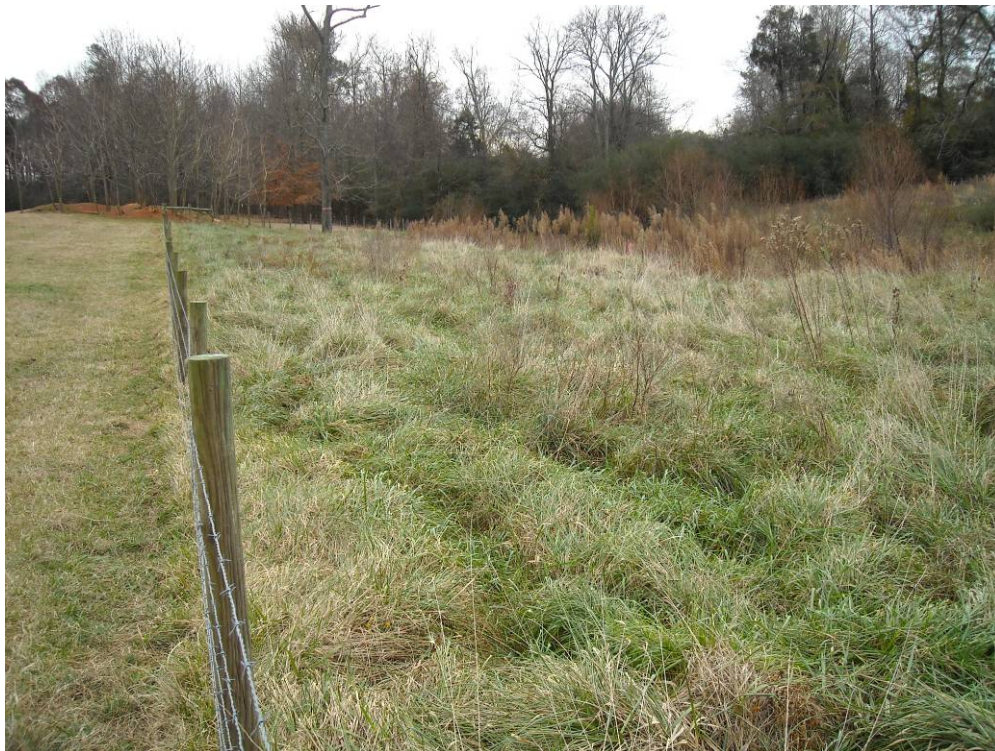
Photo 8. South facing view of tall fescue encroaching conservation easement east of the tributary.

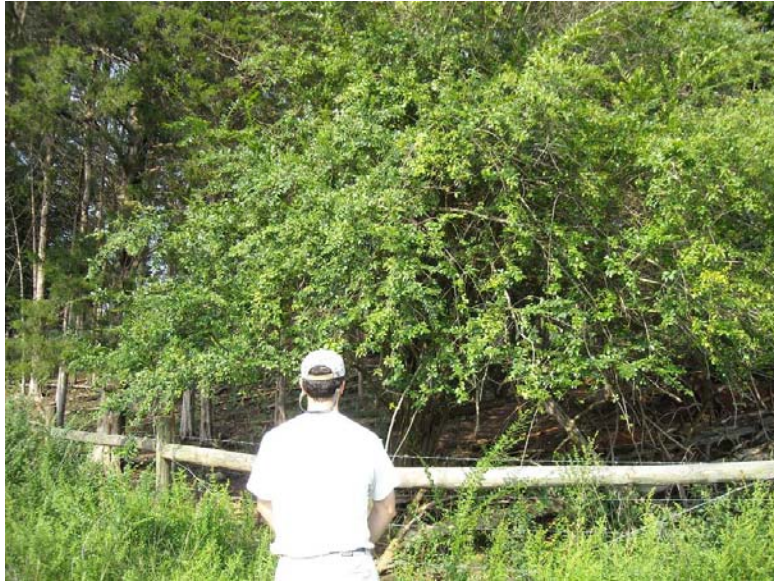
Photo 9. One of many Chinese privet shrubs observed throughout the area.

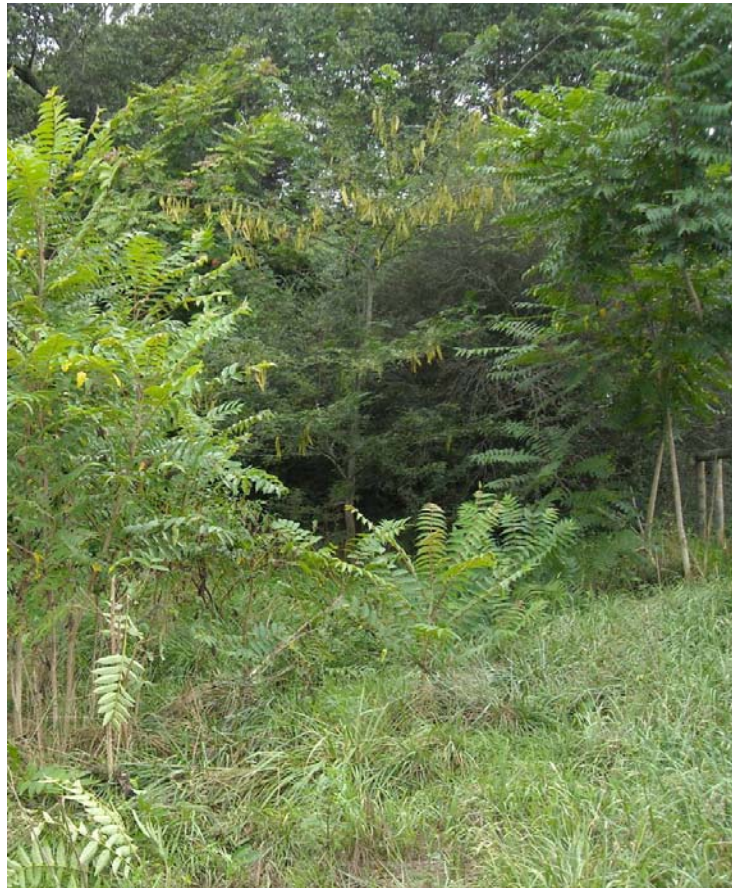
Photo 10. A colony of tree of heaven (*Ailanthus altissima*) located near the upstream end of the stream.

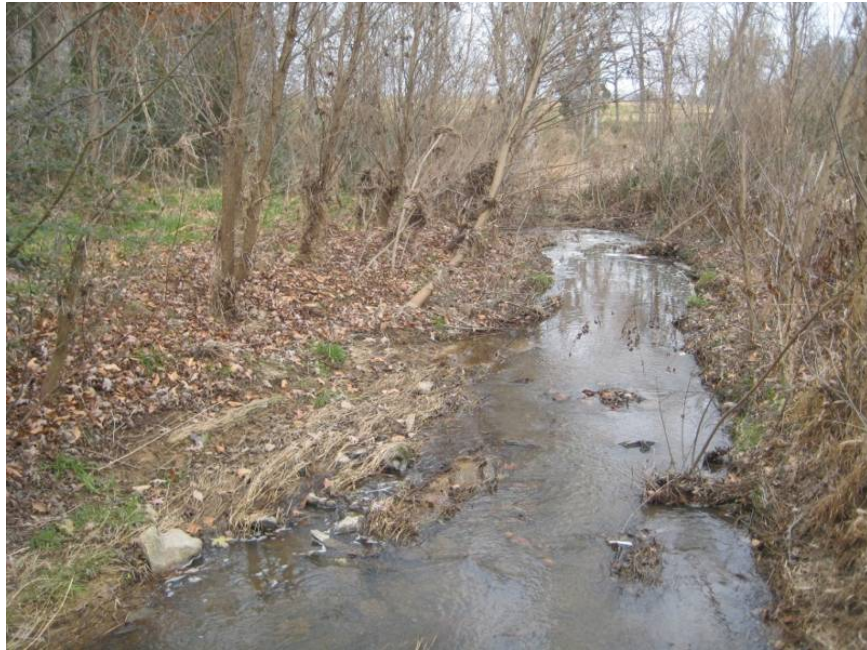
SPA 2 (Area of Concern) Light Erosion on Left Bank

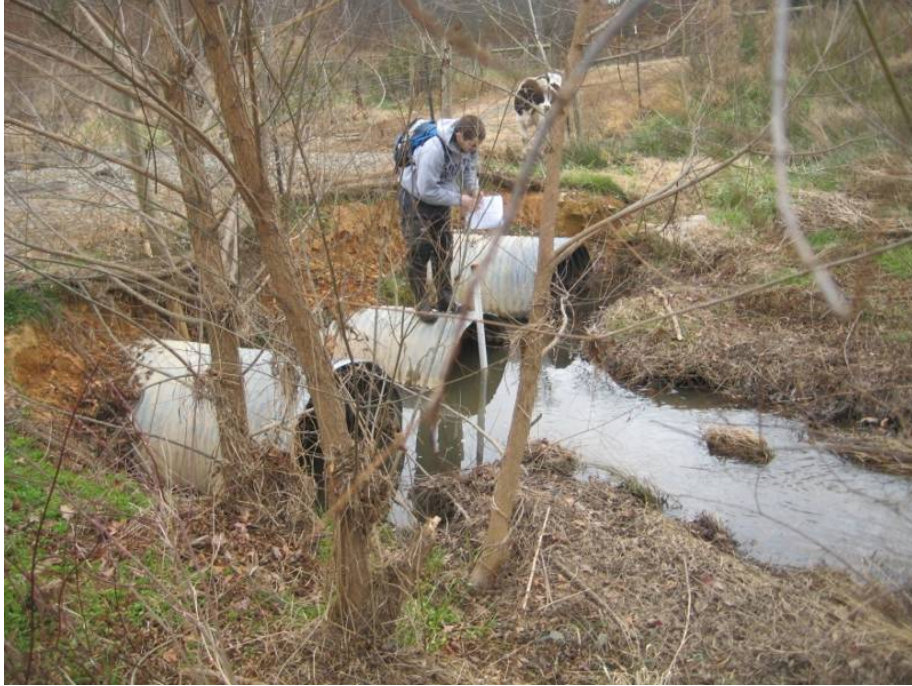
SPA 5A Upstream of Crossing

Overall Mary's Creek has problem areas that are limited in number and extent; a 30 foot segment of bank erosion, one structure that has limited piping, erosion and deposition around the stream crossing, and the beaver impacts. The main area of concern is the condition of the stream crossing, which has significant erosion on the upstream side roadway embankment and will most likely continue to degrade. The over-widened channel built for the triple culverts have narrowed to a single channel width centered on the middle culvert on the upstream and downstream side of the culverts, thereby limiting the culverts capacity to pass large storm events. It appears that the road has been overtopped during storm events since upstream roadway embankment has eroded several feet exposing the culverts. The overflow is causing the stone on the roadway to wash into the stream. The culverts are flooded to an approximate depth of 1.8 feet during normal flows which are approximately 2/3 of the available culvert area. Sediment deposits just upstream and downstream of the culverts have formed elevated riffles.

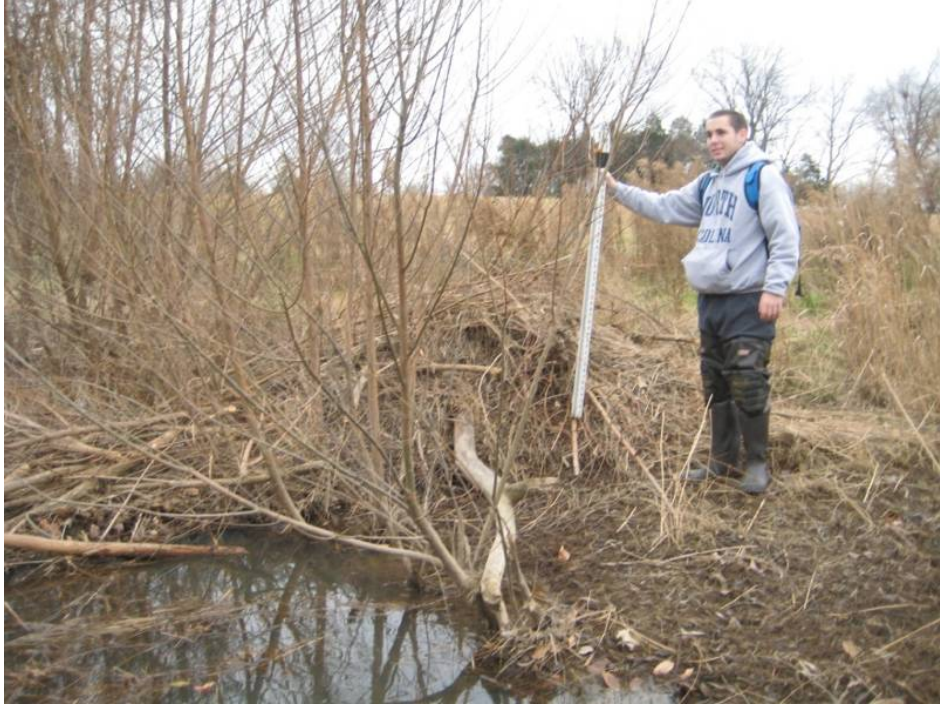
SPA 6A Beaver Hut

Beaver Population	23+50	Beaver hut on right bank. Beavers are causing bank, vegetation, and stream damage.	SPA 6A
	23+65		
Beaver Dam	24+60	Beaver dam, causing backwater upstream to crossing. Structure and design functional loss of stream.	SPA 6B
	24+60		
Bank Undercut and Erosion	24+65	Bank undercutting, a result of upstream beaver dam and bedrock, are concentrating flows to left bank.	SPA 7
	24+95		
Bank Erosion and Scour	25+40	Right bank erosion and scour occurring, no structure and high fast flows accompanied by steep upstream riffle.	SPA 8
	26+00

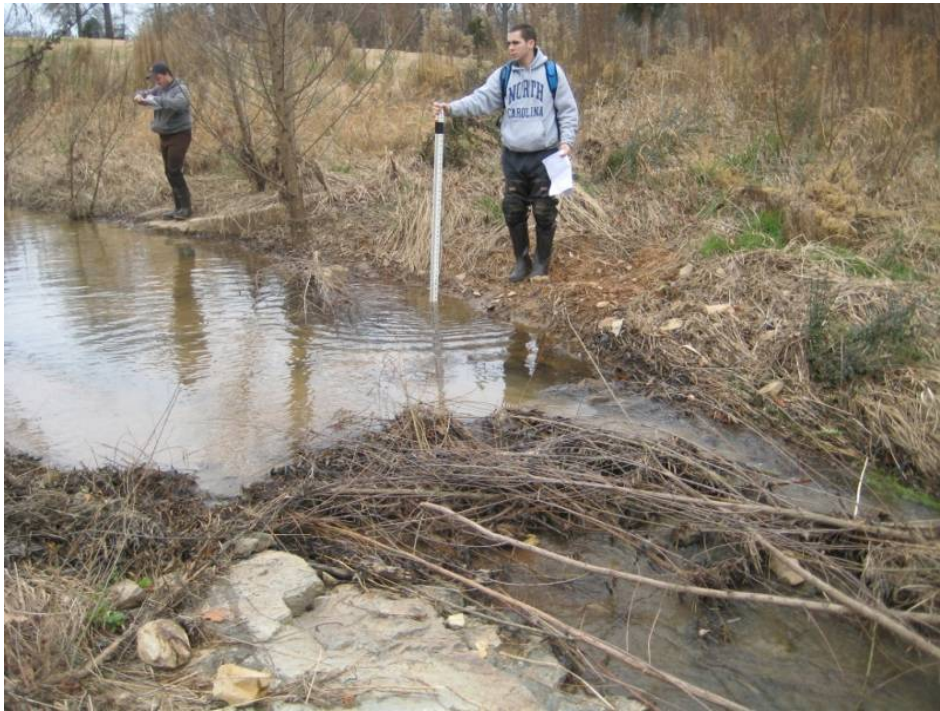
SPA 6B Beaver Dam

The beaver dam also has significant effects on Mary's Creek. The dam elevation is 498.6 feet and is located on a bedrock outcrop with an elevation 497.6 feet at station 24+67. It is causing backwater for a distance of approximately 365 feet to station 21+00. The location of the dam downstream of the culverts is adversely impacting their functionality. It should be noted that a bedrock outcrop exists at the beaver dam location, which, in the absence of the beaver dam, would still cause some backwater effects. Problem area photos are located in Appendix B for Mary's Creek.

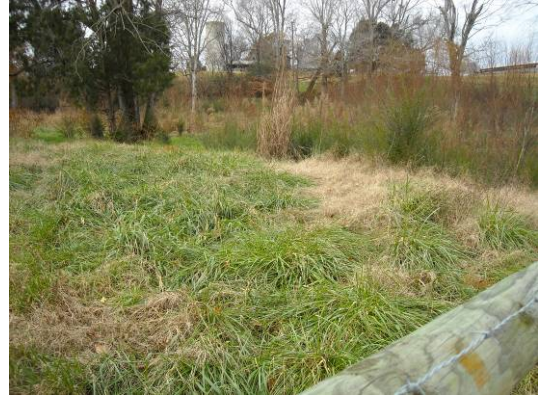
Photo Station 16. West facing view of tall fescue encroaching the easement.

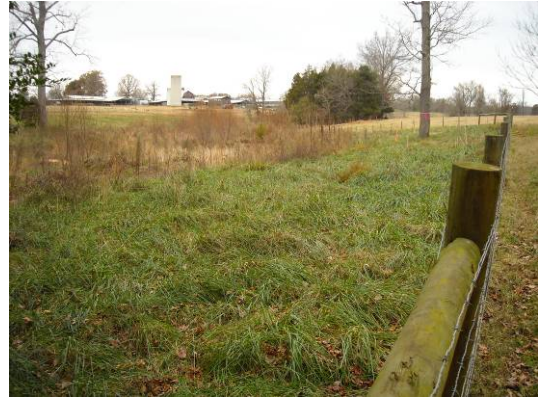
Photo Station 17. Northwest view of easement with encroaching tall fescue.
