Mary's Creek (EEP #241) Restoration Site

2009 Annual Monitoring Report (Year 3)

Alamance County
EEP Project No. 241
Design Firm: Stantec Consulting Services, Inc.

December 2009

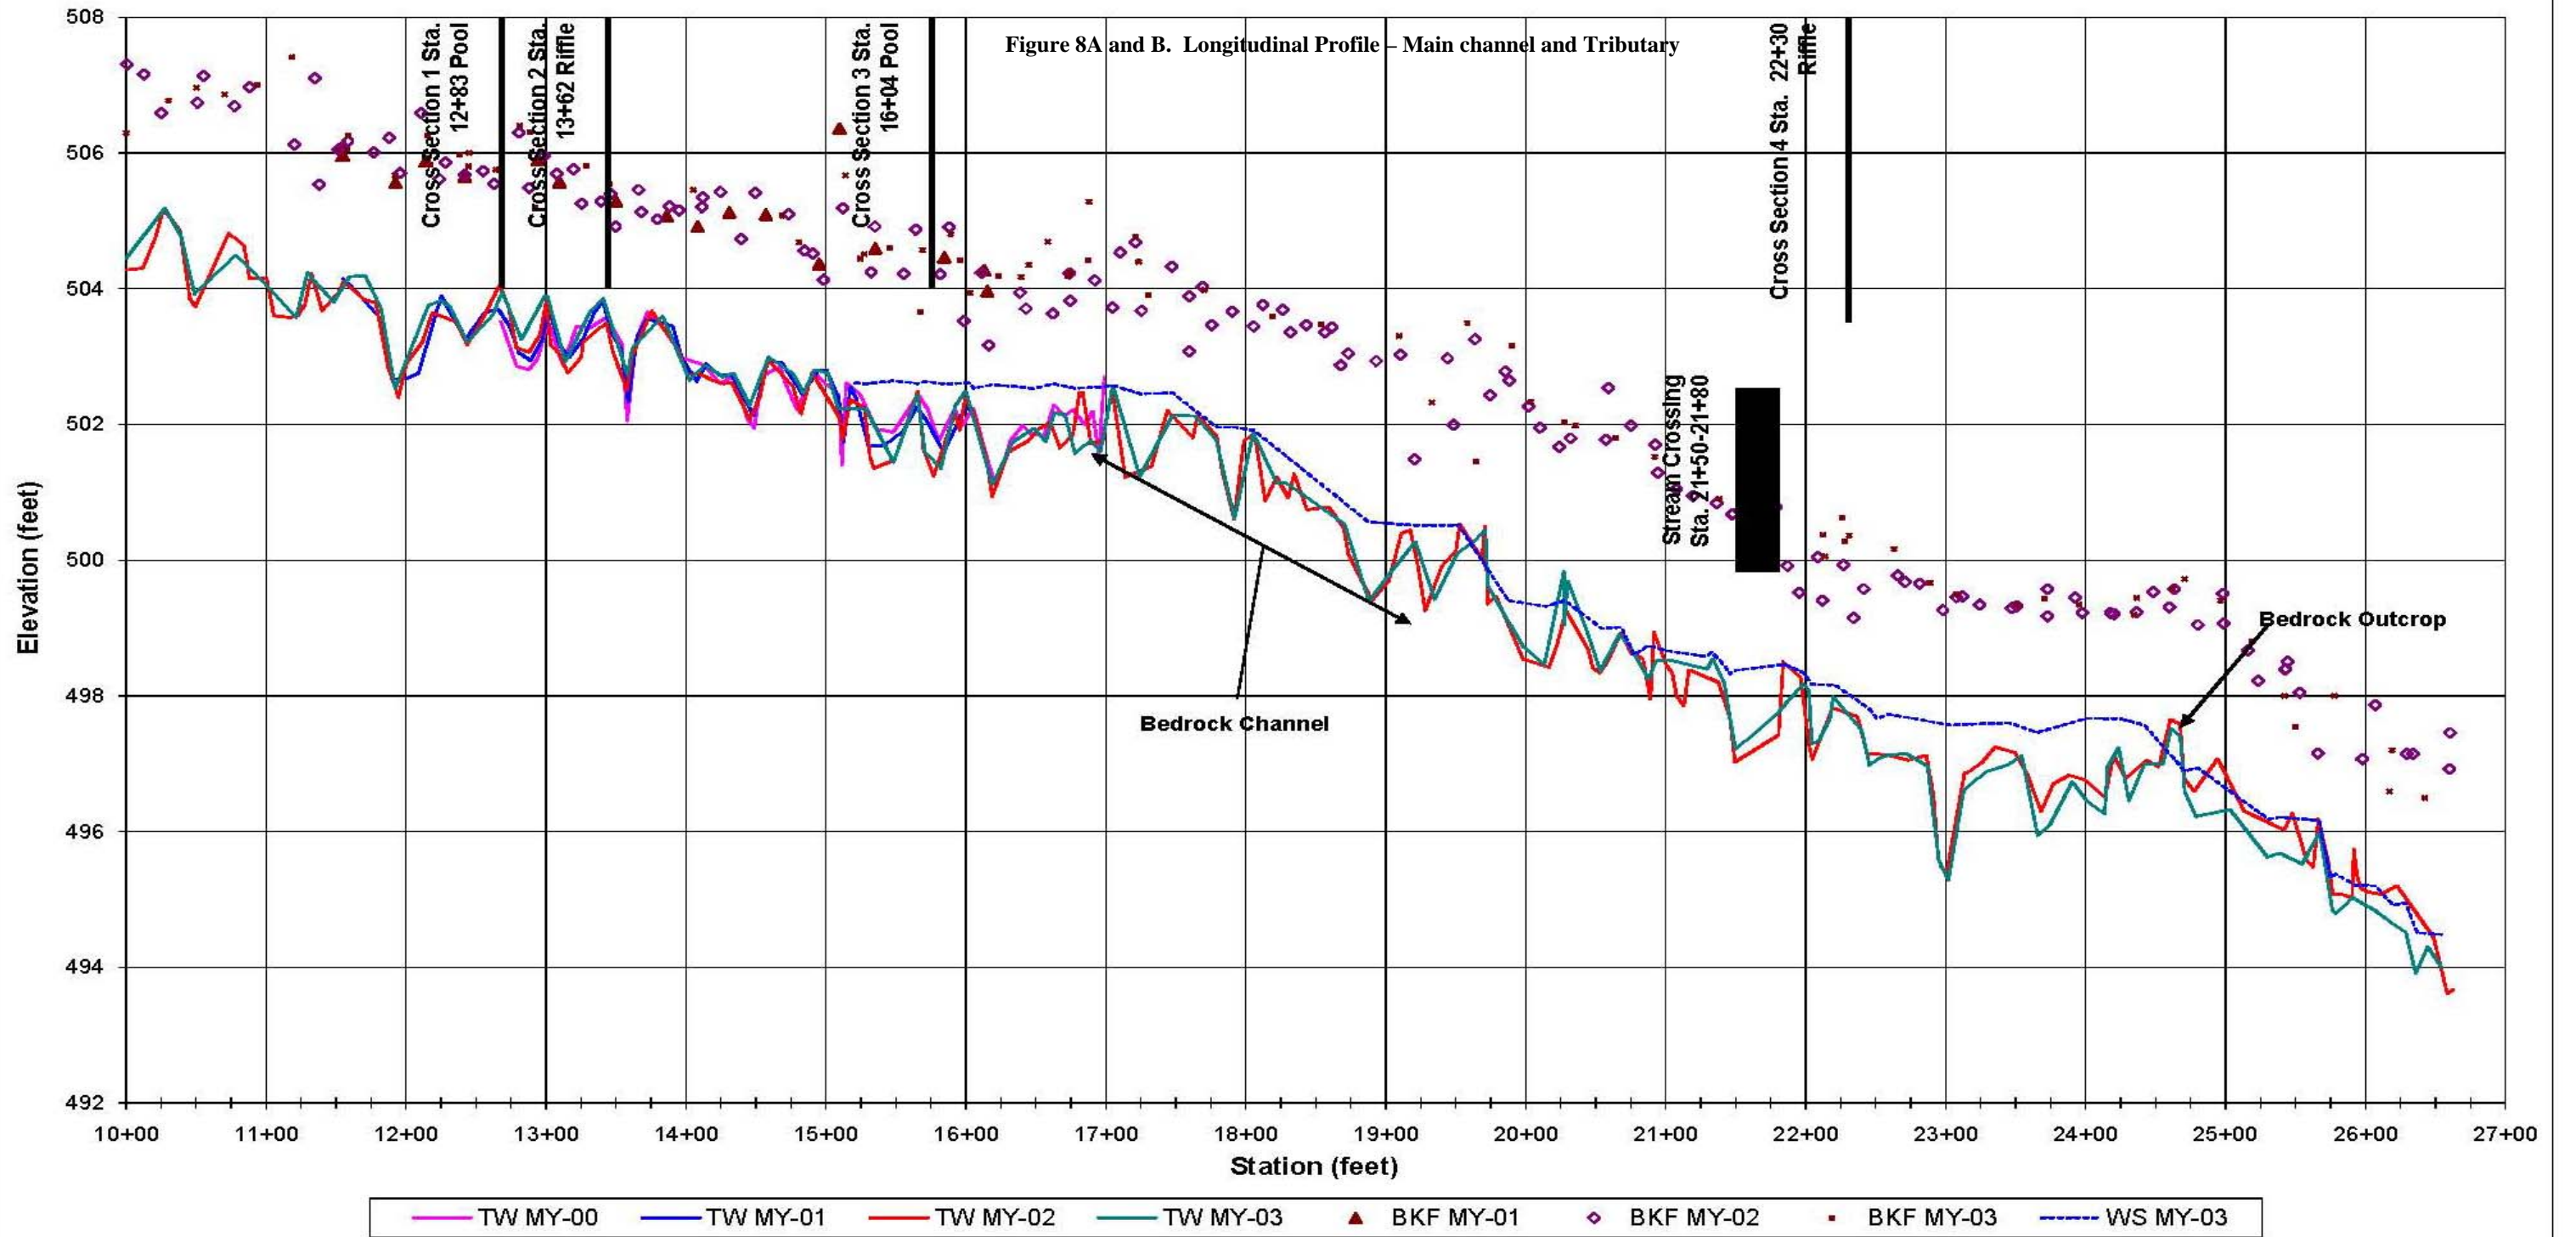
UT to Mary's Creek
 Longitudinal Profile
 Station 10+00-26+62

Changes from MY-02 to MY-03 in Mary's Creek (EEP #241) are minimal. Riffle and pool stability and performance are comparable with the riffles' substrate trending coarser. The beaver dam located on top of the bedrock outcrop (station 24+60) in MY-02 is no longer present, resulting in decreased backwater effects upstream. However, the bedrock does still back water upstream for more than 200 feet. The streambed remains stable with no significant aggradation or degradation. This is also reflected in a comparison of the cross sectional data between MY-02 and MY-03. The structures that had shown problems in MY-02 (stations 19+75 and 20+95) continue to pipe water and further degrade. Additionally, upstream of the crossing at station 21+50 continues to erode around the culverts.

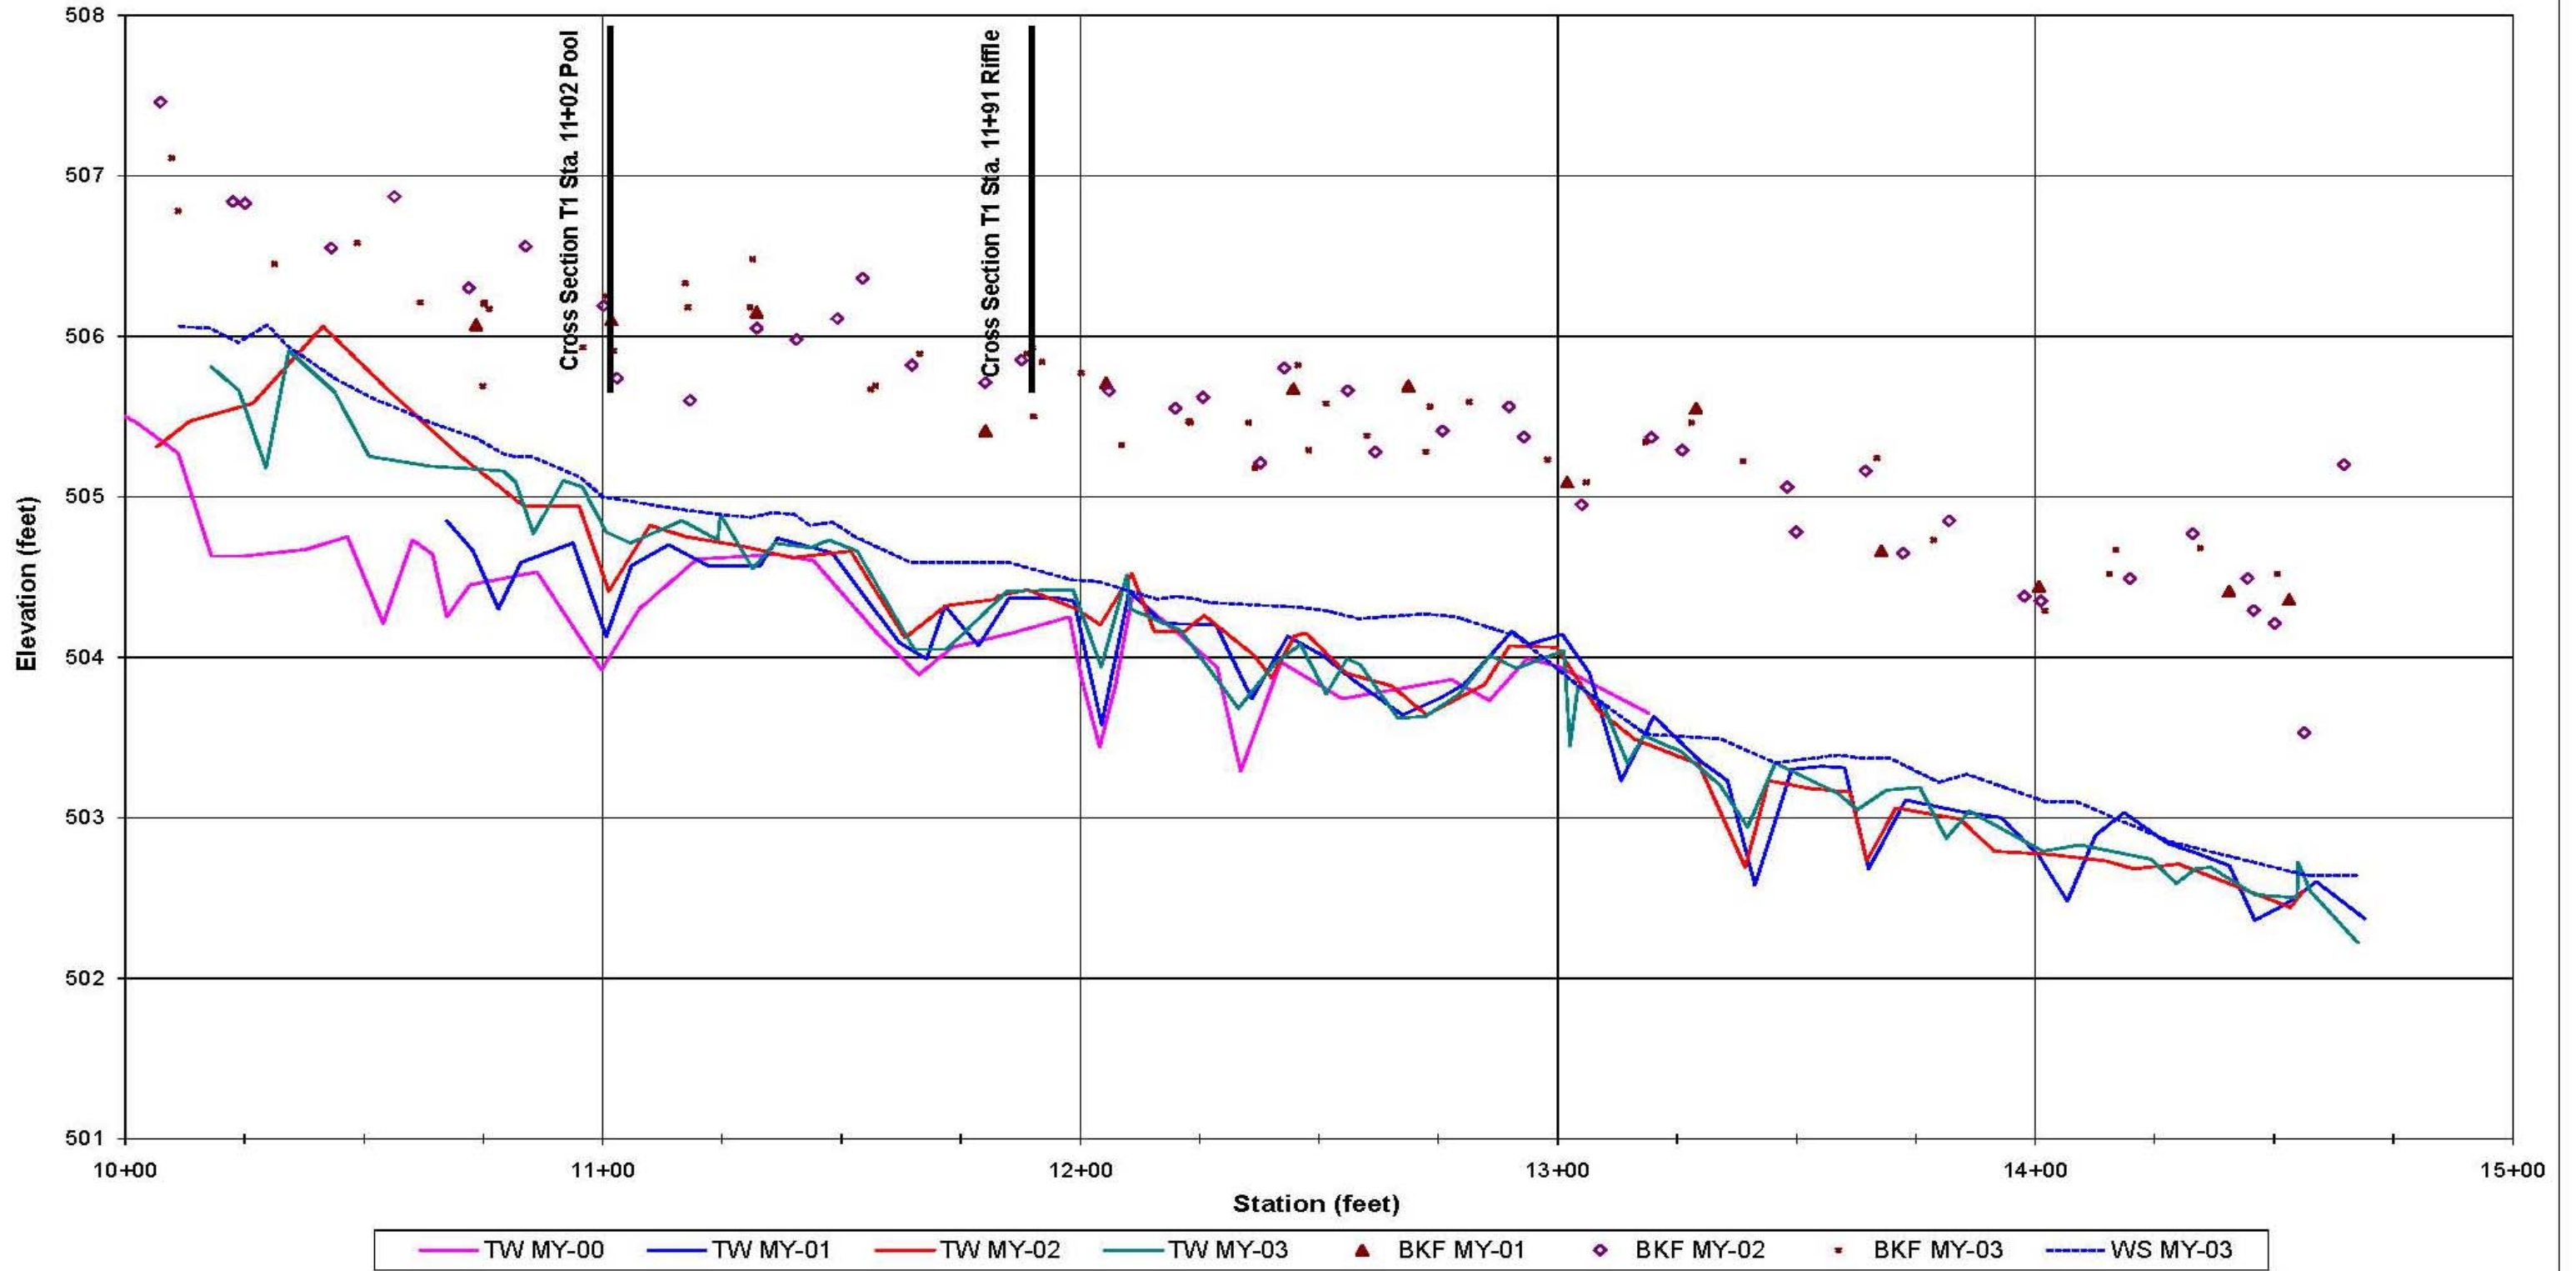
UT to UT to Mary's Creek
 Longitudinal Profile
 Station 10+00-14+70

The unnamed tributary to Mary's Creek (EEP #241) did show some changes between MY-02 and MY-03. Sediment that aggraded at the top of the reach has started to move downstream, filling some of the pools in the upper portion. This is also shown when comparing cross-sectional data between the MY-02 and MY-03. The sediment shift is also evident in the riffle pebble count, which is trending towards a coarser d_{50} . The reach is stable, and the channel is heavily vegetated. No problem areas were noted to the structures, banks, or bed.
