Mary's Creek (EEP #241) Restoration Site

2010 Annual Monitoring Report (Year 4)

Alamance County
EEP Project No. 241
Design Firm: Stantec Consulting Services, Inc.

March 2011

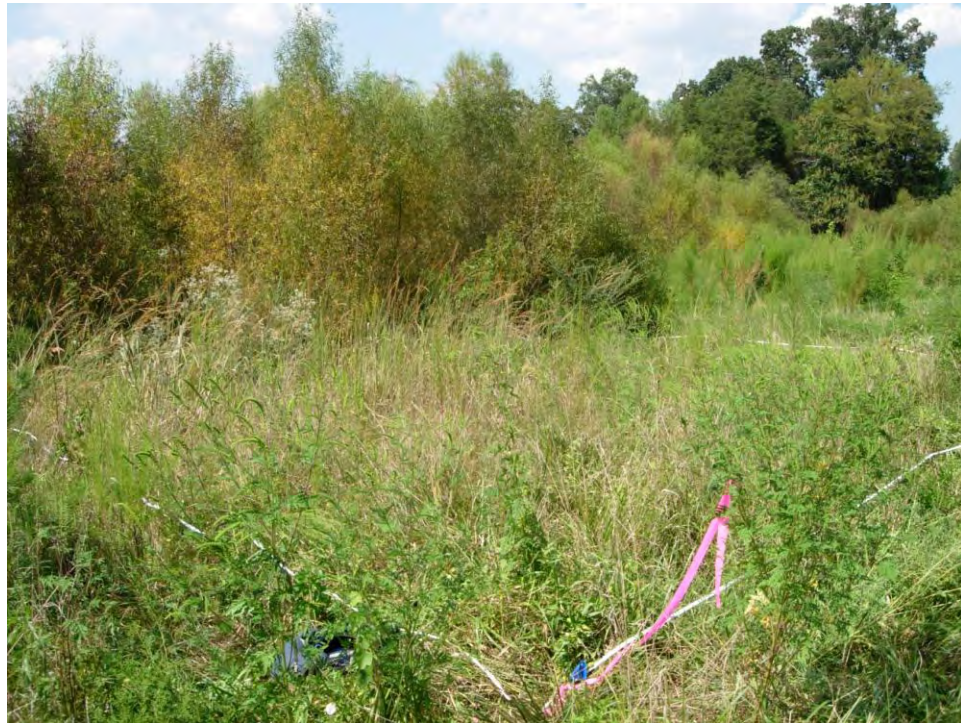
Photo 10. Vegetation Monitoring Plot 4

* Tract mean not met for Plot 4 (121 planted stems/acre), the only plot with confirmed planted stems.
