# Mary's Creek (EEP #241) Restoration Site

## 2011 Annual Monitoring Report (Year 5)

Alamance County  
EEP Project No. 241  
Design Firm: Stantec Consulting Services, Inc.

**March 2012**

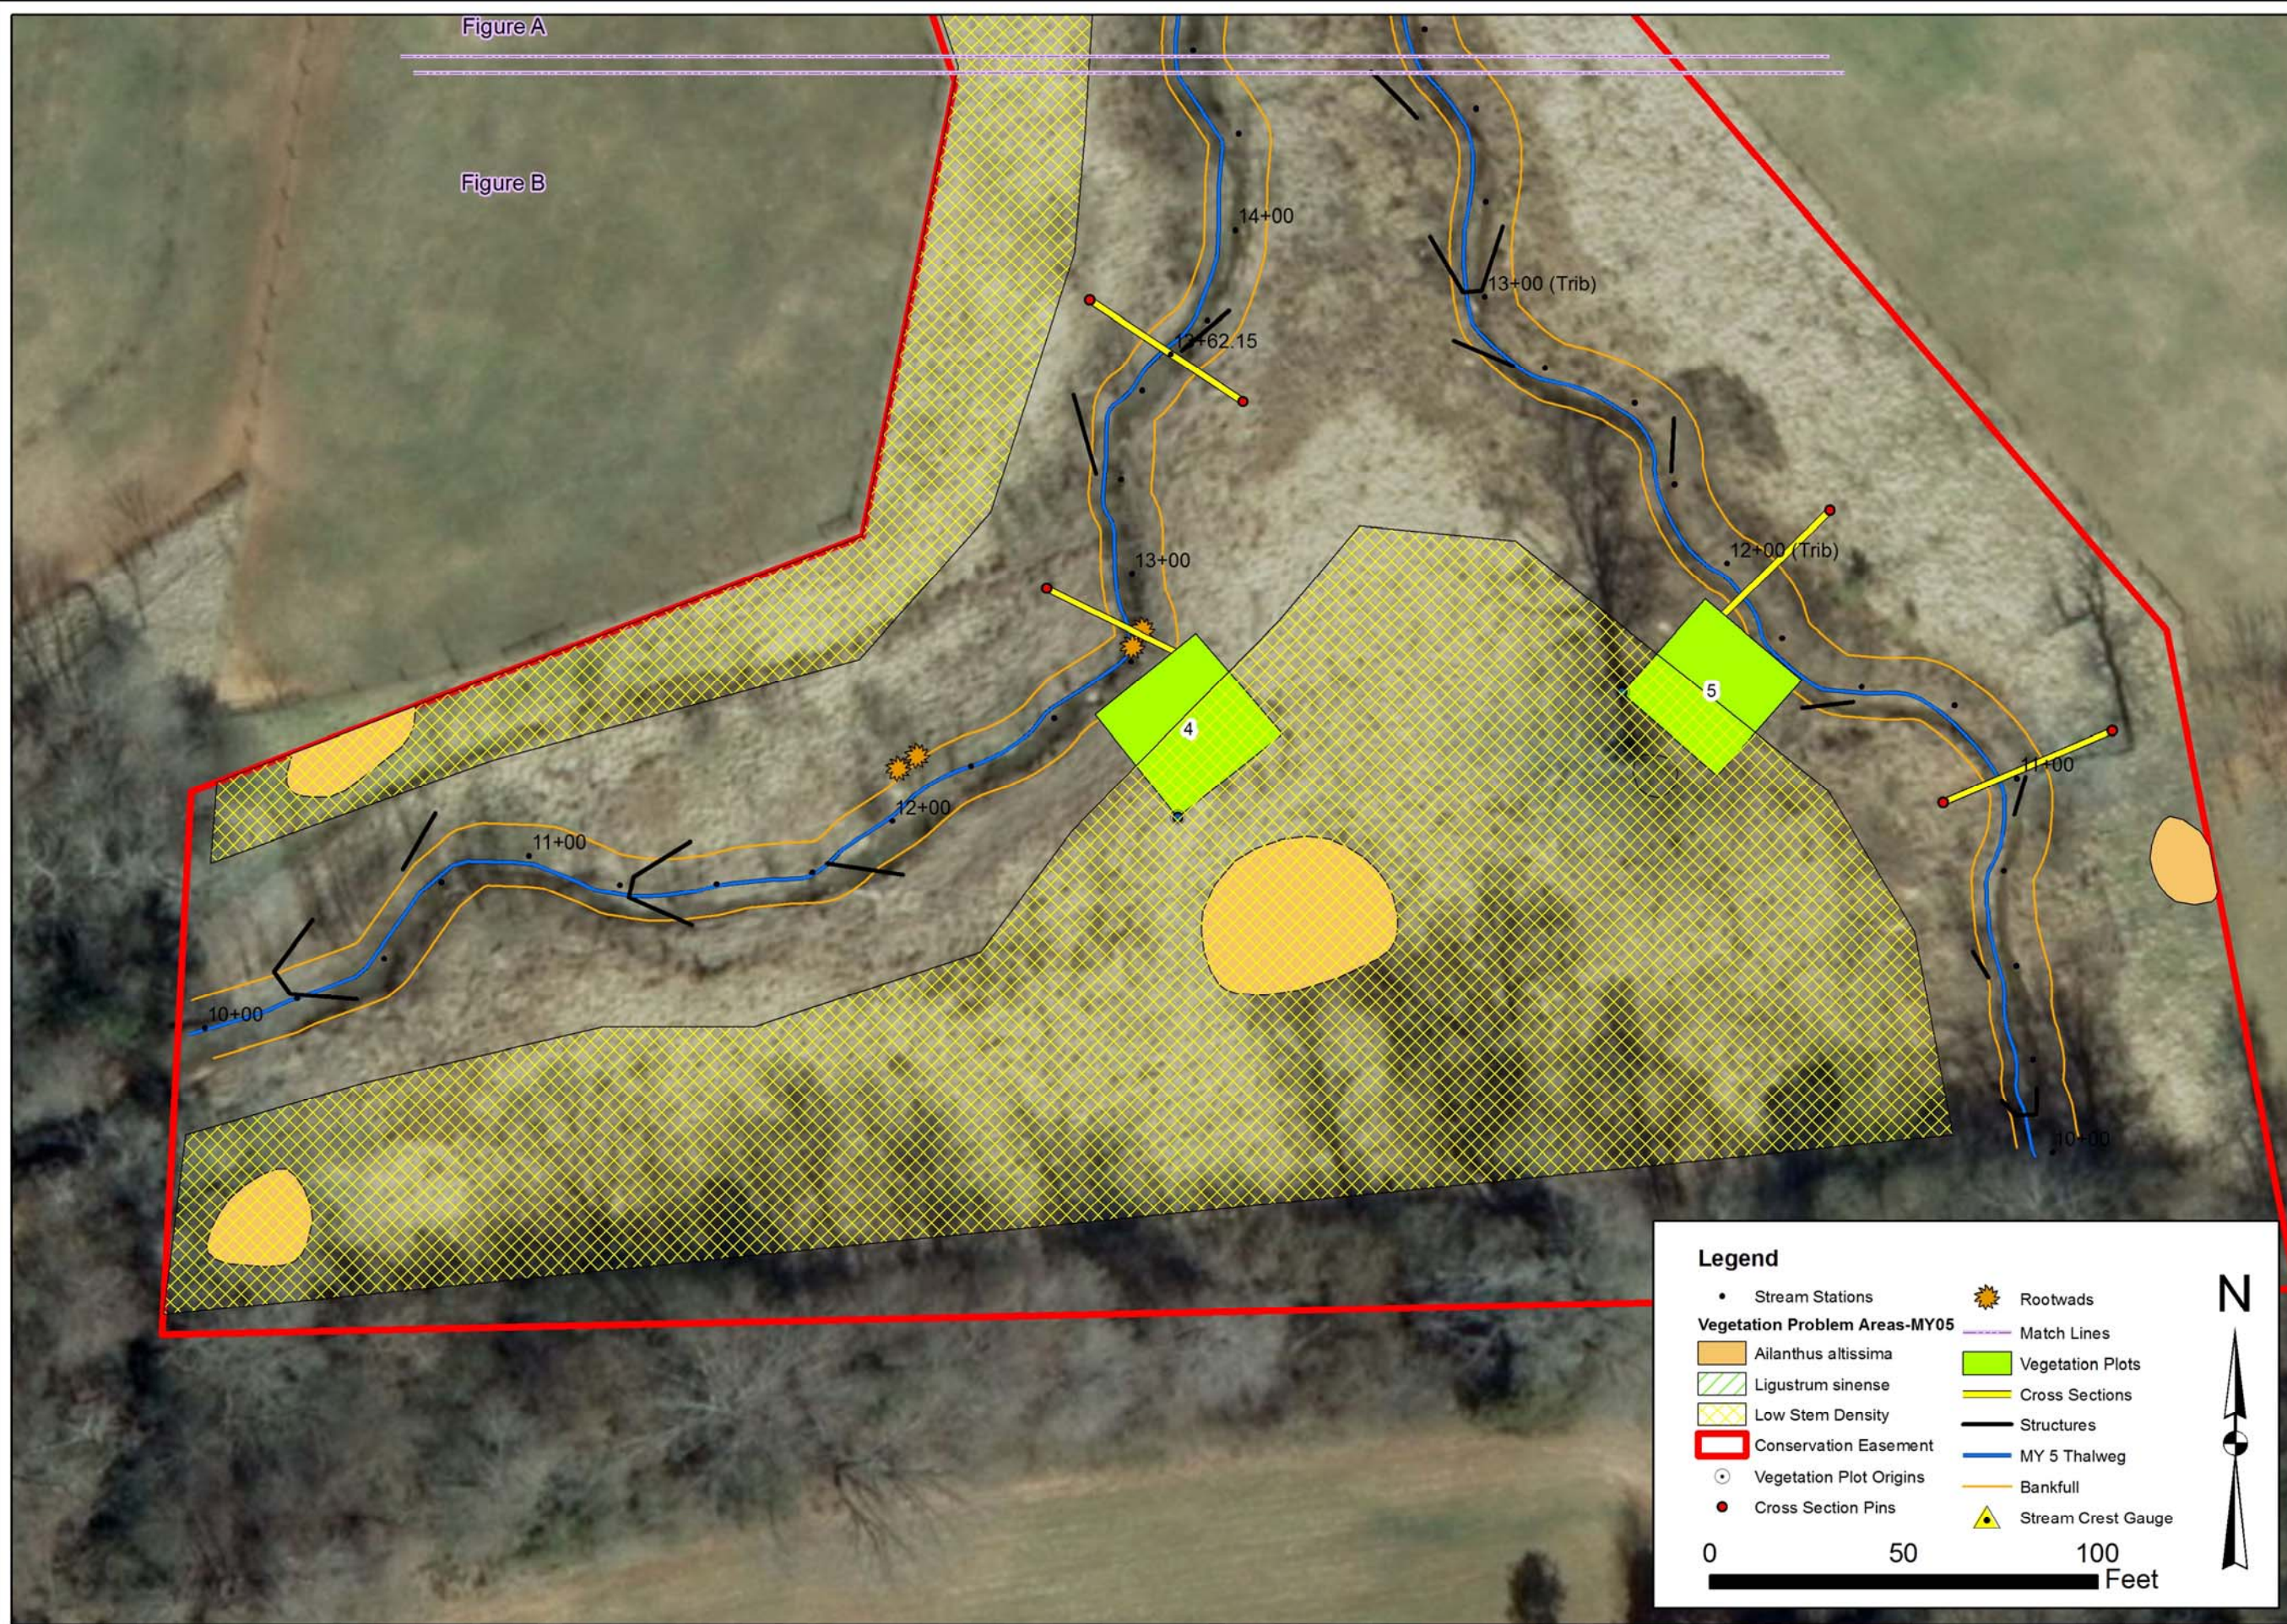
Figure  
**A**

Invasive exotics are the only notable vegetation problems areas for MY-05. Tree of heaven (*Ailanthus altissima*) and Chinese privet (*Ligustrum sinense*) have reached levels of concern. Tree of Heaven and Chinese privet are considered a species of "High Concern" according to EEP's invasive plant ranking list. Tree of Heaven is concentrated in patches near southern end of the conservation easement. Chinese privet is scattered throughout with high concentrations occurring between stations 16+00 to 26+00. Areas of low planted stem densities occur in areas near the outer limits of the conservation easement where the invasive exotic, tall fescue (*Schedonurus arundinaceus*), is dominant. These areas were cattle pastures previous to construction. See Current Conditions Plan View (Appendix B). Other invasive exotics observed sparsely scattered within the conservation easement include Gill over the ground (*Glechoma hederacea*), Johnson grass (*Sorghum halapense*), Japanese honeysuckle (*Lonicera japonica*), Japanese stiltgrass (*Microstegium vimineum*), and multiflora rose (*Rosa multiflora*). Tall fescue, Johnson grass, and Japanese stiltgrass are species of "Low/Moderate Concern". Although these species have been given different ranks of severity, the functionality of
