YEAR 1 MONITORING REPORT

UT MILLERS CREEK

Duplin County, North Carolina

DMS Project ID No. 95719, Contract No. 5000, USACE Action ID No. SAW-2013-00386

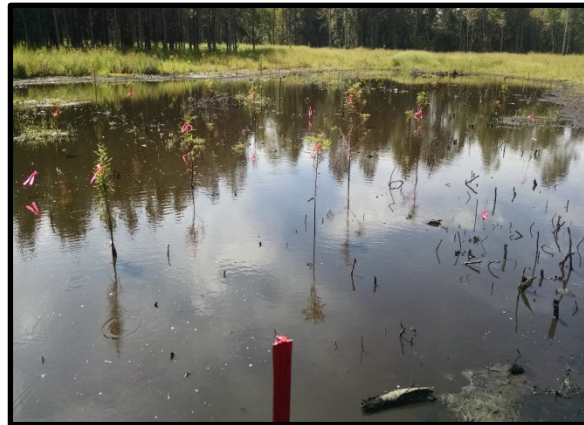
3.4 Vegetation Plot 4

Areas in the proximity of Plots 4, 5, 7, and 8 have experienced periods of prolonged inundation and exhibit thin to no herbaceous coverage; however, planted stems appear to be growing well in these areas. Morning glory (*Ipomoea* spp.) was observed within and adjacent to Plot 1. The presence of morning glory is not currently affecting the growth and survivorship of the planted stems, but this area (and other areas in which morning glory may be observed in the future) will need to be closely monitored. Its presence has the potential to adversely affect growth and survivorship of planted stems.

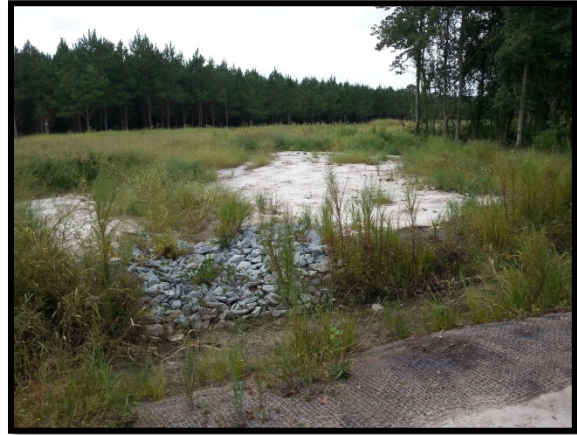
3.10 Bare area adjacent to floodplain interceptor

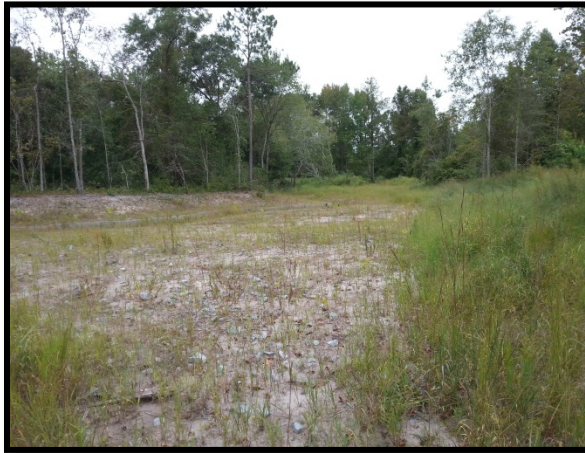
3.11 Bare area adjacent to XS-10

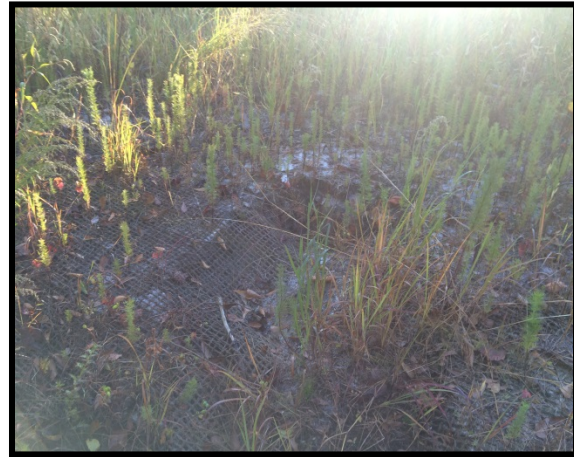
UT Millers Creek appears to be stable and functioning as designed. Cross section data shows little to no change in dimension compared to baseline. Stream pattern also remains unchanged. Small gullies have formed along the stream bank at three locations (Sta. 18+45, 33+00, and 34+80) as a result of flood waters reentering the channel combined with poor establishment of stream bank vegetation in those areas.

3.12 Minor gully near STA 19+00

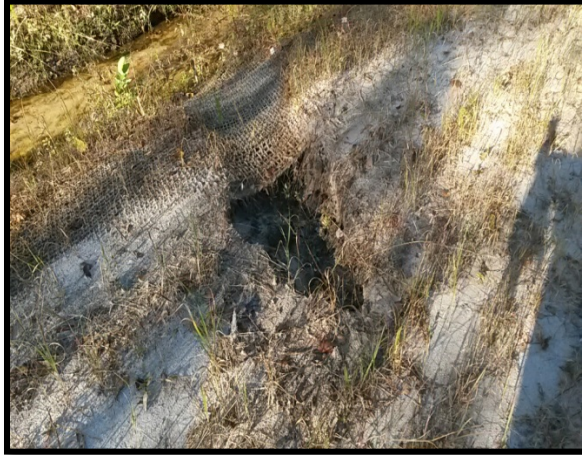
3.13 Gully on left bank at STA 34+00

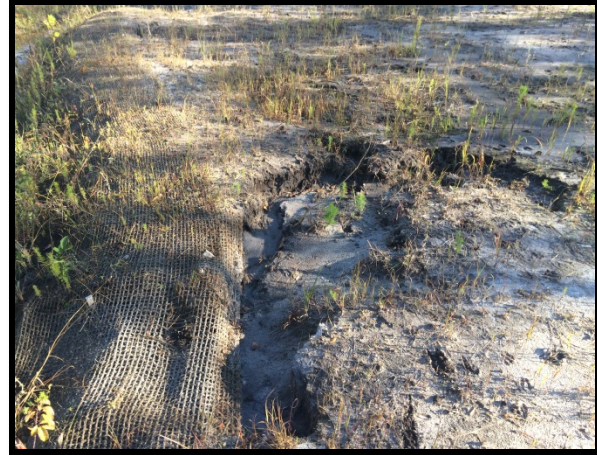
3.14 Gully on right bank at STA 34+50
