## **YEAR 2 MONITORING REPORT**

### **UT MILLERS CREEK**

Duplin County, North Carolina

DMS Project ID No. 95719, Contract No. 5000, USACE Action ID No. SAW-2013-00386

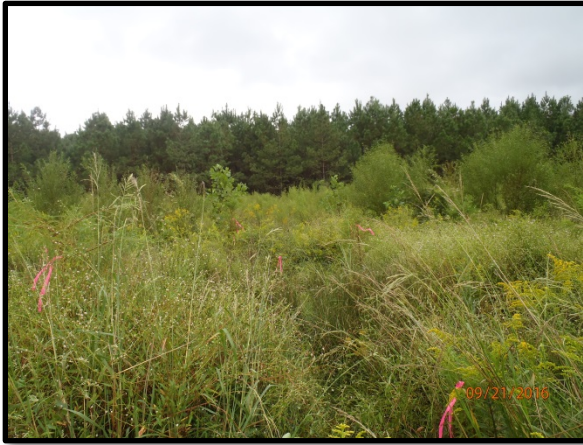
**3.1 Vegetation Plot 1**

A small amount of morning glory (*Ipomoea sp.*) was noted within Plot 1, however the cover totaled less than 5% of the plot. It is not expected that morning glory will lead to reduced survival rates on-site; however, HDR|ICA will continue to monitor the status of this species.

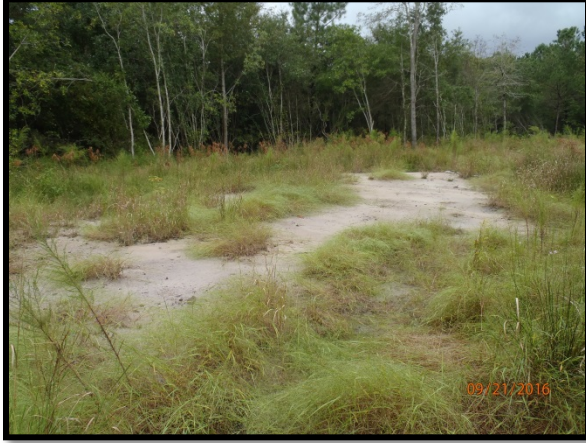
Four bare areas and two areas of thin grass are present on-site. The total acreage of bare areas is 0.23 (1.9% of planted acreage) and the total acreage of thin grass is 0.24 (2% of planted acreage). These areas have decreased slightly over the monitoring year but additional seeding may be required.

**3.10 Bare area STA 25+00**

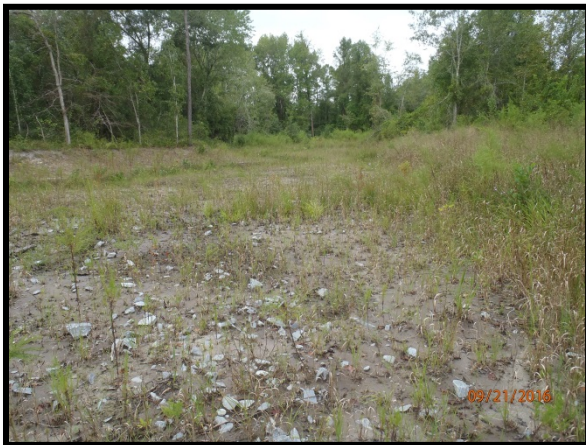
**3.11 Bare area adjacent to XS-10**

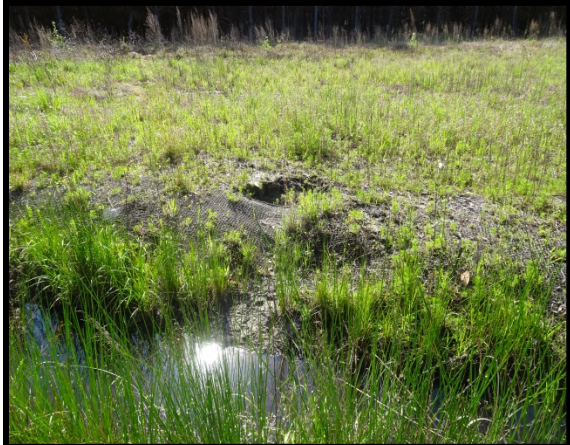
UT Millers Creek appears to be stable and functioning as designed. Cross section data shows that riffle sections have maintained bankfull cross sectional area as well as width/depth ratio over the course of the monitoring period. Additionally, the stream pattern has not changed over the monitoring year. The gullies noted at and below STA 33+00 are still present; however, it is apparent that the areas are not actively eroding and vegetation is beginning to fill in on the banks. To further stabilize the area, ICA|HDR anticipates flattening the gullies using hand rakes and planting juncus in the disturbed areas.

**3.12 Minor gully near STA 19+00**

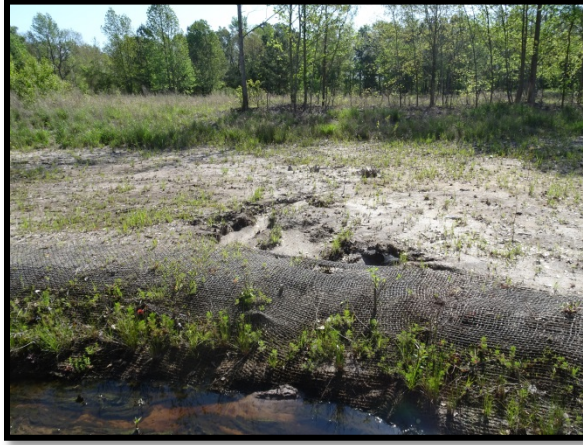
**3.13 Gully on left bank at STA 34+00**

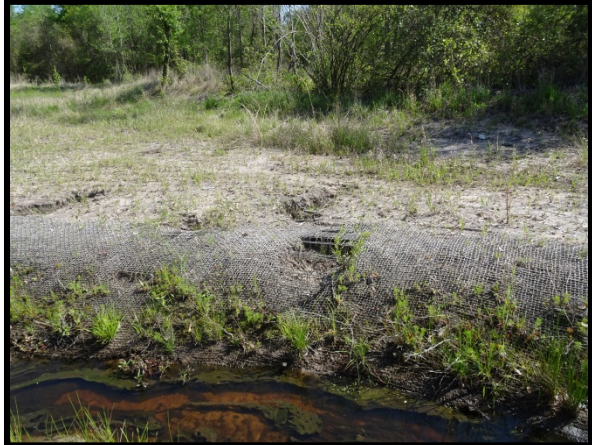
**3.14 Gully on right bank at STA 34+50**

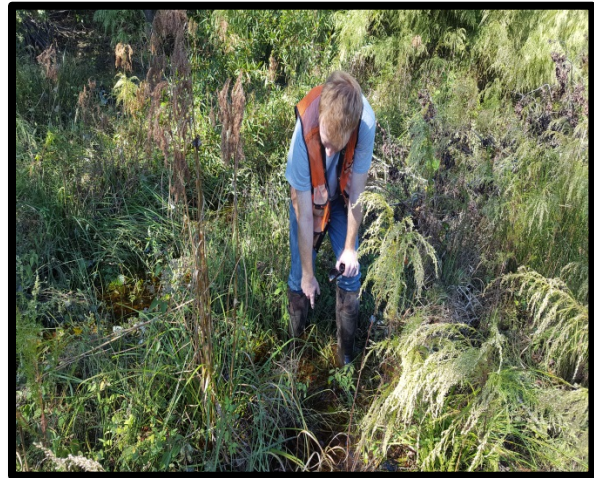
The site has experienced several bankfull flows throughout the monitoring period. Crest gauges were inspected on-site following the Hurricane Matthew rain event and showed that the site experienced a bankfull flow during the event. Additional bankfull event documentation can be found in Appendix E.

**5.4 Overbank flow (10/10/2016)**
