## **YEAR 3 MONITORING REPORT**

### **UT MILLERS CREEK**

Duplin County, North Carolina

DMS Project ID No. 95719, Contract No. 5000, USACE Action ID No. SAW-2013-00386

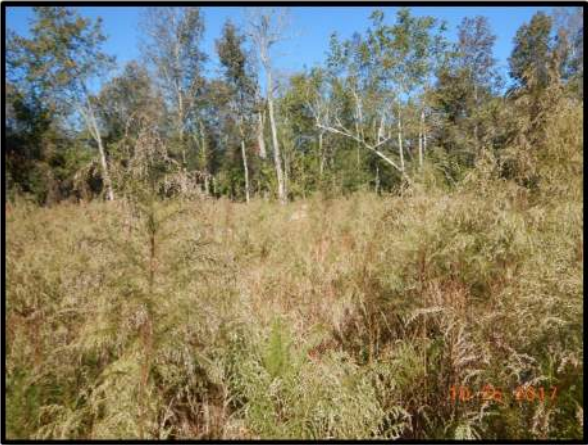
4.2 Vegetation Plot 2

Insect damage and deer browse was noted within Plot 2, however all but one of the damaged plants have a vigor of 3 or higher. It is not expected that the insects and deer will contribute to reduced survival rates on-site; however, HDR|ICA will continue to monitor the status of the damage.

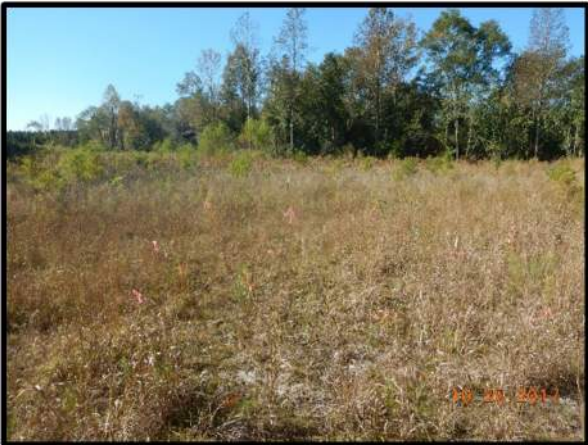
4.3 Vegetation Plot 3

In Plot 3, the majority of stems have a vigor of 2 and have shown little to no growth over the past monitoring year. Monitoring Well 4 indicates that the area immediately upstream of Plot 3 was covered by 10 inches of surface water for over half of the growing season. HDR|ICA will closely monitor vegetation in this area and may take corrective action if necessary.

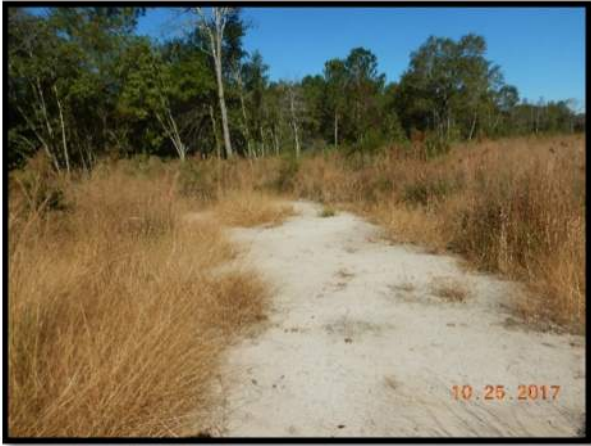
Two bare areas and two areas of thin grass remain present on-site. The thin grass areas noted near station 25+00 in Year 2 report appear to have filled in after supplemental seeding. In the two thin grass areas that remain near station 35+00, vegetation is beginning to establish. The total acreage of bare areas is 0.23 (1.9% of planted acreage) and the total acreage of thin grass is 0.14 (1% of planted acreage). Problem areas were reseeded in January and April of 2017. Following seeding, the thin grass area was reduced by 50% but bare areas have not improved.

**4.10 Bare area near STA 24+00**

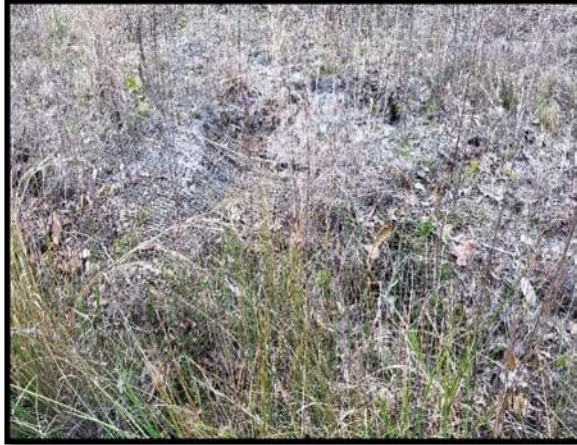
Channel bank stability continues to benefit from the maturation of vegetation along the channel toes and bank. Two areas of minor erosion have developed around soil lifts due to the sandy soil composition on-site. All instances of erosion noted during Year 3 monitoring were minor and will likely fill in with vegetation over time.

**4.13 Minor erosion on right bank at STA 18+50**
