YEAR 4 MONITORING REPORT

UT MILLERS CREEK

Duplin County, North Carolina

DMS Project ID No. 95719, Contract No. 5000, USACE Action ID No. SAW-2013-00386

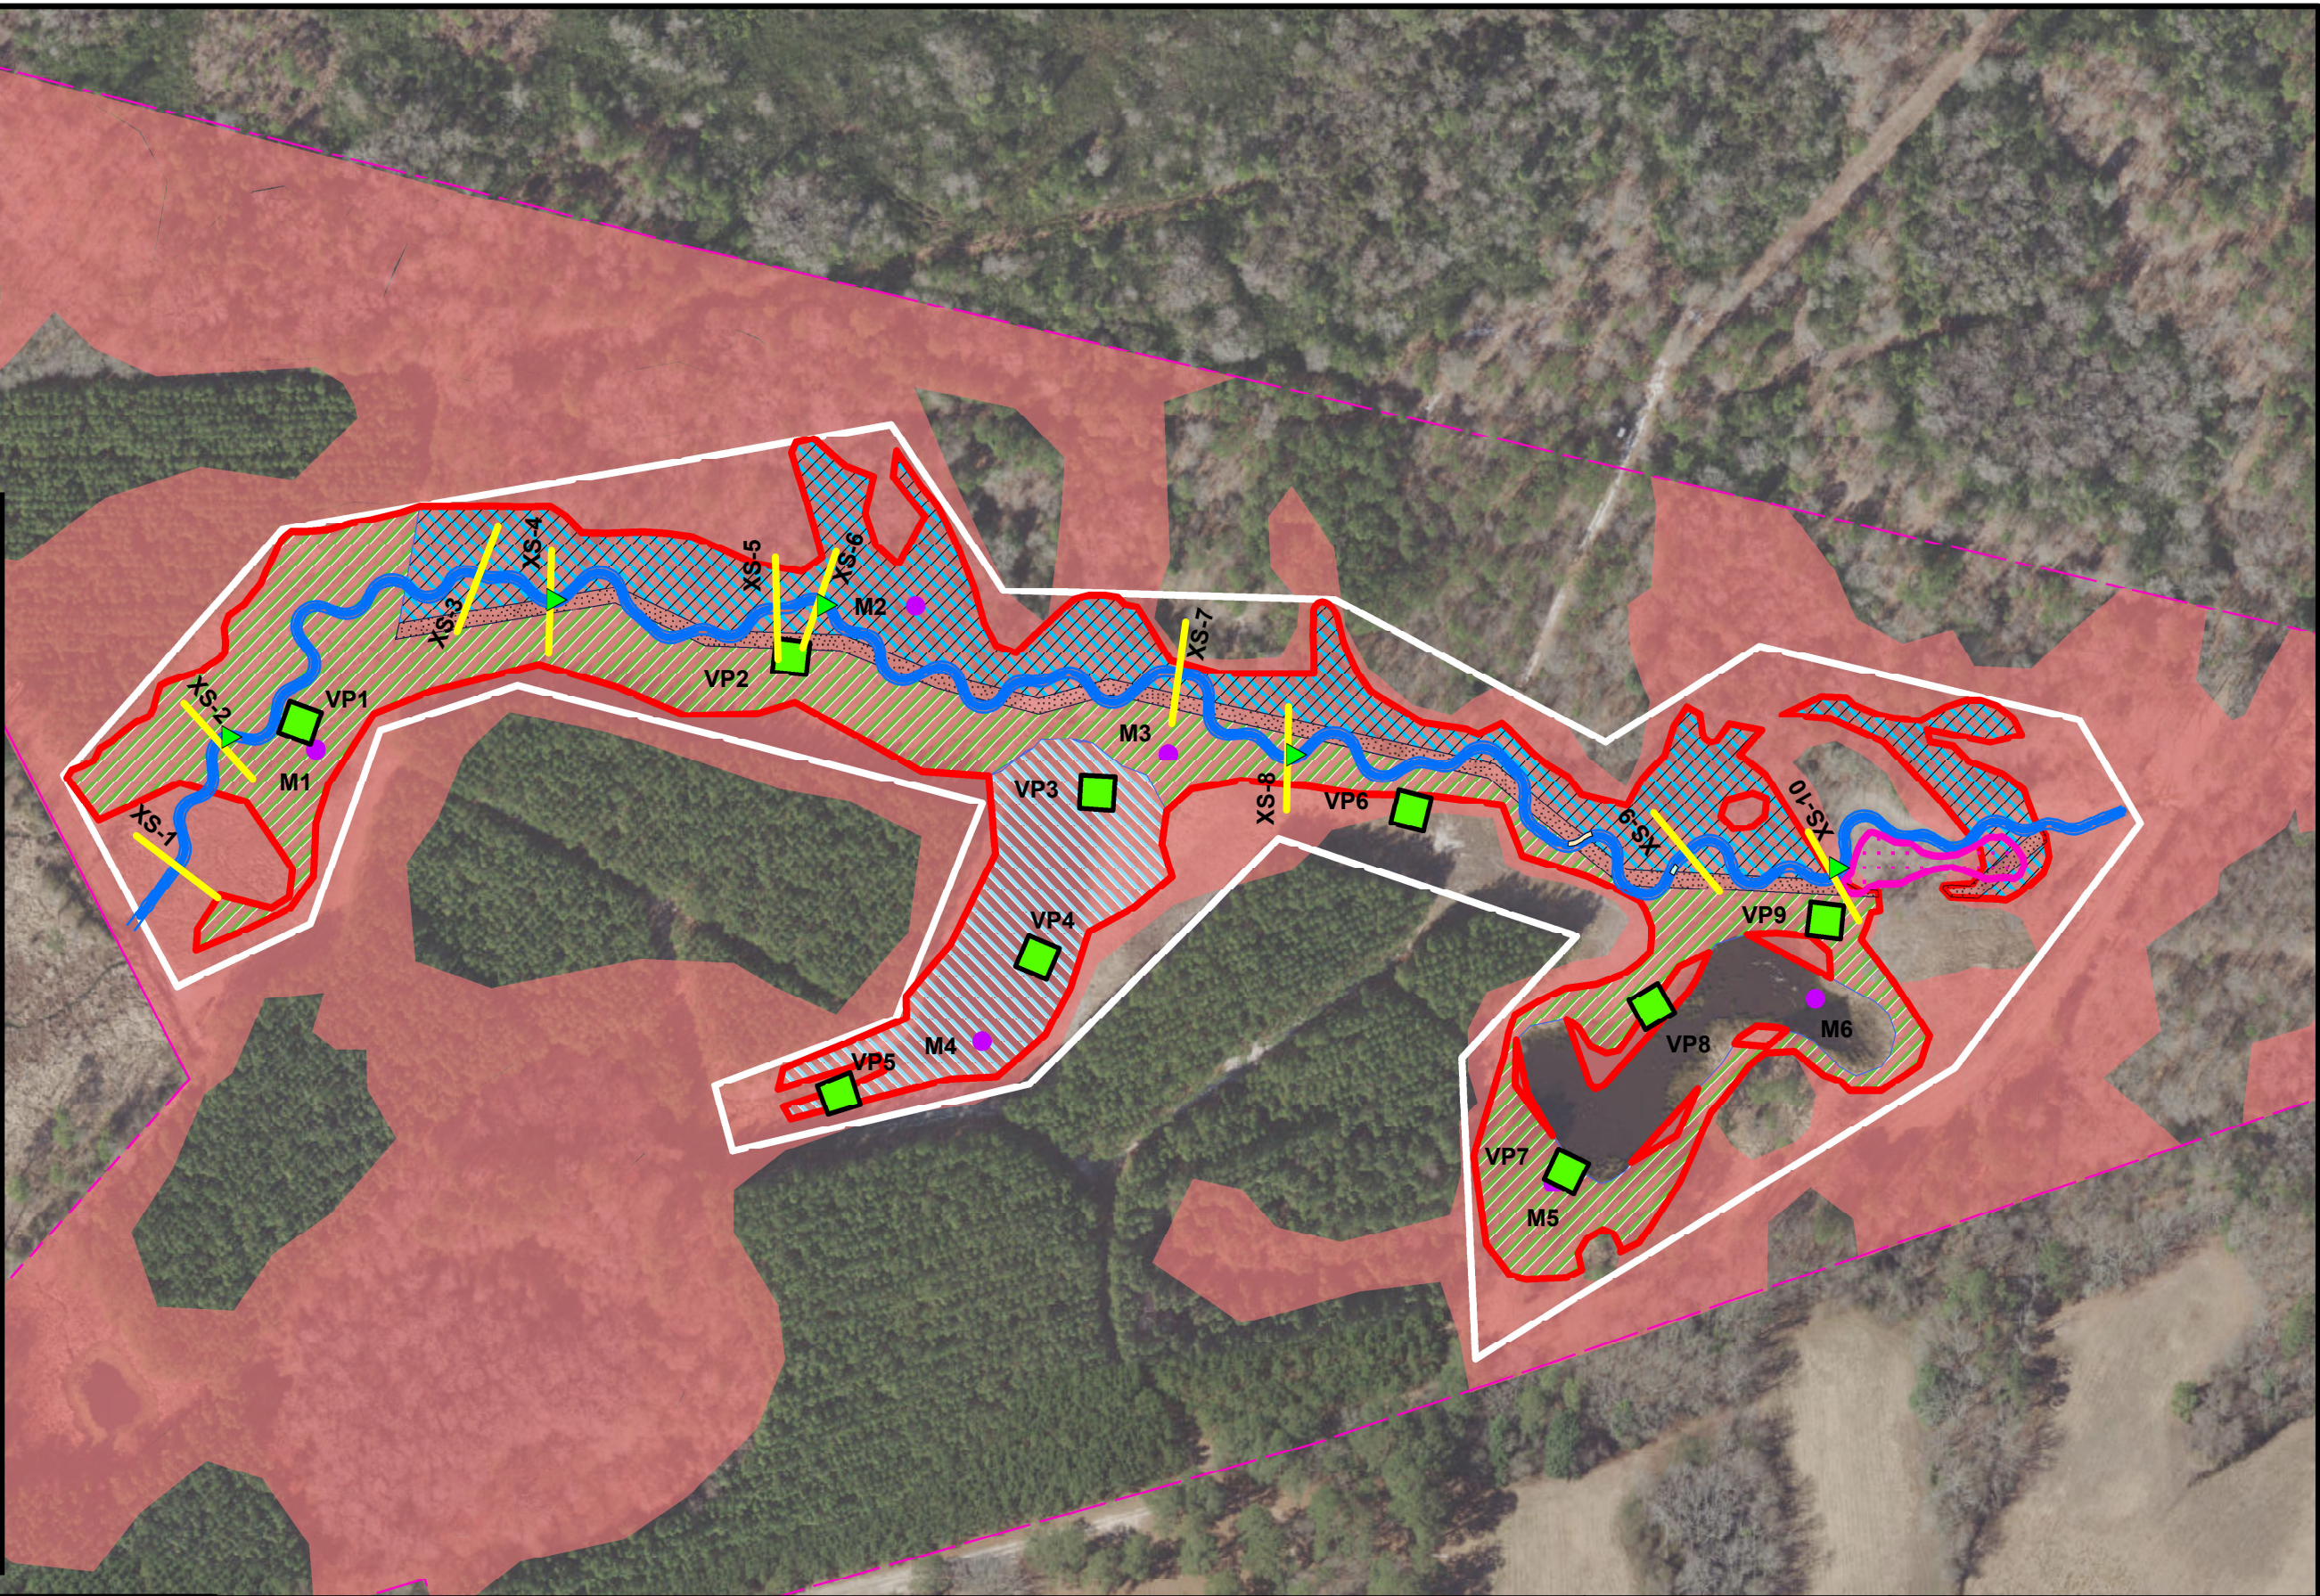
Figure 2.1

The low stem density areas were reviewed and the CCPV was revised to show only one area of low stem density that meets the mapping threshold. Table 6 was also updated to reflect the revision.

The areas of erosion have been reviewed and it was determined that only two areas of bank erosion meet the mapping threshold of over 10'. The CCPV was updated to reflect these areas, as well as the narrative and Table 5.

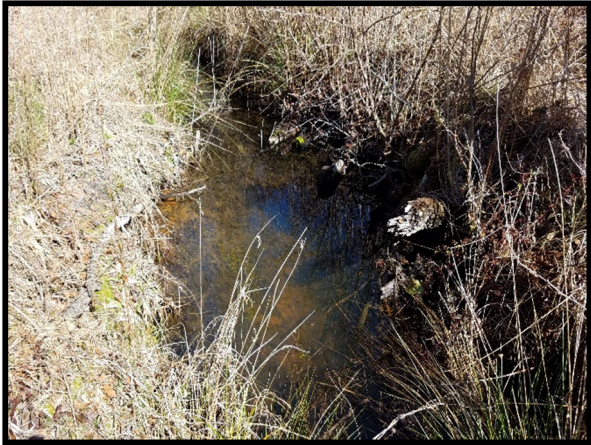
UT Millers Creek remains stable and functioning as designed. Channel bank stability continues to benefit from the maturation of vegetation along the channel toes and bank. During Year 4, two areas of minor or moderate erosion were noted. It is expected that these areas will fill with vegetation and no remedial action is recommended at this time. Photos of these areas are presented in Figures 3.1-3.3.

3.1 Erosion at 30+00

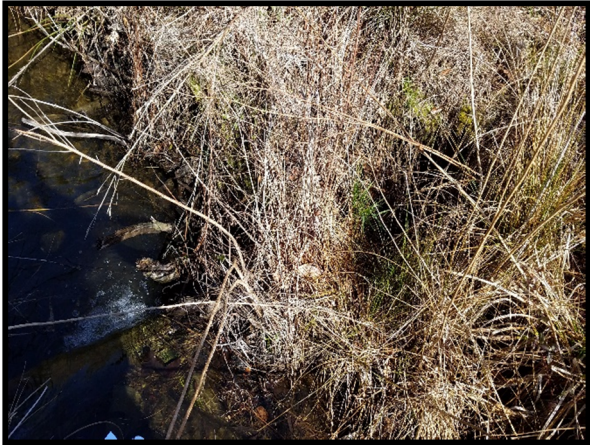
3.2 Erosion at 31+50

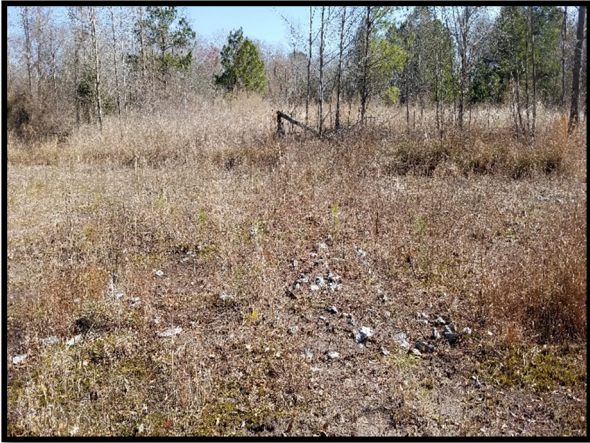
One area of low stem density remain present on-site. The total acreage of low stem density areas is 0.12 acres (approximately 1% of planted acreage). Low stem density has been noted from station 33+60 – 36+00. It is expected that volunteer species will establish in this area in future years. Photos of this area are presented in Figures 3.1-3.3.

3.3 Low stem density near STA 35+00
