YEAR 5 MONITORING REPORT

UT MILLERS CREEK

Duplin County, North Carolina

DMS Project ID No. 95719, Contract No. 5000, USACE Action ID No. SAW-2013-00386

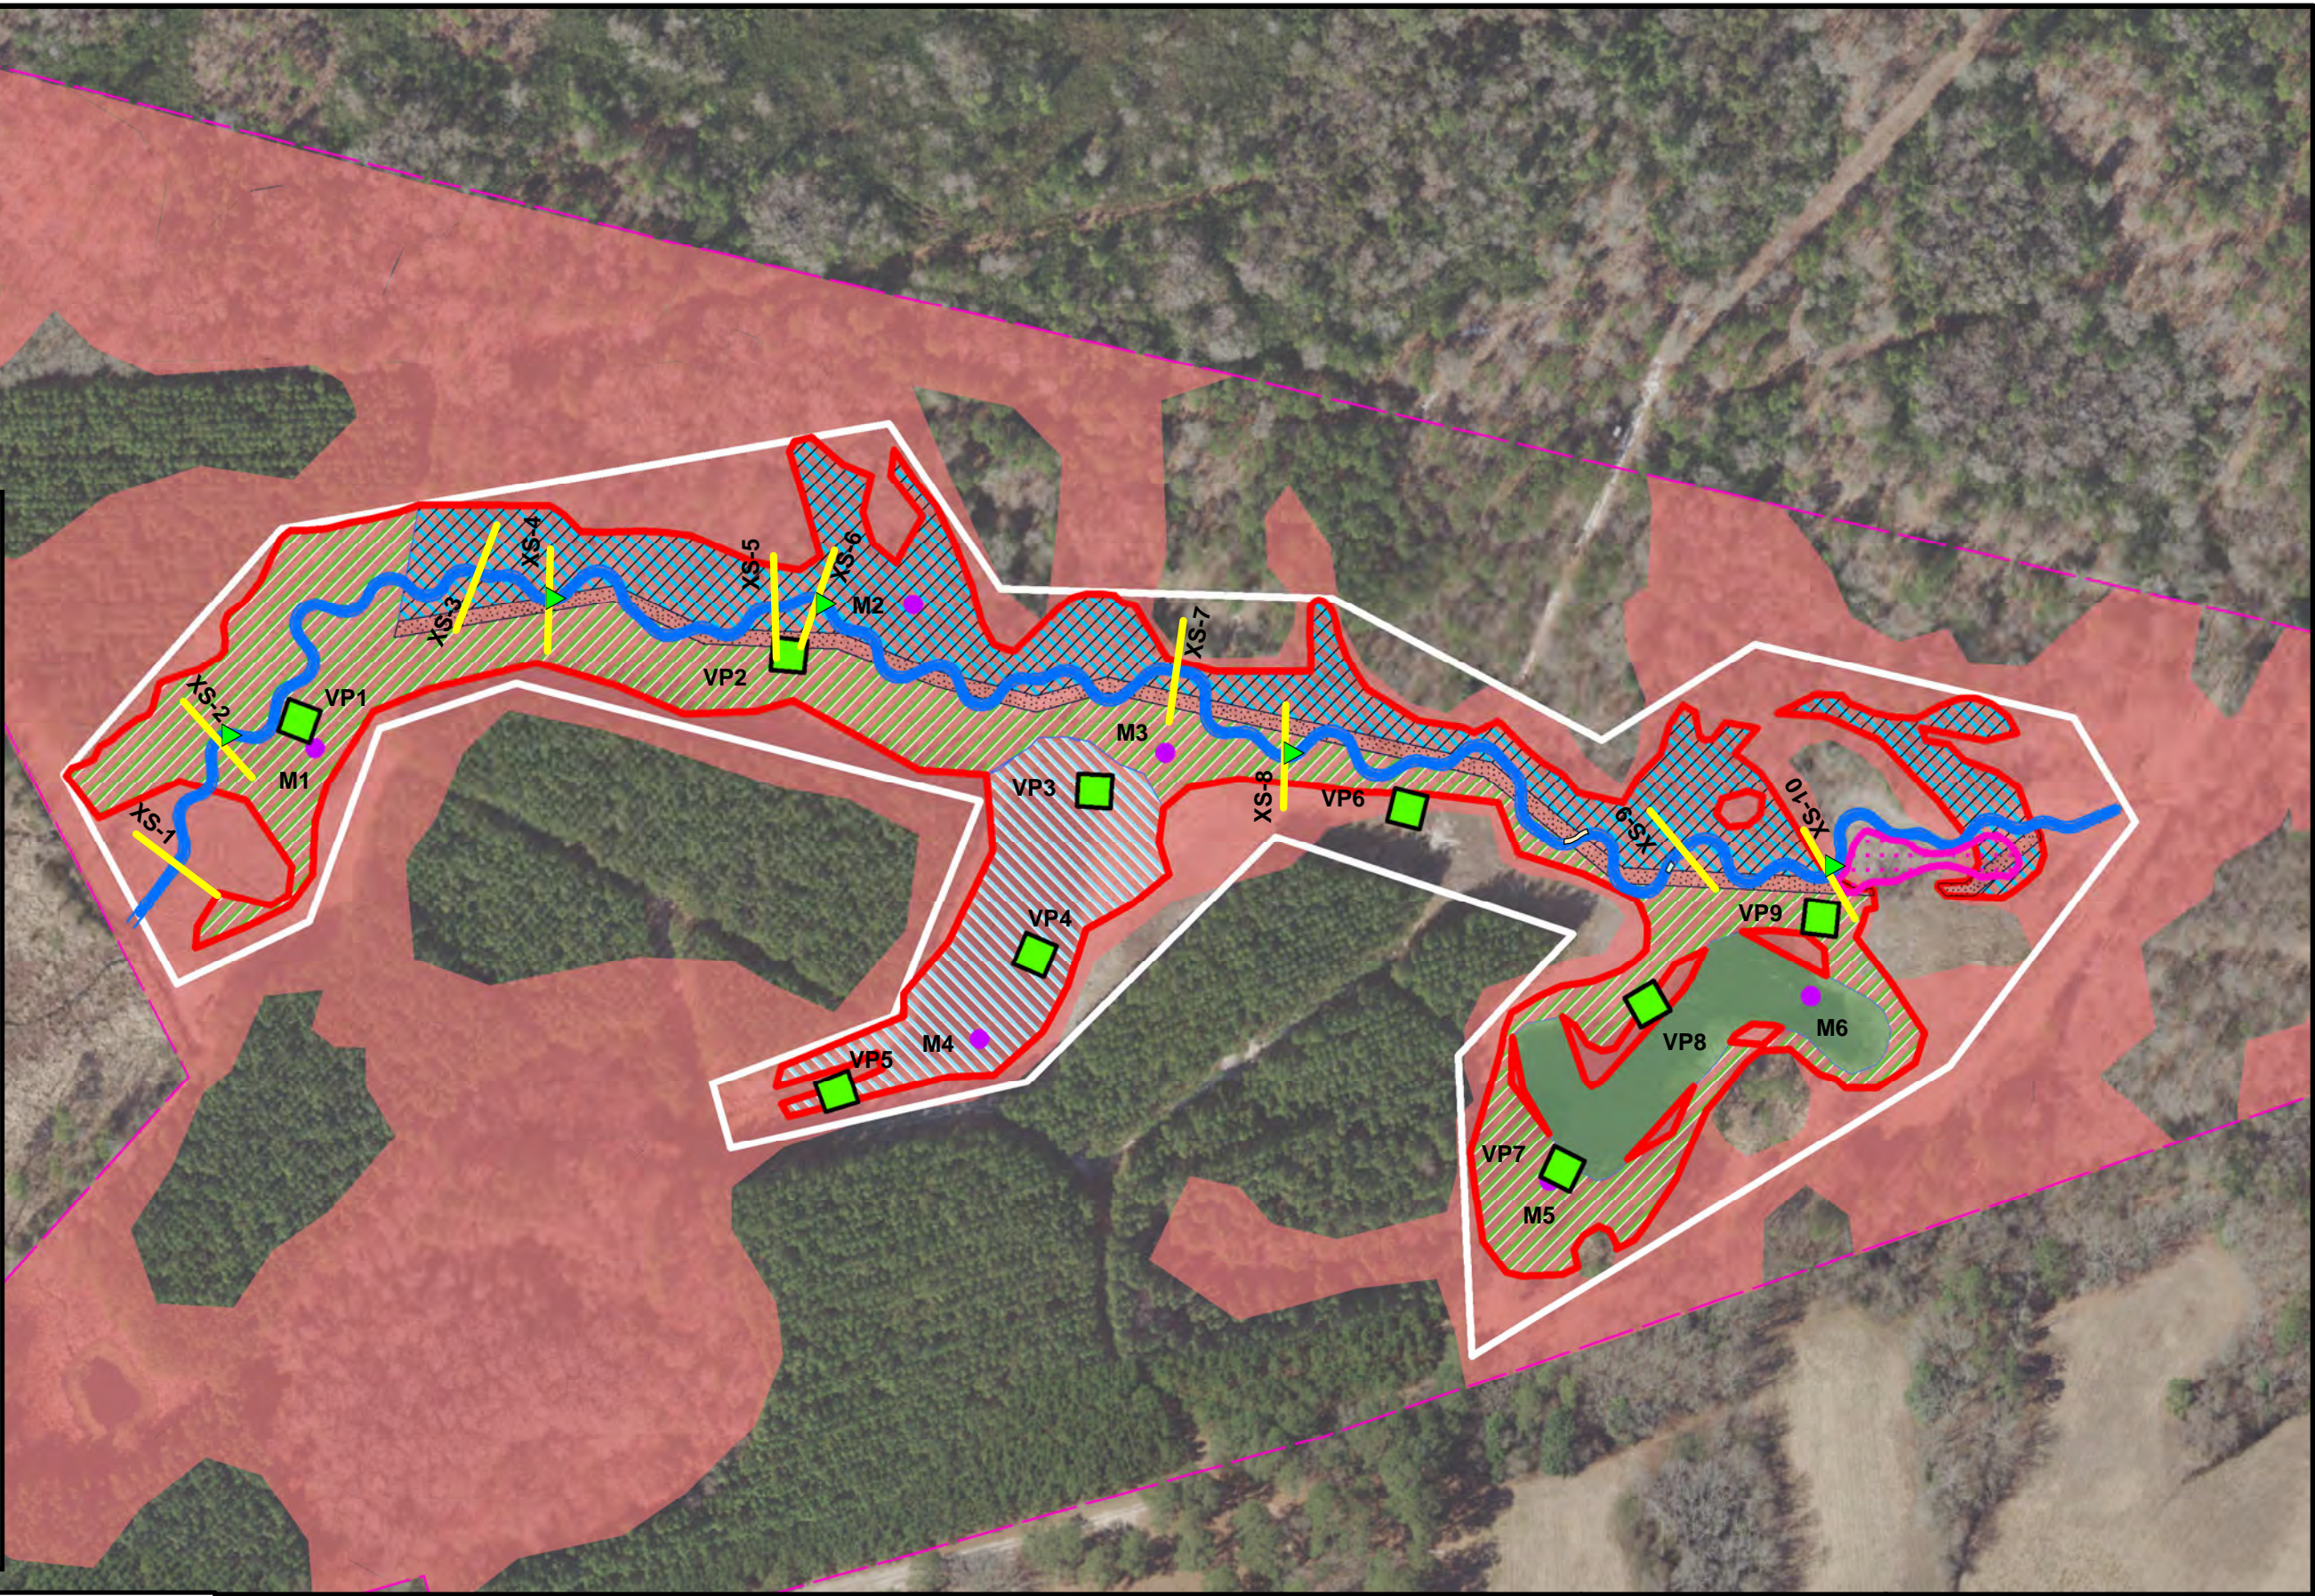
Figure 2.1

1. Appendix E, Table 11. Bankfull events. Please update this table to show cumulative bankfull events (merge this table with Appendix C of MY4 monitoring report table.)
2. CCPV. The Pond area is show as shaded but appears outlined on the CCPV.

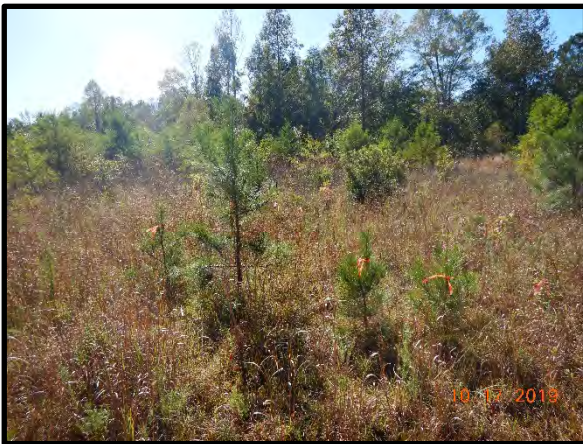
3.3 Vegetation Plot 3

In Plots 3 and 6, planted stems are averaging less than 3 feet in height. Even though there has been slow growth in these plots, 85% of the stems have a vigor of 3 or higher. This is an improvement from Year 3 when it was noted that the majority of stems in Plot 3 had a vigor of 2 or less. It is expected that these plots will meet the Year 7 requirement of 210 stems per acre, however it is unlikely that average stem height will reach 10 feet. HDR will continue to closely monitor vegetation in this area and may take corrective action if necessary.

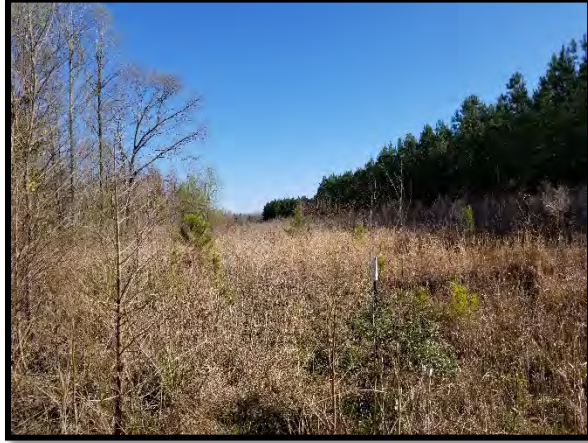
Two areas of low stem density are present on-site. Total acreage of low stem density area is 0.2 acres (approximately 1.6% of planted acreage). Low stem density is noted from station 14+50 - 16+30 as well as from station 33+60 – 36+00. It is expected that volunteer species will establish in these areas over time. Pine saplings have become dense along the right floodplain of UT to Millers Creek. The pine does not appear to be outcompeting planted stems, however HDR will continue to monitor the pine and take corrective actions if necessary.

**3.10 Low stem density area near
STA 15+00**

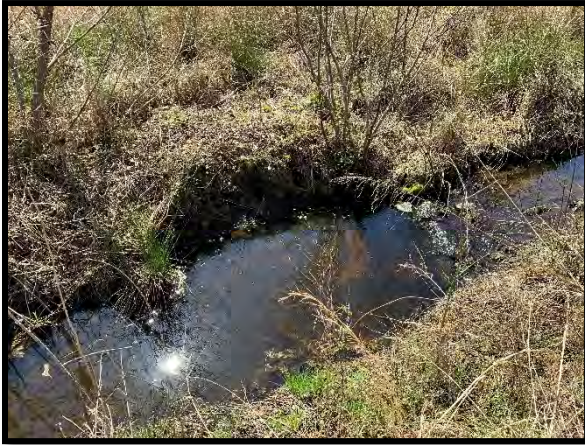
Two log sills are experiencing erosion along the banks immediately downstream of the structures. Both areas were noted in Year 4 and do not appear to have increased in length, therefore no remedial action is recommended at this time.

3.11 Minor bank erosion near STA 30+00

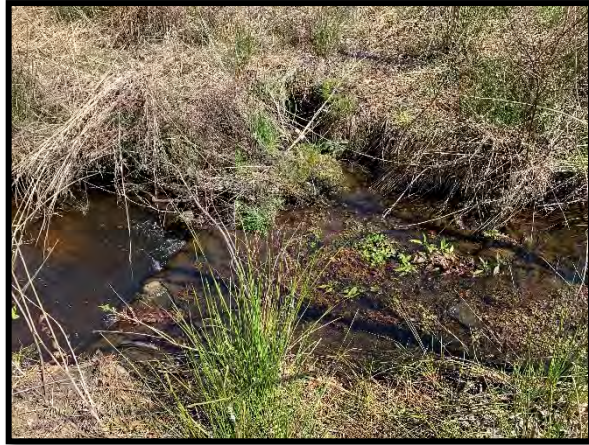
UT Millers Creek is stable and functioning as designed. Cross section geometry has remained stable over the course of Monitoring Year 5. Cross sections 5, 7, and 9 have experienced minor reductions in channel cross sectional area which can be attributed to maturation of vegetation along the channel banks and toes.

3.12 Moderate erosion near XS 9

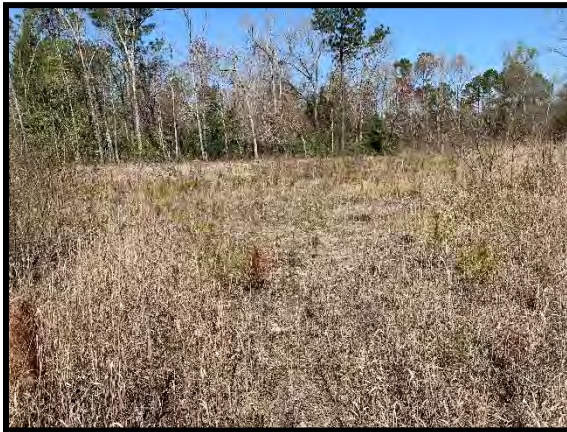
3.13 Low stem density area near STA 34+50

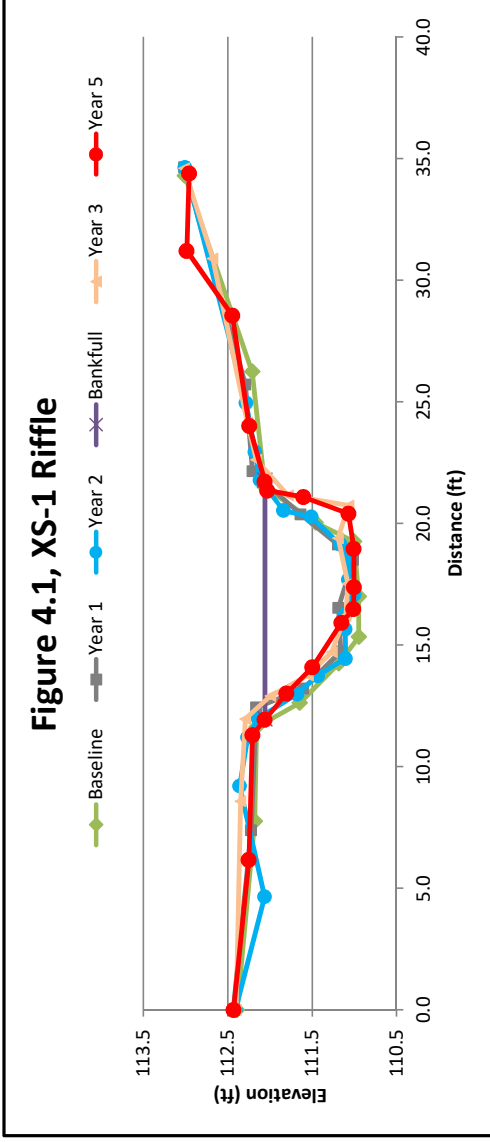
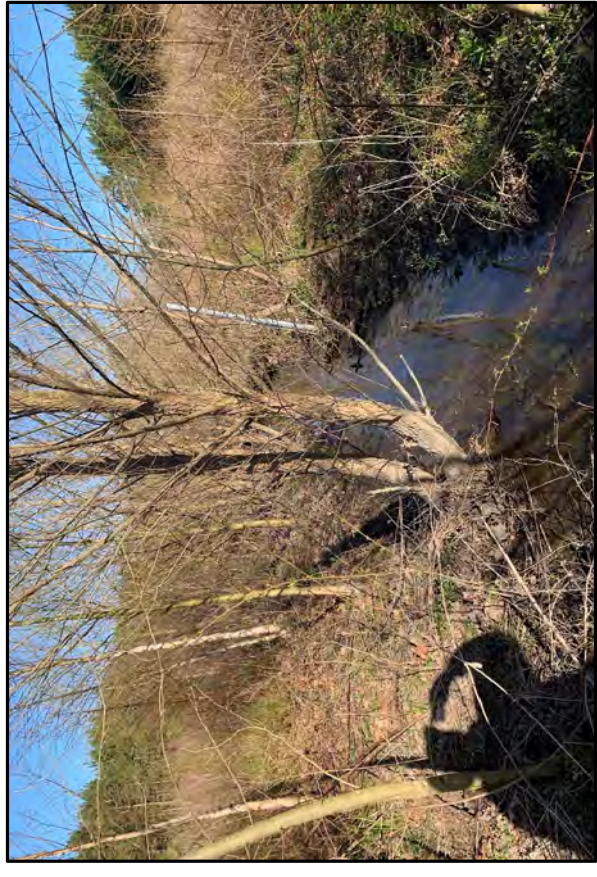
Figure 4.1, XS-1 Riffle

- In table 9, BHR for XS 1 is listed as > 1 but should be < 1
- At next gauge download, please provide DMS with the hydrology data files where the report leaves off (post October 19th, 2019).
