## **YEAR 6 MONITORING REPORT**

### **UT MILLERS CREEK**

DMS Project ID No. 95719, Contract No. 5000, USACE Action ID No. SAW-2013-00386

Visual Assessment Data Collected: May 2020

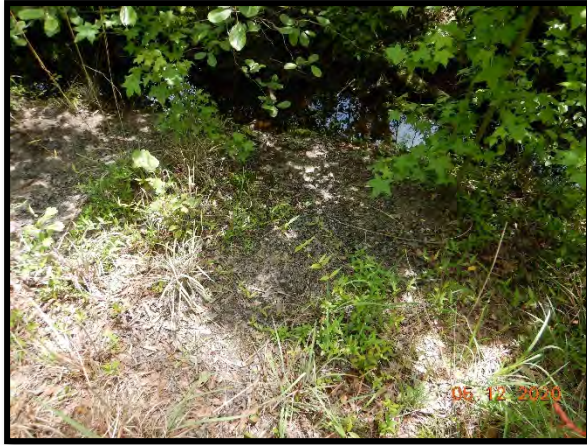
The UT remains stable and functioning as designed. Bank erosion noted in Year 4 and 5 at stations 30+00 and 31+50 have stabilized due to increased herbaceous vegetation along the banks. Photos of these areas are presented in Figure 3.1 and 3.2.

**3.1 Erosion at 30+00**

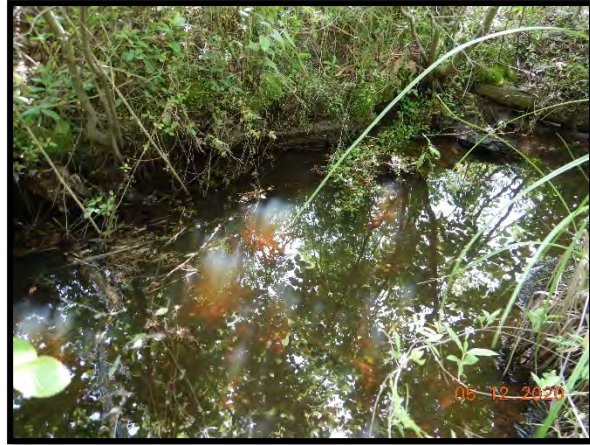
**3.2 Erosion at 31+50**

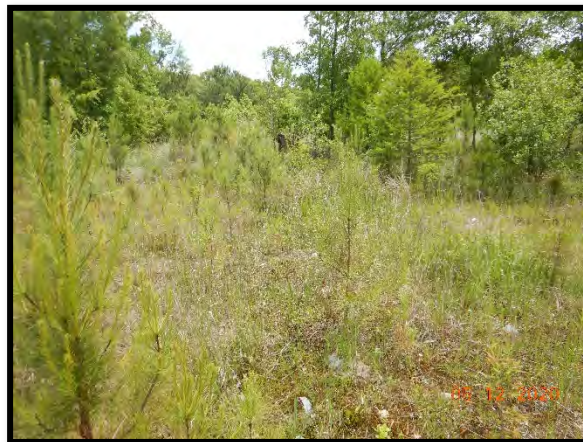
The area previously noted as having low stem density between stations 33+60 – 36+00 has seen an increase in volunteers and steady growth of planted stems. While the density of stems in this area has increased, plant growth remains stunted most likely due to poor soil quality. Photos of this area are presented in Figures 3.3.

**3.3 Right overbank area near STA 35+00**

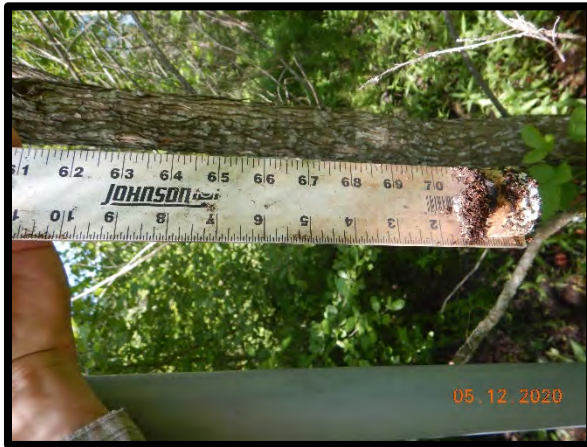
**4.1 Crest Gauge 1 (5/12/2020)**

Based on the measurement collected at the downstream crest gauge, the Site has experienced at least one bankfull flow during the monitoring period. The crest gauge located at the upstream extent of the project experienced insect damage and is unreadable. It is worth noting that the Site had reached its stream hydraulics performance standard of two bankfull events over the 7 year monitoring period by the second year of monitoring.

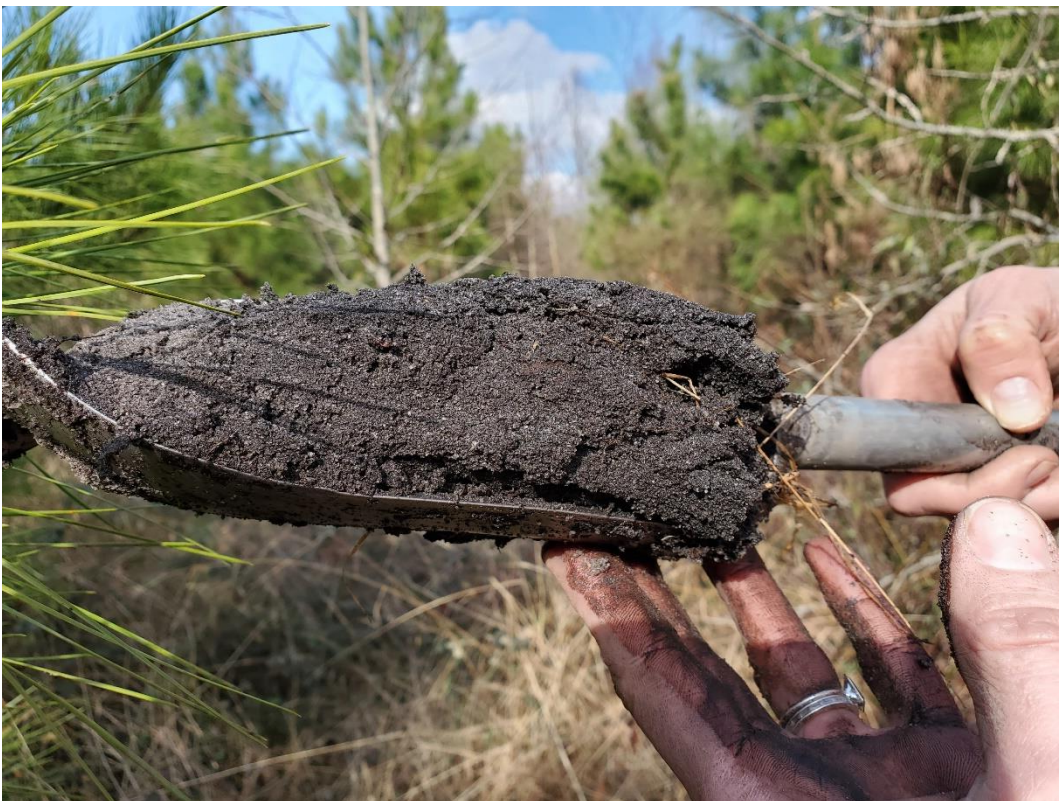
Typical example of dark surface; observe organic coating on hands.
