UT to Mill Swamp Restoration Project Year 1 Monitoring Report

Onslow County, North Carolina
NCEEP Project ID Number - 95019

Project Info: Monitoring Year: 1 of 7
 Year of Data Collection: 2013 & 2014
 Year of Completed Construction: 2013
 Submission Date: June 2014

Report Prepared and Submitted by Michael Baker Engineering, Inc.

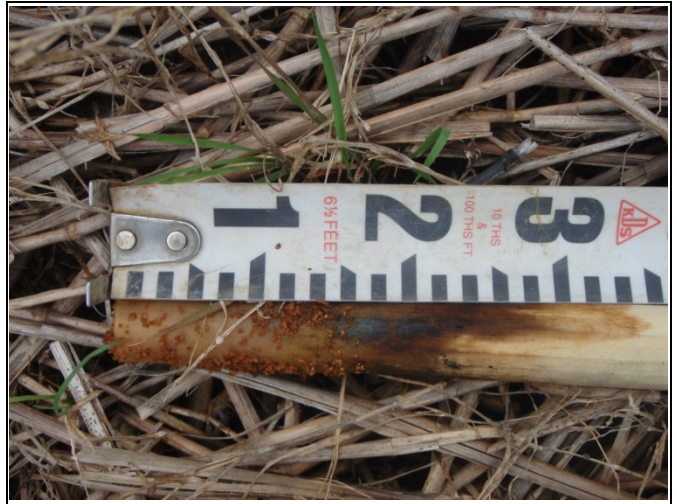
One crest gauge was installed on the floodplain at the bankfull elevation along the left top of bank on UT1c approximately at Station 45+50. The highest bankfull reading recorded in Year 1 was measured to be 0.19 feet and was estimated to have occurred on December 15, 2013. Crest gauge readings are presented in Appendix E.

Crest gauge reading, 0.17 inches – October 16, 2013

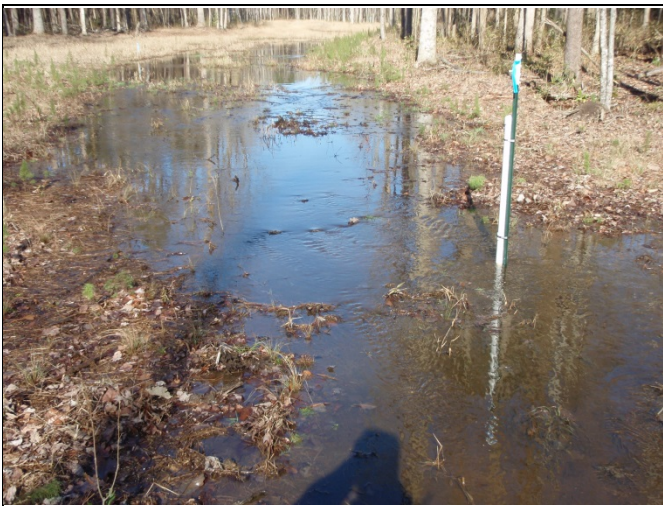
Flow Gauge #1 – December 16, 2013

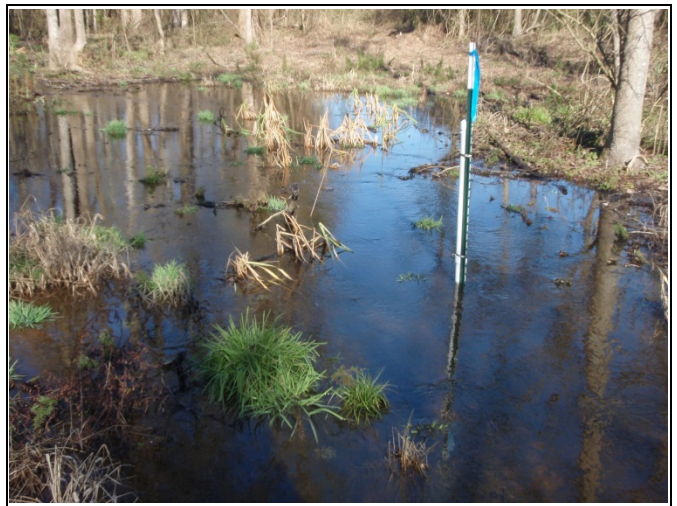
Flow Gauge #2 – December 16, 2013

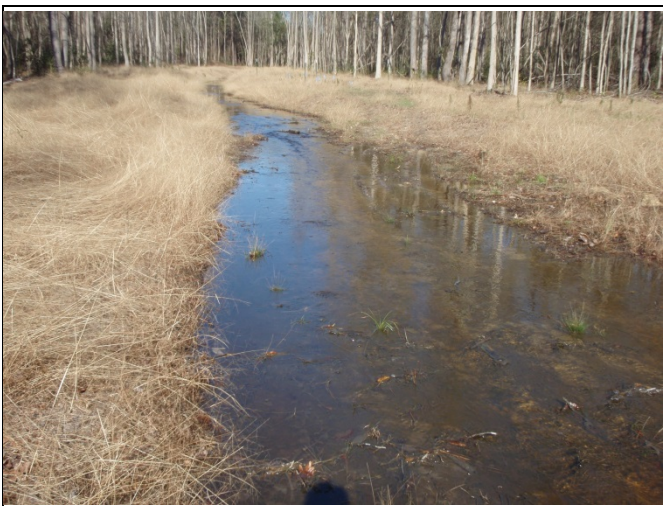
Flow through UT1a and UT1b was recorded in late November 2013 and for the entire month of December 2013. Of the two flow gauges installed on the Site, both gauges recorded flow during this period. The gauges demonstrated similar patterns relative to rainfall events in the vicinity of the Site.

Flow in UT1a - December 16, 2013

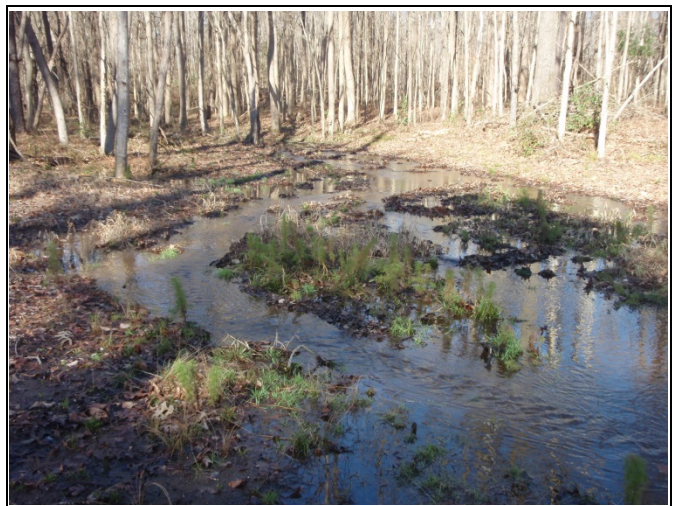
Flow in UT1b - December 16, 2013

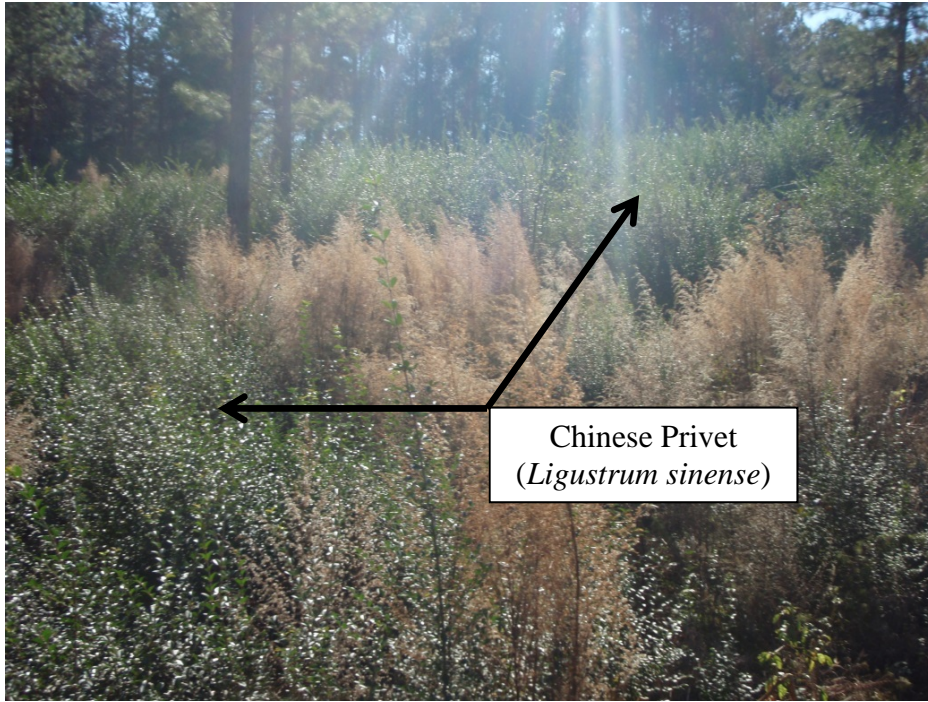
Invasive species vegetation areas of concern were observed and documented accordingly. One area, totaling approximately 0.18 acre, or 0.9% of the total easement acreage for the Site, was found to contain the invasive species Chinese privet (*Ligustrum sinense*). However, this population of Chinese privet is currently located outside of the 50 foot stream buffer. To control this area of invasive species early, this area was treated in 2014 during the appropriate treatment window by use of the herbicide Glyphosate.

| Table 6b. Vegetation Problem Areas | | | |
|---|---|---|---|
| Invasive/Exotic Populations | 48+00 to 52+00 | Ligustrum sinense | Vegetaton Photo Log |

View of Chinese Privet Problem Area 1 - View is East

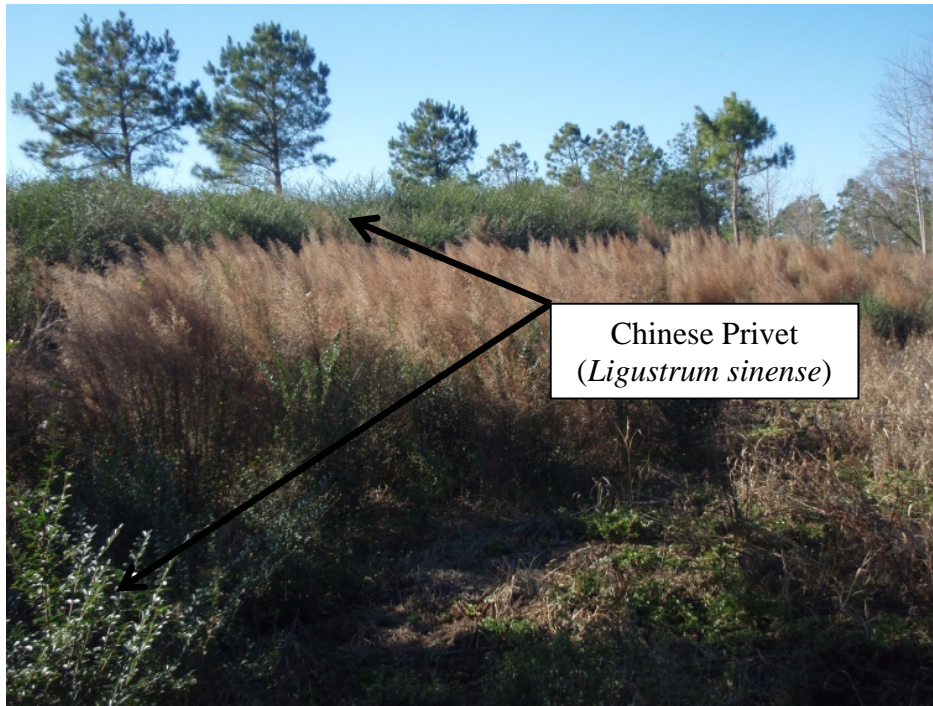
View of Chinese Privet Problem Area 1 - View is West
