UT to Mill Swamp Restoration Project Year 2 Final Monitoring Report

Onslow County, North Carolina
NCEEP Project ID Number - 95019

Project Info: Monitoring Year: 2 of 7
 Year of Data Collection: 2014
 Year of Completed Construction: 2013
 Submission Date: March 2015

Report Prepared and Submitted by Michael Baker Engineering, Inc.
NC Professional Engineering License # F-1084

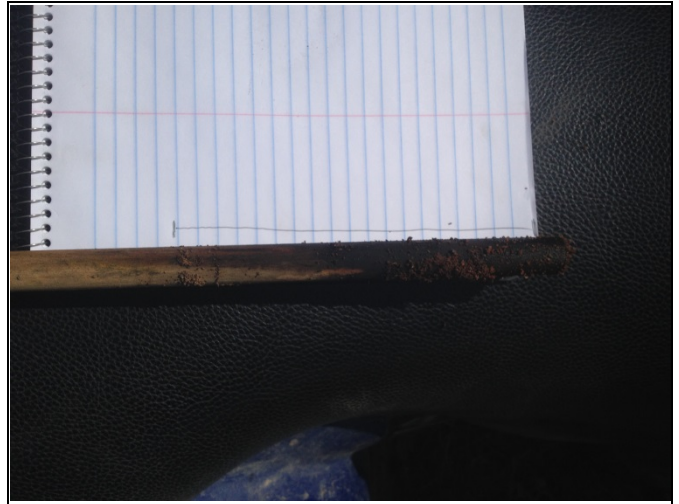
Crest gauge reading, 0.56 inches – October 14, 2014

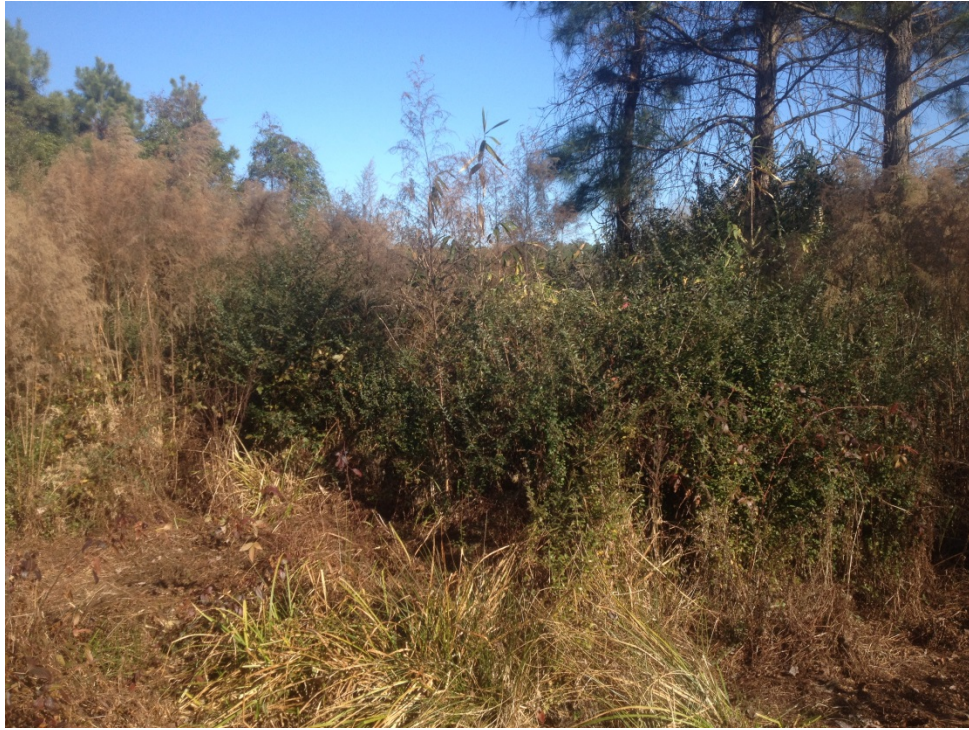
Table 6b. Vegetation Problem Areas (VPAs)			
UT to Mill Swamp Restoration Project: EEP Project ID No. 95019			
Feature Issue	Station Number	Suspected Cause	Photo Number
Invasive/Exotic Populations	38+50	<i>Ligustrum sinense</i>	NA
Invasive/Exotic Populations	47+00 to 50+00	<i>Ligustrum sinense</i>	2
Invasive/Exotic Populations	50+50 to 52+00	<i>Ligustrum sinense</i>	1

1. View of Chinese Privet problem area downstream UT1c floodplain - View is East

Invasive species vegetation areas of concern were observed and documented accordingly during Year 2. Following Year 2, three areas totaling approximately 0.68 acre, or 5.7 percent of the total planted area (12 acres) within the easement for the Site was found to contain the invasive species Chinese privet (*Ligustrum sinense*). To control areas of invasive species early, these areas are scheduled to be treated in 2015 during the appropriate treatment window by use of the herbicide Glyphosate.

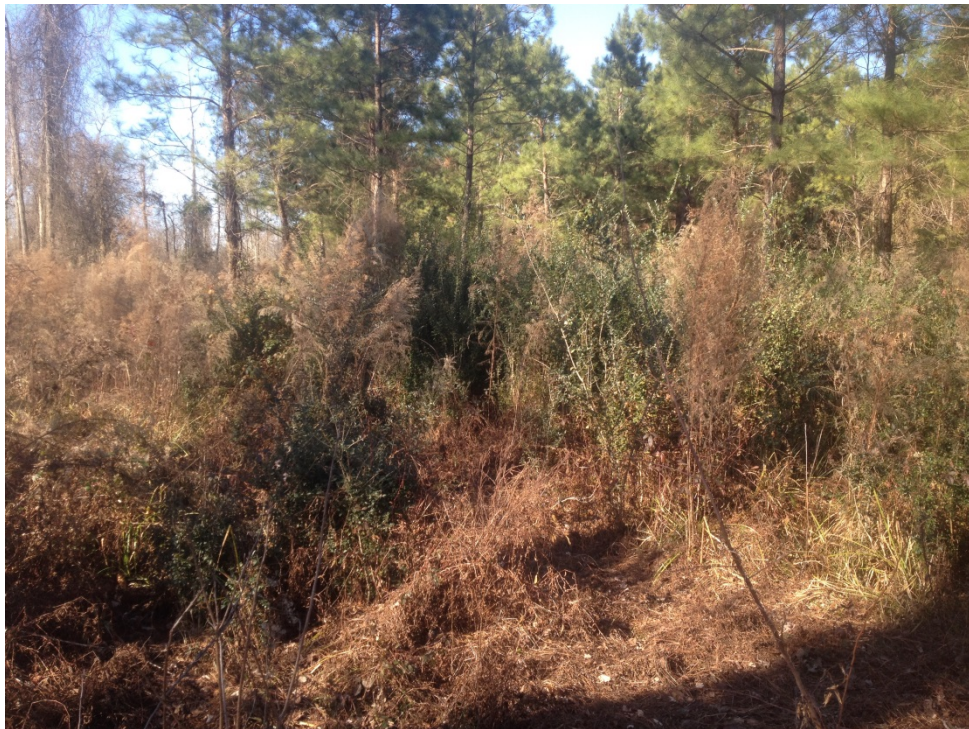
2. View of Chinese Privet problem area downstream UT1c floodplain - View is West
