UT to Mill Swamp - Monitoring Report Third Monitoring Measurement Second Year of Credit Release

**Onslow County, North Carolina
NCDMS Project ID Number - 95019**

Project Info: Credit Release Year: 2 of 7 (Third site measurement since construction)
Year of Data Collection: 2015
Year of Completed Construction: 2013
Submission Date: January 2016

Report Prepared and Submitted by Michael Baker Engineering, Inc.

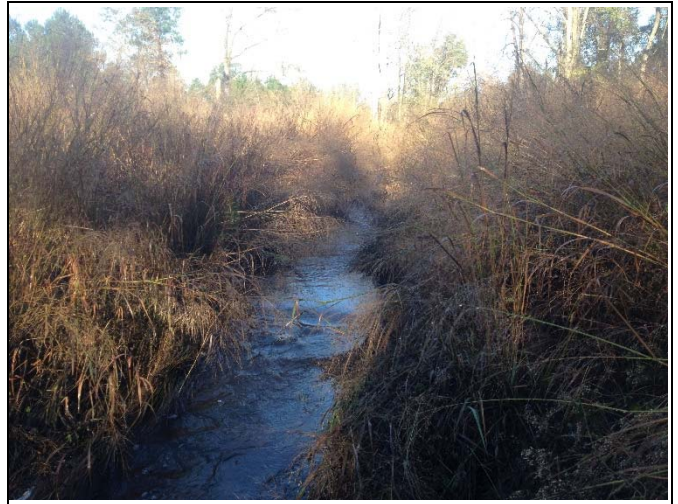
Photo Point 2 – Log Jam

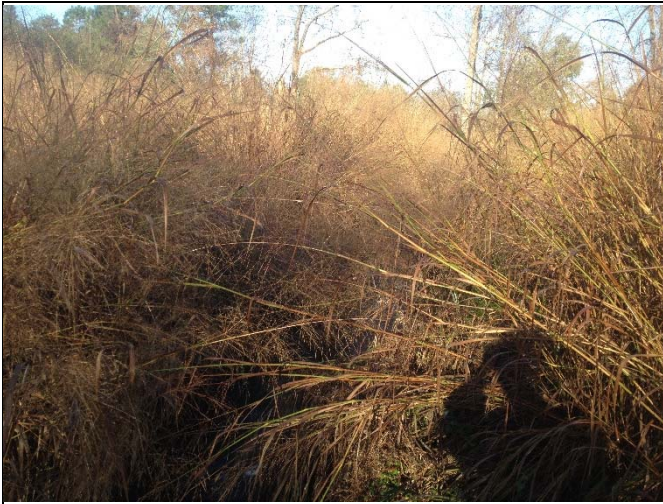
Photo Point 3 – Log Jam

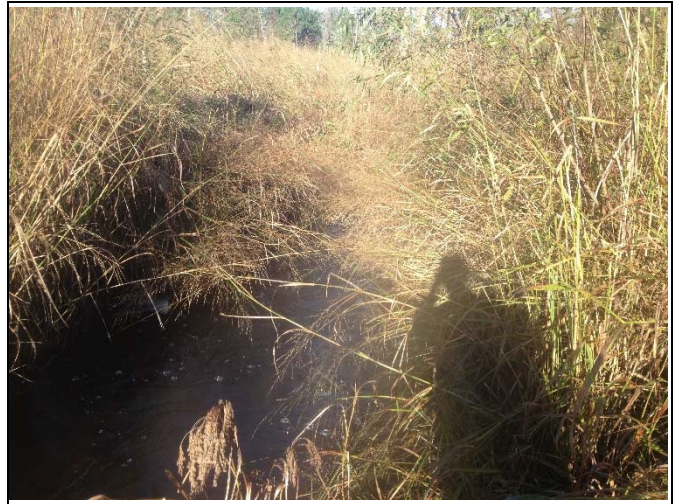
Photo Point 4 – Log Weir/Log Jam

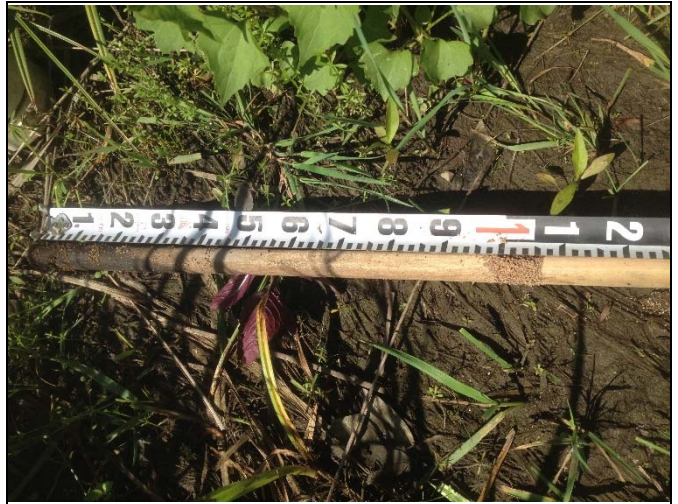
Crest gauge reading, 1.07 feet – April 27, 2015

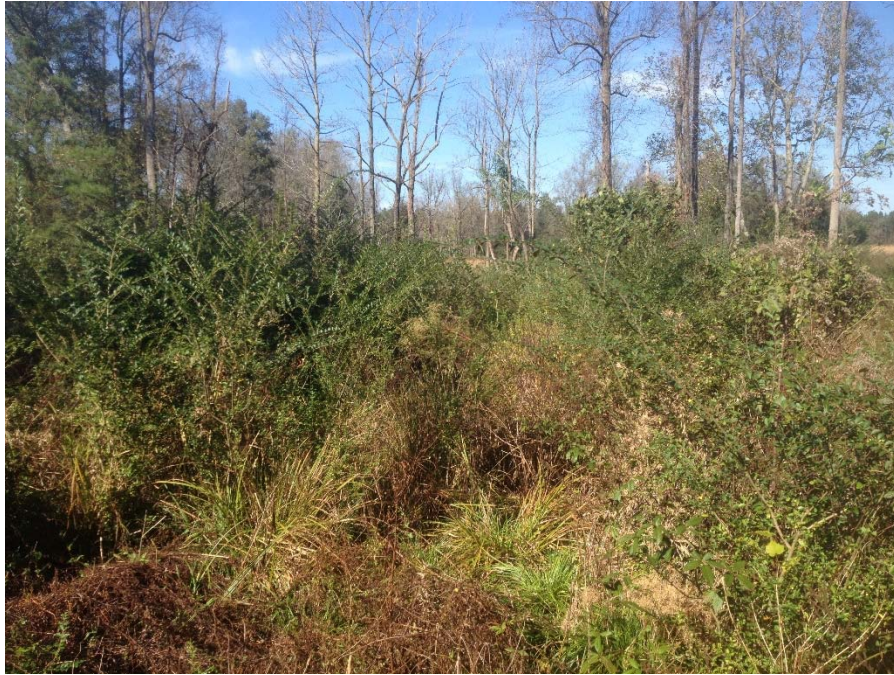
1. View of Chinese Privet in Vegetation Problem Area #1 (See CCPV).

Downstream UT1c - View is north

Invasive species areas of concern were observed and documented accordingly during Year 2. Following Year 2 monitoring, four areas totaling approximately 1.48 acres of the planted area were found to contain the invasive species, Chinese privet. To control areas of invasive species, these areas are scheduled to be treated in 2016 during the appropriate treatment window by use of the herbicide Glyphosate.

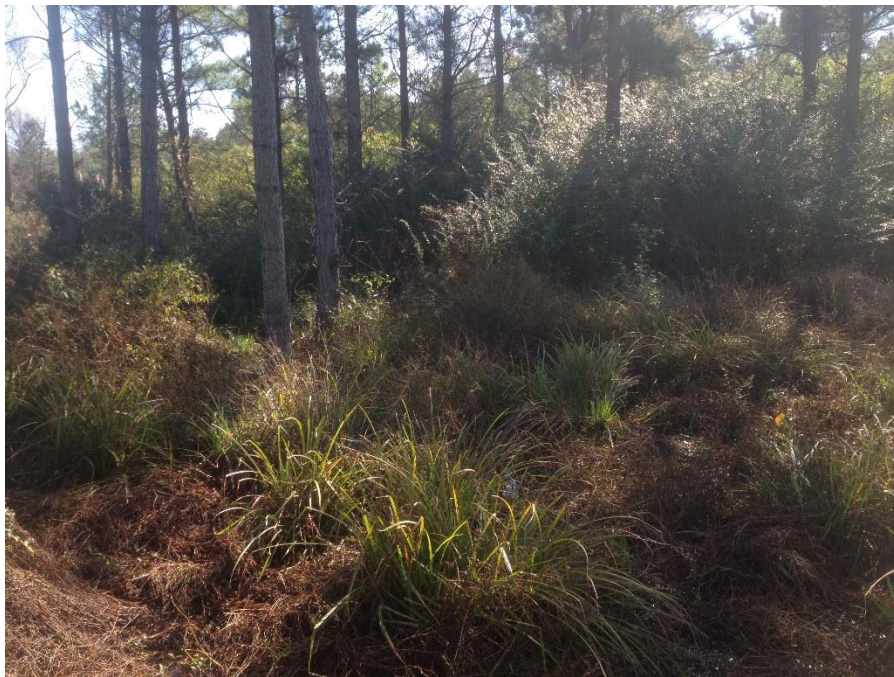
2. View of Chinese Privet in Vegetation Problem Area #2 (See CCPV)

Downstream UT1c - View is south

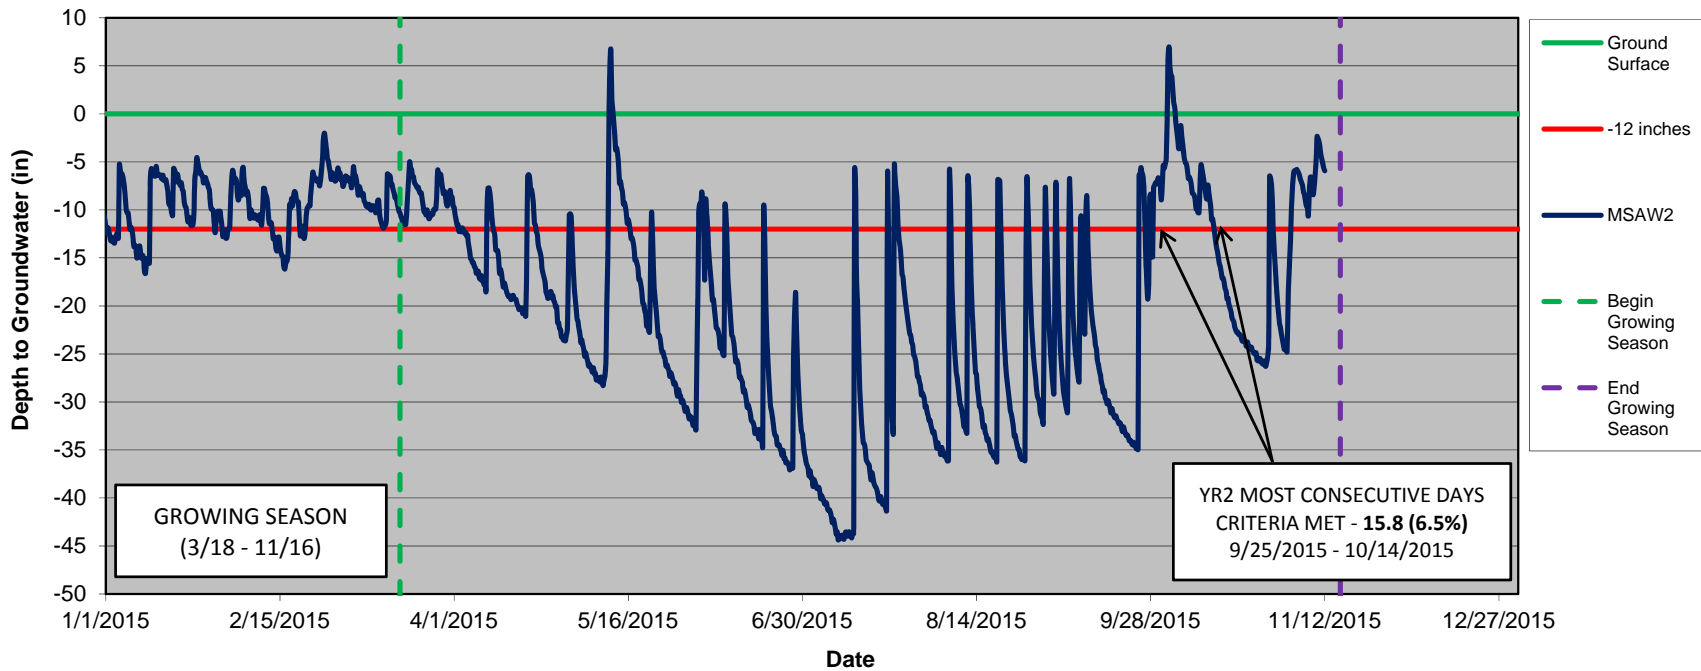
UT to Mill Swamp Wetland Restoration Well (MSAW2)

During Year 2 monitoring, it was determined that monitoring wells (MSAW2, MSAW3, MSAW6, MSAW7, MSAW9 and MSAW10) were potentially providing erroneous data. The cause of the data errors was estimated to be two-fold. The first cause was estimated to be a hardware issue. During field investigations, it was determined that the water pressure sensor of some the pressure transducers had become clogged with bentonite. The transducers have since been unclogged and elevated within the well casing to reduce the likelihood of clogging, and the holes pumped out to remove remaining bentonite particles existing within the well casing. In addition, all pressure transducers are cleaned during each logger download. The second cause is estimated to be due to the installation of the wells during less than ideal conditions. Auguring well holes during the wet conditions of the site potentially smeared the soil of the well hole wall which could decrease soil permeability.

Due to the aforementioned issues, a minimum of six additional wells will be installed in 2016 along the left floodplain of UT1c. In addition, poorly performing well locations may be adjusted and new well holes augured. During subsequent well data collection, the automatic wells will be calibrated by measuring the ground water level before the data logger is removed from the well casing. The manual measurement will ensure accurate and real-time data provided by the automatic wells.
