UT to Mill Swamp - Monitoring Report Fourth Monitoring Measurement Third Year of Credit Release

**Onslow County, North Carolina
NCDMS Project ID Number - 95019**

Project Info: Credit Release Year: 3 of 7 (Fourth site measurement since construction)
Year of Data Collection: 2016
Year of Completed Construction: 2013
Submission Date: January 2017

Report Prepared and Submitted by Michael Baker Engineering, Inc.

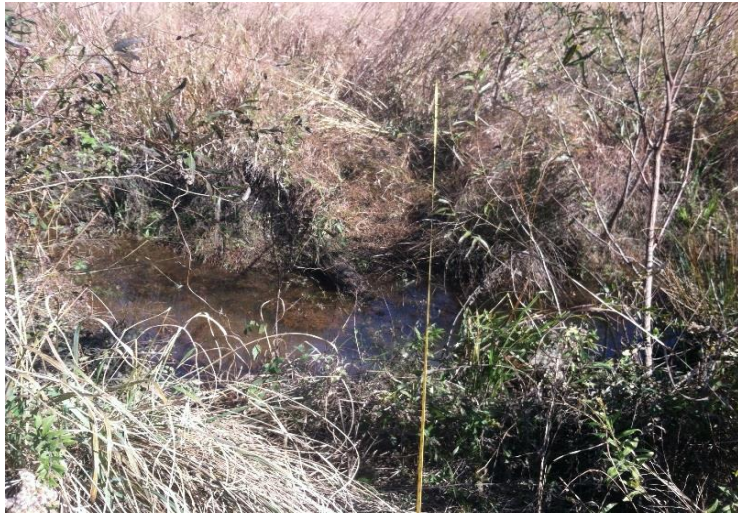
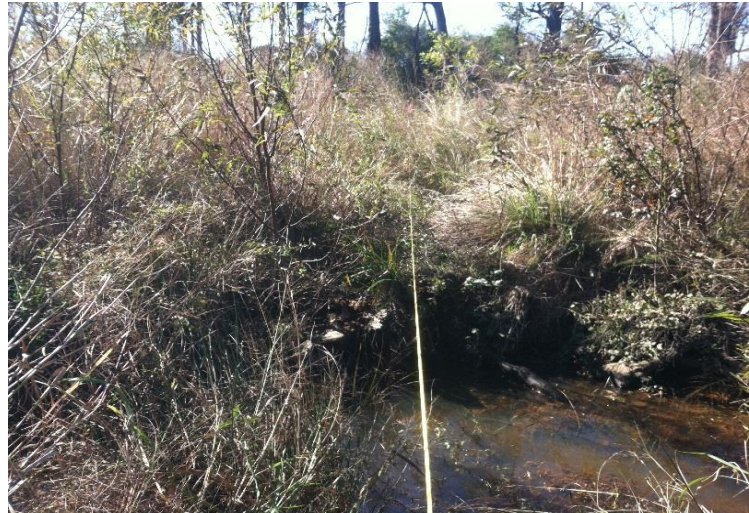
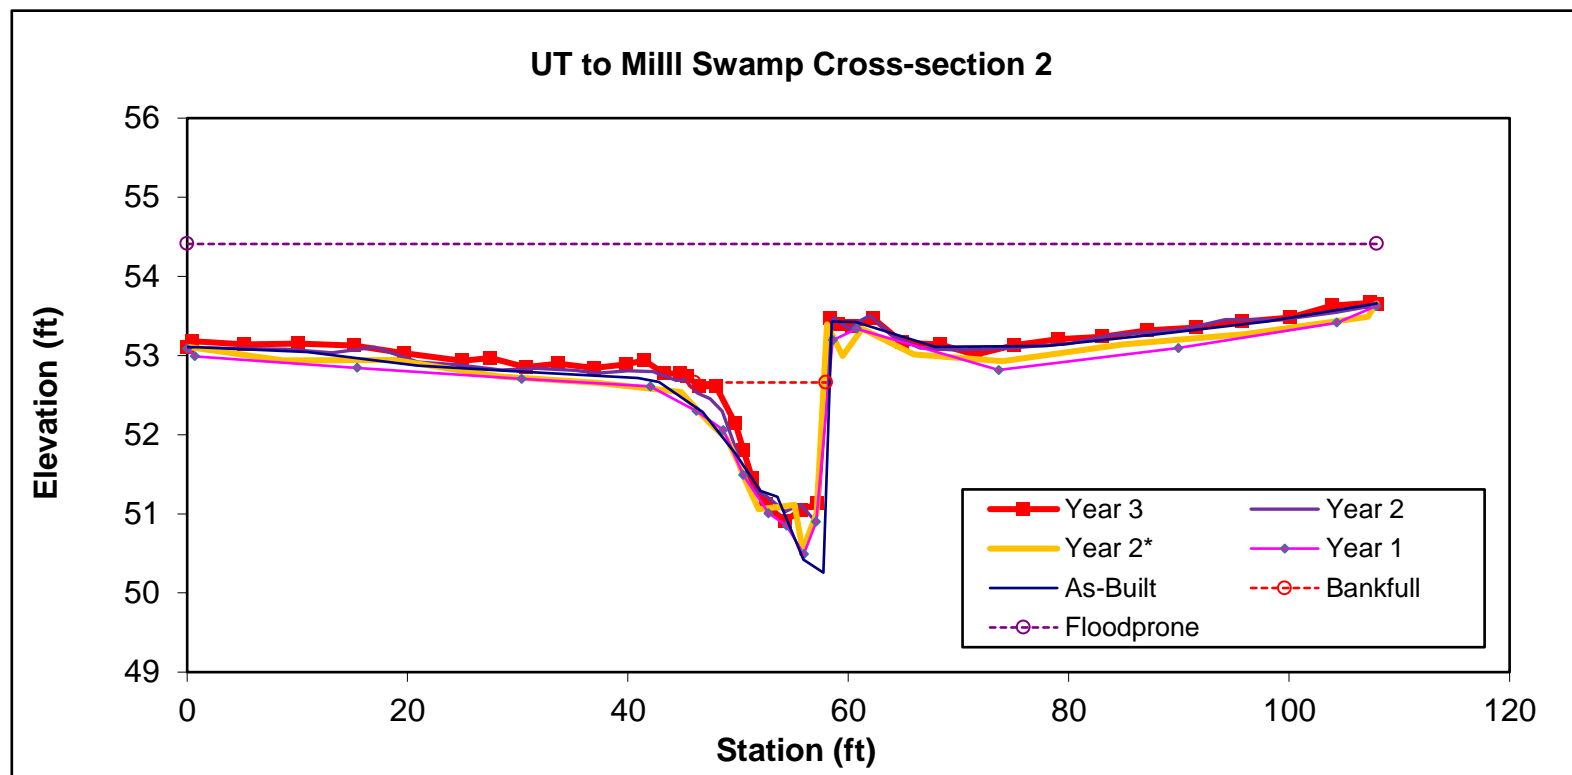
Permanent Cross-section 2

Feature	Stream Type	BKF Area	BKF Width	BKF Depth	Max BKF Depth	W/D	BH Ratio	ER	BKF Elev	TOB Elev
Pool		11.9	11.94	0.99	1.75	12.02	1.1	9	52.66	52.77

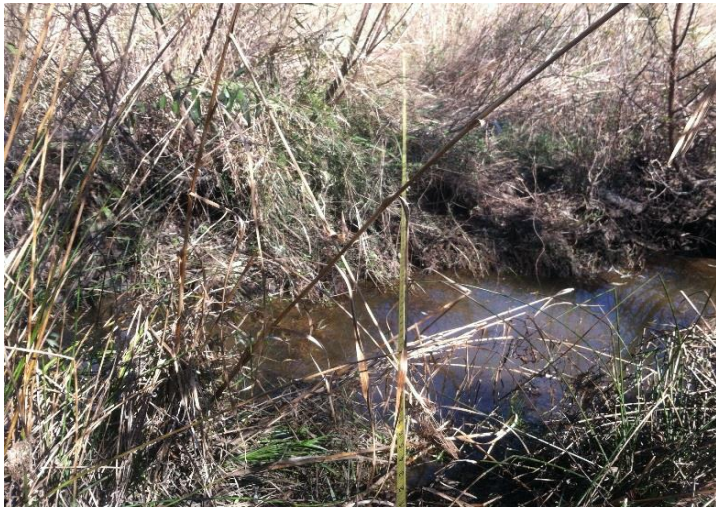
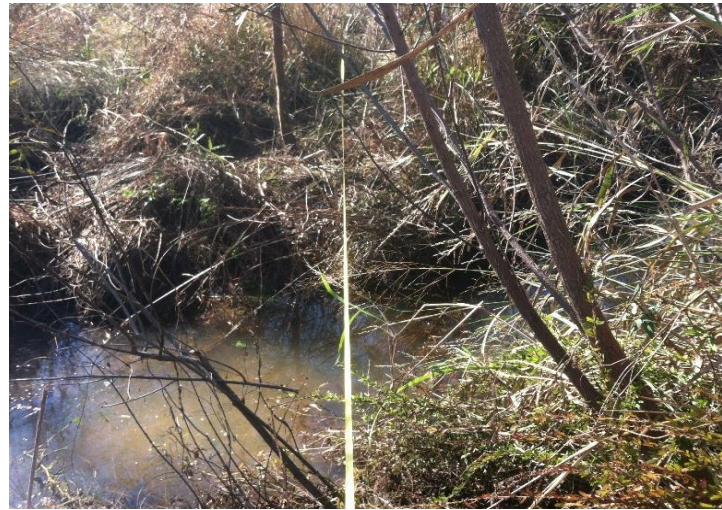
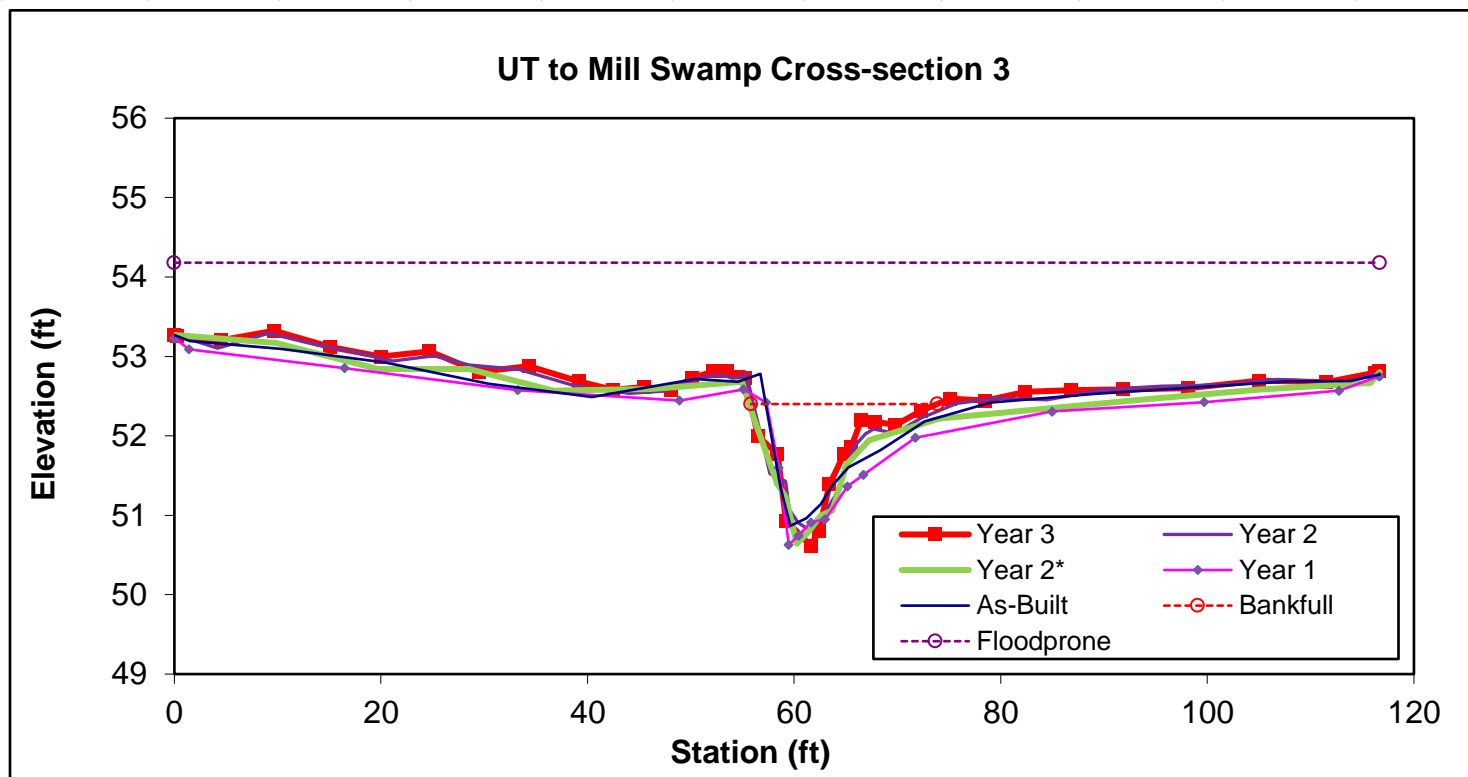
Permanent Cross-section 3

Feature	Stream Type	BKF Area	BKF Width	BKF Depth	Max BKF Depth	W/D	BH Ratio	ER	BKF Elev	TOB Elev
Pool		11.7	18.06	0.65	1.78	27.84	1	6.5	52.4	52.47

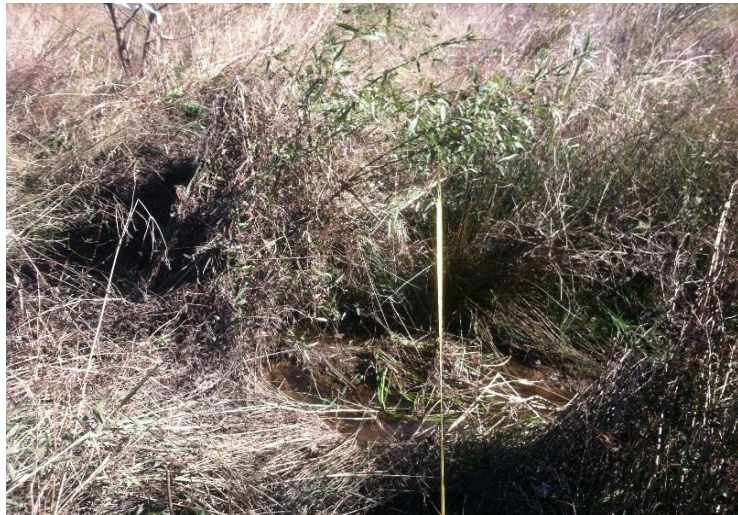
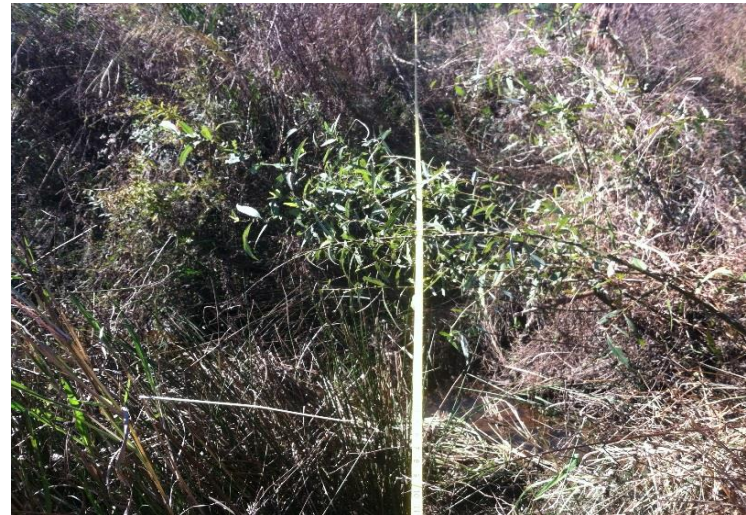
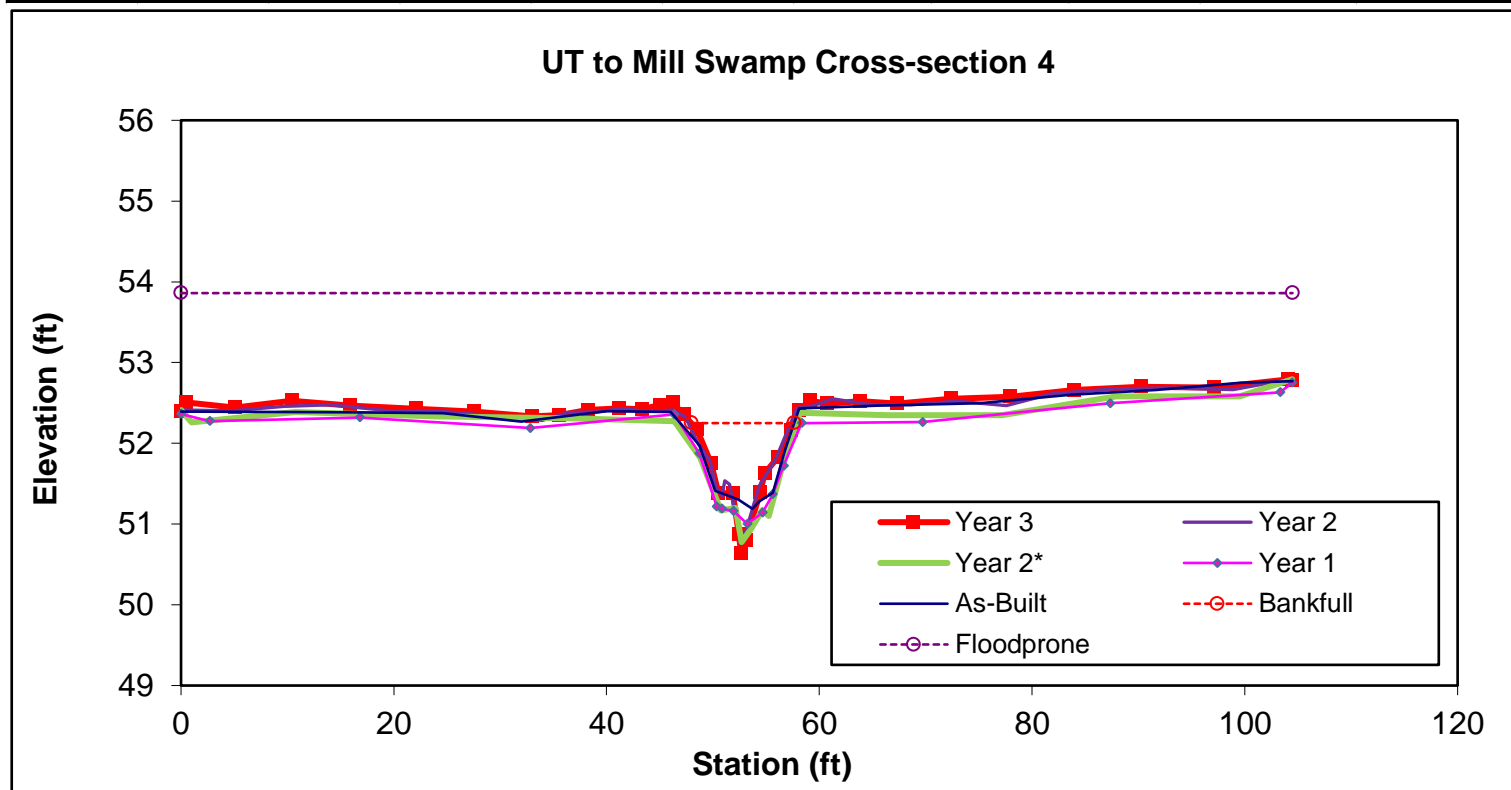
Permanent Cross-section 4

Feature	Stream Type	BKF Area	BKF Width	BKF Depth	Max BKF Depth	W/D	BH Ratio	ER	BKF Elev	TOB Elev
Riffle	C	6.6	9.66	0.68	1.61	14.25	1.2	10.8	52.25	52.5

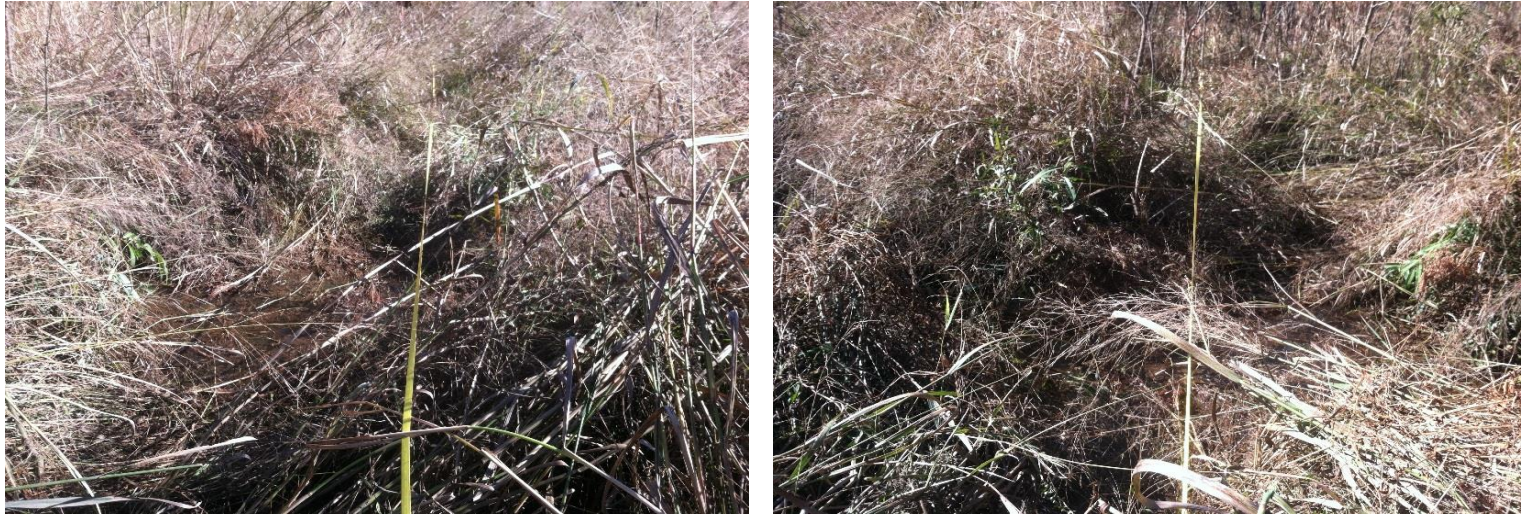
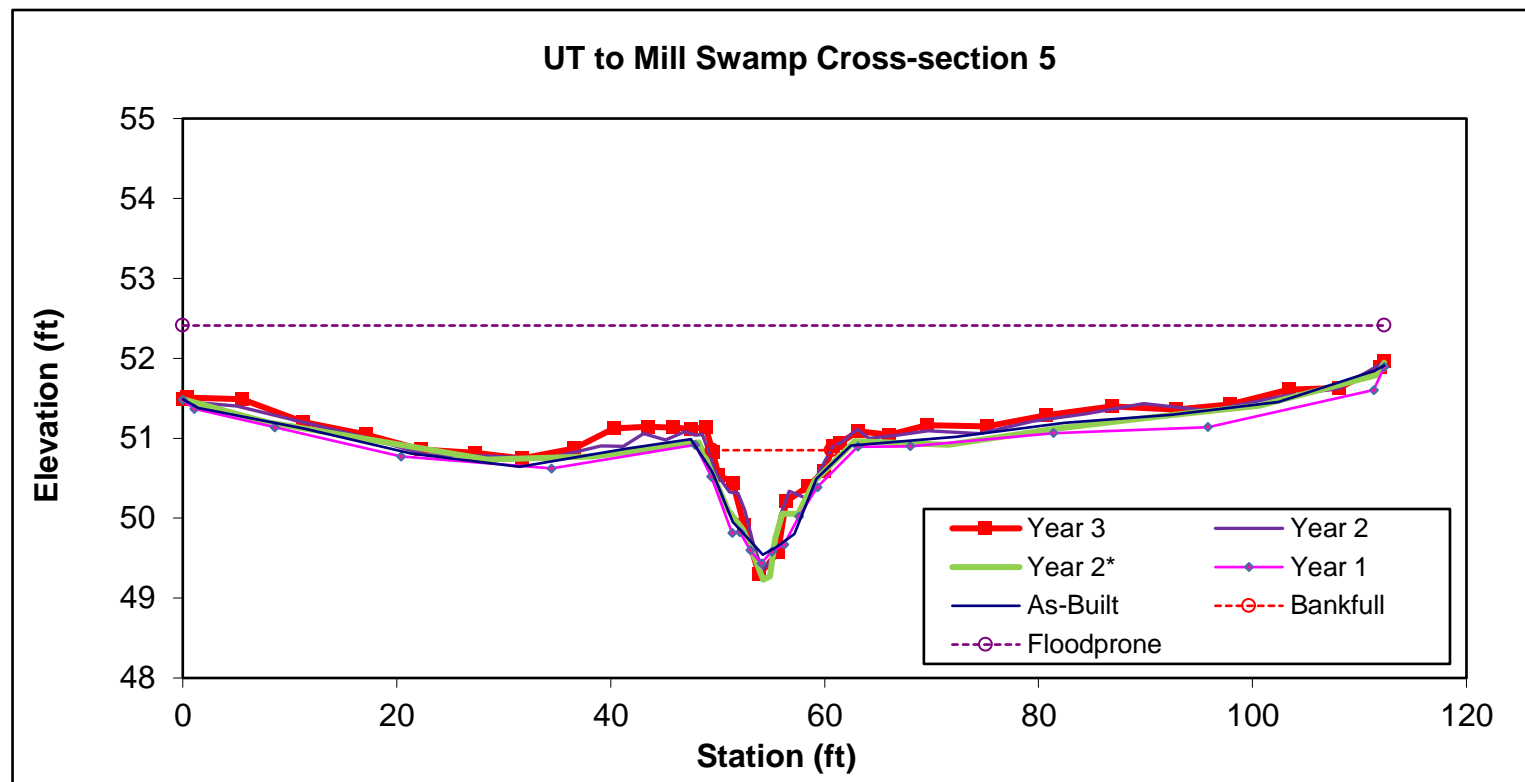
Permanent Cross-section 5

Feature	Stream Type	BKF Area	BKF Width	BKF Depth	Max BKF Depth	W/D	BH Ratio	ER	BKF Elev	TOB Elev
Riffle	C	8	11.15	0.72	1.56	15.54	1.2	10.1	50.85	51.09

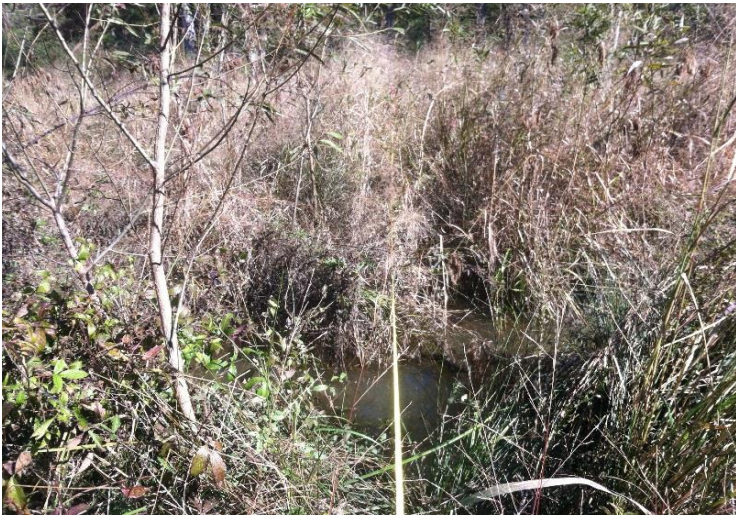
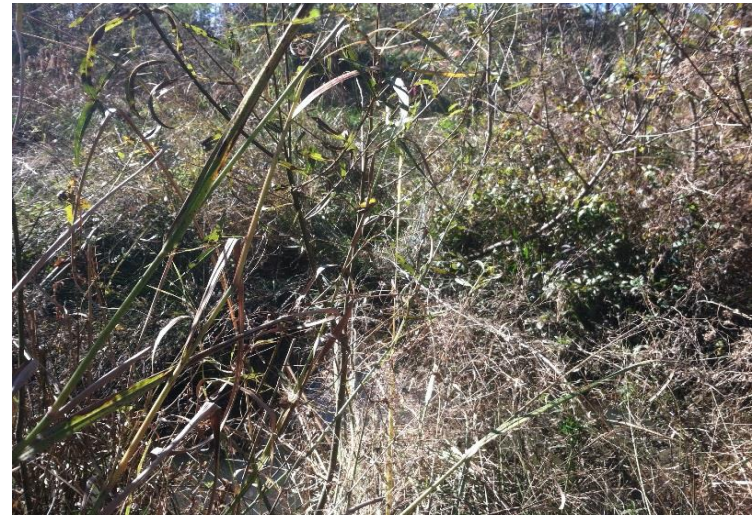
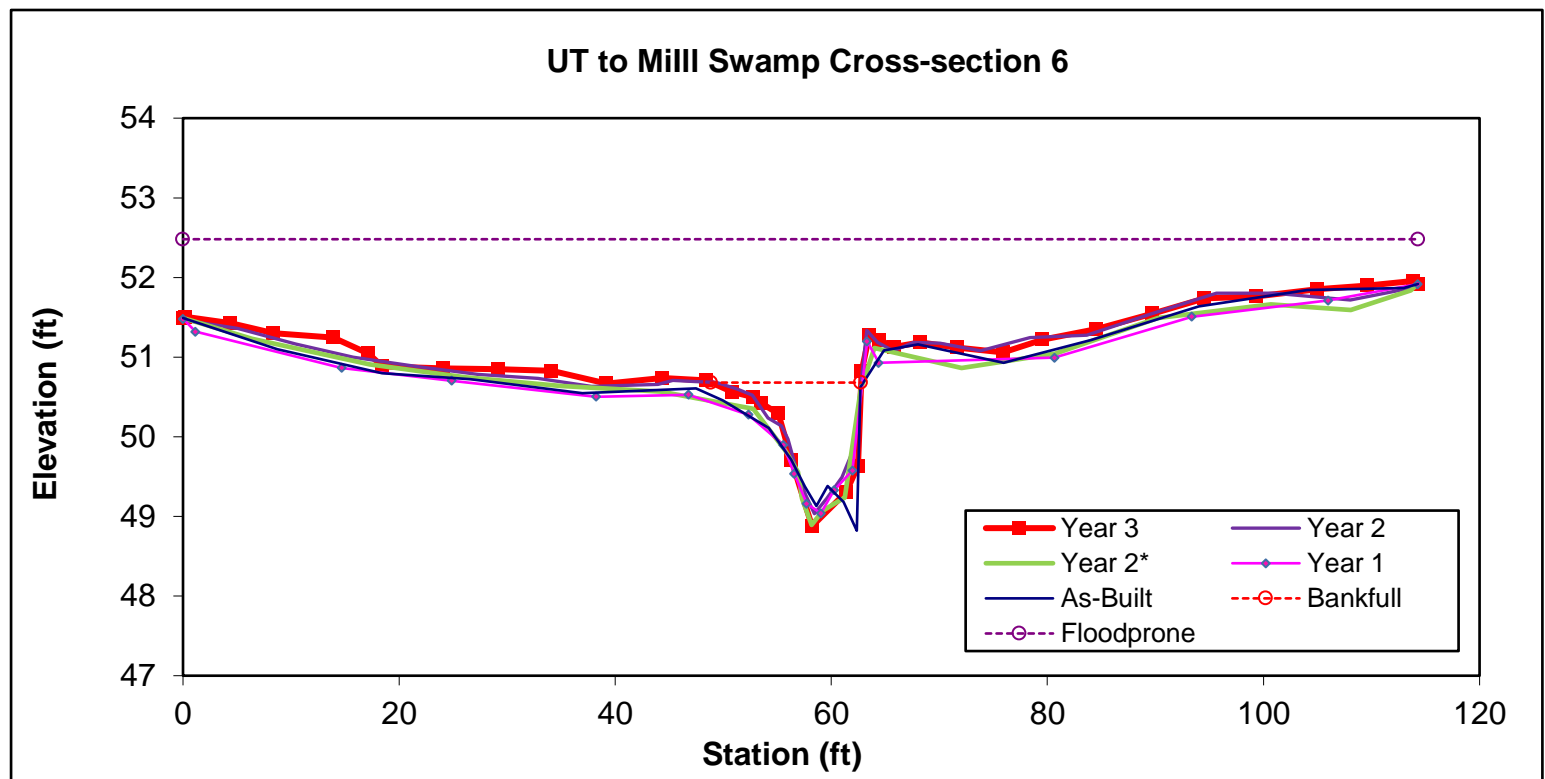
Permanent Cross-section 6

Feature	Stream Type	BKF Area	BKF Width	BKF Depth	Max BKF Depth	W/D	BH Ratio	ER	BKF Elev	TOB Elev
Pool		11.1	13.9	0.8	1.8	17.47	1	8.2	50.68	50.71

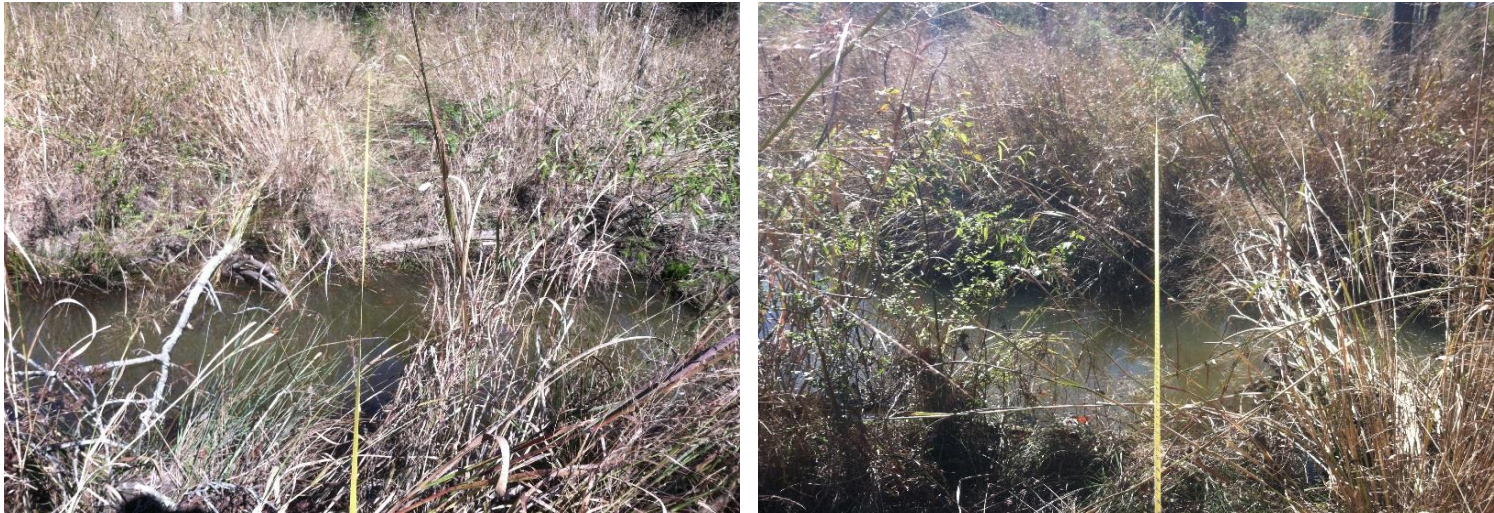
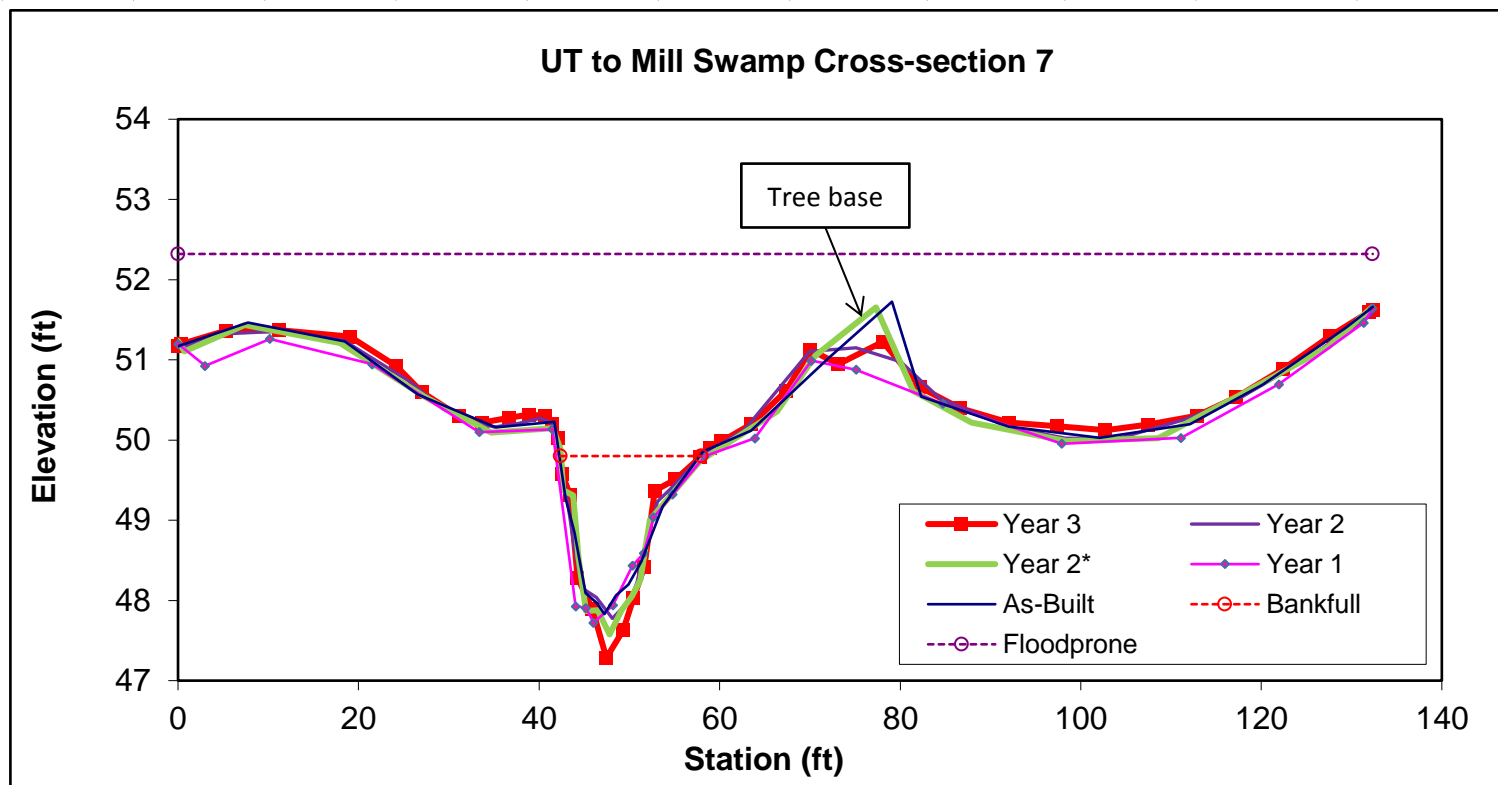
Permanent Cross-section 7

Feature	Stream Type	BKF Area	BKF Width	BKF Depth	Max BKF Depth	W/D	BH Ratio	ER	BKF Elev	TOB Elev
Pool		18.2	15.59	1.17	2.52	13.37	1	8.5	49.8	49.9

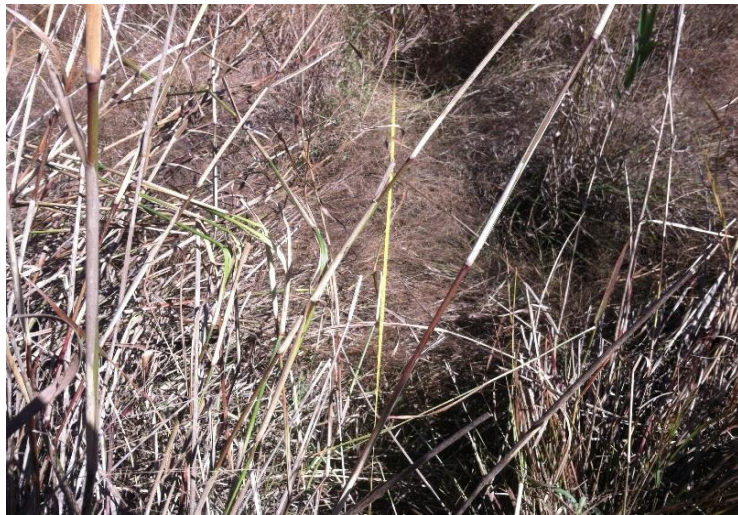
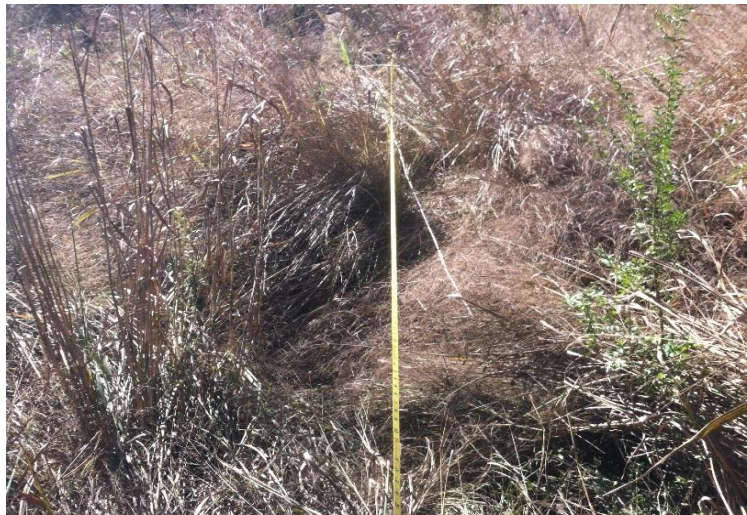
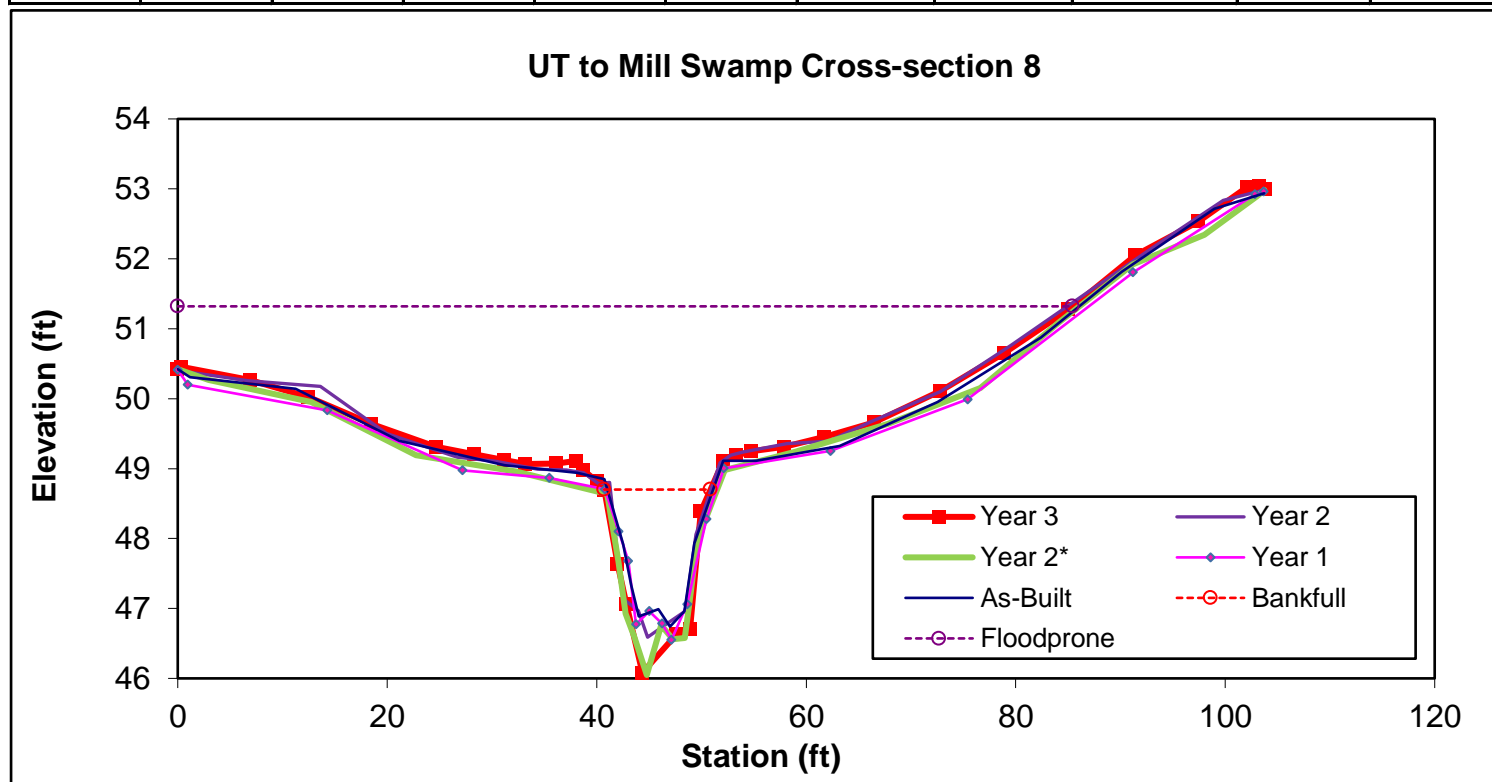
Permanent Cross-section 8

Feature	Stream Type	BKF Area	BKF Width	BKF Depth	Max BKF Depth	W/D	BH Ratio	ER	BKF Elev	TOB Elev
Riffle	E	16.7	10.16	1.64	2.62	6.19	1.2	8.4	48.7	49.1

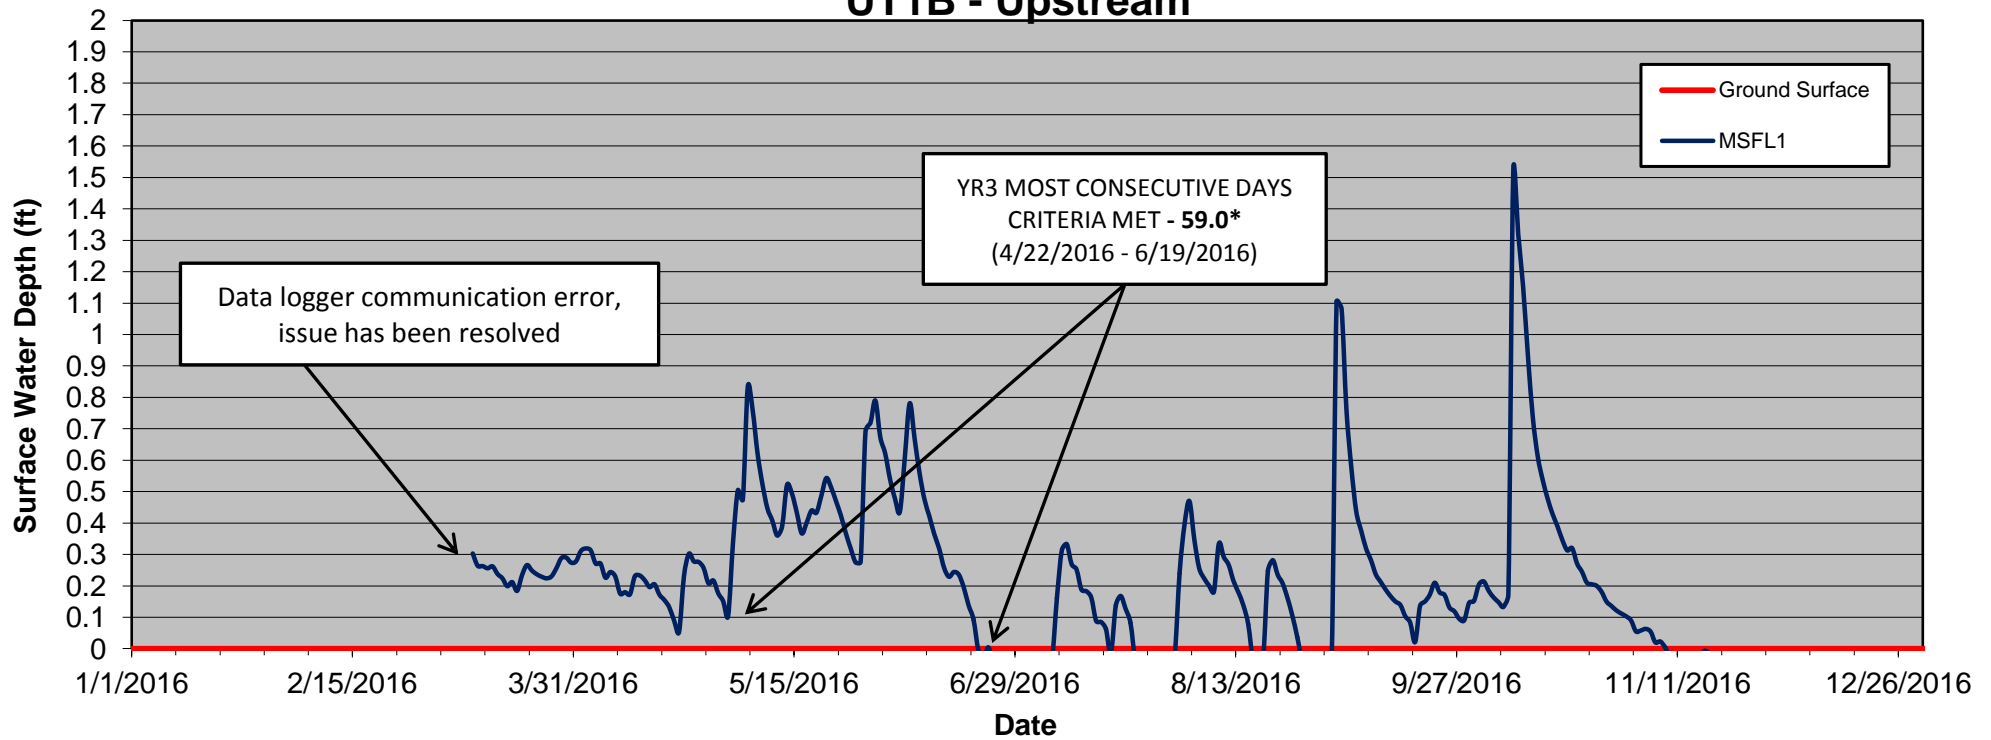
UT to Mill Swamp (Flow Gauge 1 - MSFL1) UT1B - Upstream

* Surface water flow is estimated to have occurred when the pressure transducer reading is equal to or above 0.1 feet in depth.

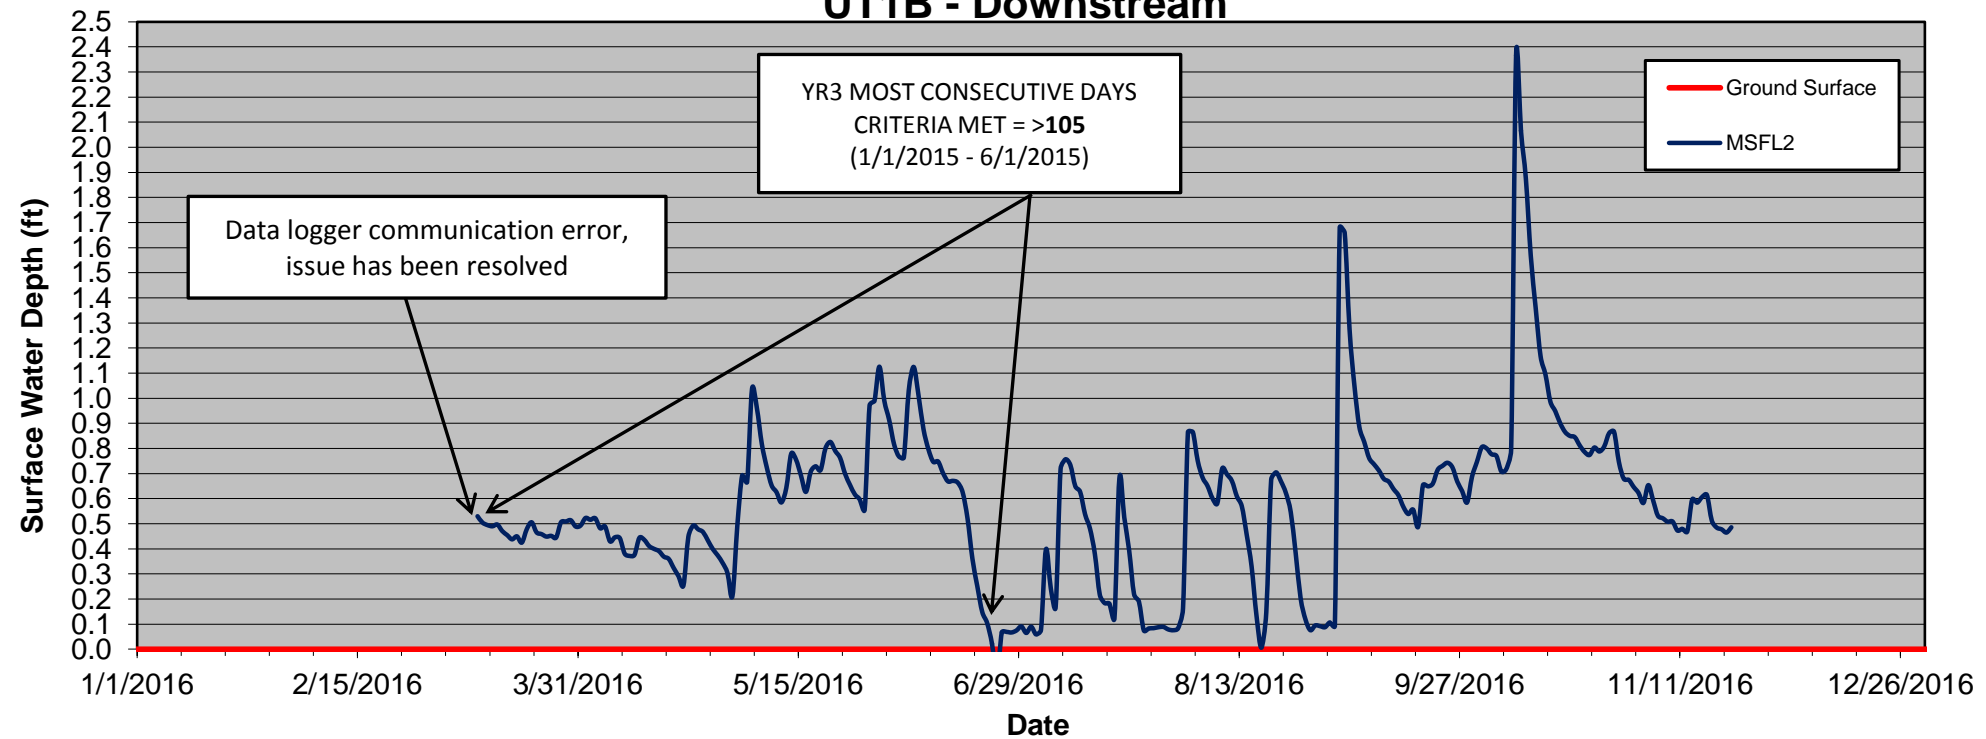
UT to Mill Swamp (Flow Gauge 2 - MSFL2) UT1B - Downstream

* Surface water flow is estimated to have occurred when the pressure transducer reading is equal to or above 0.1 feet in depth.
