UT to Mill Swamp Restoration Project Fifth Monitoring Measurement Fourth Year of Credit Release - Final

Onslow County, North Carolina

DMS Project ID Number – 95019, DEQ Contract No. 003992

Report Prepared and Submitted by Michael Baker Engineering, Inc.

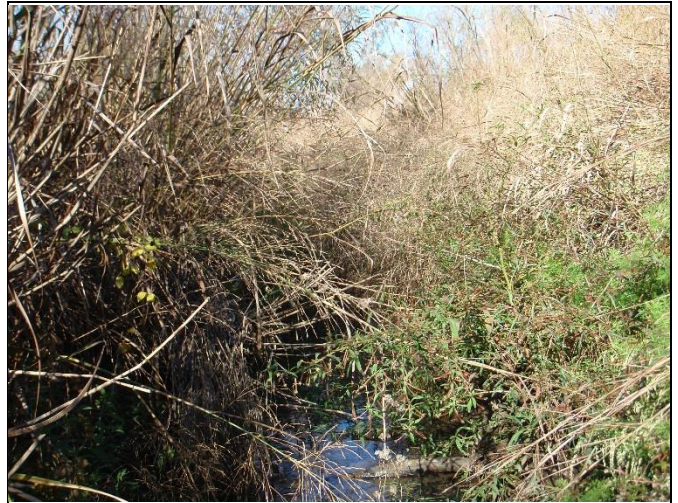
Photo Point 2 – Log Jam

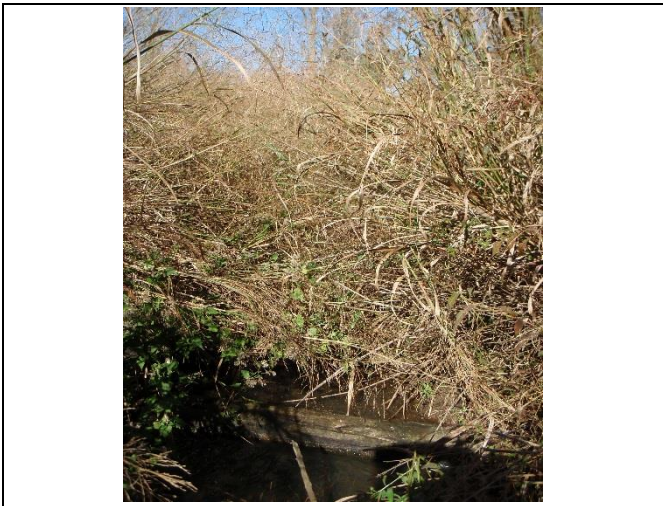
Photo Point 3 – Log Jam

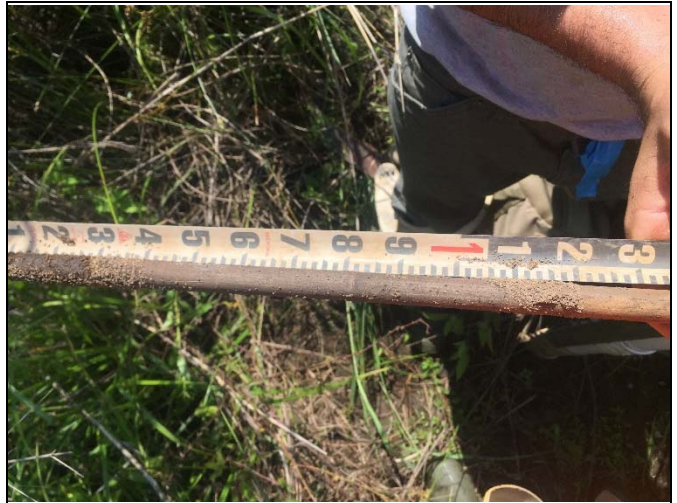
Crest gauge reading, 1.20 ft from 4/25/17 storm

Table 14. Verification of Bankfull Events UT to Mill Swamp Restoration Project: DMS Project No. 95019			
Date of Data Collection	Estimated Occurrence of Bankfull Event	Method of Data Collection	Gauge Reading (feet)
Year 1 (2013)			
10/16/2013	10/11/2013	Crest Gauge	0.17
12/24/2013	12/15/2013	Crest Gauge	0.19
Year 2* (2014)			
3/27/2014	3/7/2014	Crest Gauge	0.32
10/14/2014	8/4/2014	Crest Gauge	0.56
12/19/2014	11/26/2014	Crest Gauge	0.27
Year 2 (2015)			
1/24/2015	1/24/2015	Crest Gauge	0.59
4/27/2015	2/26/2015	Crest Gauge	1.07
6/23/2015	5/11/2015	Crest Gauge	1.61
11/12/2015	10/3/2015	Crest Gauge	1.54
Year 3 (2016)			
3/10/2016	2/5/2016	Crest Gauge	1.44
11/22/2016	10/8/2016 (Hurricane Matthew)	Crest Gauge	2.32
Year 4 (2017)			
3/20/2017	1/2/2017	Crest Gauge	1.18
6/2/2017	4/25/2017	Crest Gauge	1.20

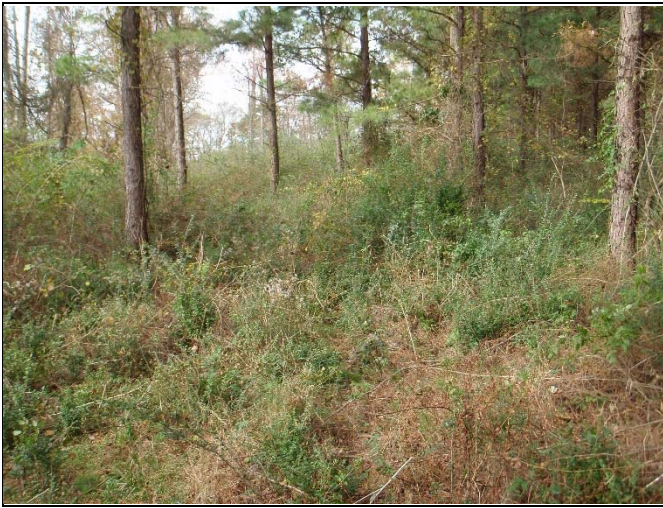
Invasive species areas of concern were observed and documented during Year 4 monitoring. One area of Chinese privet (*Ligustrum sinense*) re-sprouts totaling 0.58 acres was discovered along the left floodplain of the lower section of Reach UT1c. This is an area that had previously been treated for privet in November of 2016, and will again be treated in Monitoring Year 5.

Table 6b. Vegetation Problem Areas (VPAs)			
UT to Mill Swamp Restoration Project: DMS Project ID No. 95019			
Feature Issue	Vegetation Problem Area (as shown on CCPV)	Suspected Cause	Photo Number
Invasive/Exotic Populations	#1 (See CCPV)	Resprouts of <i>Ligustrum sinense</i>	Photos 1-3

VPA (*Ligustrum sinense* resprouts) 11/21/2017

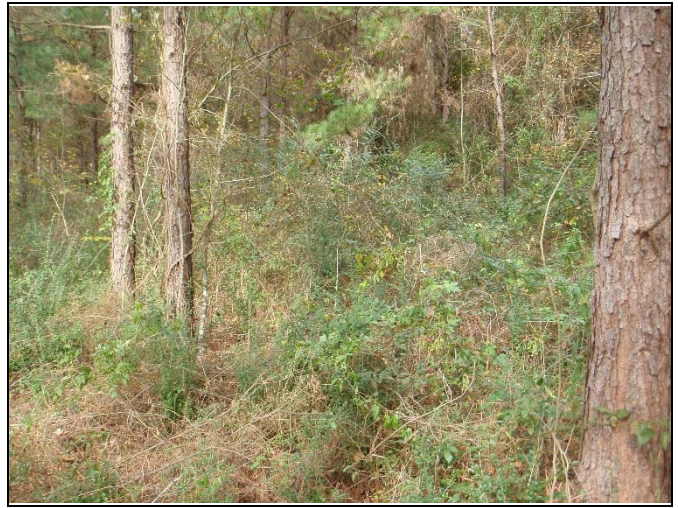
VPA (*Ligustrum sinense* resprouts) 11/21/2017

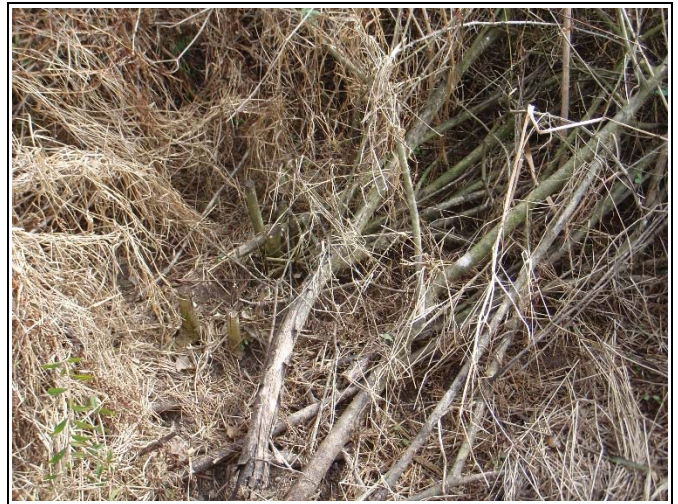
Ligustrum sinense (previously treated in Nov 2016)
